**Year 4 Monitoring Report**

**CATBIRD SITE**

NCDMS Project #100022 (Contract #7186)  
USACE Action ID: SAW-2017-01506  
DWR Project #20171039

RE: Catbird Site: Year 4 Monitoring Report (NCDMS ID 100022)

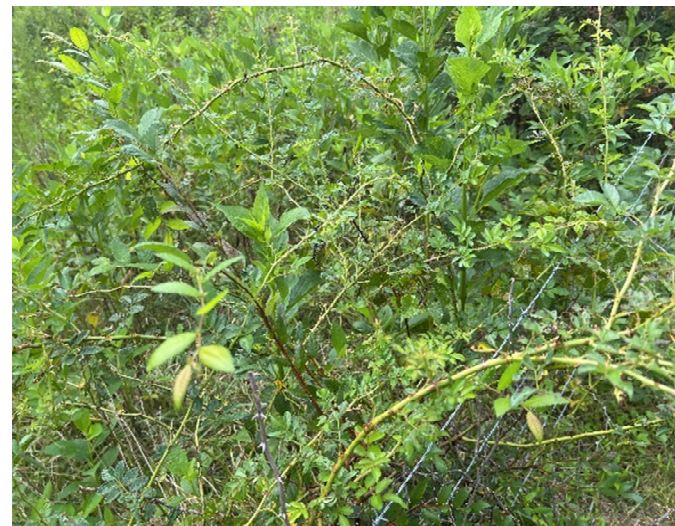
Visual assessment of vegetation outside of the monitoring plots indicates that the herbaceous vegetation is becoming well established throughout the project. Small, localized areas of Chinese privet and Multiflora rose were observed in late MY3, these areas will be treated this year (MY4). RES continued to remove black walnut and southern crabapple stems in MY4 and will continue as needed throughout the monitoring period.

Multiflora Rose Patch/ DS1/ 0.03 acres
