**Cat Creek
Stream and Wetland Restoration
NCEEP Project Number: 71
Monitoring Year 2
2011 Final Report**

**Submitted to
North Carolina Ecosystem Enhancement Program
North Carolina Department of Environment and Natural Resources
November 2011**

Cat Creek Stream and Wetland Restoration 2011 Monitoring Report (MY 2)

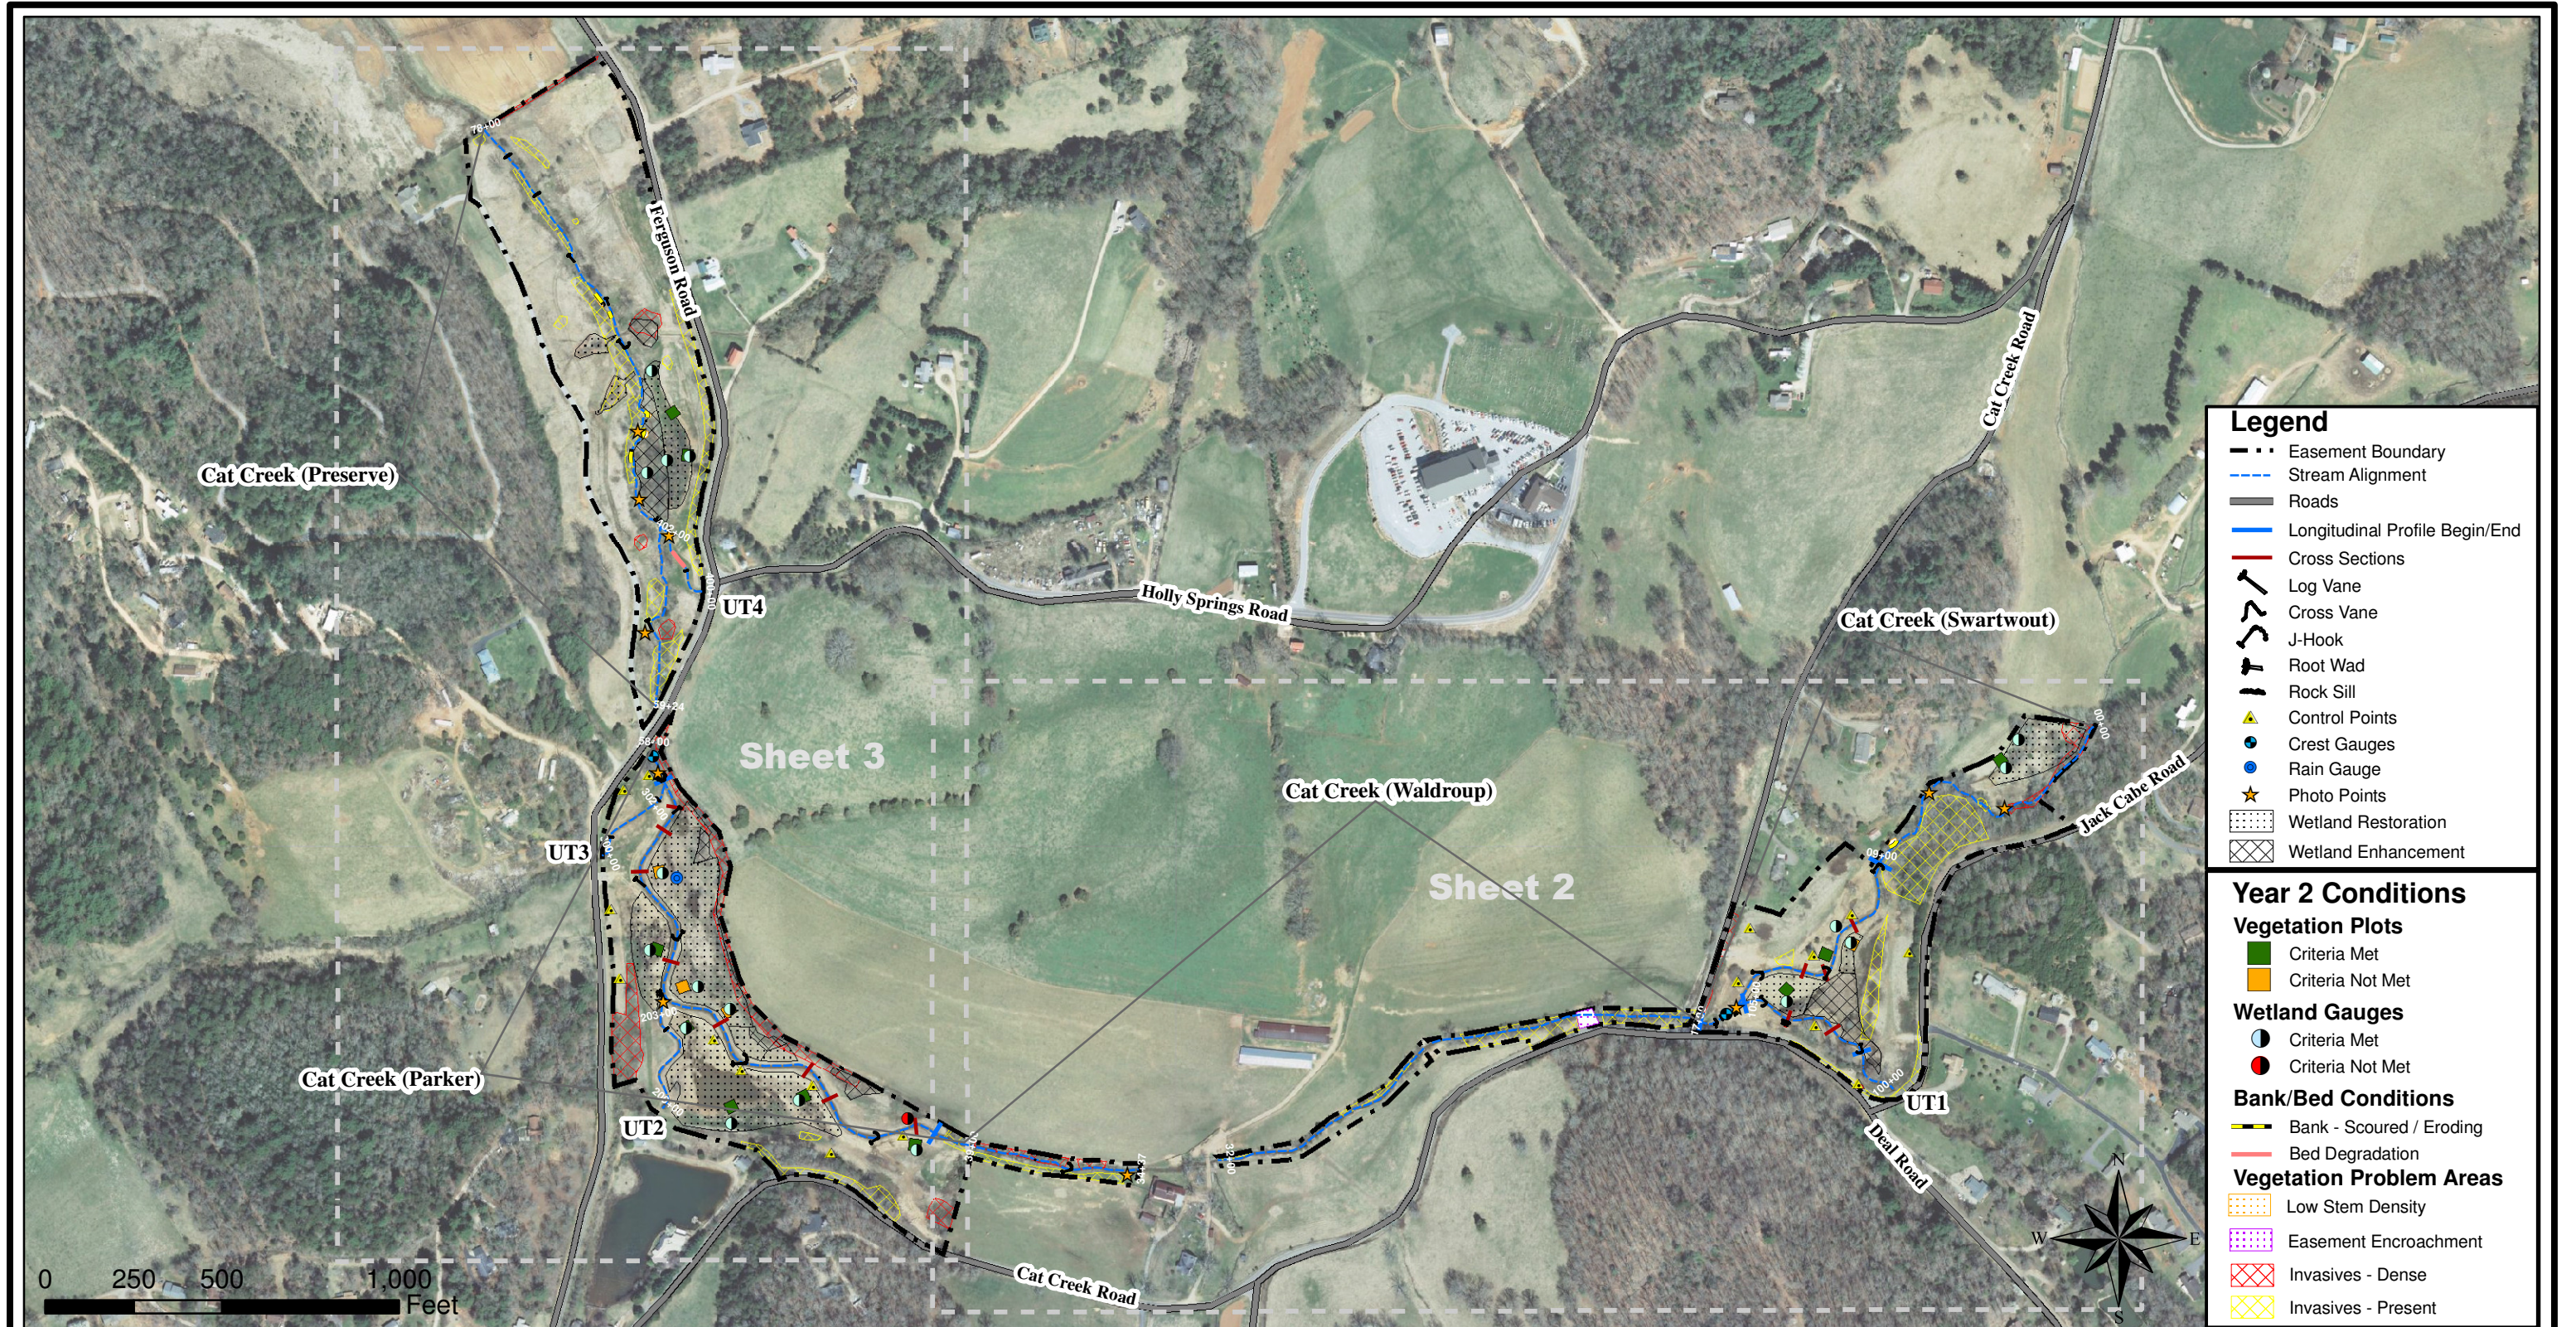
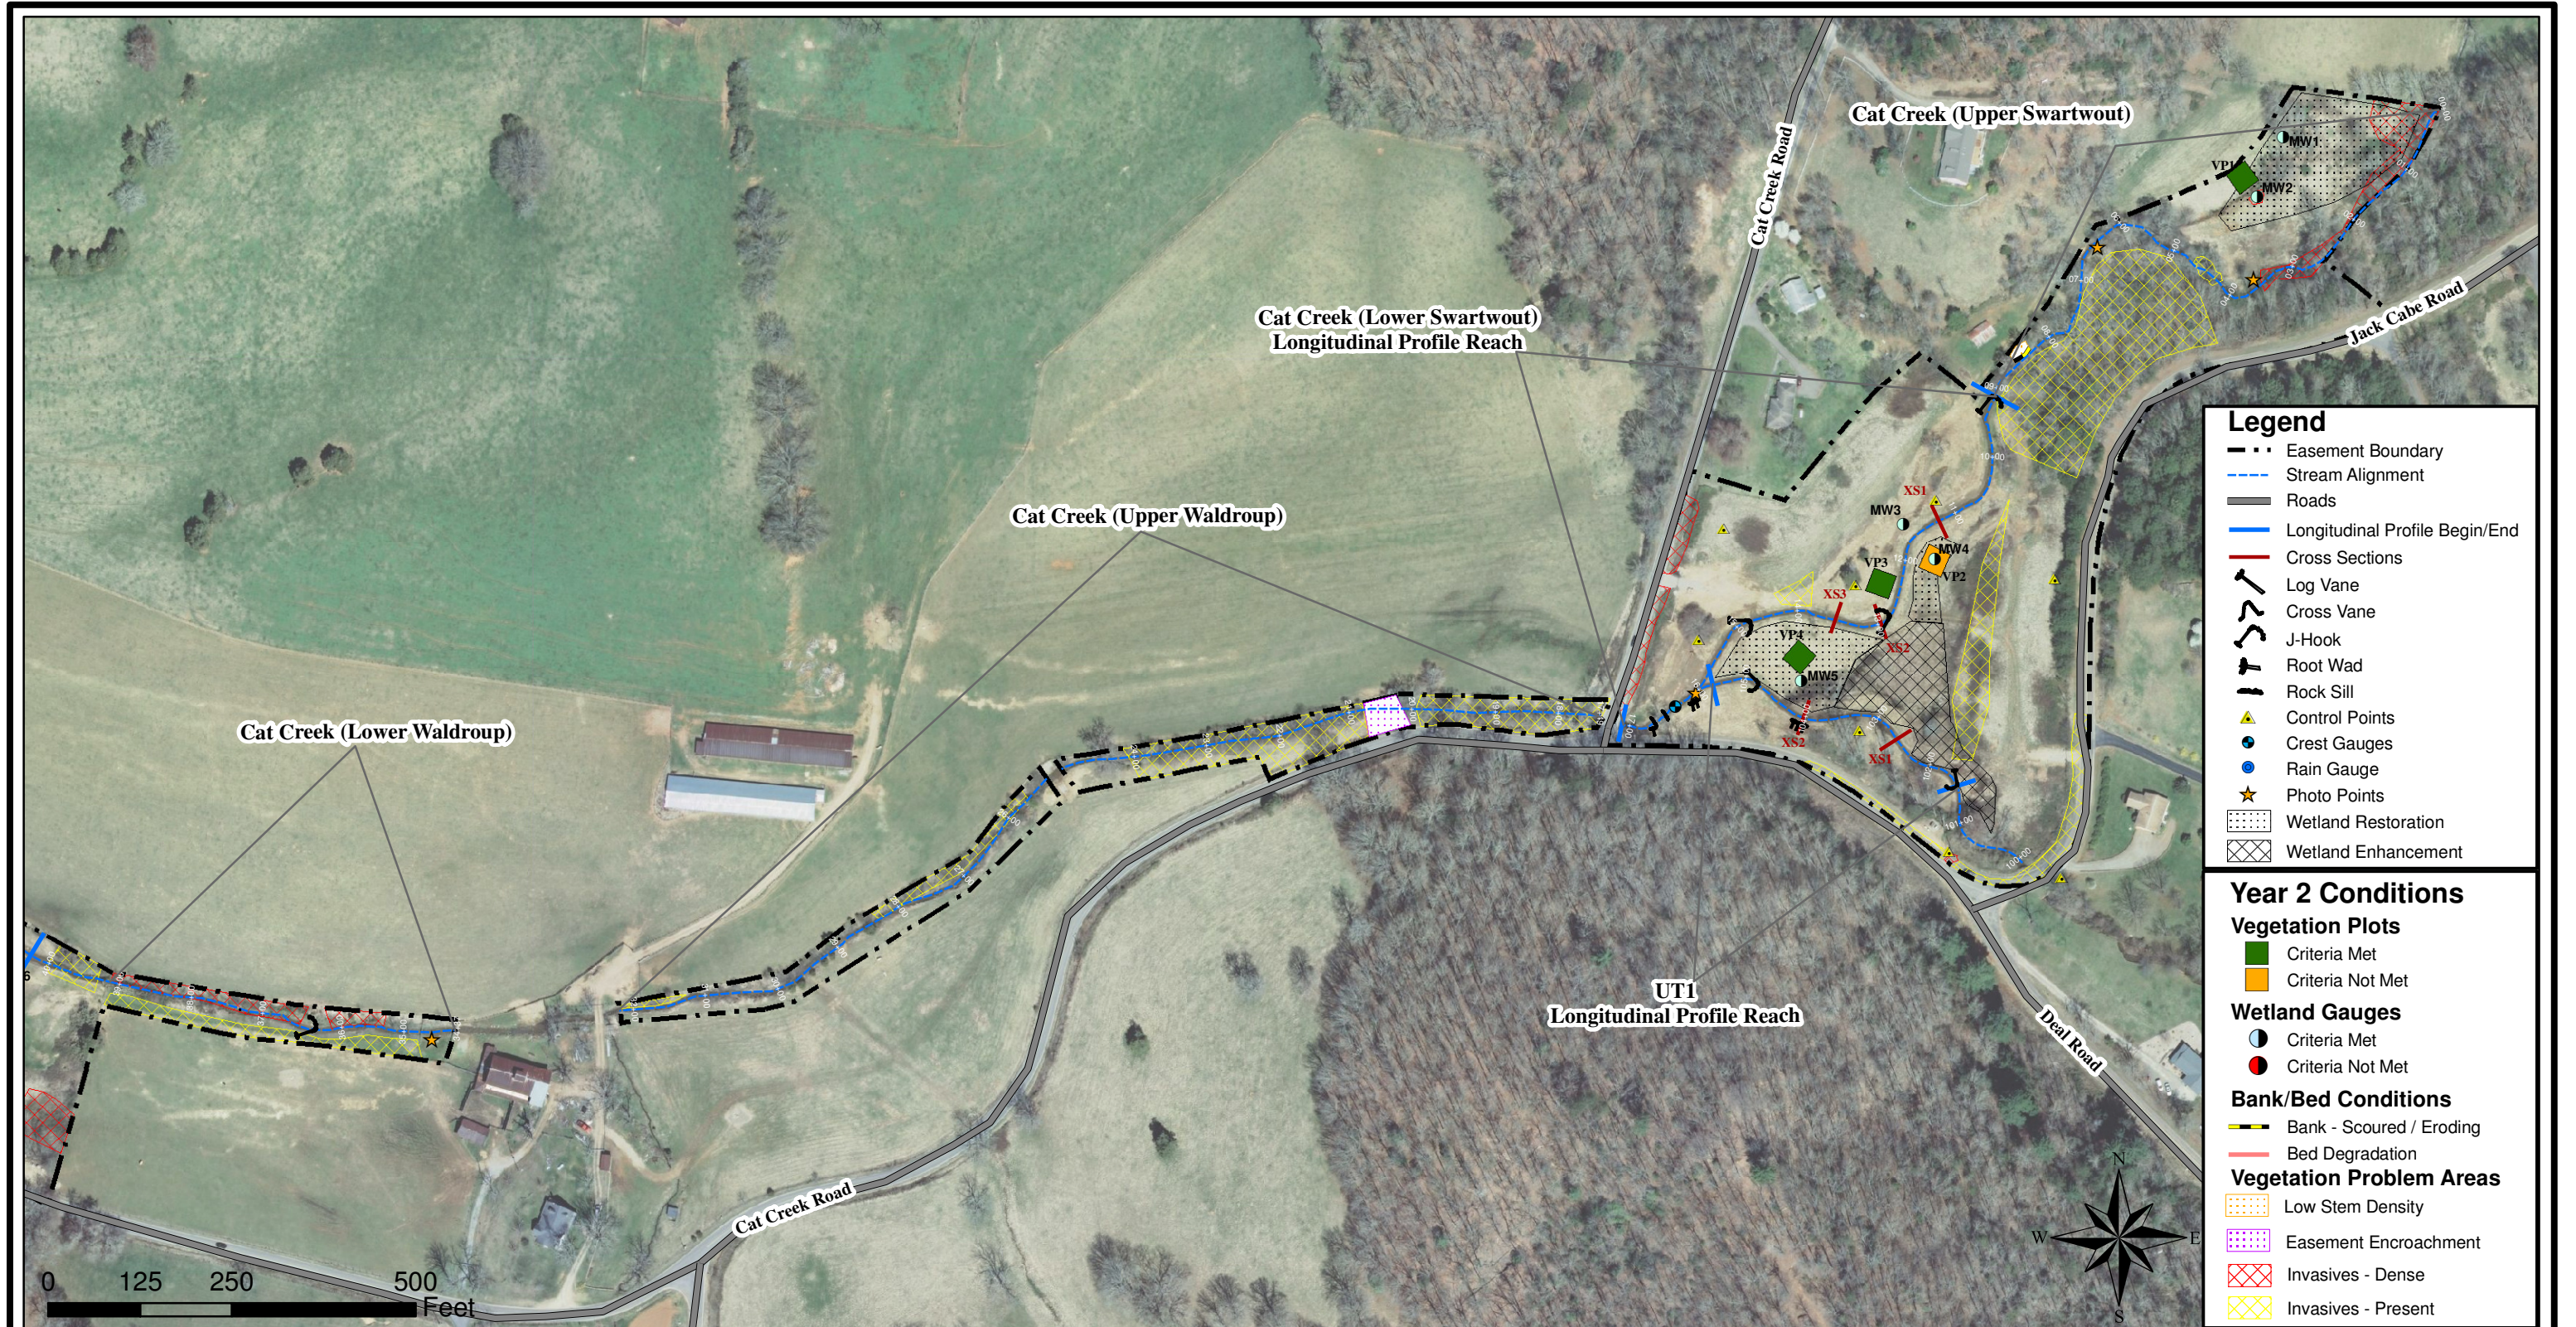
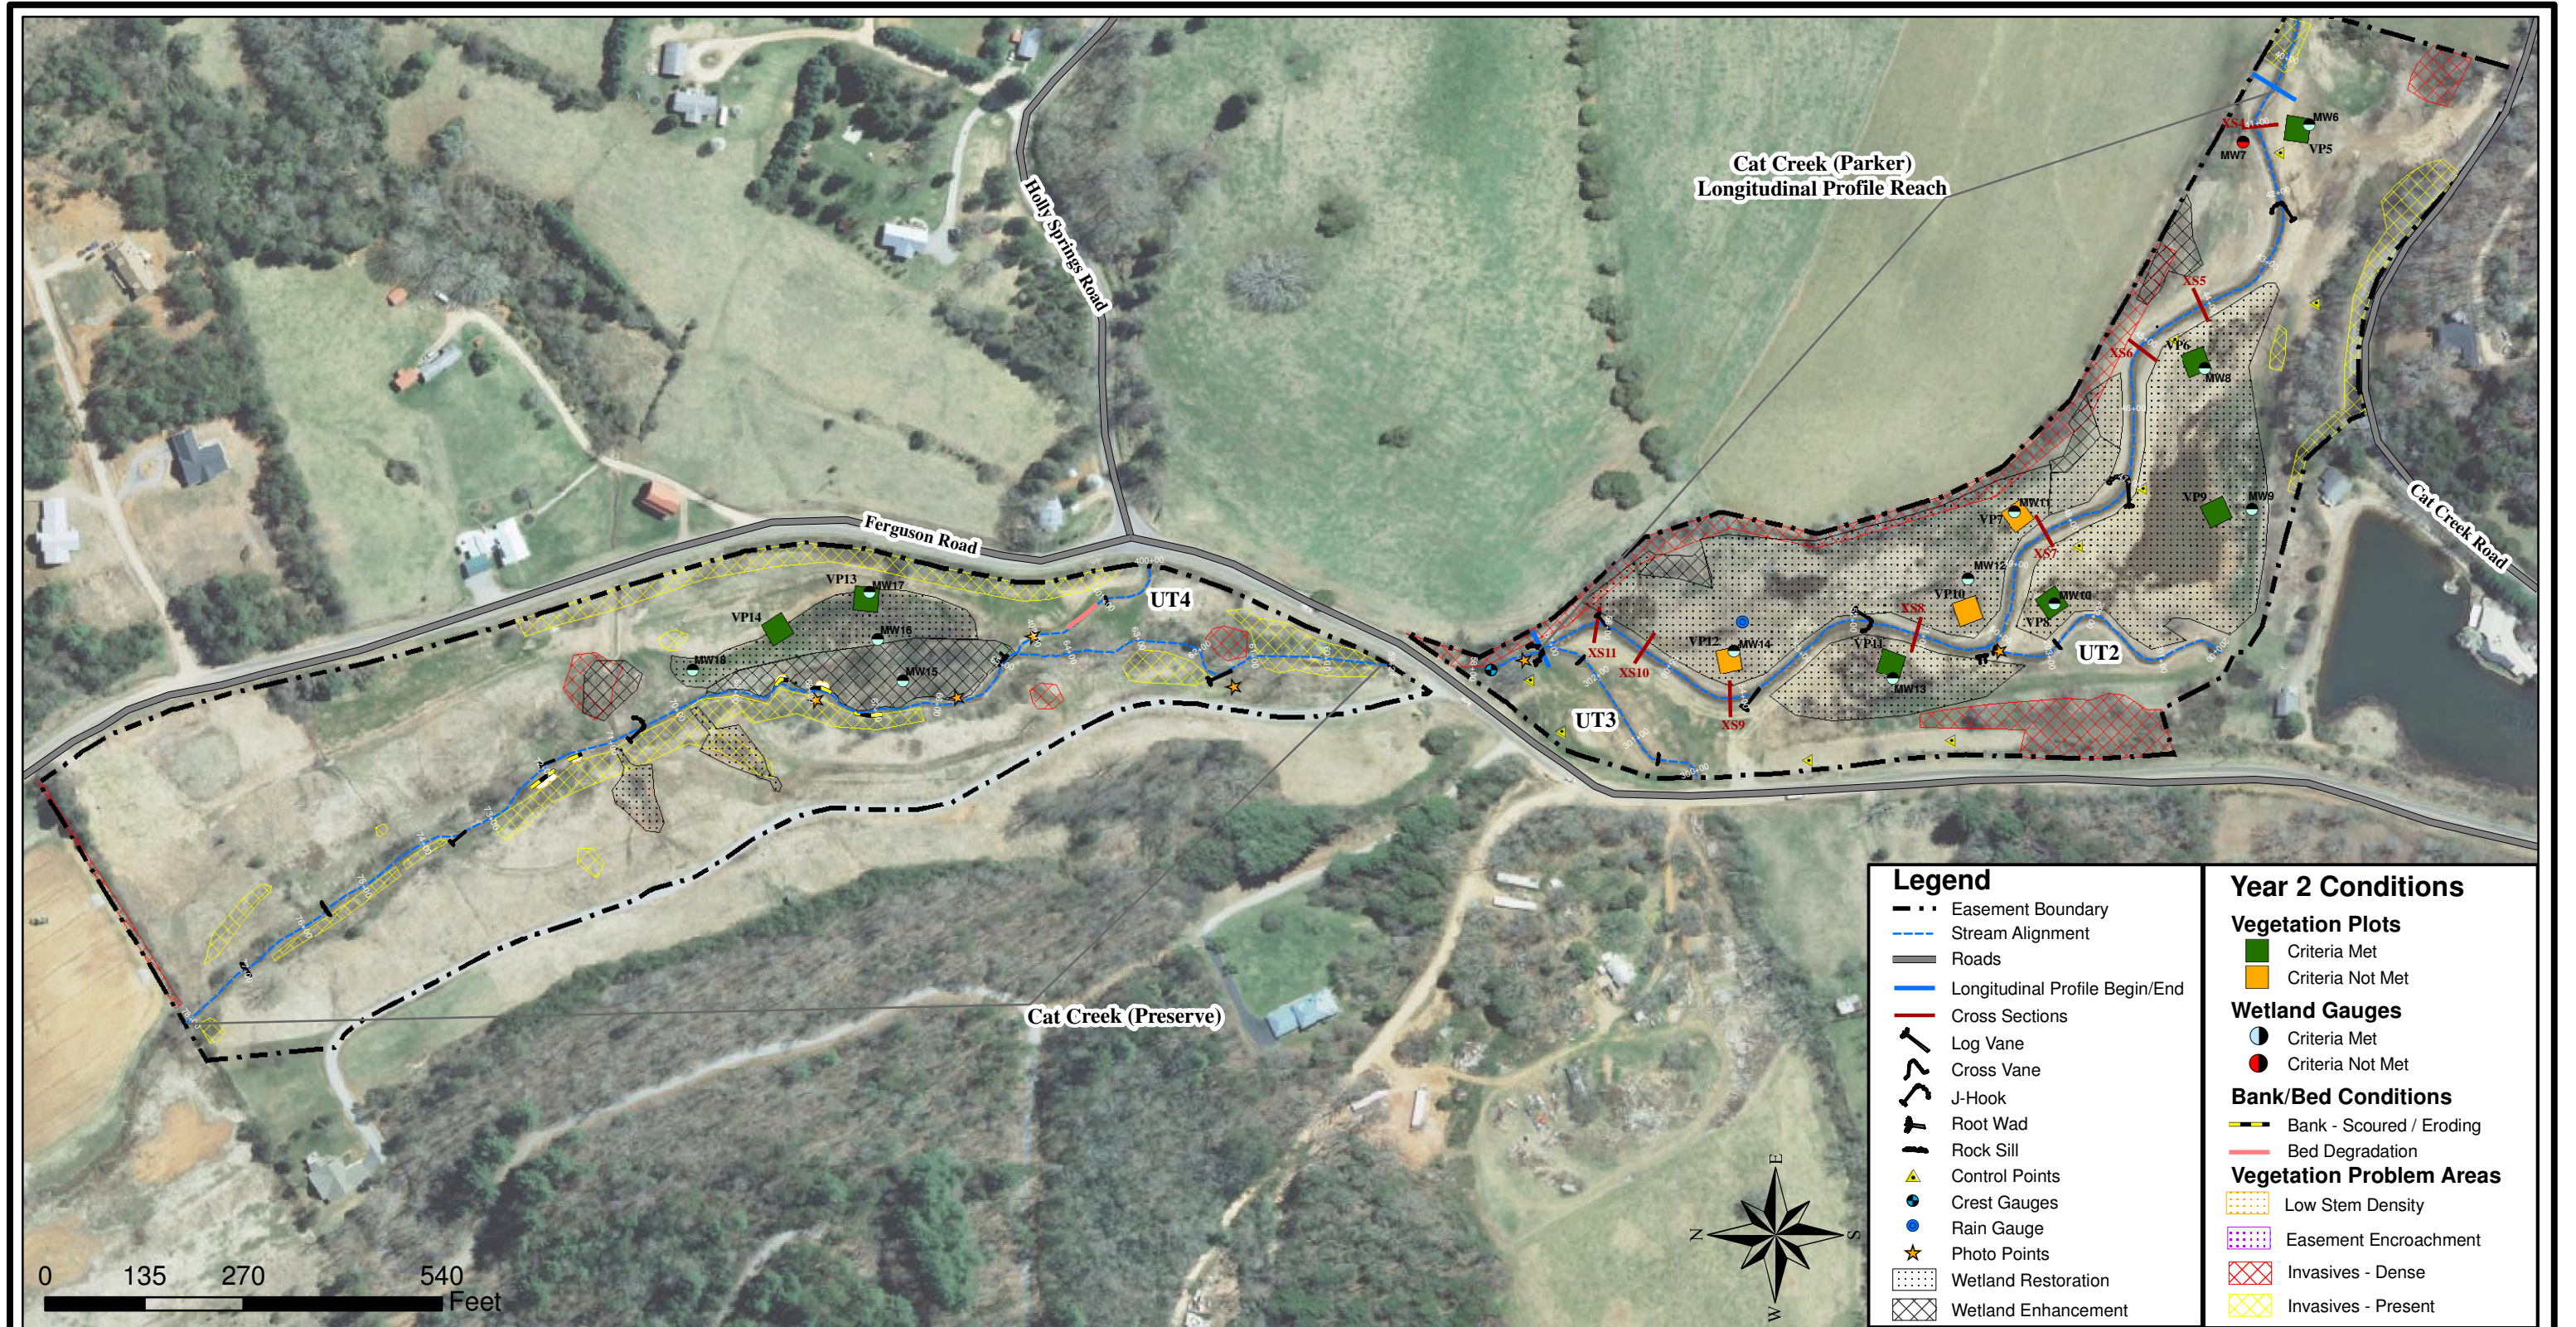
Figure 2. Integrated Current Condition Plan View

Stream longitudinal profiles have remained stable among monitoring years. Stream issues observed during MY2 were minimal and consisted of six bank erosion areas and one area of bed degradation, with all but one of these areas occurring within the Preserve project reaches. Based on the presence of wrack lines and crest gauge monitoring no bankfull event was documented in MY2.
