MONITORING YEAR 2 ANNUAL REPORT FINAL

CATFISH POND MITIGATION SITE

Durham County, NC

DMS Project No. 100039

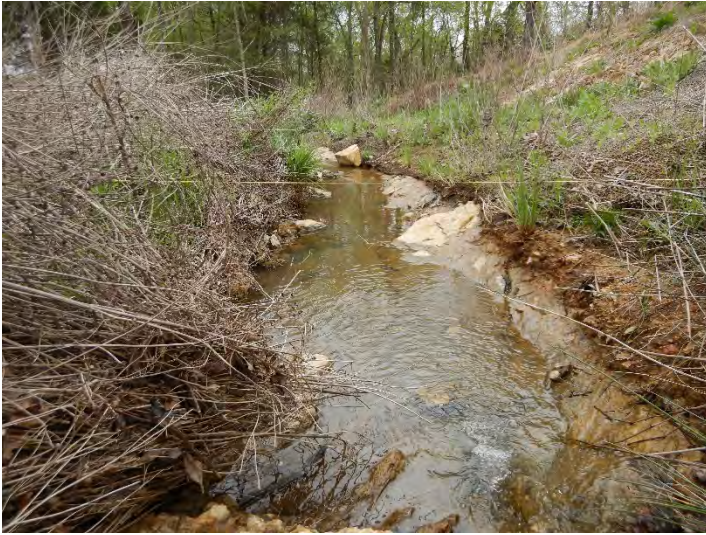
Riffle material along the stream bed in portions of the Catfish Creek Reach 6 was washed downstream during the winter of 2020/2021. During construction, bedrock was discovered beneath the old pond bed and adjustments to design were made. The riffle material that was placed on the bedrock did not hold. However, the bedrock streambed is stable and Wildlands proposes to leave the reach as it is now. The location is shown in Figure 3a, the length of stream channel affected is shown in Table 5b, and bedrock photographs are included in Stream Areas of Concern Photographs in Appendix 2.

**Catfish Creek R6 XS4 downstream –
Area of Bedload Movement (Bedrock) (04/15/2021)**

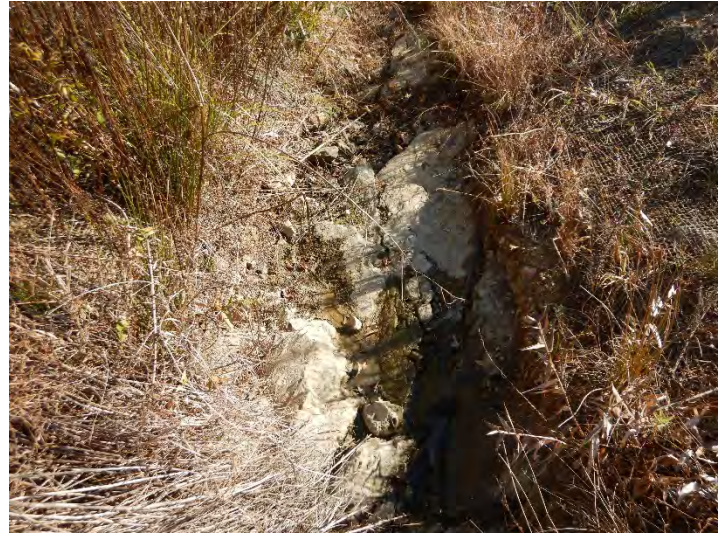
**Catfish Creek R6 XS4 downstream –
Area of Bedload Movement (Bedrock) (11/18/2021)**

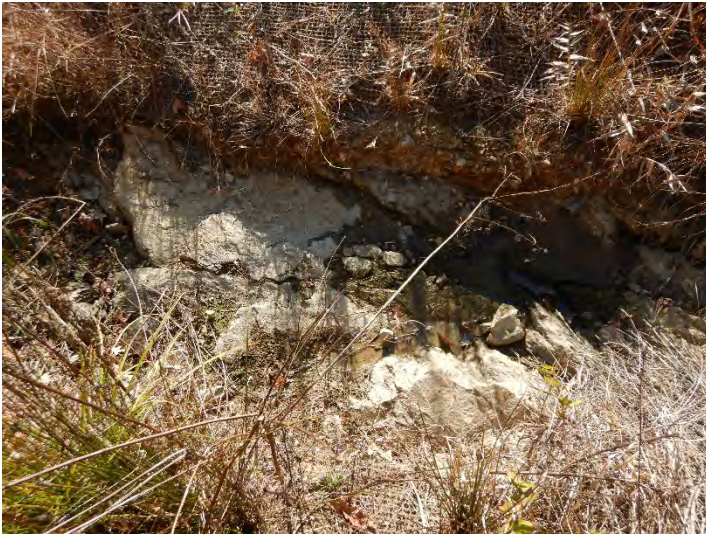
**Catfish Creek R6 XS4 facing right bank –
Area of Bedload Movement (Bedrock) (11/18/2021)**

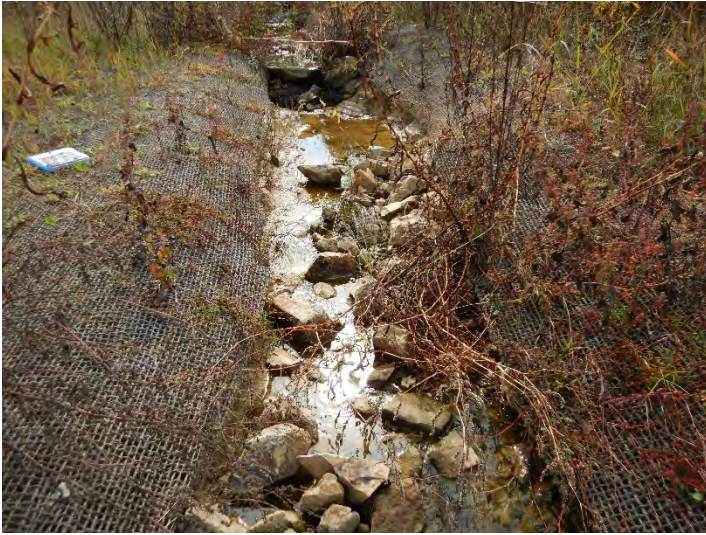
Additionally, erosion and degradation was noticed in the stream channel around cross-section 7 on UT1 Reach 3 after the 2020/2021 winter rains. A small section of the stream was stabilized and repaired in July. The cross-section was re-surveyed in October 2021. Cross-section 7 dimensions on the Cross-Section Plots and in Table 12d in Appendix 4 differ slightly from As-Built and MY0 dimensions but this is to be expected after repairs were made. The stream channel is now stable and functioning, but

**UT1 R3 upstream –
Area of Bedload Movement (Pre-Repair) (10/22/2020)**

Wildlands will continue to observe the area to confirm stability. The location is shown in Figure 3b, the length of stream repaired is shown in Table 5d, and stream channel photographs from pre and post repair are included in Stream Areas of Concern Photographs in Appendix 2.

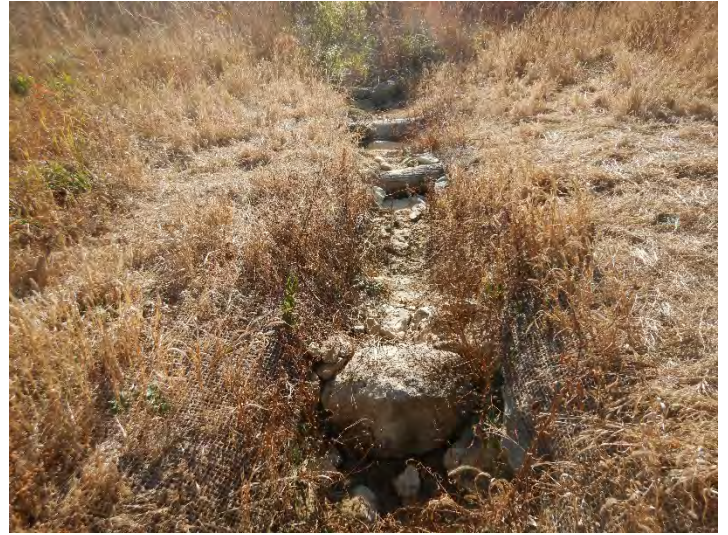
**UT1 R3 upstream –
Area of Bedload Movement (Post-Repair) (11/18/2021)**

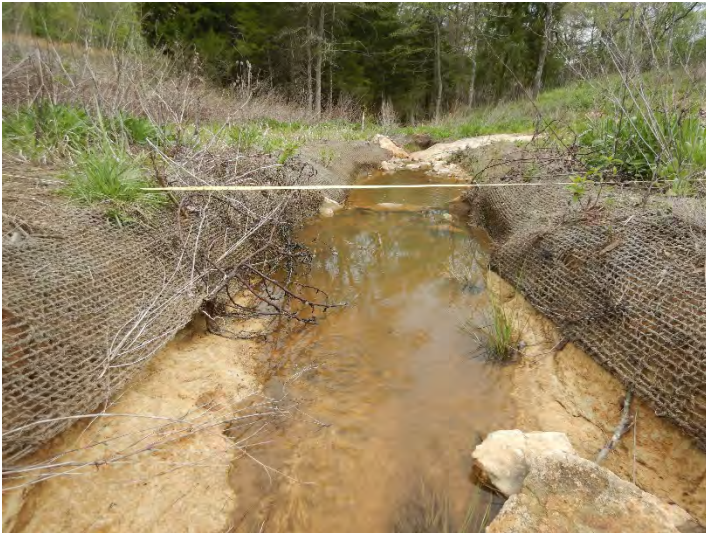
**UT1 R3 XS7 downstream –
Area of Bedload Movement (Pre-Repair) (04/15/2021)**

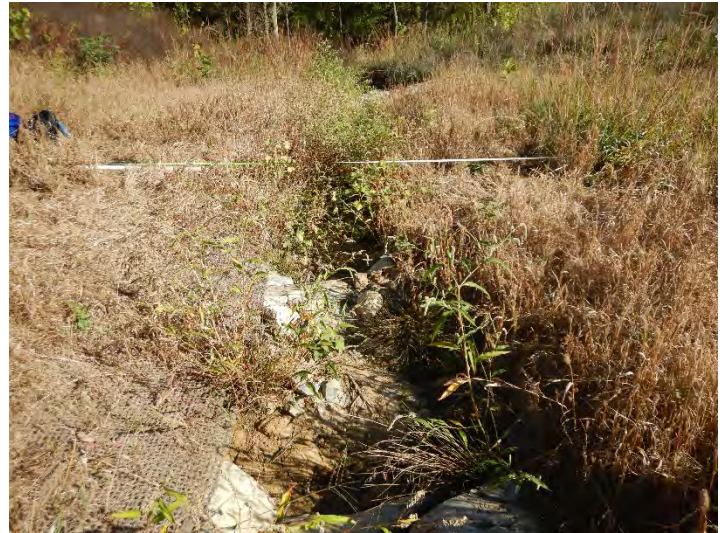
**UT1 R3 XS7 downstream –
Area of Bedload Movement (Post-Repair) (10/18/2021)**
