MONITORING YEAR 3 ANNUAL REPORT FINAL

CATFISH POND MITIGATION SITE

Durham County, NC
Neuse River Basin
HUC 03020201

DMS Project No. 100039
NCDEQ Contract No. 007424
NCDWR Project No. 2018-0196
USACE Action ID No. 2018-00424
Data Collection Dates: January - November 2022

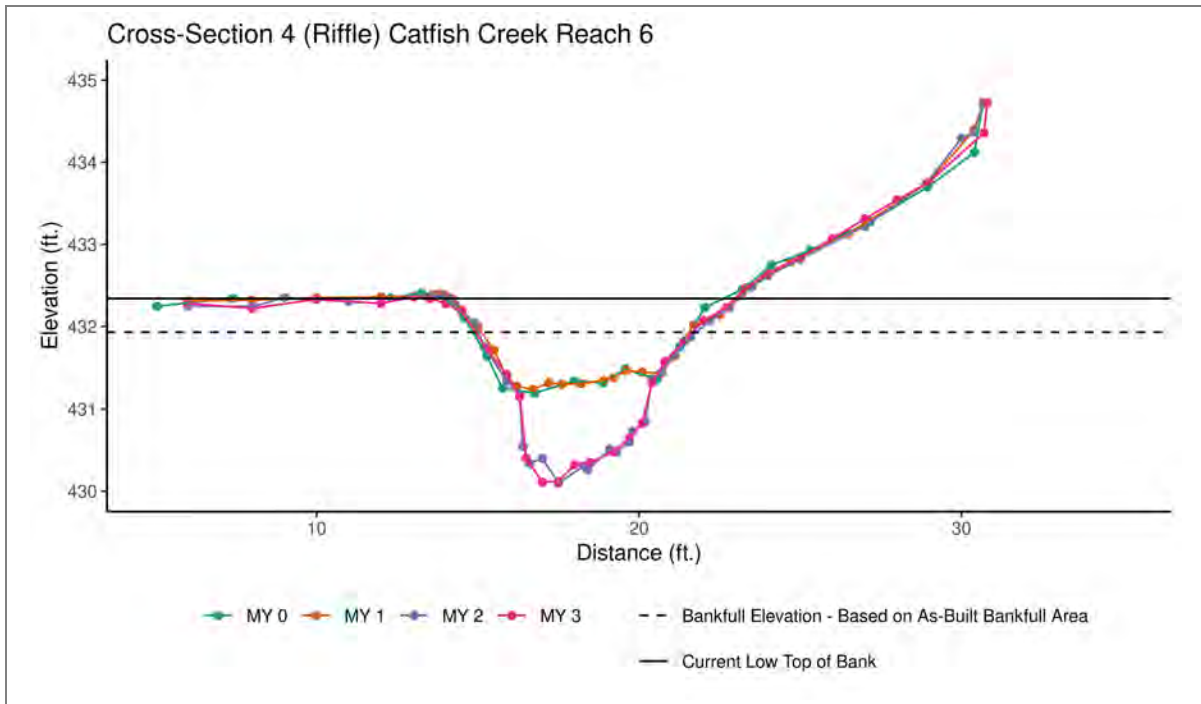
Cross-section 4 on Catfish Creek Reach 6 has not changed noticeably since MY2, after the riffle material in the area washed downstream over the bedrock. Although the bank height ratio is just over 1.2, this is to be expected with the deeper channel. The bedrock stream channel is stable and no longer an area of concern.

MY0	MY1	MY2	MY3	MY5	MY7
Bankfull Elevation - Based on AB-Bankfull Area	432.39	432.41	431.92	431.93		
Bank Height Ratio - Based on AB-Bankfull Area	1.00	0.99	1.25	1.23		
Thalweg Elevation	431.20	431.24	430.10	430.11		
LTOB Elevation	432.39	432.40	432.38	432.34		
LTOB Max Depth	1.19	1.16	2.28	2.23		
LTOB Cross-Sectional Area	6.96	6.88	10.61	10.19

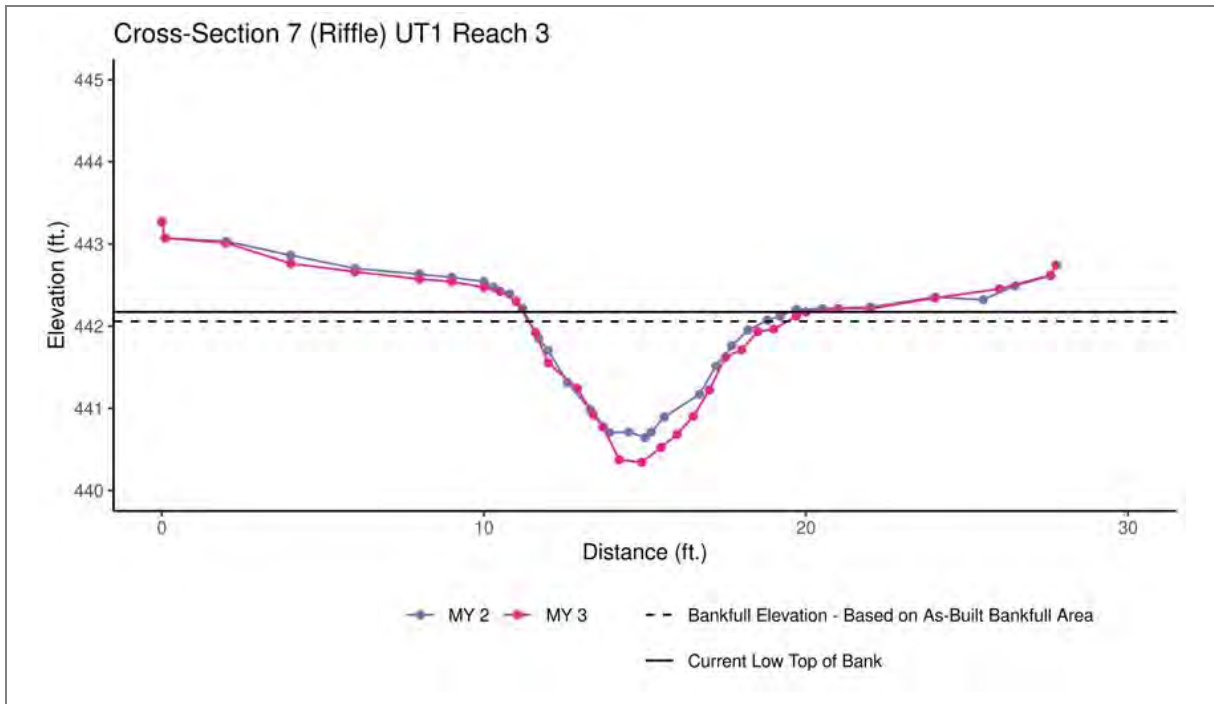
Cross-section 7 on UT1 Reach 3 is now stable. After repairs, this reach is a step pool system with short riffles and longer glides. This leaves cross-section 7 in a step pool glide, rather than a typical riffle in a C type stream channel. The MY2 and MY3 “Bank Height Ratio – Based on AB-Bankfull Area” in the Cross-Section Plot table and Table 9 (Appendix C) are based on the bankfull area of the channel after repairs were completed in MY2. The repairs changed the channels dimensions, so the low top of bank elevation

and the cross-sectional area are no longer comparable to the MY0 AB-Bankfull Elevation or BHR. When the MY3 cross-section 7 graph is compared to the repaired channel in MY2, it has not changed significantly. The Bank Height Ratio is less than 1.2 and the entrenchment ratio is over 2.2.

The repairs around cross-section 7 on UT1 Reach 3 seem to be stable and holding up well. Cross-section 7 has deepened slightly, which is to be expected in a step pool system, but no significant changes have occurred. Wildlands will continue to observe this reach to confirm stability.

MY0	MY1	MY2*	MY3	MY5	MY7
Bankfull Elevation - Based on AB-Bankfull Area	442.36	442.40	442.20	442.06		
Bank Height Ratio - Based on AB-Bankfull Area	1.00	0.97	1.00	1.07		
Thalweg Elevation	440.83	440.87	440.64	440.34		
LTOB Elevation	442.36	442.34	442.20	442.17		
LTOB Max Depth	1.53	1.47	1.56	1.83		
LTOB Cross-Sectional Area	5.39	5.07	7.06	8.02

*Repairs during MY2 changed channel dimensions along this reach. MY2-7 calculations and the graph above are based off the MY2 repaired channel because they are no longer comparable to MY0-1.

Wildlands will continue to monitor the stability of UT1 Reach 3 around cross-section 7. Currently the area is functioning well, and no problems are anticipated.
