MONITORING YEAR 4 ANNUAL REPORT FINAL

CATFISH POND MITIGATION SITE

Durham County, NC
Neuse River Basin
HUC 03020201

DMS Project No. 100039
NCDEQ Contract No. 007424
NCDWR Project No. 2018-0196 v1
USACE Action ID No. 2018-00424

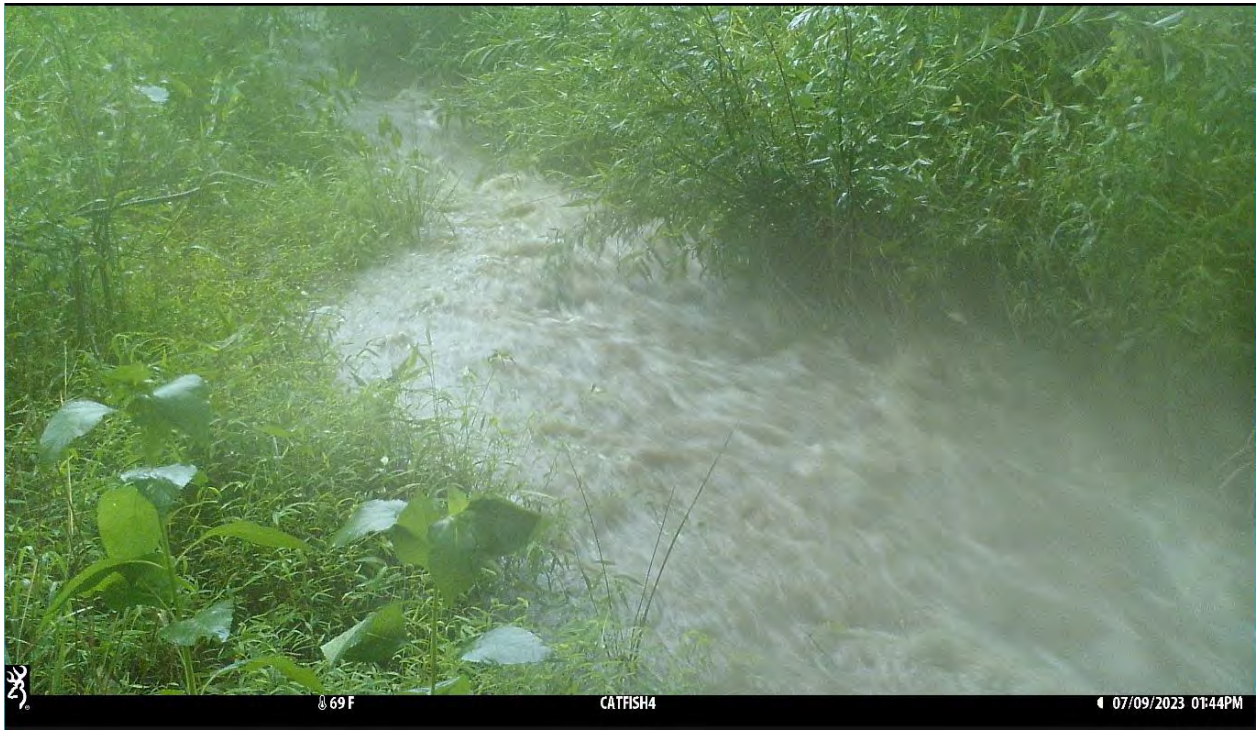
None of the pressure transducers on Catfish Creek have recorded a bankfull event in MY4 so far. They did record a significant spike in flow on July 9, 2023 when the bankfull event was recorded on UT1 and the Catfish Creek trail camera. We believe they are functioning correctly, but the pressure transducers are set to read every 30 minutes at the 00- and 30-minute marks. The trail camera on Catfish Creek Reach 6 happened to be taking quick videos every 30 minutes around the 15- and 45-minute marks. The bankfull was recorded at around the 45-minute mark. While it is possible Catfish Creek did not reach bankfull at the location of the Catfish Creek Reach 6 pressure transducer, we believe that the crest of bankfull flow at that location did not last long enough for the pressure transducer to take a reading while it was out of bank.

^Bankfull documented visually on trail camera. A screenshot from the Catfish Creek Reach 6 video is included in Appendix D.

Catfish Creek Reach 6: Bankfull event recorded on Catfish 4 trail camera (07/09/2023)
