# Cato Farms Stream Restoration Project

## Mitigation Plan and As-Built Report

*November 2005*

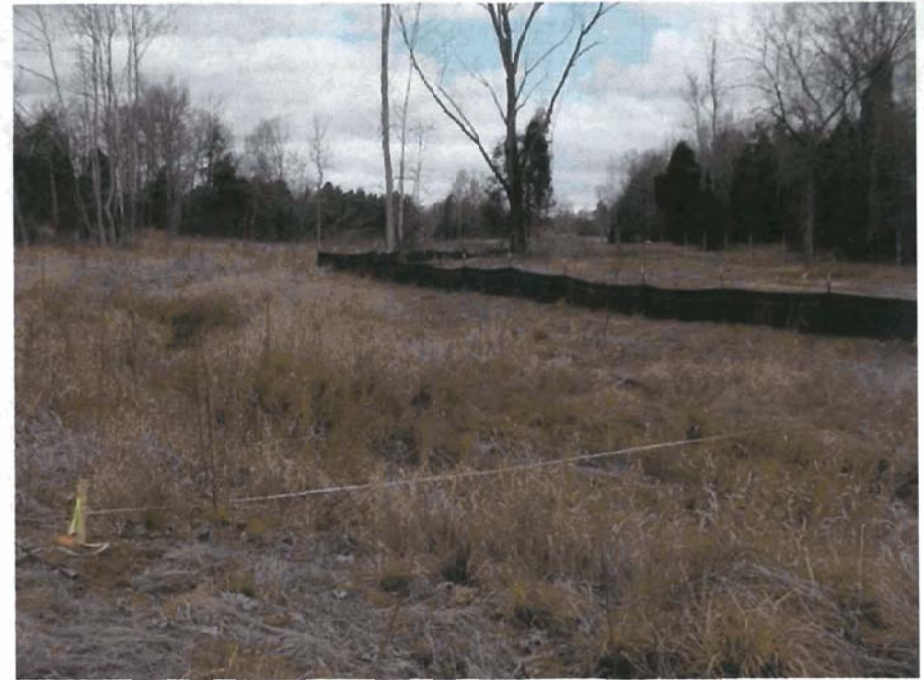
It should be noted that Cross Section 2 was established across the center of a cross vane, which is experiencing aggregation of materials. The cross section location was specifically selected to monitor the change in this area.

Photo Station 5C: Looking at cross-section 2.

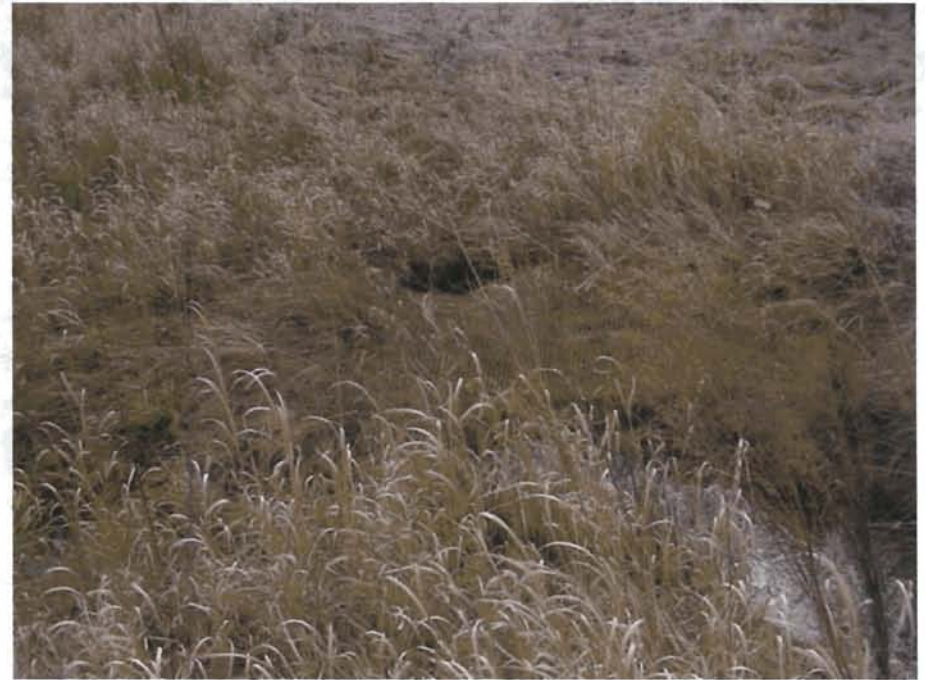
Photo Station 13.A: Looking at hole in right bank.

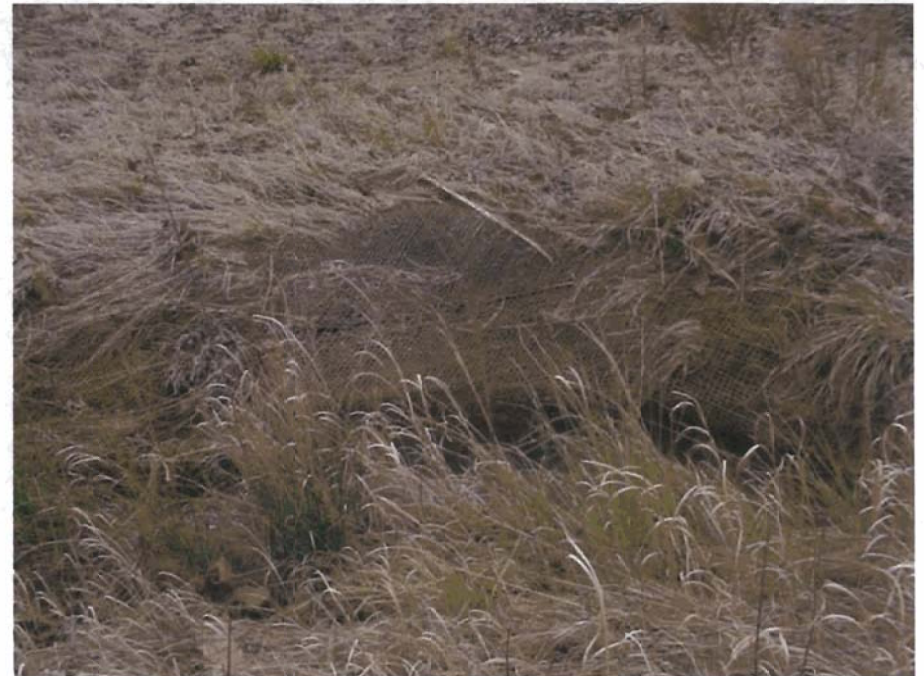
Photo Station 14.A: Looking at erosion hole.

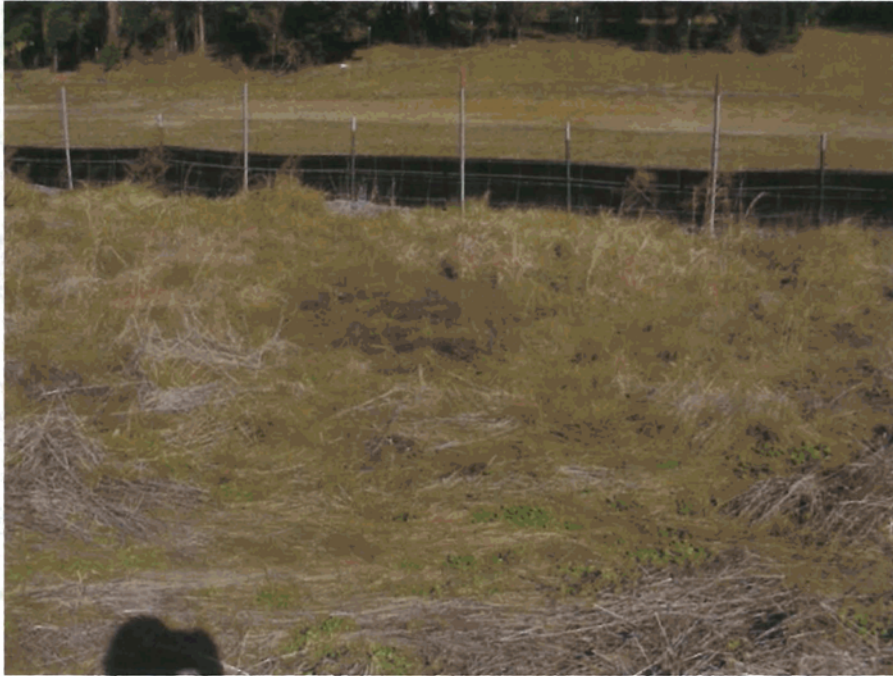
Photo Station 16.D: Looking at standing water (often present in spring season) and sewer line right-of-way.

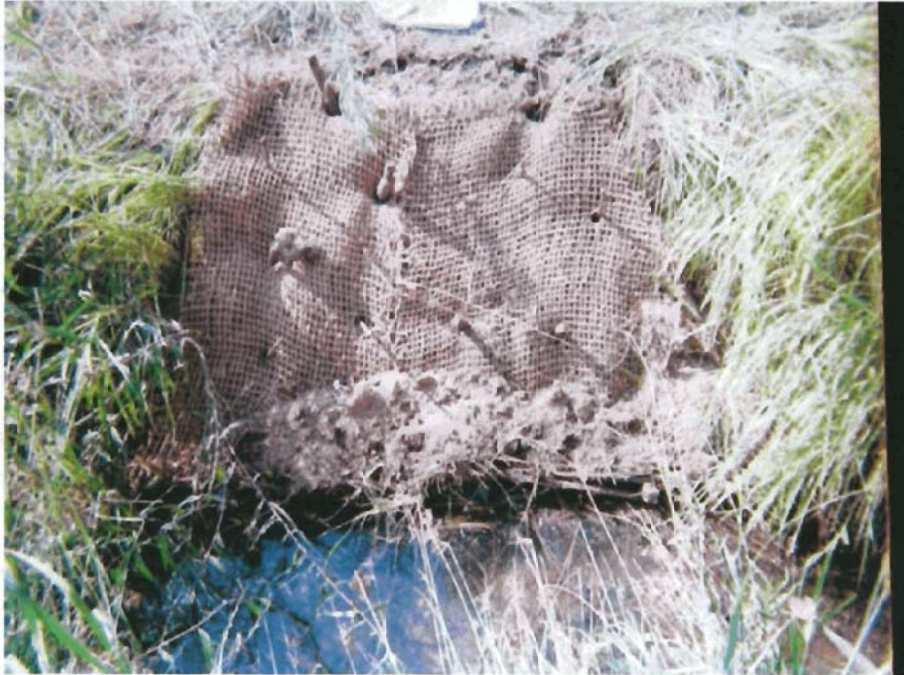
Photo 1: Looking at erosion hole fix upstream of Station 20+00

In July 2005, a section of erosion was repaired by installing coir fiber logs, backfilling erosion areas, and re-establishing vegetation. Photographs from this effort are included in Appendix B. Also, a tree had fallen across the channel in the fall of 2004 during a

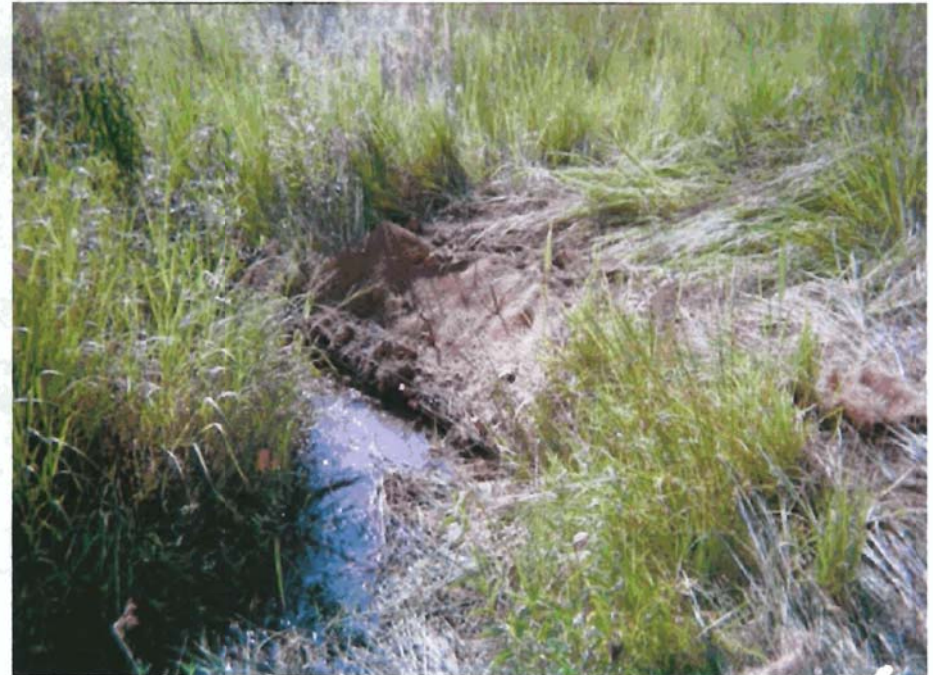
Photo 2: Looking at erosion fix between Stations 20+00 and 20+50

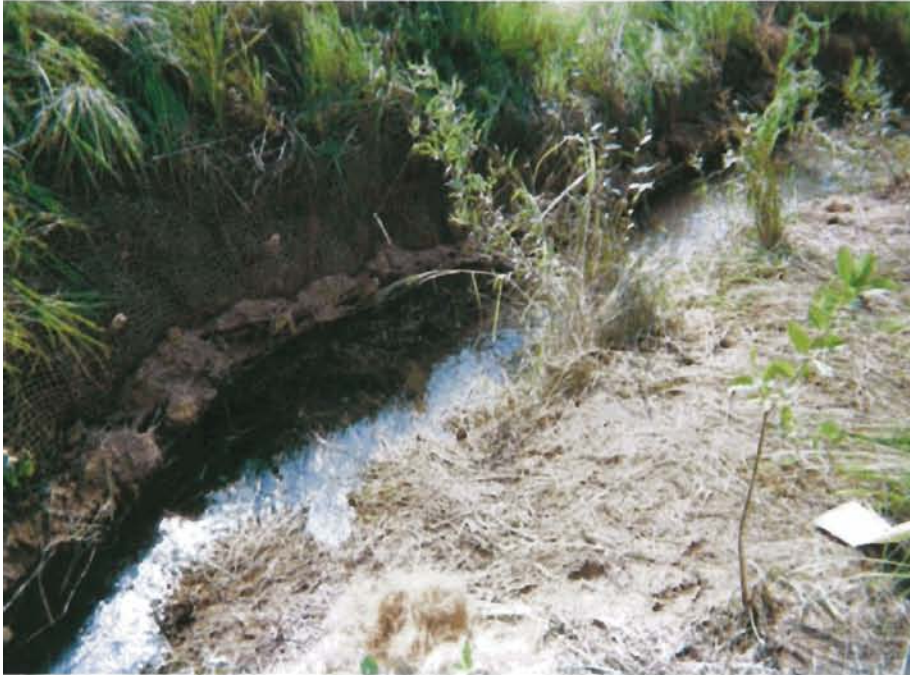
Photo 3: Looking at erosion fix between Stations 20+20 and 20+50

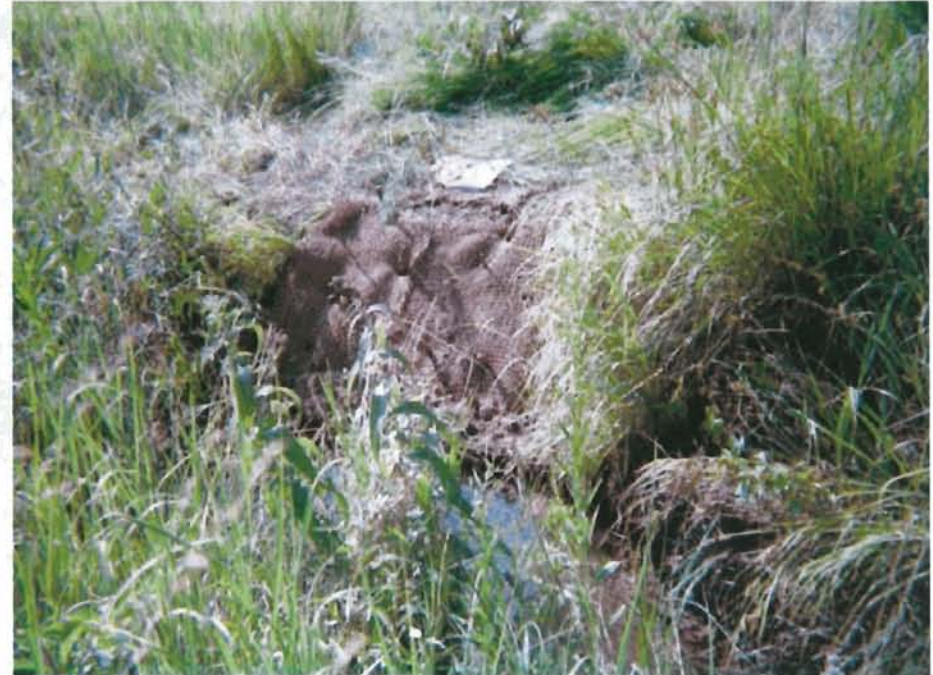
Photo 4: Looking at erosion fix on outer bend downstream of Station 20+00

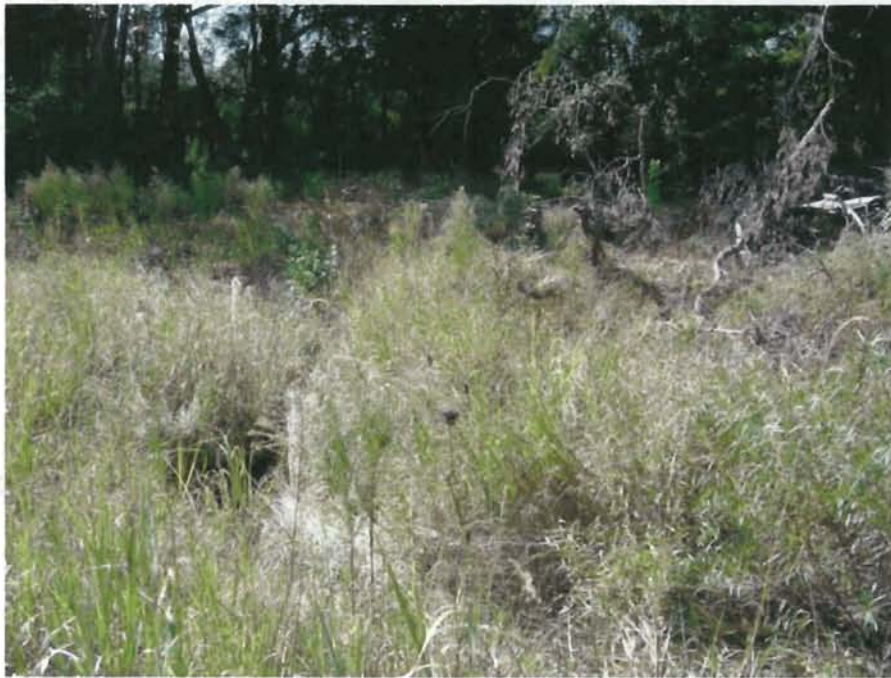
Photo 4: Tree removed from channel near Station 14+00
