UT to Clark Creek at Cato Farms Stream Restoration Annual Monitoring Report

Monitoring Year: 2005

NCEEP Project Number: 072

UT CLARK CREEK at CATO FARMS STREAM RESTORATION 2005 MONITORING REPORT

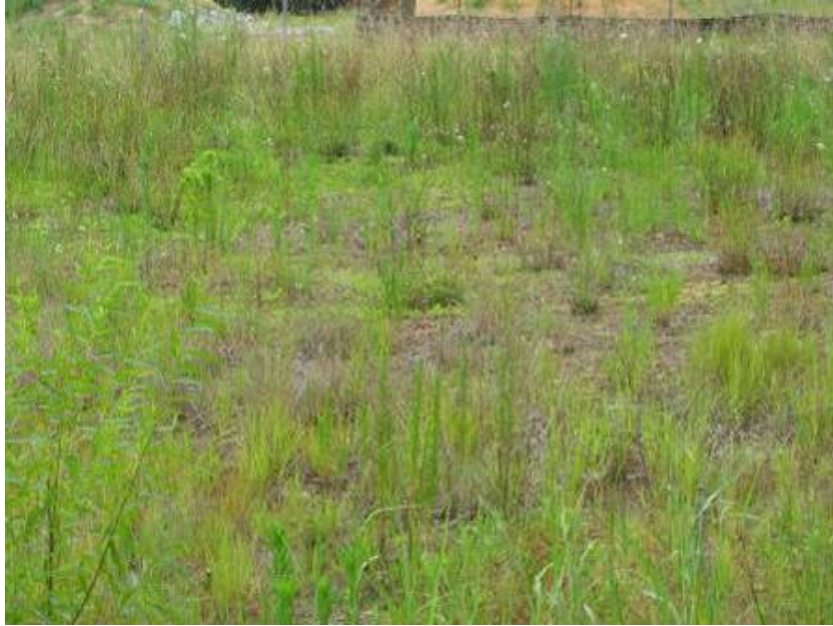
VPA 1. Bare Flood Plain

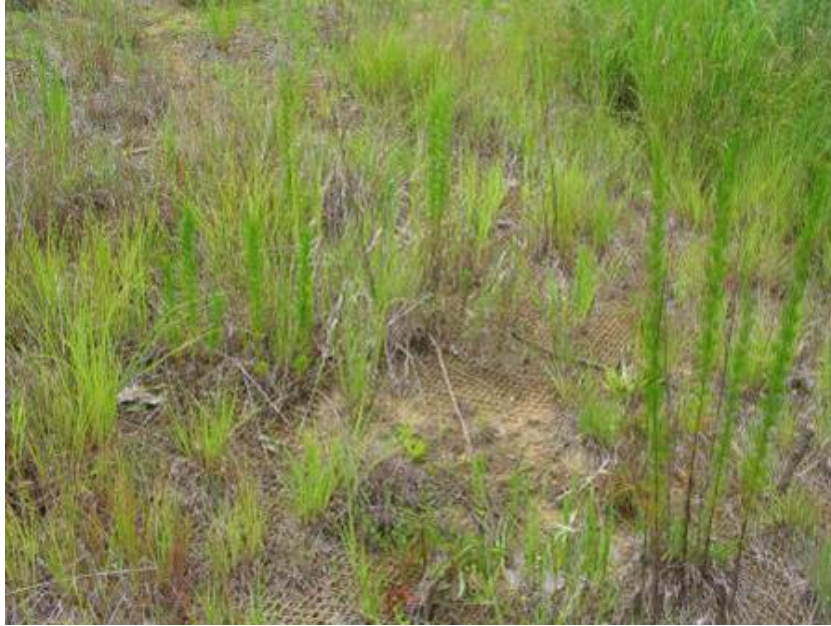
VPA 2b, Bare Bank, photo 2

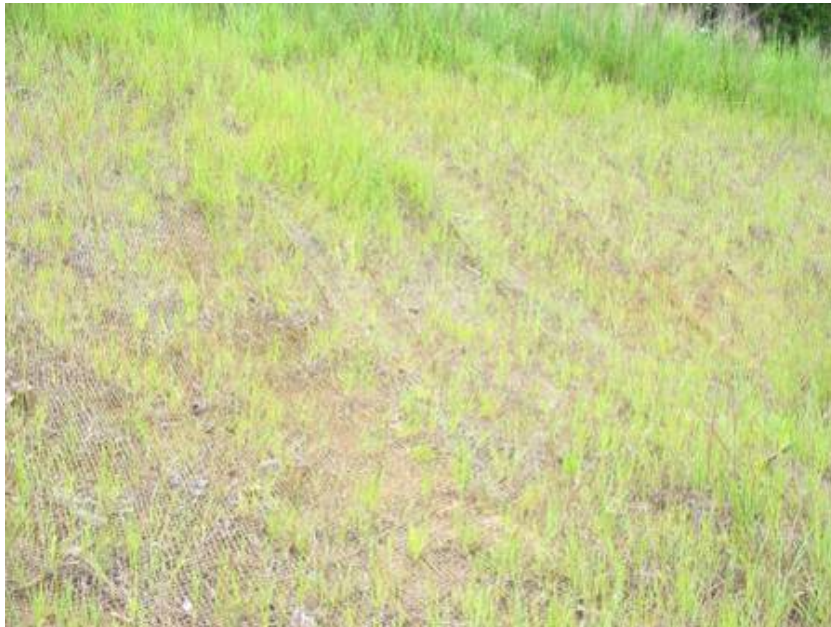
VPA 3, Bare Bank

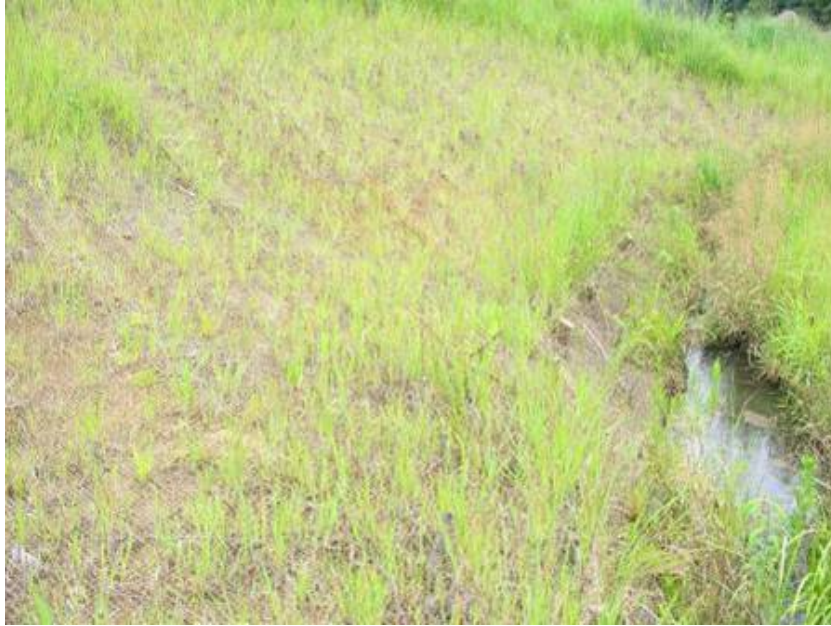
VPA 3b. Bare Bank, photo

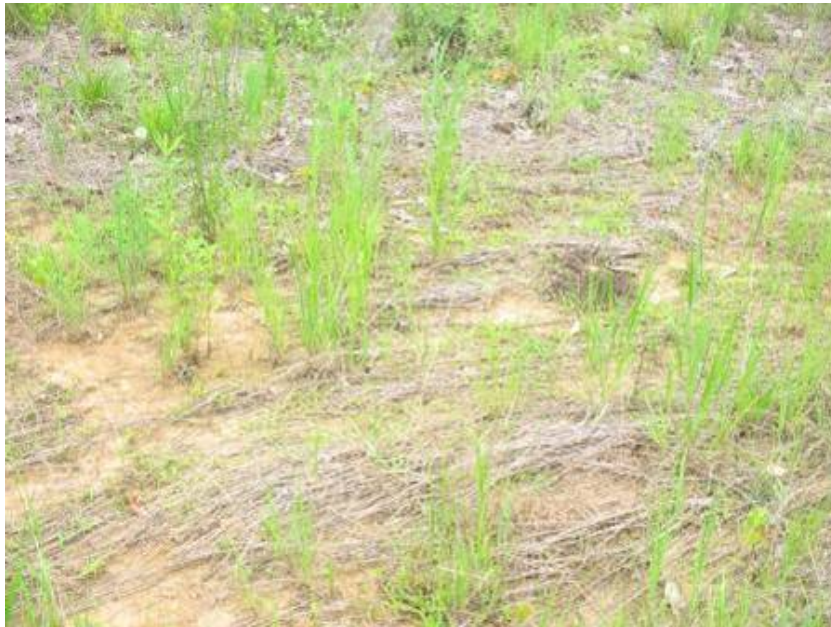
VPA 3c, Bare Flood Plain

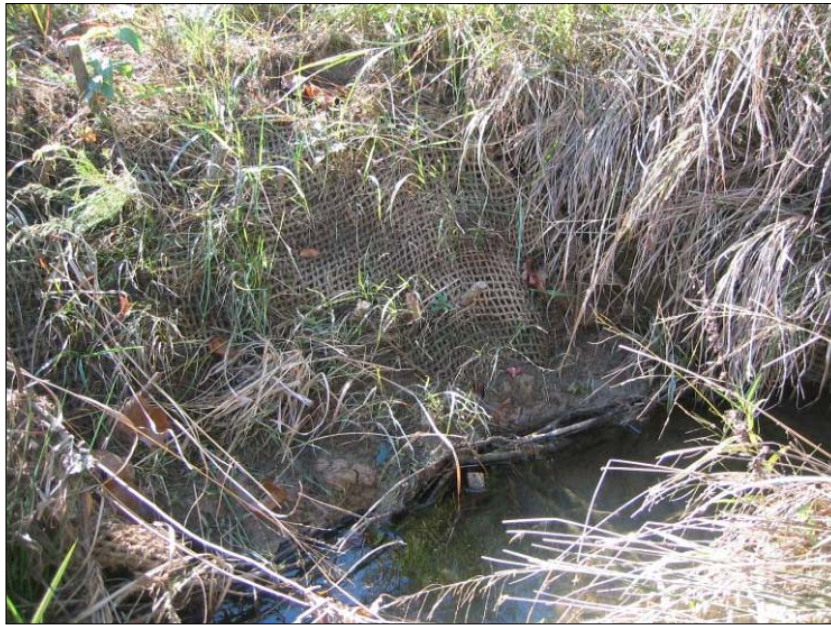
PA6

Problem Number	Feature Issue	Station numbers	Suspected Cause	Photo number
PA 1	Erosion and scour behind matting	2+50 to 2+60	Lack of deep rooting vegetation	PA 1
PA 2	Minor bank slump	3+10 to 3+20	Lack of deep rooting vegetation Overland flow being directed by upstream point bar	PA 2
PA 3	Rills forming along channel bank/slope Note: repair efforts failed in this area	4+00 to 4+60	Lack of deep rooting vegetation Poor soil preparation Compacted soil Sub-soil conditions (lack of nutrients)	PA 3
PA 4	Erosion and scour behind matting	5+00 to 5+10	Lack of deep rooting vegetation	PA 4
PA 5	Scour and slump along outside bank	9+25 to 9+30	Lack of deep rooting vegetation	PA 5
PA 6	Scour and slump along outside bank Note: repair efforts failed in this area due to soil washing out around facines and facines out of water	9+95 to 10+05	Lack of deep rooting vegetation Matting on repair area not adequately secured	PA 6

PA-4	35.41100	80.82205 6'x3' scour behind matting, no veg, not repaired
PA-5	35.41029	80.82191 2'x4' scour and slump on outside bank
PA-6	35.41026	80.82181 Scour and slump along outside bank
PA-7	35.41014	80.82183 Scour and slump along outside bank
PA-8	35.41004	80.82181 Scour and slump along outside bank
PA-9	35.40934	80.82147 Minor Bank Slump
PA-10	35.40918	80.82152 Rills forming along channel bank/slope
PA-11	35.40910	80.82120 Scour and slump along outside bank
PA-12	35.40891	80.82122 Scour and slump along outside bank
PA-13	35.40812	80.82061 Rills forming along channel bank/slope
PA-14	35.40859	80.82107 Scour and slump along outside bank
PA-15	35.40812	80.82061 Bank scour upstream of xvane

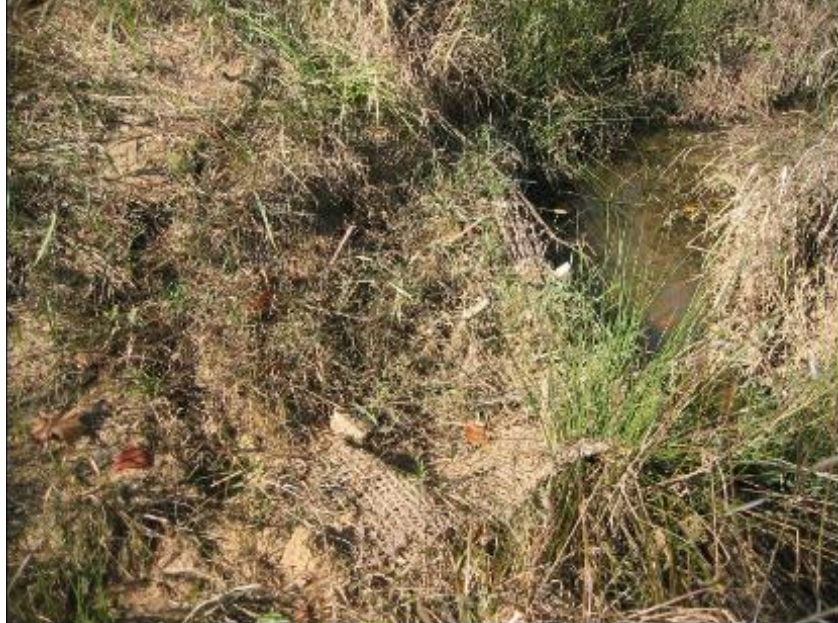
PA8

PA 7	Scour and slump along outside bank Note: repair efforts failed in this area due to soil washing out around facines and facines out of water	10+20 to 10+65	Lack of deep rooting vegetation Matting on repair area not adequately secured	PA 7
PA 8	Scour and slump along outside bank Note: repair efforts failed in this area due to soil washing out around facines and facines out of water	10+95 to 11+00	Lack of deep rooting vegetation Matting on repair area not adequately secured	PA 8
PA 9	Minor Bank Slump	15+40 to 15+50	High bank along outside bend Lack of deep rooting vegetation	PA 9
PA 10	Rills forming along channel bank/slope	15+75 to 16+25	Lack of deep rooting vegetation Poor soil preparation Compacted soil Sub-soil conditions (lack of nutrients)	PA 10
PA 11	Scour and slump along outside bank Note: repair efforts failed in this area due to soil washing out around facines and facines out of water	16+75 to 16+90	Lack of deep rooting vegetation Matting on repair area not adequately secured	PA 11
