# Cato Farms Stream Restoration

## Project No. 72

### 2006 Monitoring Report: Year 2 of 5

**March 2007**

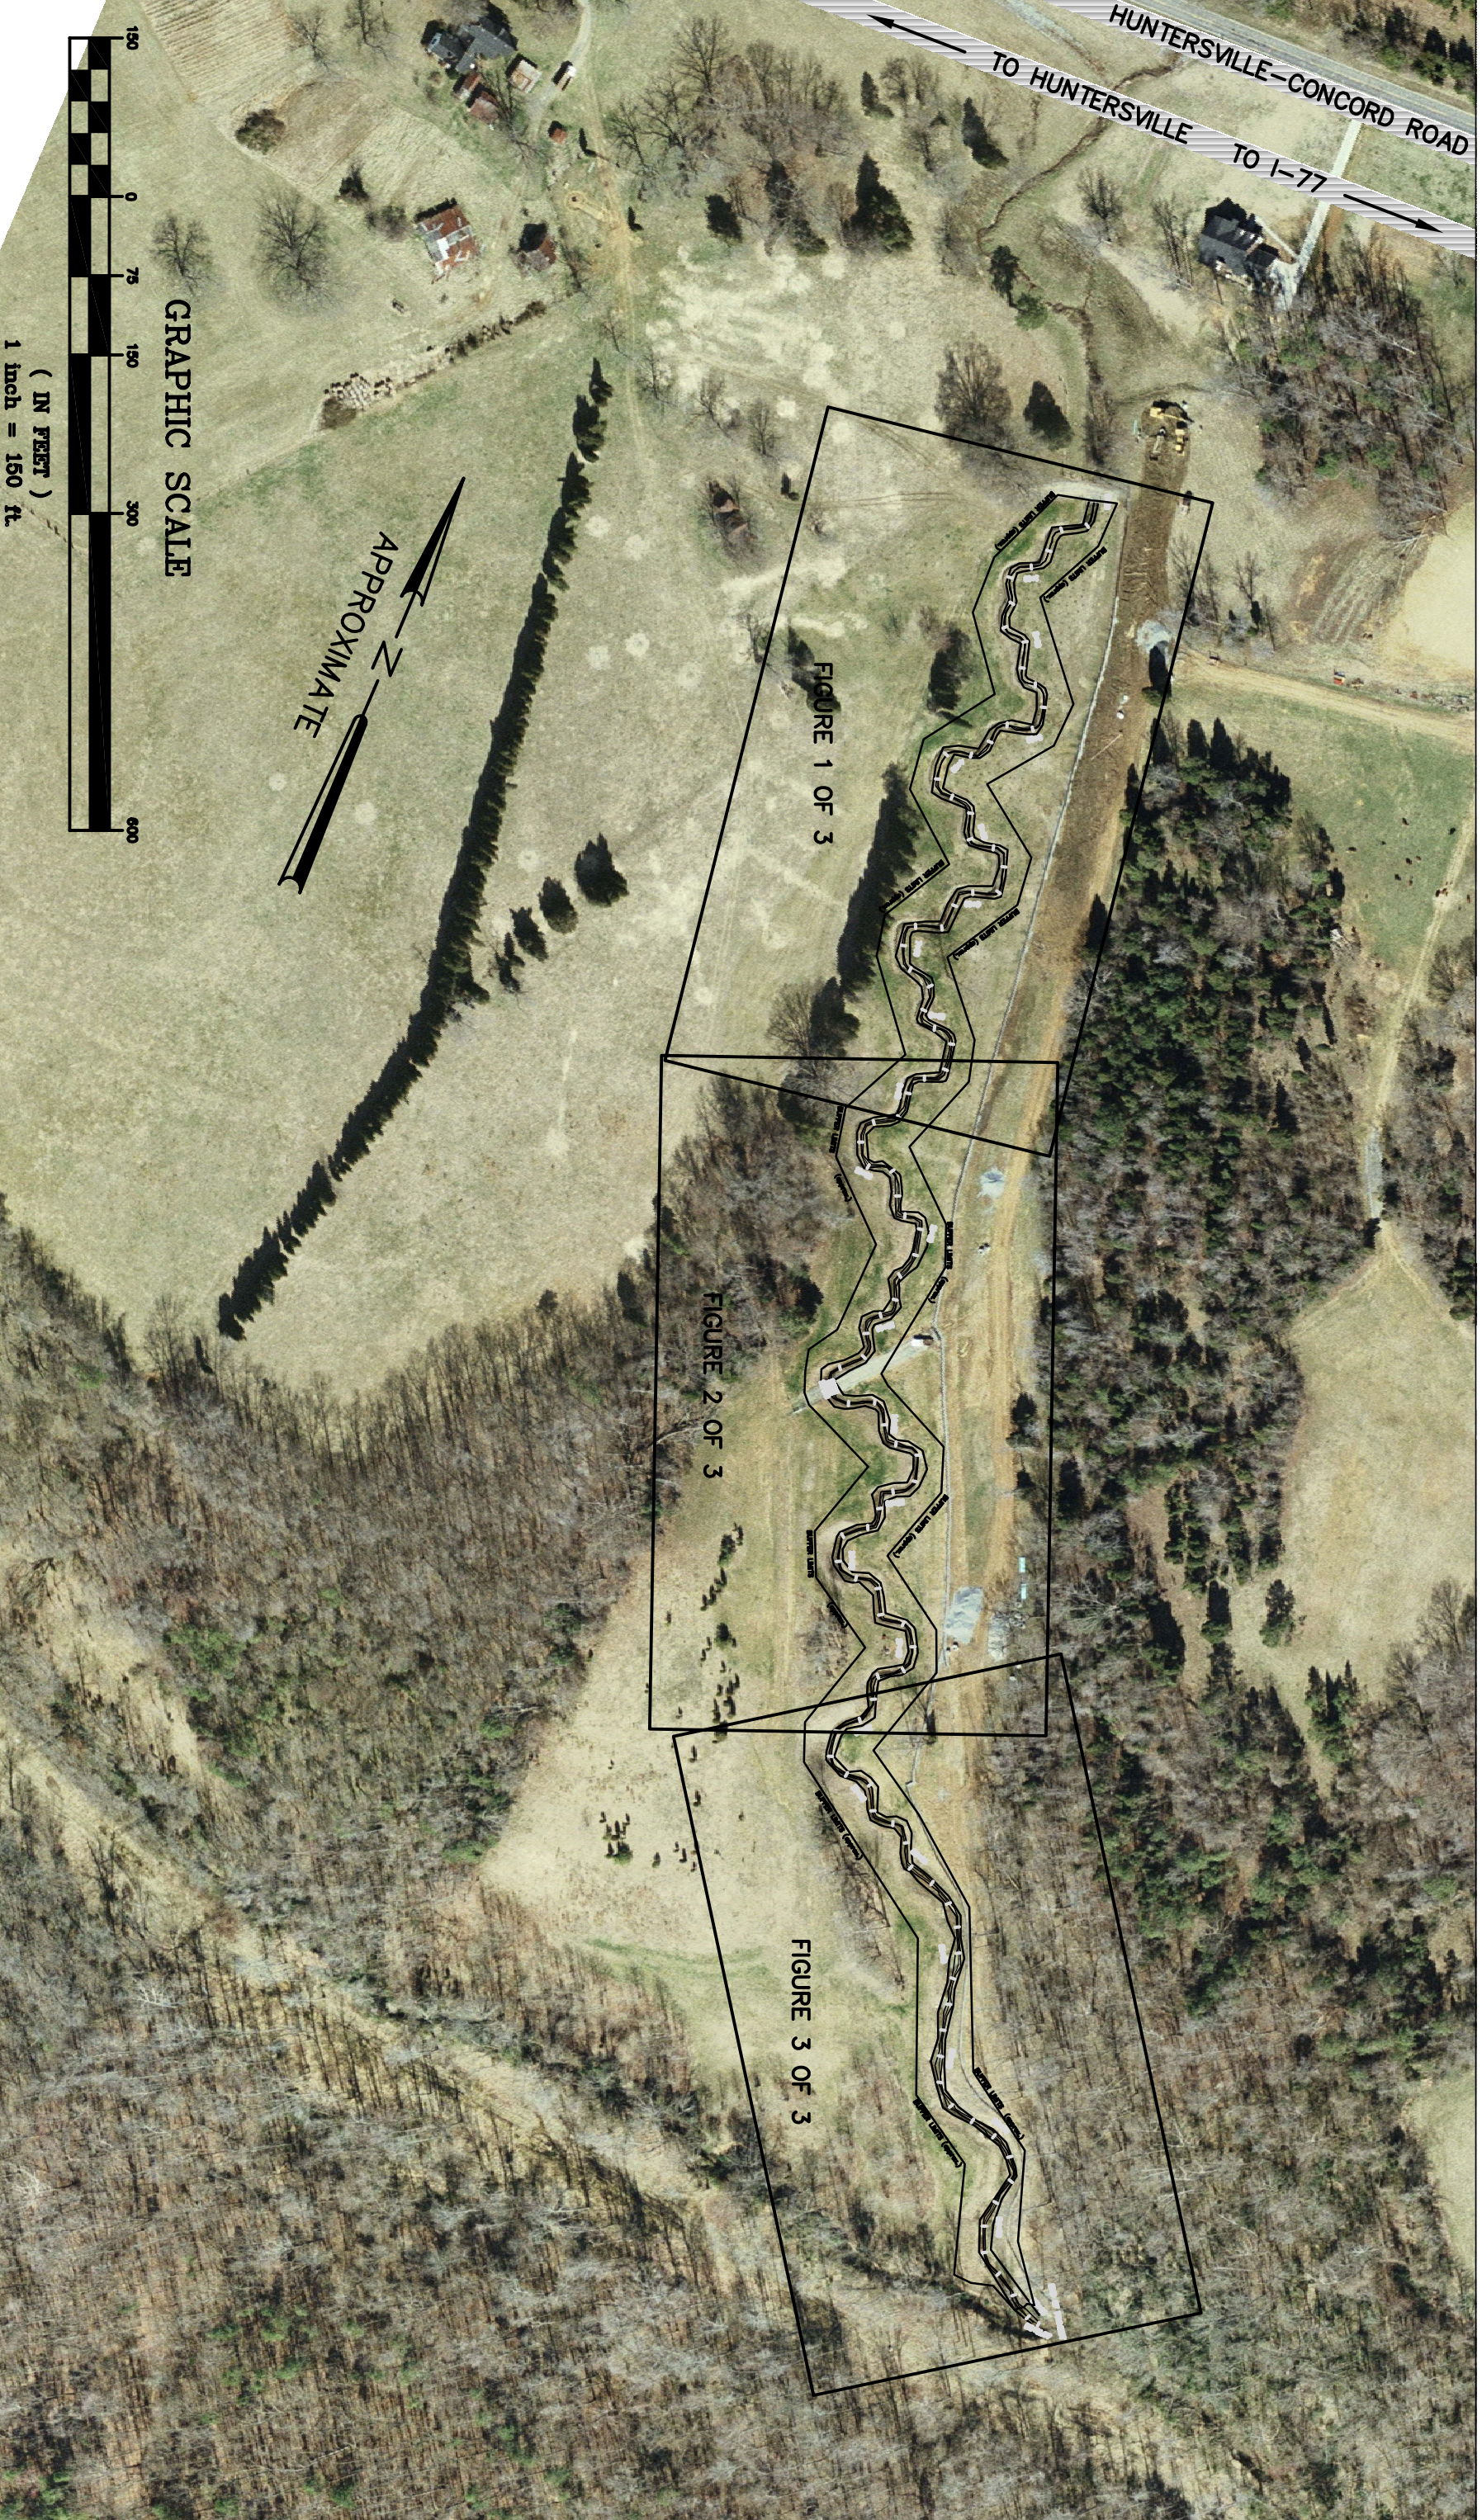
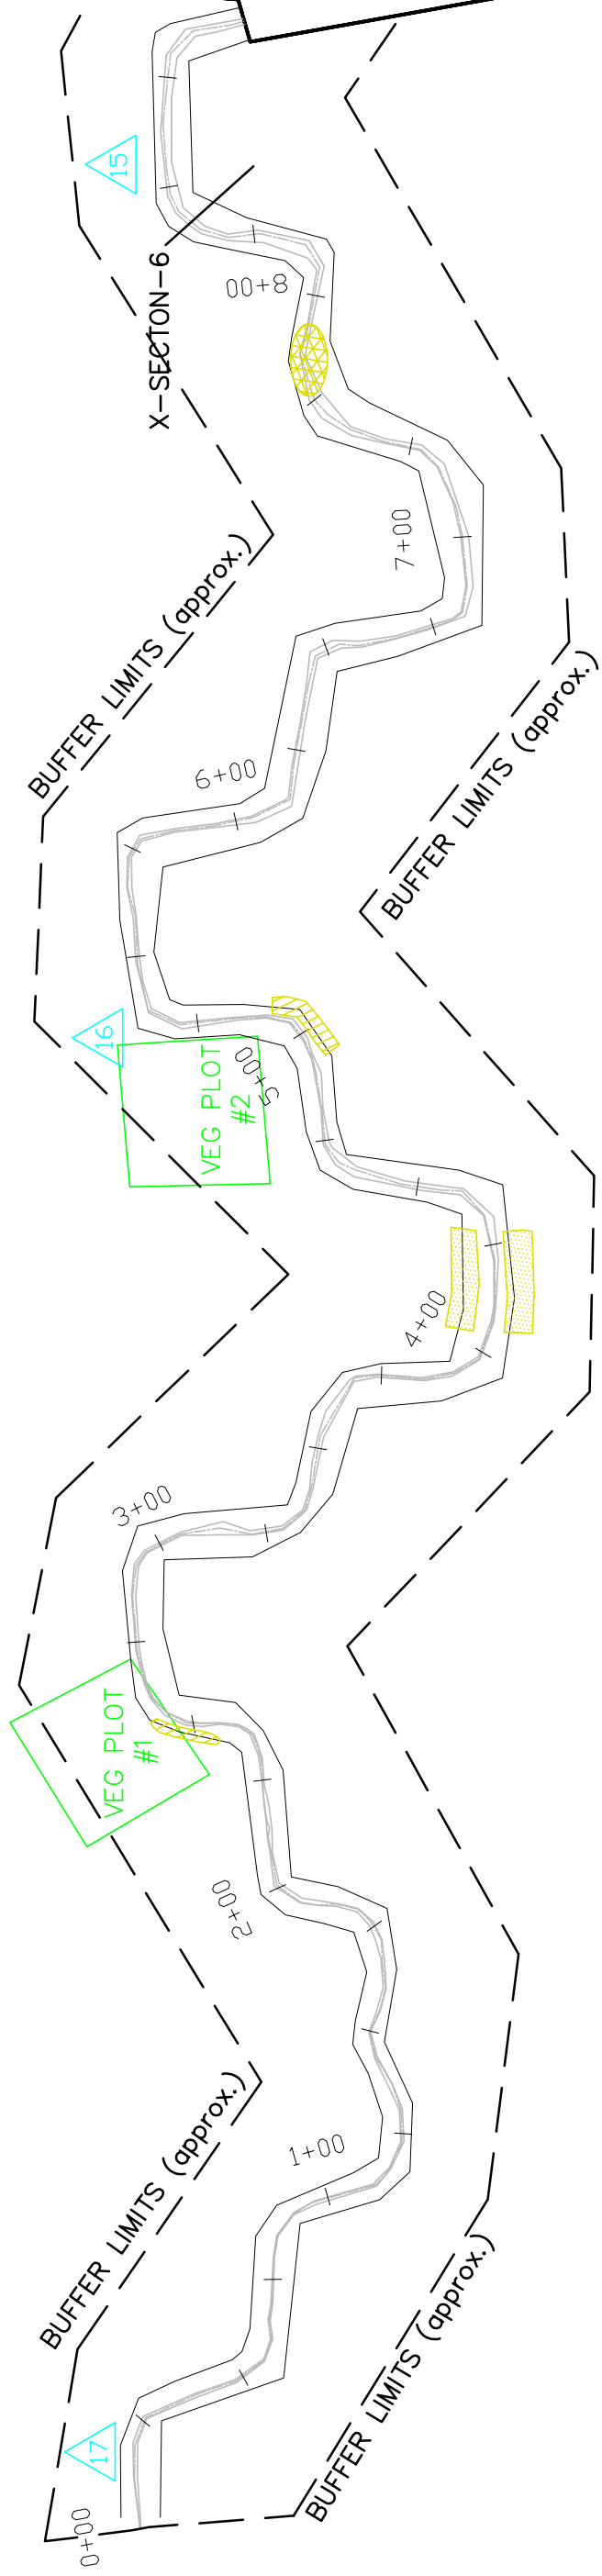
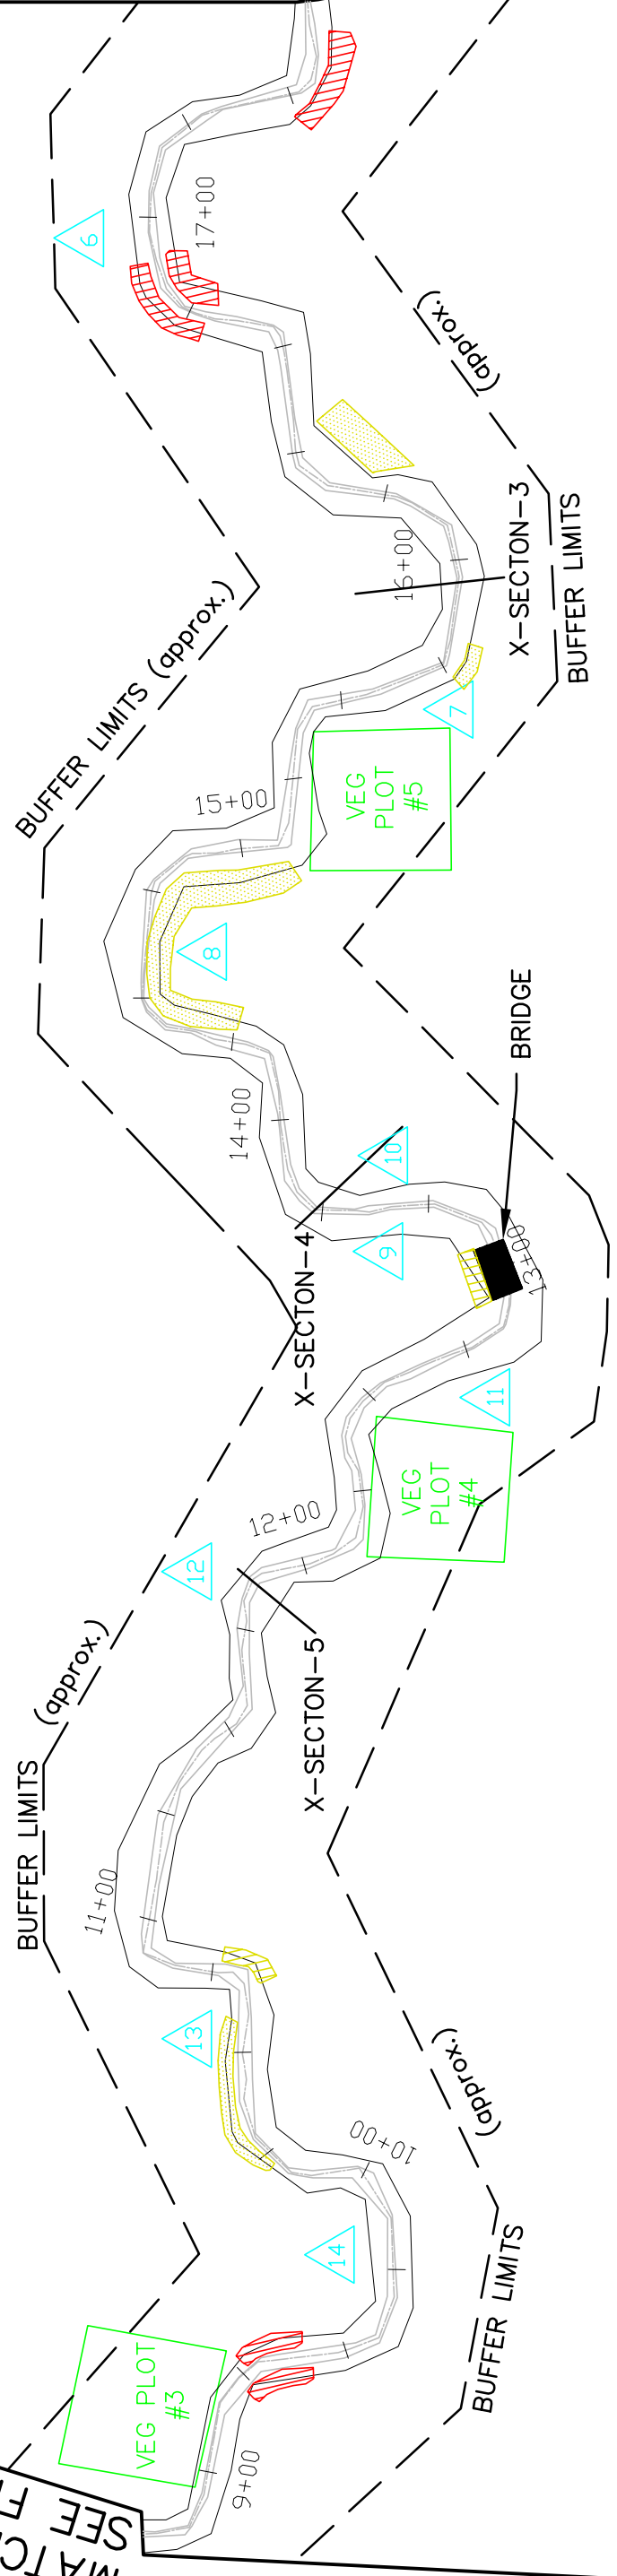
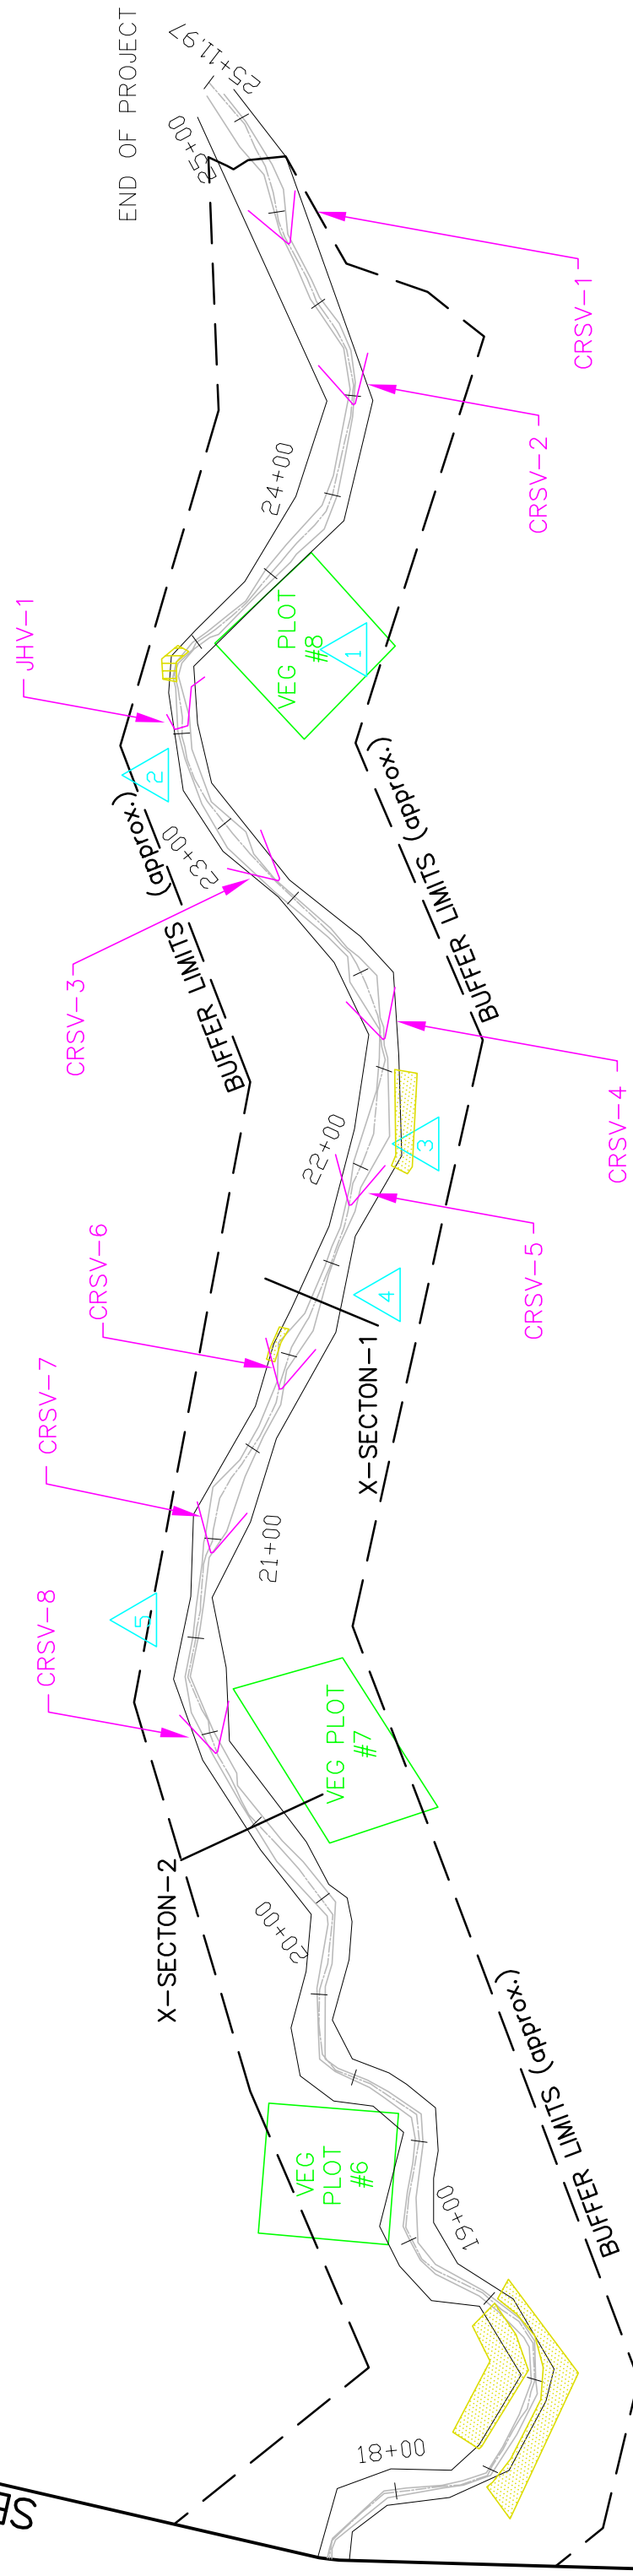
NC ECOSYSTEM ENHANCEMENT PROGRAM  
CATO FARMS STREAM RESTORATION  
**APPENDIX B1**  
PROBLEM AREAS PLAN VIEW

Feature Issue		Station Numbers	Suspected Cause	Photo ID #
<b>Bank erosion - moderate</b>	Reach 1	2+45 - 2+55	Bank erosion - no cover - LB	B2.1
		10+65 - 10+75	Bank erosion - no cover - RB	
		13+00	Storm flow overflow along east side of bridge/some erosion - LB	
	Reach 2	24+40 - 24+45	Bank failure - small portion in stream - LB	
<b>Bank erosion - severe</b>	Reach 1	4+95 - 5+10	Bank erosion - no cover - RB	B2.2
		9+25 - 9+40	Bank failure - no cover - Both banks	
		16+70 - 16+90	Bank failure/bank erosion - no cover - Both banks	
		17+50 - 17+70	Bank erosion severe - no cover - RB	
<b>Mid-channel bar</b>	Reach 1	7+60	Channel slightly over widened	B2.3
<b>Vegetative cover - poor</b>	Reach 1	4+10 - 4+30	Dead stakes & vegetation - Both banks	B2.4 B2.5
		10+20 - 10+60	Dead fascines - LB	
		14+25 - 15+10	Bare bankfull bench & riparian area - RB	
		15+75 - 15+85	Bare upper slope/exposed - RB	
		16+25 - 16+50	Bare bankfull bench & point bar/dead stakes - RB

In summary, the channel appears to be stable with some minor areas of moderate to severe bank erosion due to lack of vegetative cover. Some minor bank repair work was completed after construction, but no specific information was provided.

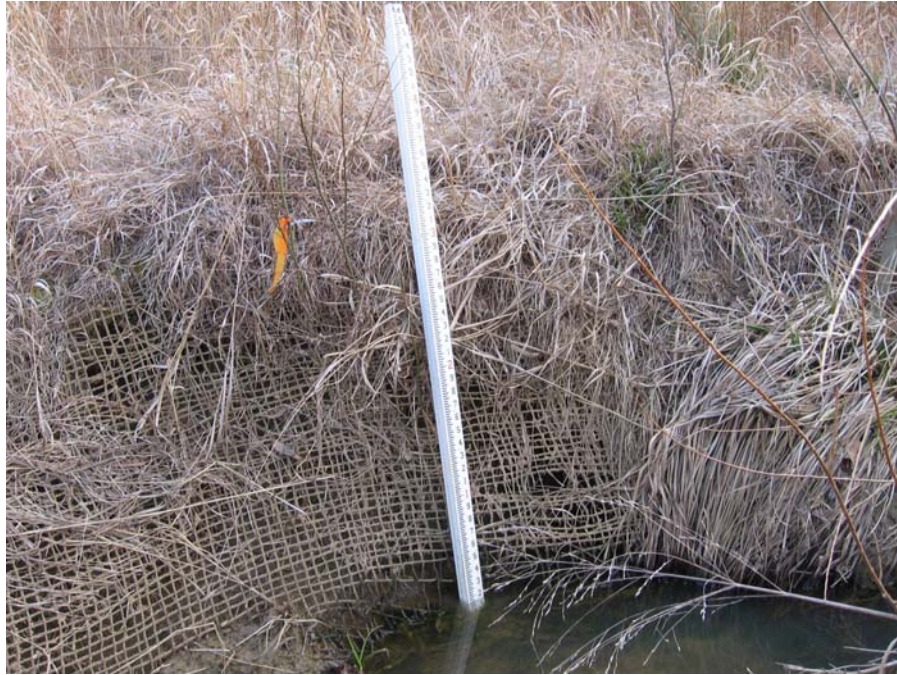
1. Bank Erosion: Moderate– 3/30/06

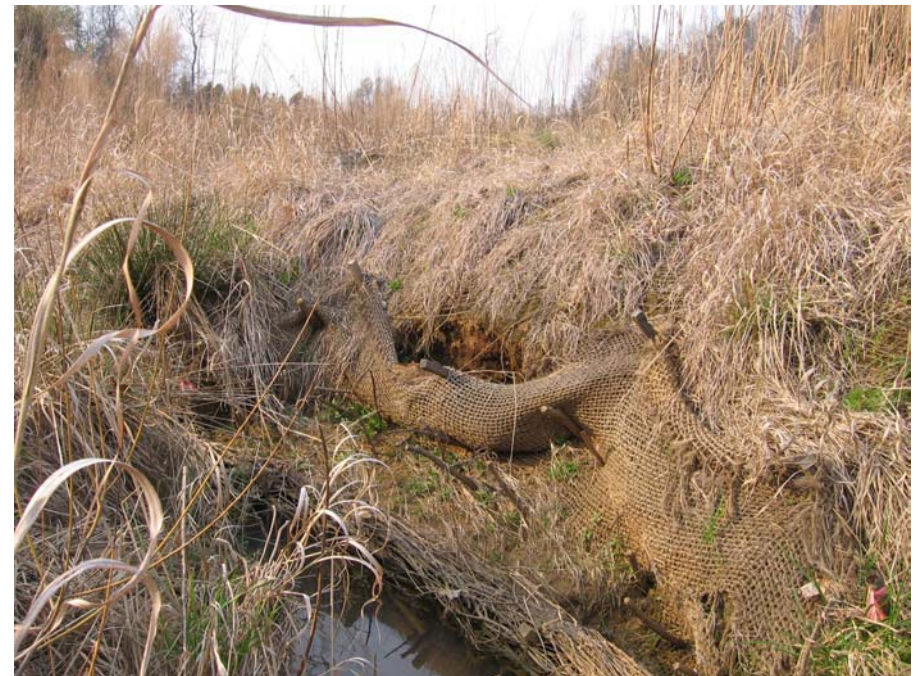
2. Bank Erosion: Severe– 3/30/06

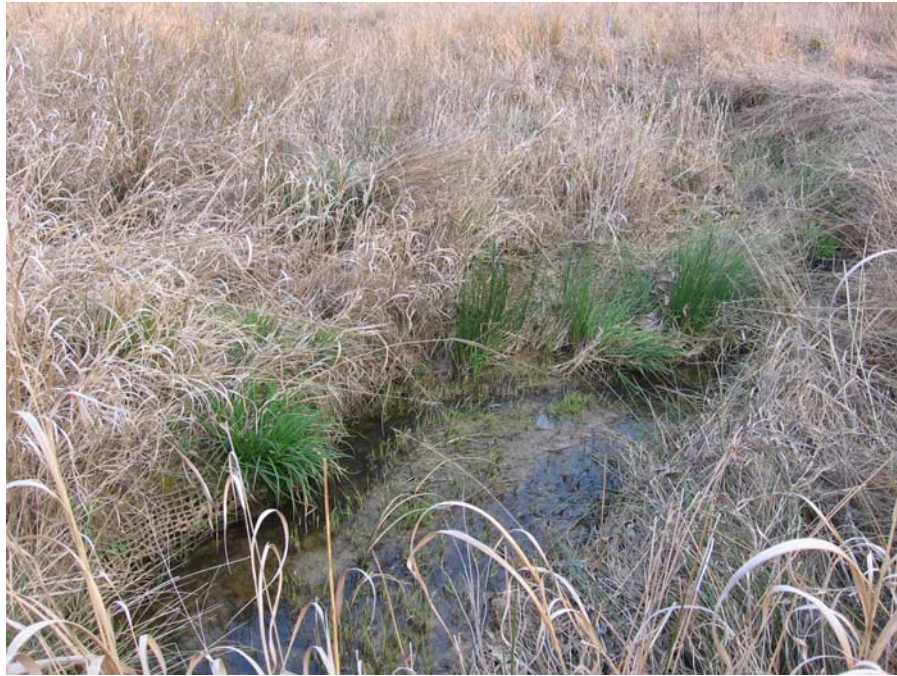
3. Mid Channel Bar– 3/30/06

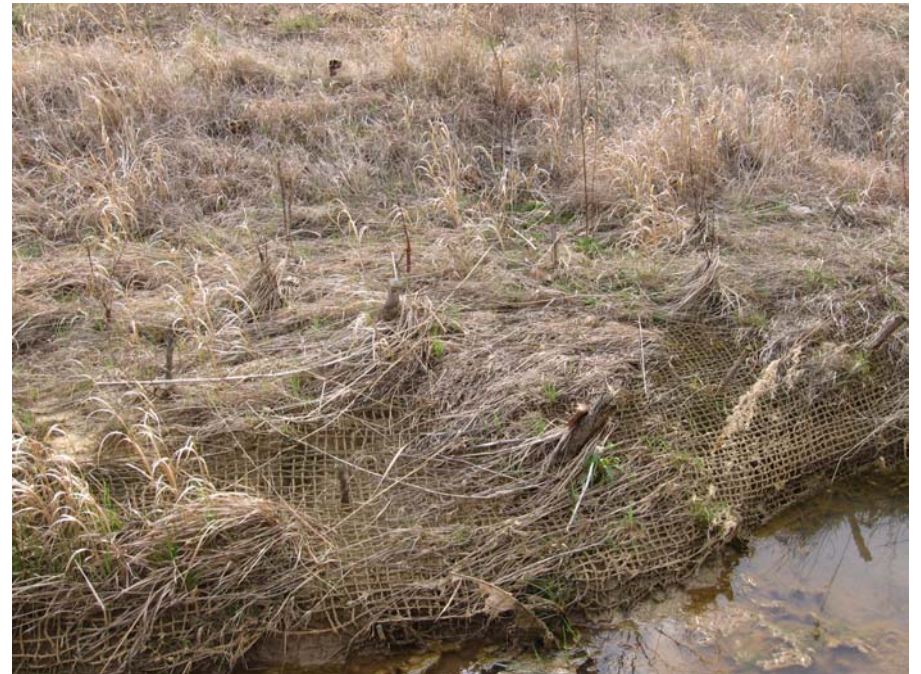
4. Vegetative Cover Poor– 3/30/06

In the limited areas where vegetation has not established, addition of temporary and permanent seeding is recommended. On the banks with high live stake mortality, replacement of live stakes will provide long-term stability.

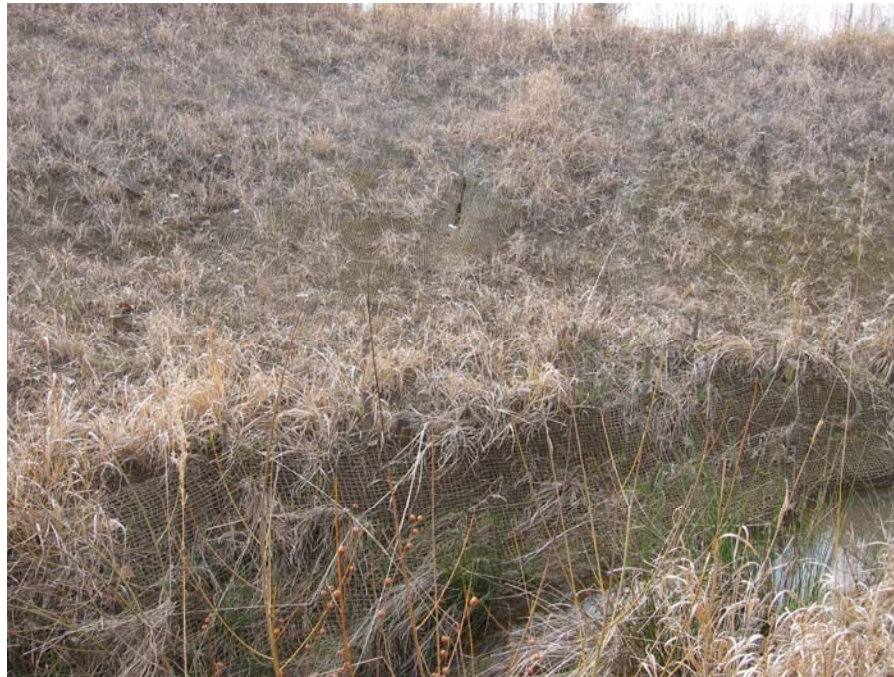
5. Vegetative Cover Poor– 3/30/06
