**Cato Farms Stream Restoration**  
**Project No. 72**  
**2007 Monitoring Report (Final): Year 3 of 5**

**March 2008**

Prepared for: NCDENR-EEP  
1652 Mail Service Center  
Raleigh, NC 27699-1652

Prepared by: Jordan, Jones, and Goulding, Inc.  
9101 Southern Pine Blvd., Suite 160  
Charlotte, NC 28273

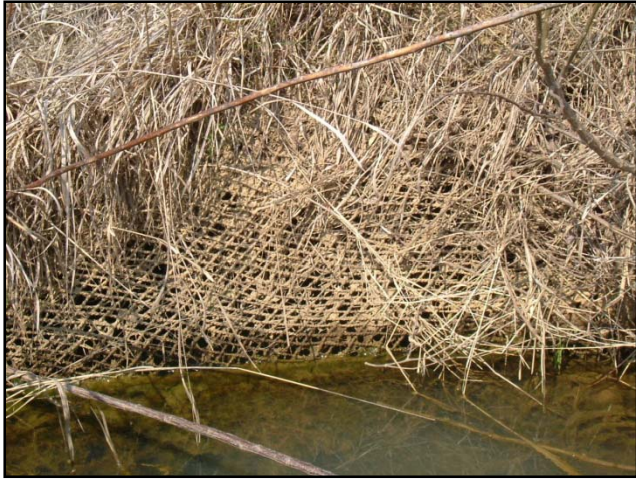
1. Bank Erosion: Moderate  
3/22/2007

In the limited areas where vegetation has not established, addition of temporary and permanent seeding is recommended. On the banks with high live stake mortality, replacement of live stakes is recommended to provide long-term stability.

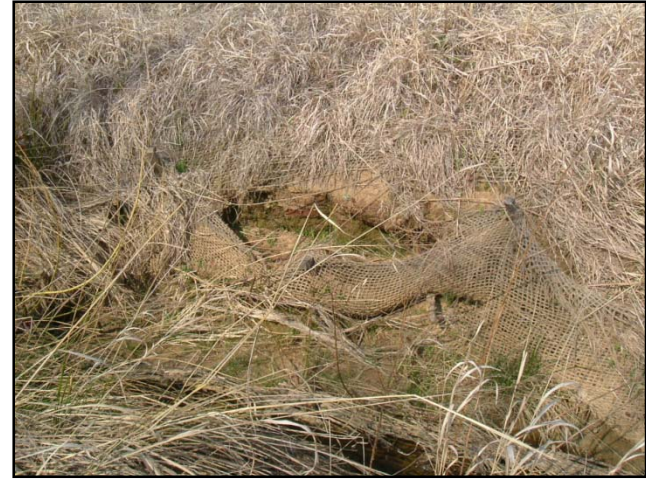
2. Bank Erosion: Severe  
3/22/2007

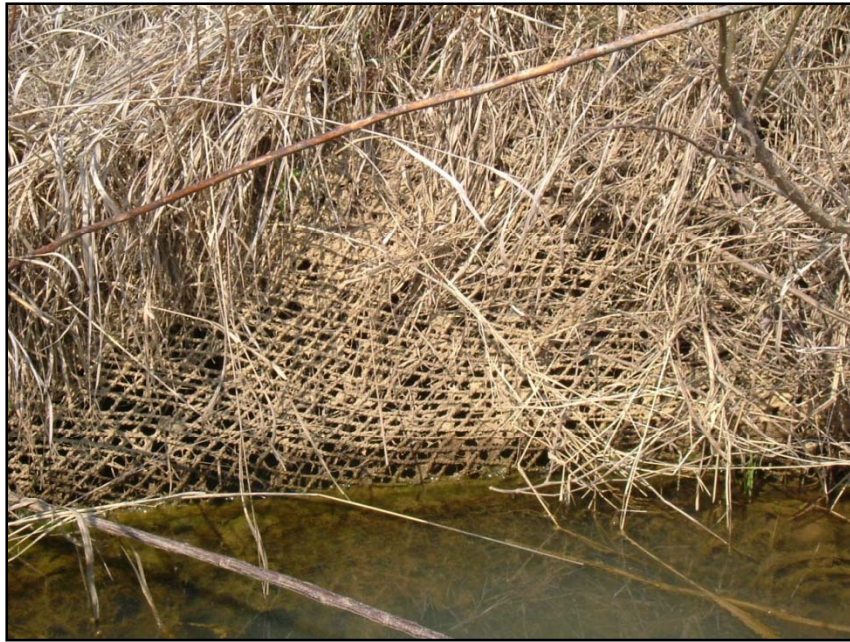
Feature Issue		Station Numbers	Suspected Cause	Photo ID #
Bank Erosion - Moderate	Reach 1	0+50 - 0+51	Scour under matting, loose matting - RB	1
		2+20 - 2+30	Scour under matting, loose matting - LB	
		2+45 - 2+55	Bare bank - LB	
		3+23	Bank erosion - stream widened - BB	
		4+10 - 4+30	Bank erosion under matting - BB	
		4+95 - 5+10	Bank erosion - RB	
		5+75 - 5+80	Bank erosion under matting - LB	
		6+05 - 6+15	Bank erosion under matting - RB	
		6+50 - 6+51	Bank erosion under matting - LB	
		7+25 7+27	Bank erosion under matting - RB	
		7+50 - 7+52	Bank erosion under matting - LB	
		7+75 - 7+77	Bank erosion under matting - LB	
		8+90 - 8+92	Bank erosion under matting - LB	
		10+65 - 10+75	Bare bank - RB	
		11+30 - 11+50	Bank scour - LB	
		13+00	Storm flow overflow along east side of bridge/some erosion - LB	
		14+75 - 14+76	Bank erosion under matting - LB	
	17+25 - 17+35	Bank erosion under matting - LB		
	18+50 - 18+75	No vegetation cover - RB

1. Bank Erosion: Moderate  
3/21/2007

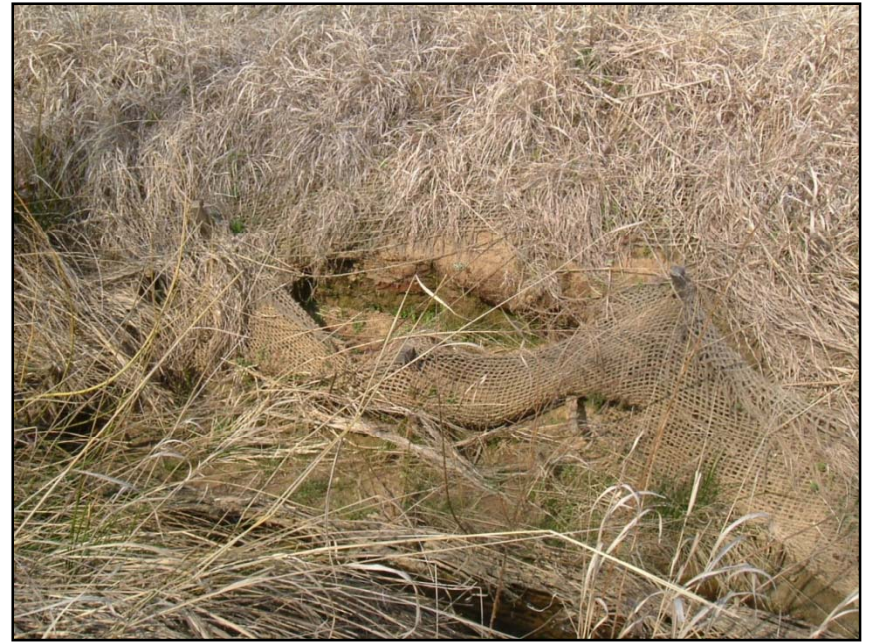
2. Bank Erosion: Severe  
3/21/2007

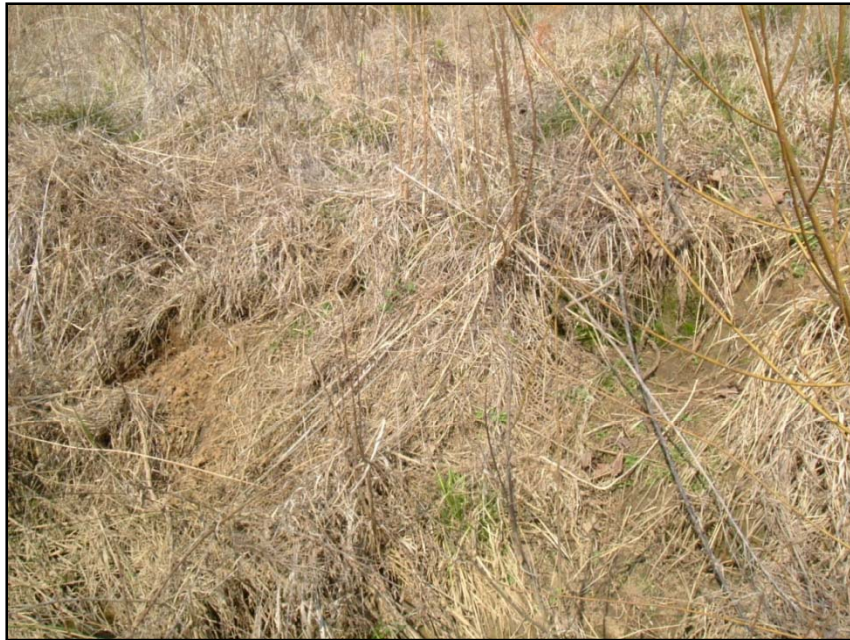
3. Bank Slump  
3/21/2007

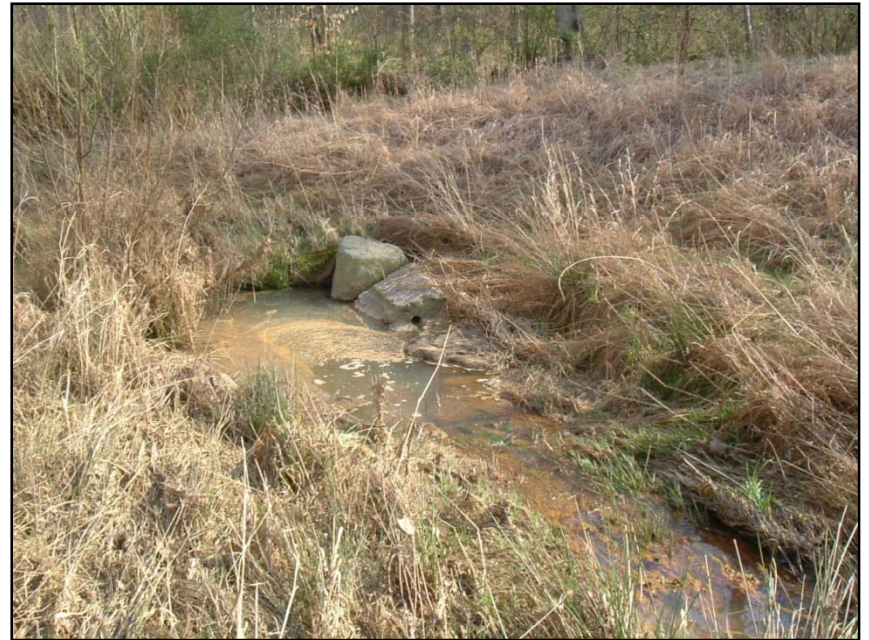
The pattern, profile, and dimensions of Reach 1 and 2 appear stable with some isolated signs of moderate erosion and heavy sediment deposition. These areas of moderate and severe bank erosion are primarily due to lack of vegetative cover. There are also numerous areas that are not actively eroding but are susceptible to bank erosion due to poor vegetative cover. Current drought conditions during the 2007 monitoring year have severely lowered the normal baseflow levels, creating minimal flow. These conditions most likely attributed to high silt deposition throughout Reach 1 and 2 and stagnant pools with algal blooms in Reach 2. It is assumed that a few high flow events would decrease and flush out some of the fine sediment depositions and algal blooms observed in the 2007 monitoring year.

4. In-stream Vegetation/Mid-Channel Bar  
3/21/2007

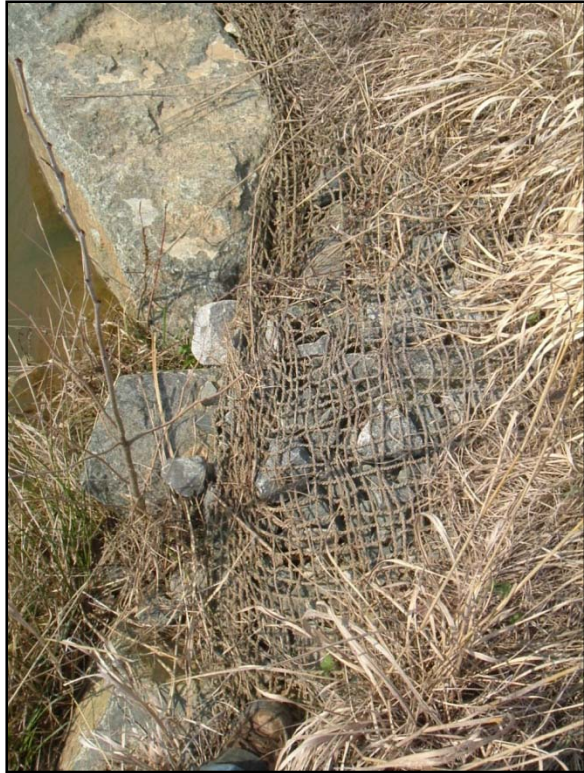
During the initial assessment survey conducted in April 2007, it was noted that some minor areas of streambank have suffered localized loss of vegetative cover. In these areas, it is apparent that flood events likely caused the bank erosion resulting in a loss of vegetation. Furthermore, the compaction of soil and nutrient poor conditions may also be contributing to the mortality of live stakes and herbaceous cover in these limited areas. During the vegetative survey completed in August, it was observed that many of the problem areas noted during the initial vegetation assessment (March 2007) have improved throughout the growing season. It should be noted that much of the sites herbaceous cover in the riparian area is dog-fennel (*Eupatorium capillifolium*). This species seems to be invasive on site; however, it is not listed as an invasive species for North Carolina. Control of this species may need to be done in order to allow for preferred riparian species to establish. Please refer to Appendix 1.1 for the vegetative problem areas table.

5. Vegetation Cover-Poor  
3/21/2007

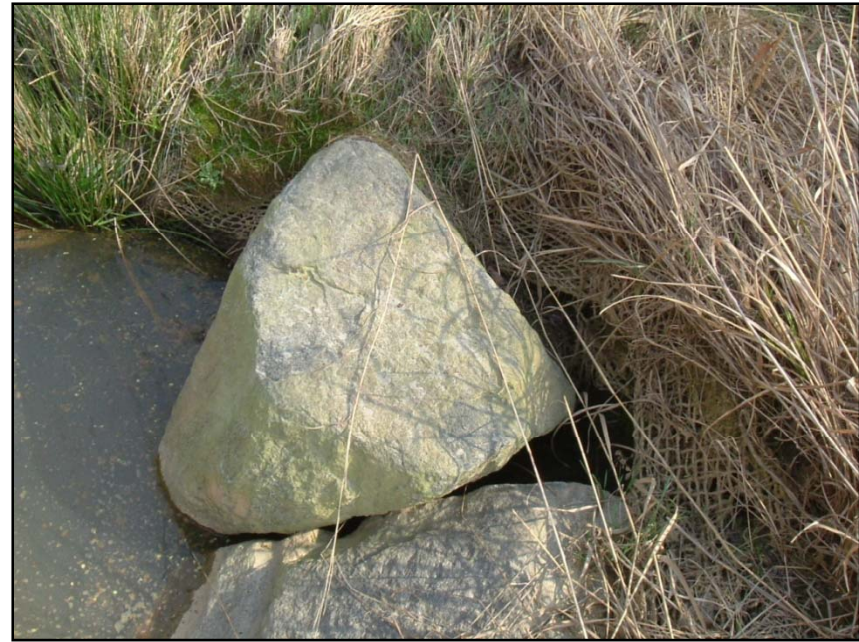
Overall, the structures within the transition zone appear to be in good condition; however, the outer arm of some structures are lacking in vegetative cover; therefore, moderate to severe scouring is occurring (Stationing 21+00, 21+50, 22+50, 22+90, 23+90, 23+25, and 24+30). The cross-vane at stationing 24+25 has vegetation growing on the invert and lateral bars are forming on the downstream side of a few cross-vanes below stationing 22+25.

20+10 - 20+13	Bank scour - RB	
22+00 - 22+50	Bank erosion under matting - RB		
23+35 - 23+50	Bank erosion under matting - RB		
23+50 - 23+70	Moderate bank erosion - RB		
Bank Erosion - Severe	9+15 - 9+25	Severe bank erosion under matting - LB	2
	17+50 - 17+70	Bank erosion eroded bank severe - RB	
Bank Slump	5+40	Bank slump - LB	3
	16+70 - 16+90	Bank failure/bank erosion - BB	
Mid-Channel Bar	7+60	Mid-channel bar channel, over widened	4
Aggradation	22+50	Depositional lateral bar behind cross vane arm	*
	22+90	Deposition in scour pool behind cross vane	
In-Stream Vegetation	12+25 - 12+75	Soft rush in main channel	4
	24+25	Soft rush in main channel	
Vegetative Cover - Poor	10+25 - 10+55	Poor vegetative cover - LB	5
	14+25 - 15+10	Bare bench/riparian area - RB	
	15+75 - 15+85	Bare slope/exposed - RB	
	16+25 - 16+50	Bare benches & points/dead stakes - RB	
	18+25 - 18+75	Bare bank, dead live stakes - BB	
Structure - Stressed	21+00	Moderate scour behind cross vane arm - RB	6

6. Structure-Stressed  
3/21/2007
