Cato Farms Stream Restoration
Project No. 72
2008 Monitoring Report (Final): Year 4 of 5

March 2009

Prepared for: NCDENR-EEP
1652 Mail Service Center
Raleigh, NC 27699-1652

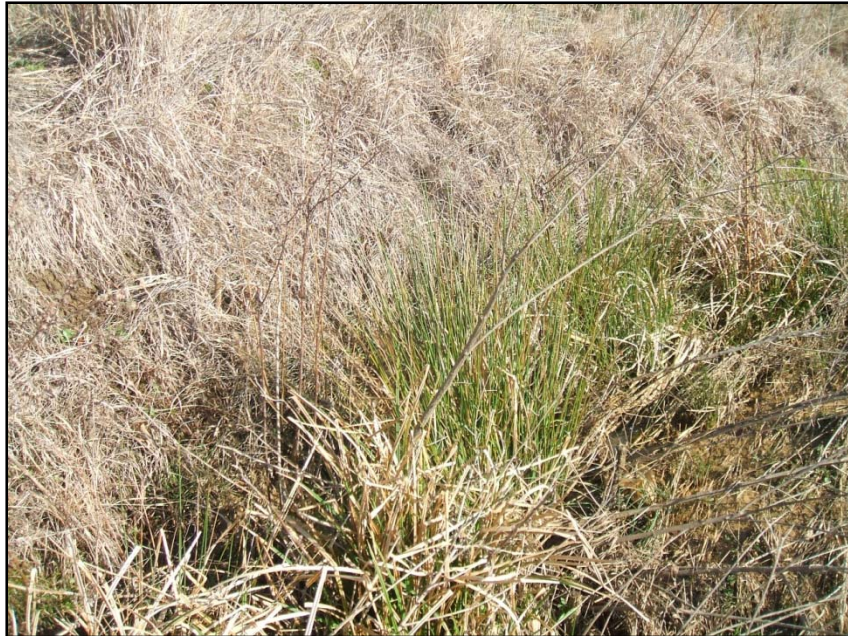
18+75	Soft rush and grasses in main channel	
	19+75 - 19+78	Soft rush and grasses in main channel	
	22+40	soft rush on invert	
	22+80	soft rush on invert	
24+68	soft rush on invert

1. In-Stream Vegetation (3/2008)

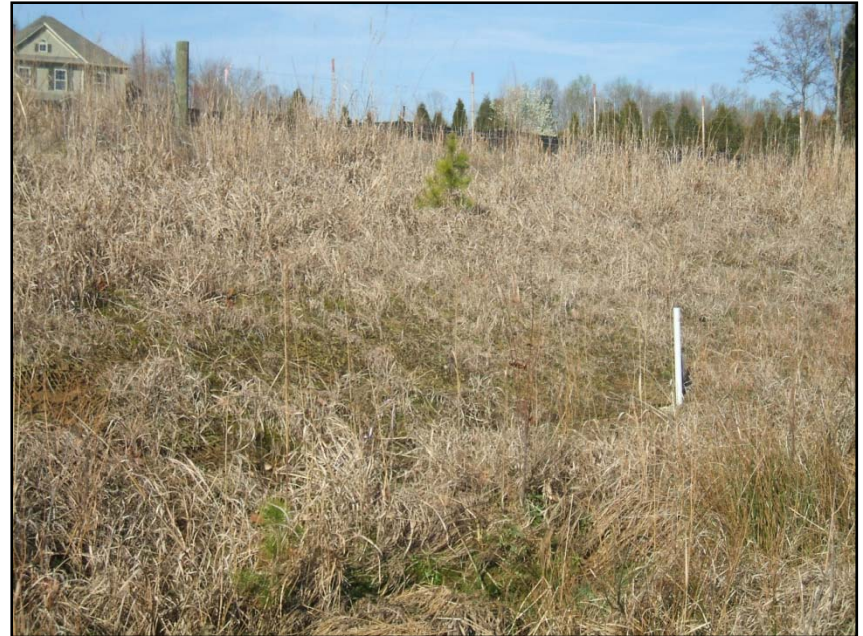
Feature Issue	Station Numbers	Suspected Cause	Photo ID #
Vegetative Cover - Poor	10+35 - 10+50	Poor vegetative cover - LB	1
	15+75 - 15+85	Bare slope/exposed - RB	
	16+25 - 16+50	Baren benches & points/dead stakes - RB	
	18+25 - 18+75	Bare bank, dead live stakes - BB	
In-Stream Vegetation	3+90 - 4+50	Soft rush and grasses in main channel	2
	5+10 - 6+00	Soft rush and grasses in main channel-Sporadic	
	6+70 - 9+00	Soft rush and grasses in main channel-Sporadic	
	10+00 - 10+04	Soft rush and grasses in main channel	
	10+95 - 11+05	Soft rush and grasses in main channel-Sporadic	
	11+75 - 12+00	Soft rush and grasses in main channel	
	12+25 - 13+25	Soft rush and grasses in main channel	
	14+00 - 14+25	Soft rush and grasses in main channel-Sporadic	
	14+75 - 14+87	Soft rush and grasses in main channel	
	15+24 - 15+26	Soft rush and grasses in main channel	
	15+73 - 16+24	Soft rush and grasses in main channel	
	17+25 - 17+35	Soft rush and grasses in main channel

2. Poor Vegetation Cover (3/2008)

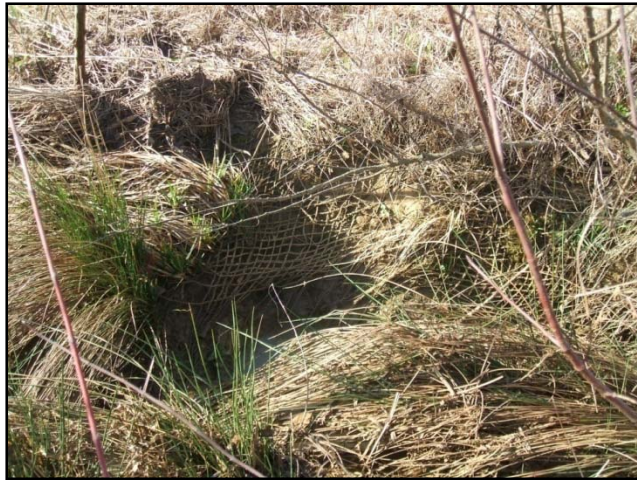
Feature Issue	Station Numbers	Suspected Cause	Photo ID #
Bank Erosion - Moderate	2+20 - 2+30	Scour under matting, loose matting - LB	1
	2+45 - 2+55	Bare bank - LB	
	4+10 - 4+30	Bank erosion under matting - BB	
	4+95 - 5+10	Bank erosion - RB	
	5+75 - 5+80	Bank erosion under matting - LB	
	6+05 - 6+15	Bank erosion under matting - RB	
	17+25 - 17+35	Bank erosion under matting - LB	
	18+50 - 18+75	No vegetation cover - RB	
	22+00 - 22+10	Bank erosion under matting - RB	
23+50 - 23+70	Moderate bank erosion - RB	2	
9+15 - 9+25	Severe bank erosion under matting - LB		
16+85 - 17+59	Severe bank erosion under matting - LB		
Structure - Stressed	17+50 - 17+70	Bank erosion eroded bank severe - RB	6
	21+50	Lack of Veg around cross-vane arm - LB	
	22+90	Scour under cross vane arm - LB	
	24+30	Scour behind cross vane arm - RB

1. Bank Erosion: Moderate (3/2008)

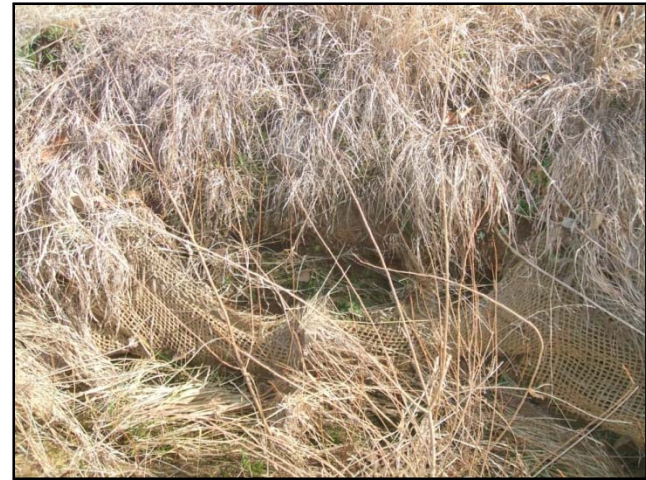
- In several outer bends, there are areas of moderate to severe bank erosion under the matting due to the lack of vegetative cover (Approximate stationing 9+15 and 17+00).
- Overall, the structures appear to be in good condition; however, the outer arm of some structures are lacking vegetative cover; therefore, moderate to severe scouring has occurred over the years (Stationing 21+00, 21+50, 22+50, 22+90, 23+90, 23+25, and 24+30).
- Several cross vanes (Stationing 22+40, 22+80, and 24+68) have vegetation growing on the inverts.

2. Bank Erosion: Severe (3/2008)
