# Cato Farms Stream Restoration

## Project No. 72

### 2009 Monitoring Report: Year 5 of 5

**November 2009 (Revised April 2010)**

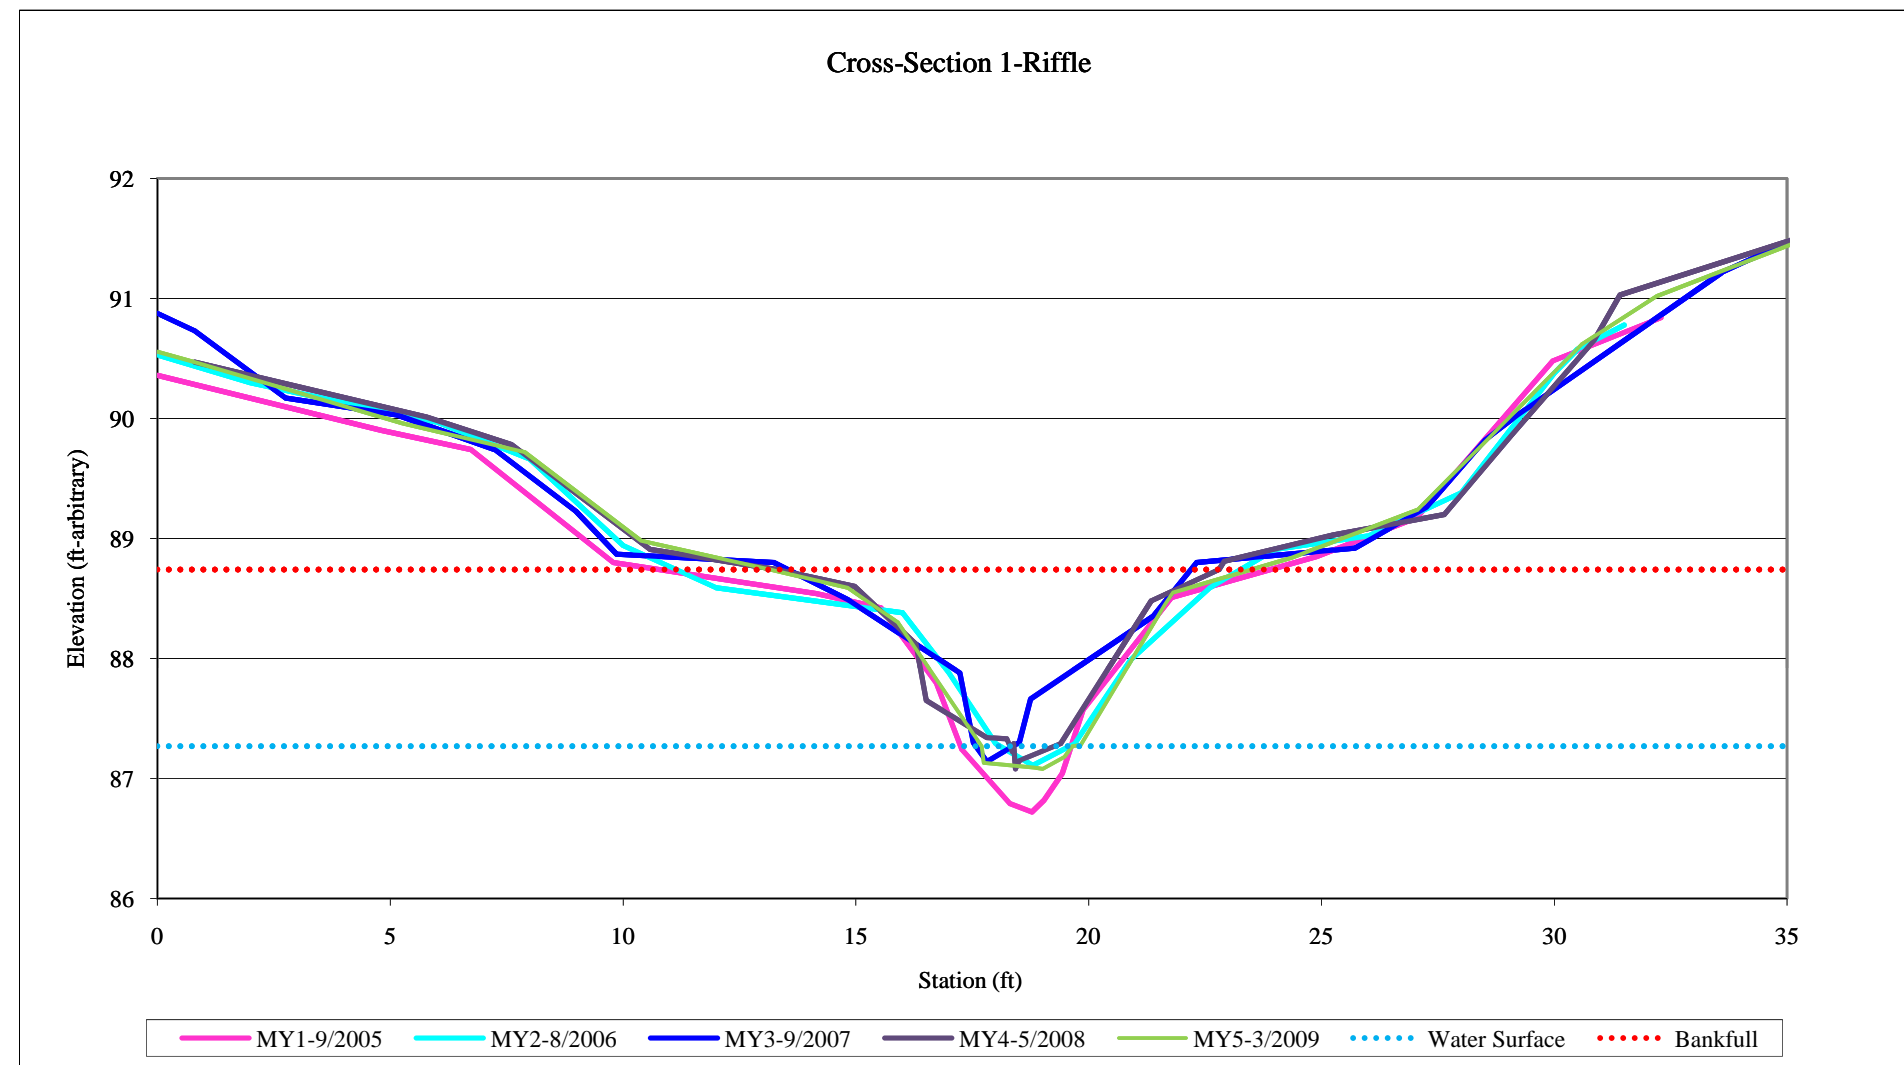
Cross-sections 1 and 2 are located within Reach 2. Both cross-section 1 and 2 are riffles and appear to be stable with minimal erosion occurring. The average water surface slope and the average bankfull slope are the same for the surveyed reach, 0.0090 ft/ft. The surveyed water surface slope was slightly lower than the proposed 0.010 ft/ft and similar to the previous surveyed water surface and bankfull slopes in 2006 (0.0093 ft/ft and 0.0083 ft/ft, respectively). The profile appears stable and is not showing significant shifting in the bed features.

Summary Data	
Bankfull Cross-Sectional Area (ft <sup>2</sup> )	7.36
Bankfull Width (ft)	10.32
Bankfull Mean Depth (ft)	0.71
Bankfull Max Depth (ft)	1.66
Width/Depth Ratio	14.54
Entrenchment Ratio	2.77

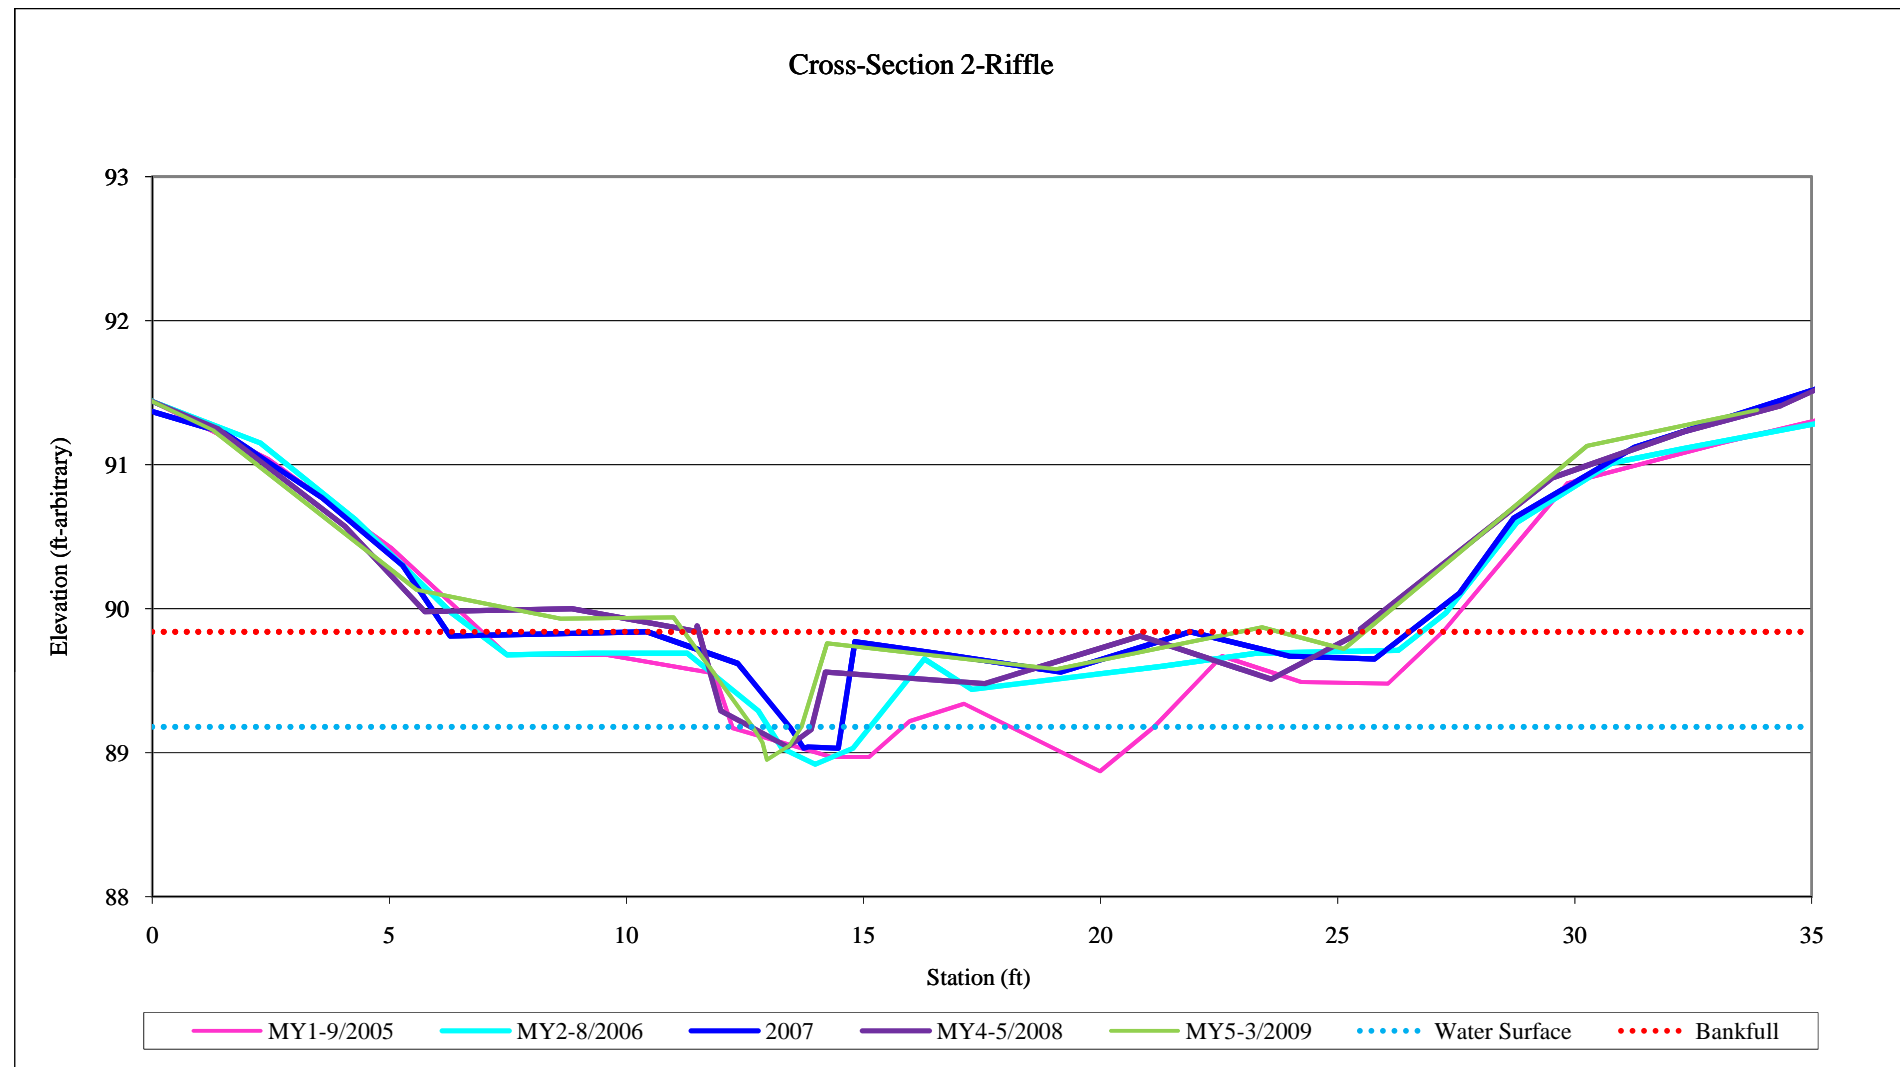
Summary Data	
Bankfull Cross-Sectional Area (ft <sup>2</sup> )	2.79
Bankfull Width (ft)	11.68
Bankfull Mean Depth (ft)	0.24
Bankfull Max Depth (ft)	0.89
Width/Depth Ratio	48.67
Entrenchment Ratio	2.19

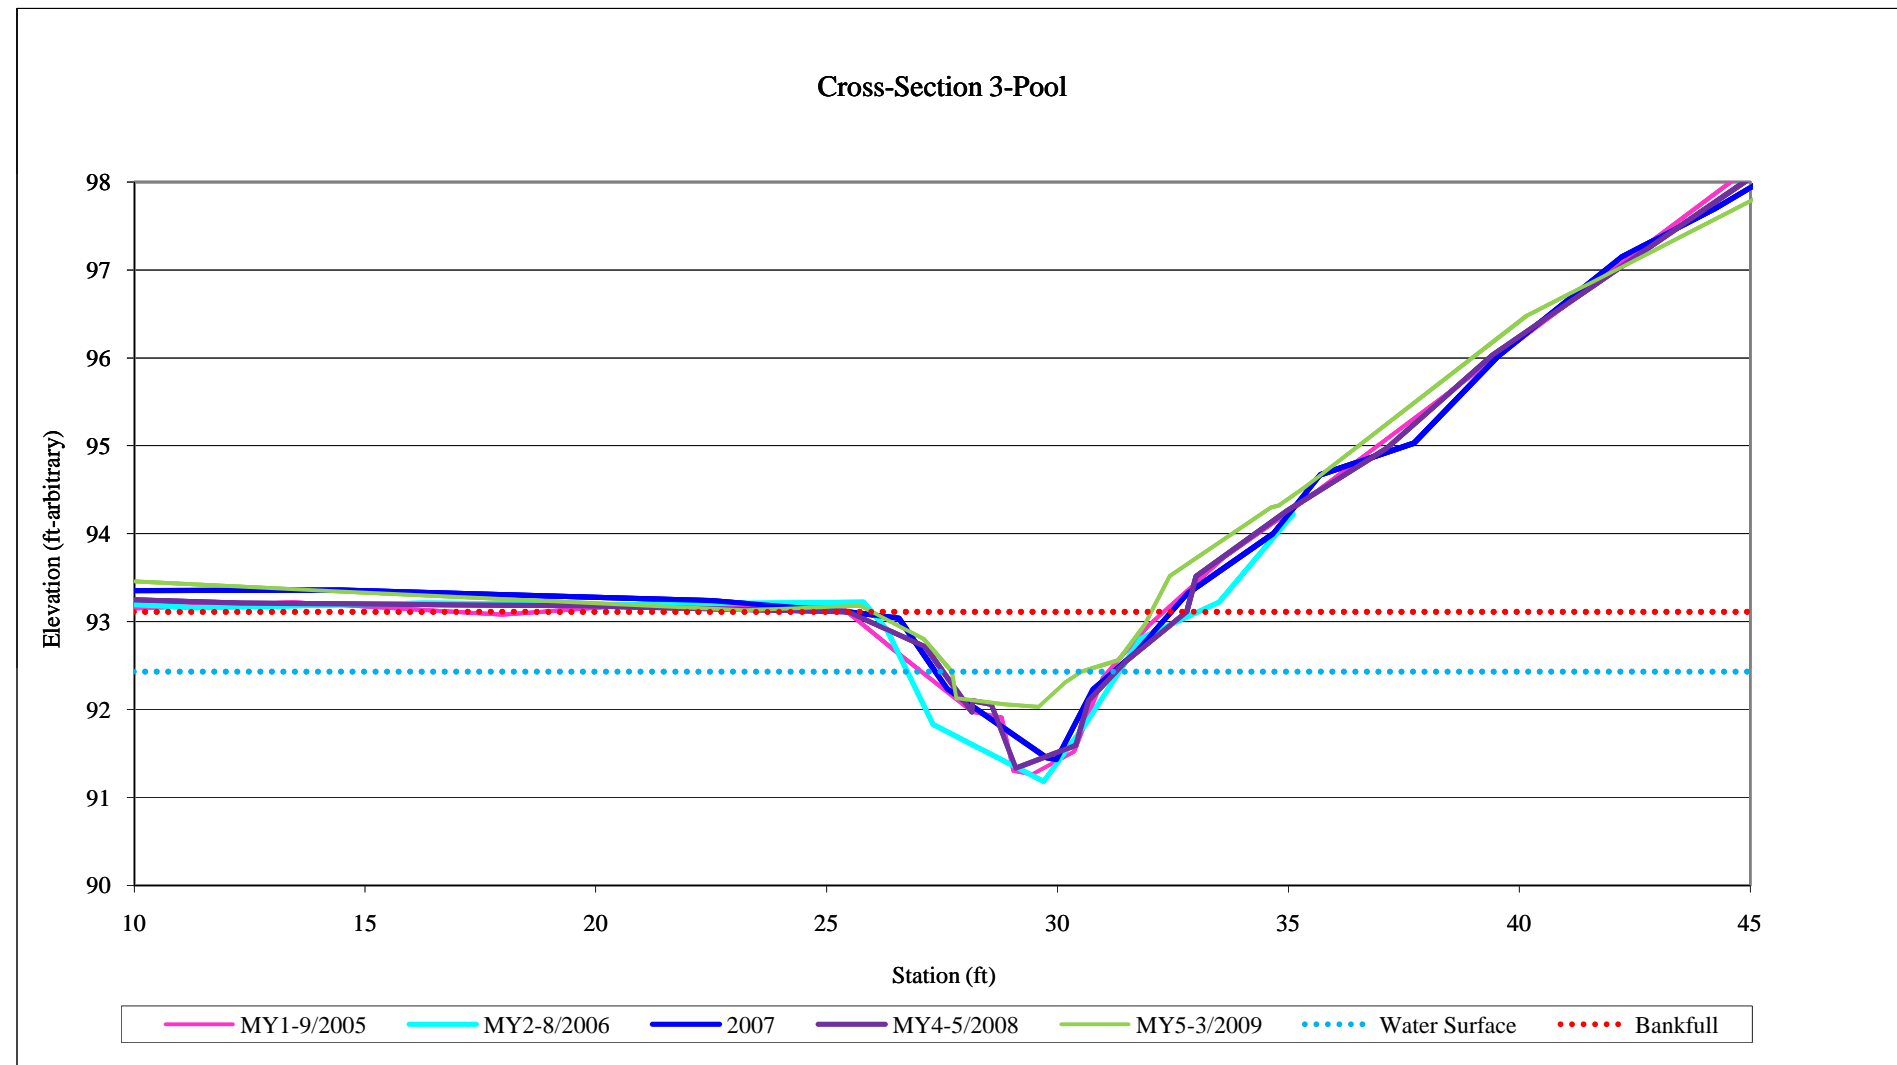
Within Reach 1, cross-sections 3, 4, 5, and 6 are located. All of these cross-sections have had sediment deposition occurring over the past monitoring years. These cross-sections have all illustrated a decrease in the bankfull mean depth and cross-sectional area. The substrate analysis shows a shift towards finer material. Again, the trapping of this finer material is apparently related to the drought induced channel vegetation. In addition, the watershed immediately above and on the Western edge of the project boundary saw a great deal of development over the last several years. Although the channel is illustrating a shift in substrate and cross-sectional

Summary Data	
Bankfull Cross-Sectional Area (ft <sup>2</sup> )	3.90
Bankfull Width (ft)	6.05
Bankfull Mean Depth (ft)	0.64
Bankfull Max Depth (ft)	1.08
Width/Depth Ratio	9.45
Entrenchment Ratio	N/A

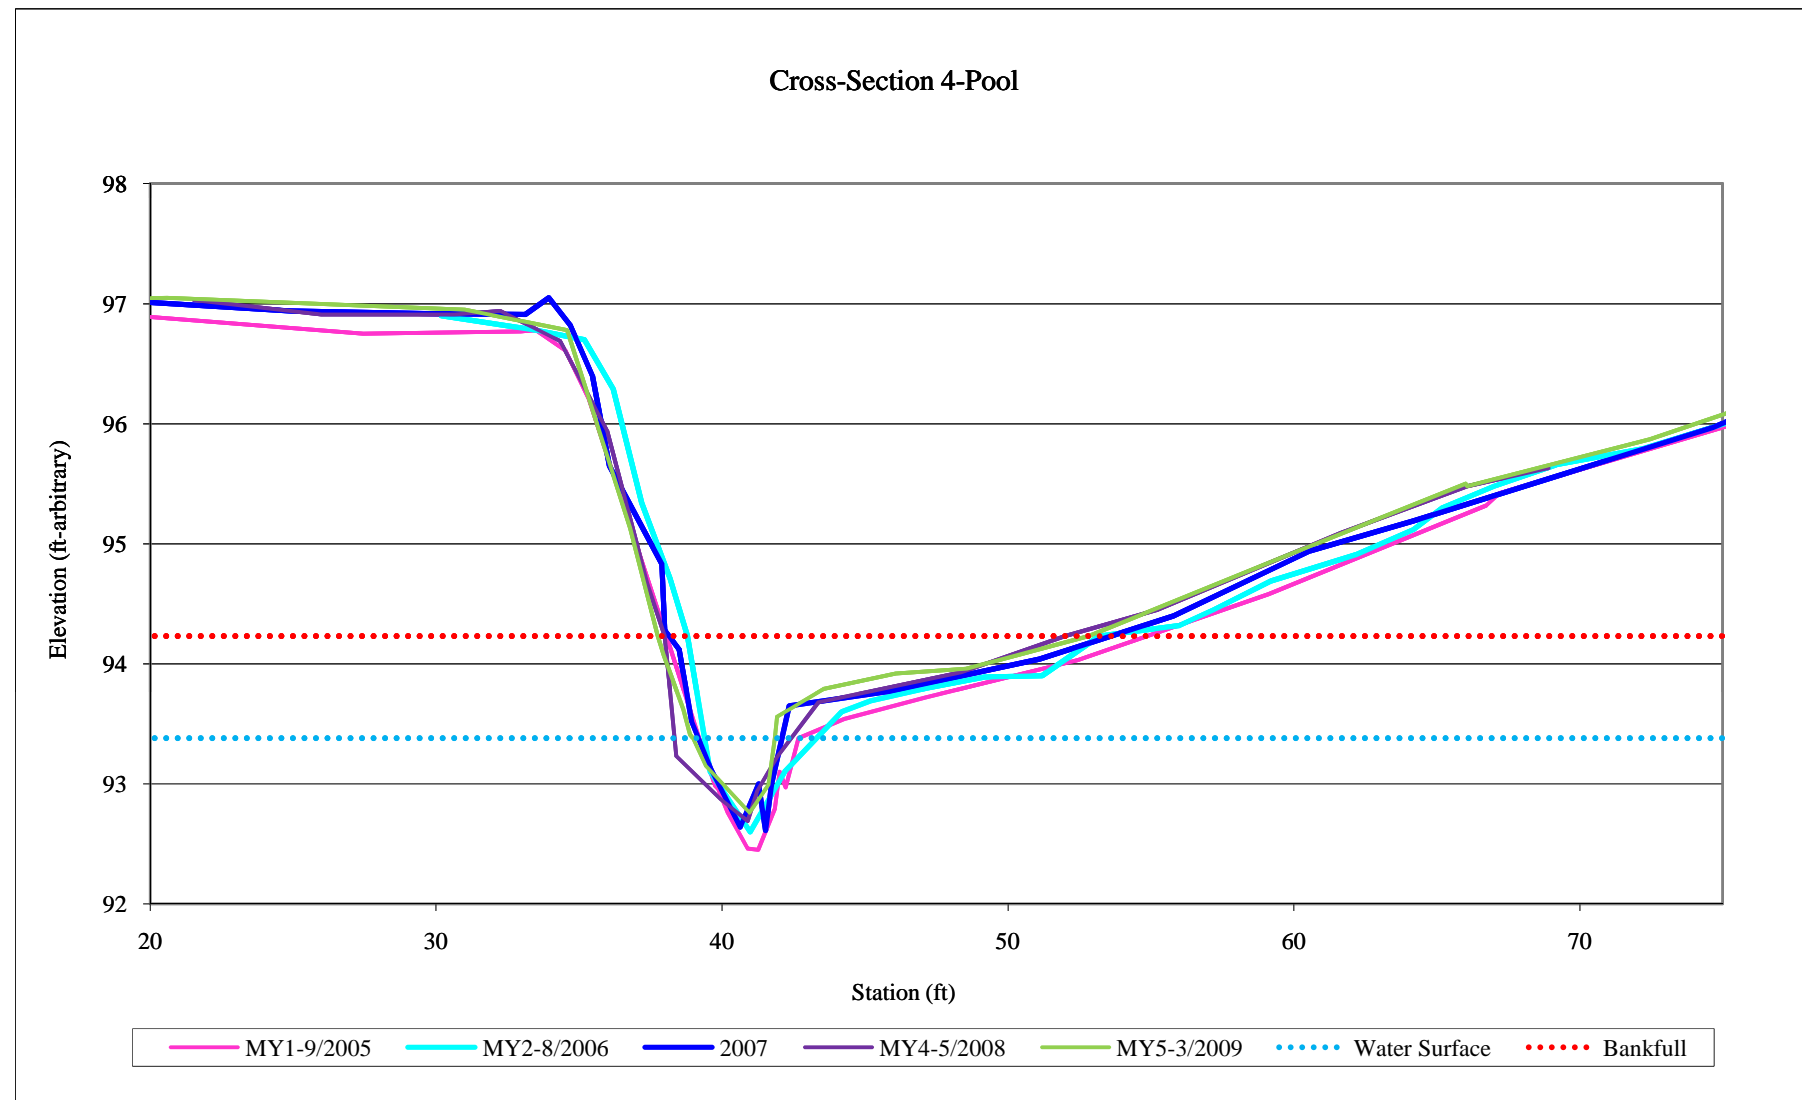
Summary Data	
Bankfull Cross-Sectional Area (ft <sup>2</sup> )	7.24
Bankfull Width (ft)	15.07
Bankfull Mean Depth (ft)	0.48
Bankfull Max Depth (ft)	1.47
Width/Depth Ratio	31.40
Entrenchment Ratio	N/A

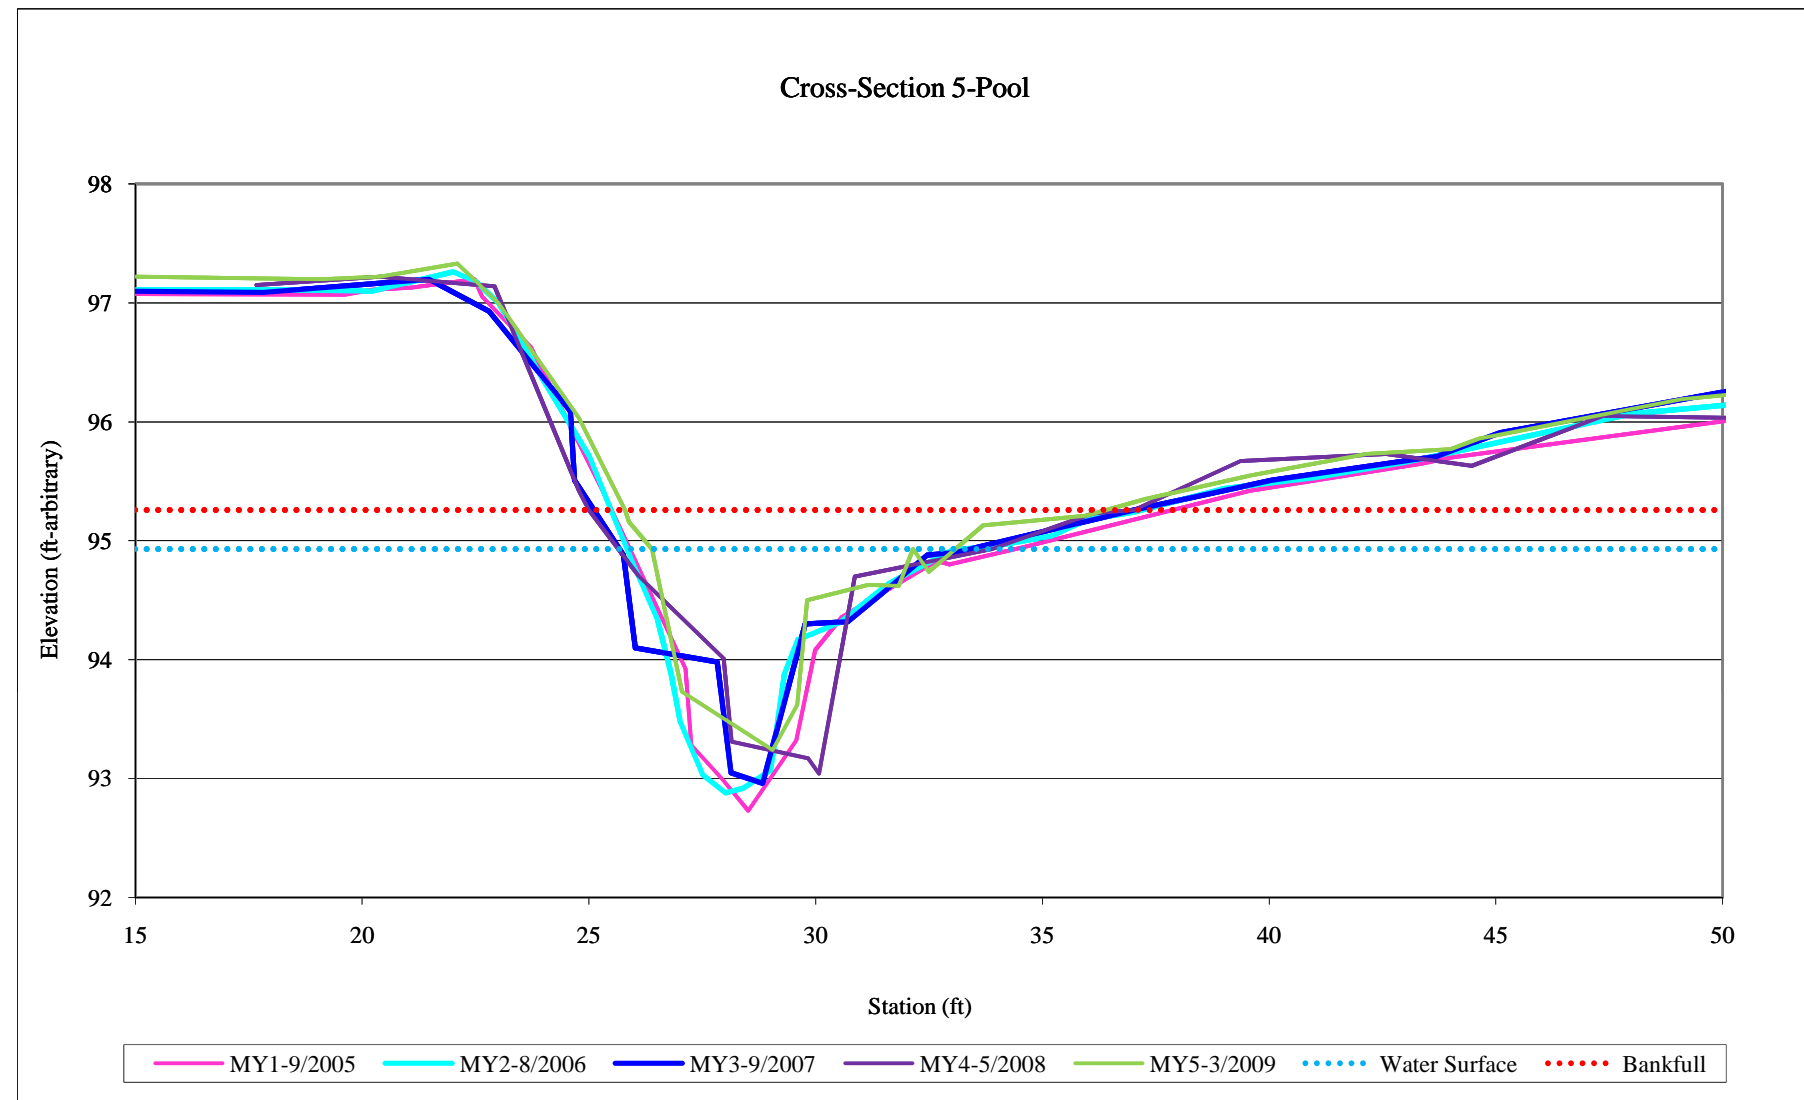
Summary Data	
Bankfull Cross-Sectional Area (ft <sup>2</sup> )	7.80
Bankfull Width (ft)	10.62
Bankfull Mean Depth (ft)	0.73
Bankfull Max Depth (ft)	2.02
Width/Depth Ratio	14.55
Entrenchment Ratio	N/A

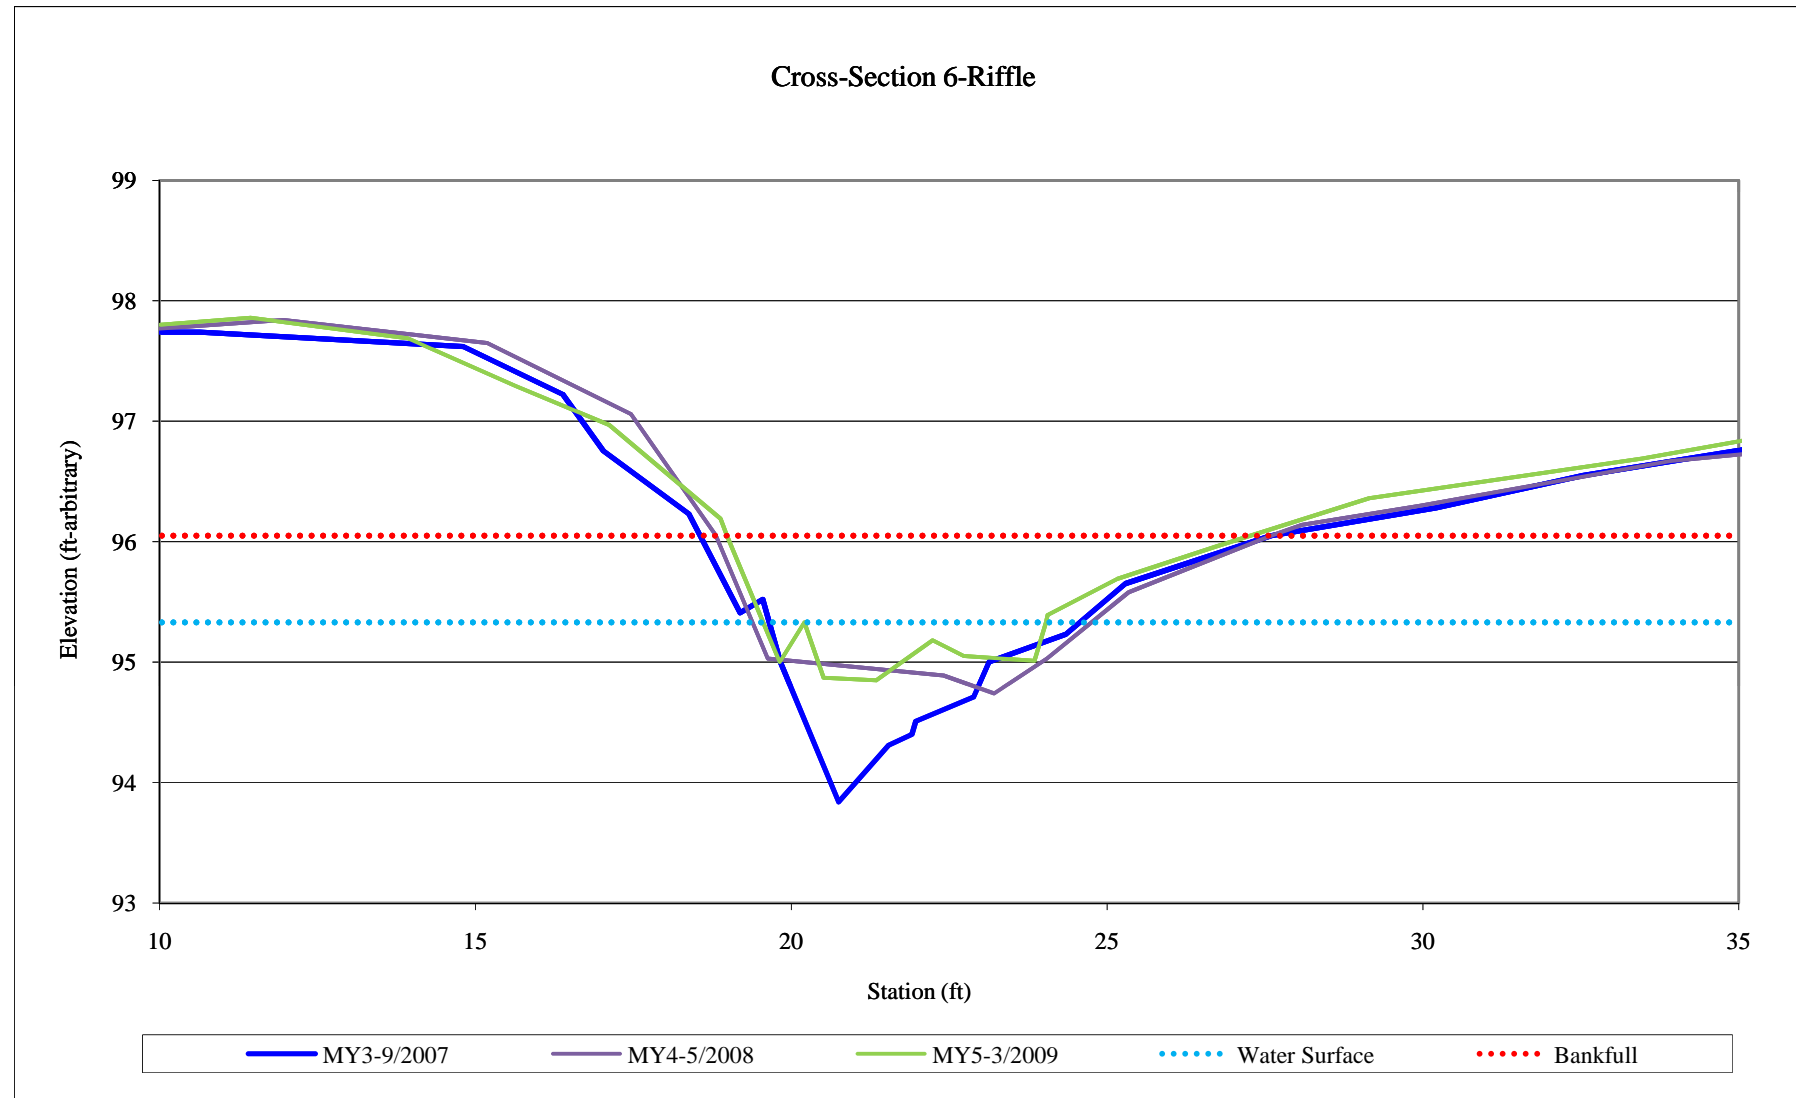
Summary Data	
Bankfull Cross-Sectional Area (ft <sup>2</sup> )	5.71
Bankfull Width (ft)	8.29
Bankfull Mean Depth (ft)	0.69
Bankfull Max Depth (ft)	1.20
Width/Depth Ratio	12.01
Entrenchment Ratio	3.05

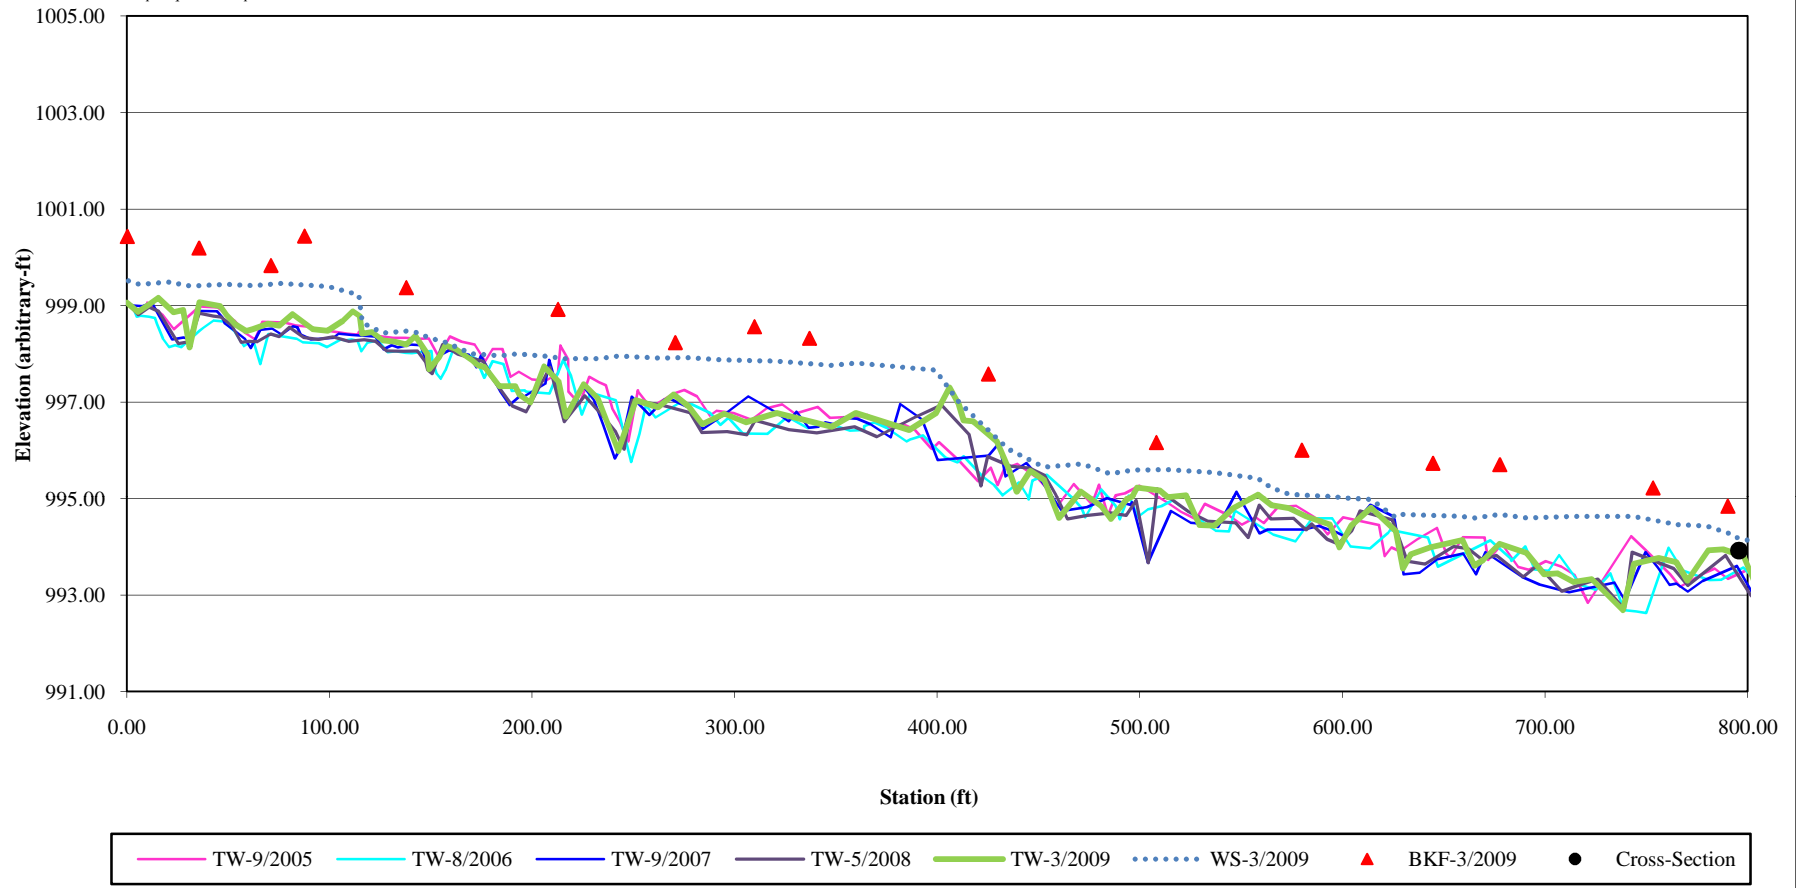
**Cato Farms  
Longitudinal Profile  
2009 Monitoring Year**

The average water surface slope and the average bankfull slope were the same for the surveyed reach, 0.0066 ft/ft. The surveyed water surface slope was slightly lower than the proposed 0.0100 ft/ft, but similar to the previous monitoring year's surveyed slopes. The profile appears stable and is not showing vertical incision; however, fine silt deposition has impacted the substrate composition. Upstream sources from construction development and abnormal rainfall conditions are most likely contributing to the increase in sediment deposition. Several compound pools have developed throughout the reach, which is most likely due to the increase of in-stream vegetation growth and sediment deposition.
