Caviness Farm (Tibbs Run) Stream Restoration

NCDENR-EEP Project Number 73

**Annual Monitoring Report
Performance Year: 2005
Monitoring Year: 2 of 5**

**CAVINESS FARM (TIBBS RUN) STREAM RESTORATION
2005 MONITORING REPORT**

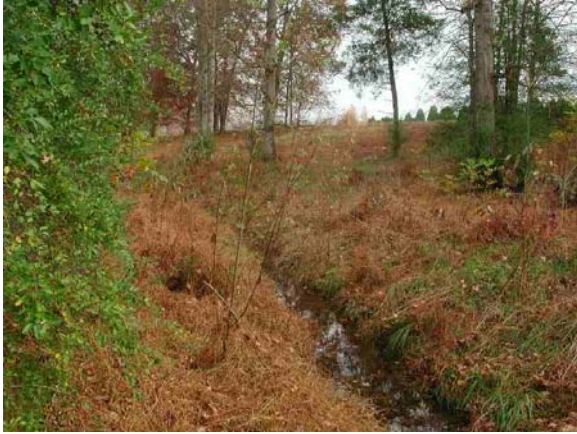
Three exotic and invasive species were observed within the plots. These include Chinese privet (*Ligustrum sinense*), Japanese honeysuckle (*Lonicera japonica*), and Nepalese browntop (*Microstegium vimineum*). The Chinese privet and Japanese honeysuckle occur in all plots, but a large privet shrub greater than 15 feet in height is located in Plot 1. This large shrub is currently producing seeds. The Nepalese browntop is currently of minor importance in Plot 2.

VPA1. Chinese privet.

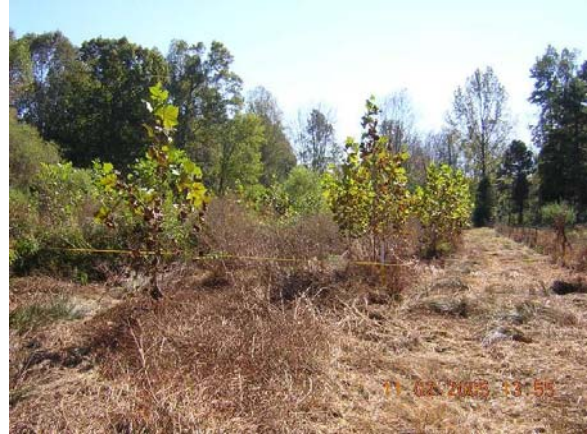
It was observed that mowing within the right-of-way has recently occurred in and around Plot 3. The mowing removed much of the herbaceous cover in the plot and damaged some of the planted seedlings. This occurred as a result of a misunderstanding between the landowner and the mower operator. The mower operator apparently deliberately removed fencing in the vicinity of the crossing at Station 18+60-18+80 in order to obtain access for mowing. The landowner noticed the error and redirected the mower operator before the entire easement was disturbed.

VPA2. Mowing in Plot 3.

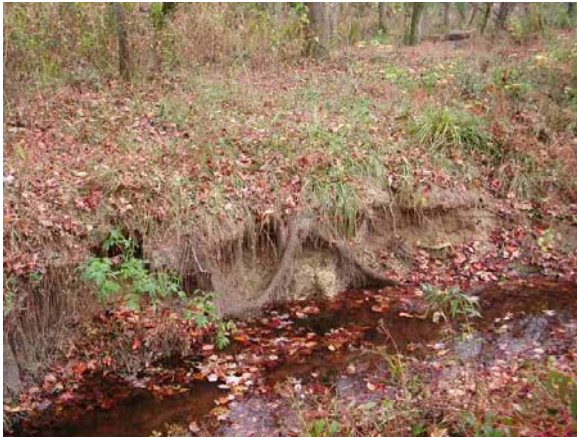
Every structure from Station 24+00 to the end is failing to some extent. Vegetation is poorly established over much of this length. Specific areas of bare banks and failures are marked on Figure B-2 in **Appendix B**.

VPA3. Bare banks.

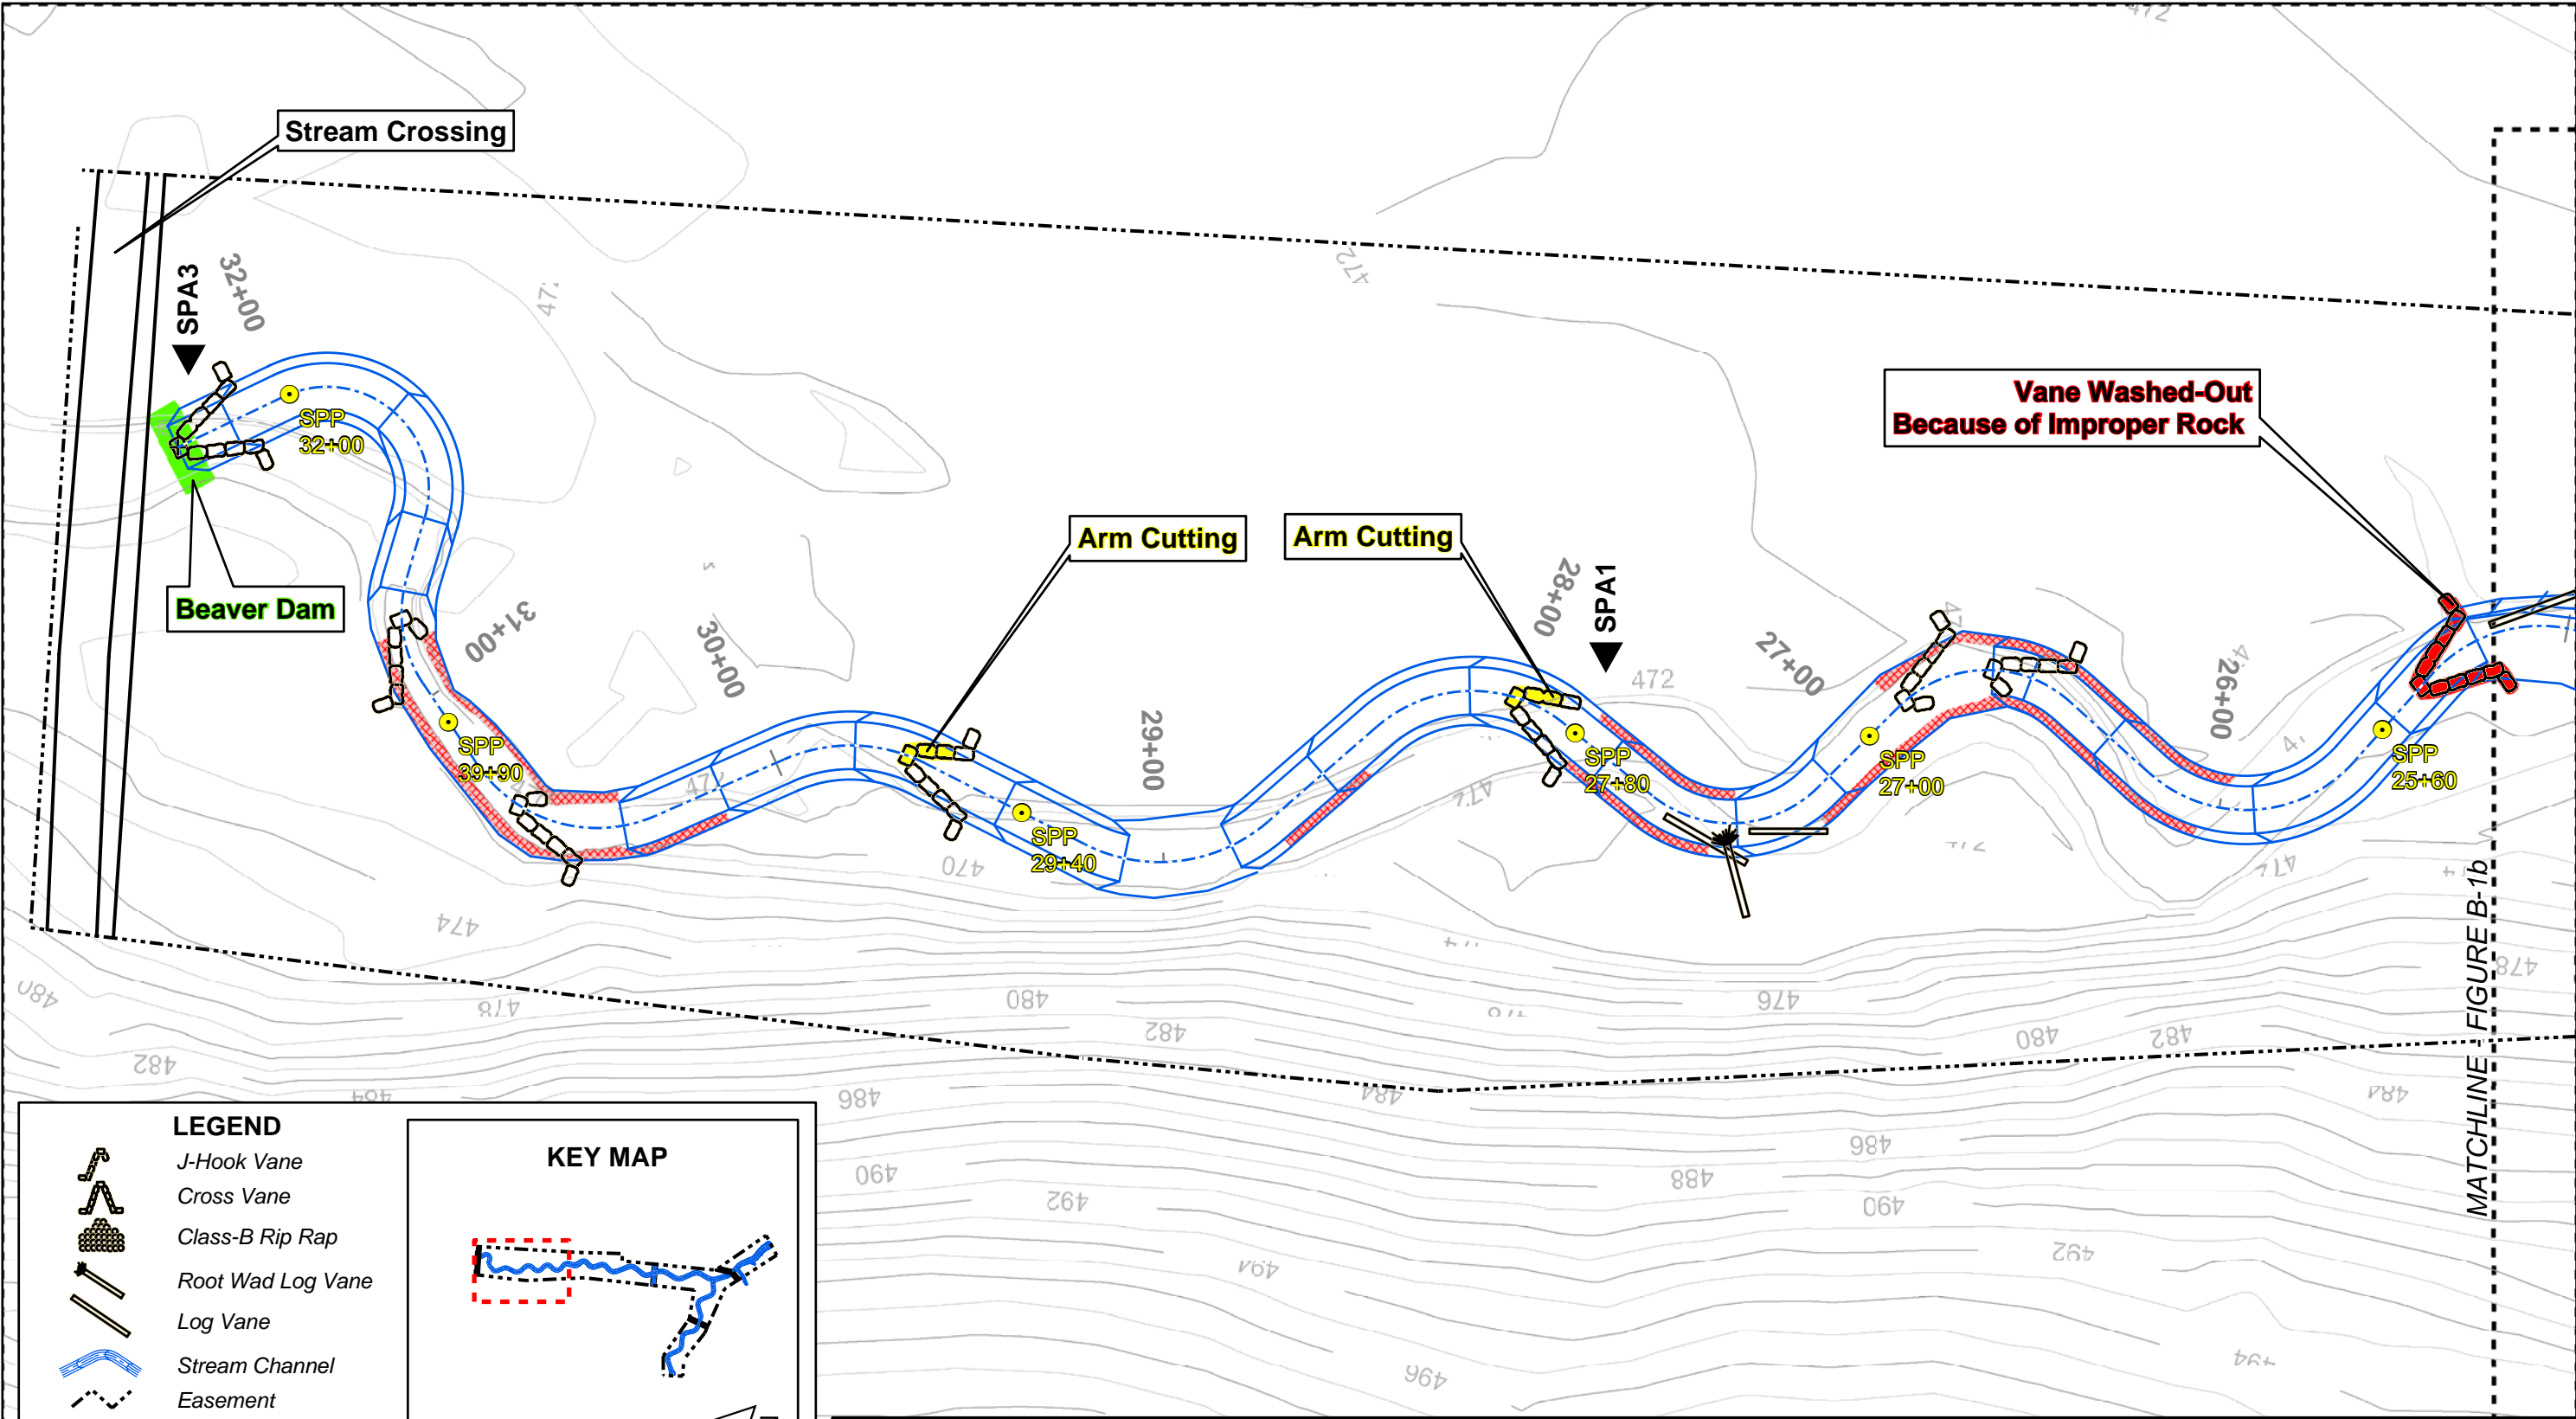
FIGURE B-1a
YEAR-2 MONITORING REPORT
STREAM PROBLEM AREAS PLAN VIEW
CAVINNESS FARM STREAM RESTORATION
 Randolph County, North Carolina
 FEB 2006

Vane Washed-Out Because of Improper Rock

Beaver Dam

Arm Cutting

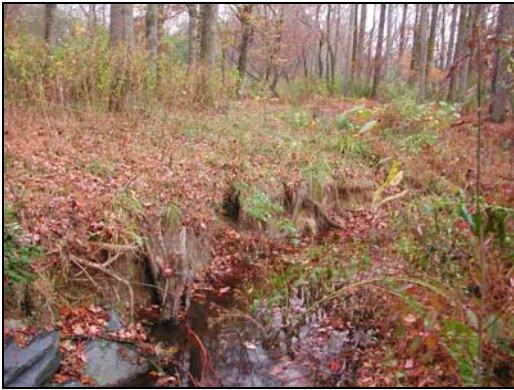
SPA1. Station 27+50 to 27+75: Matting detached DS of cross vane

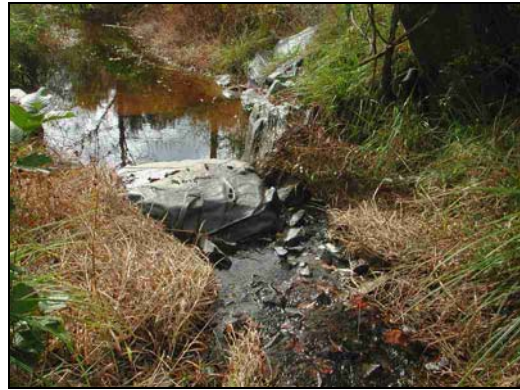
SPA2. Station 10+85: Minor erosion below arm.

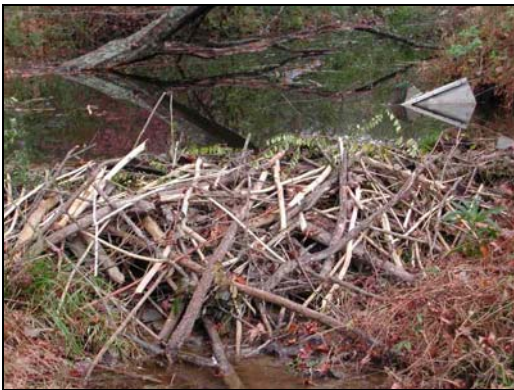
SPA3. Station 32+30: Beaver dam.

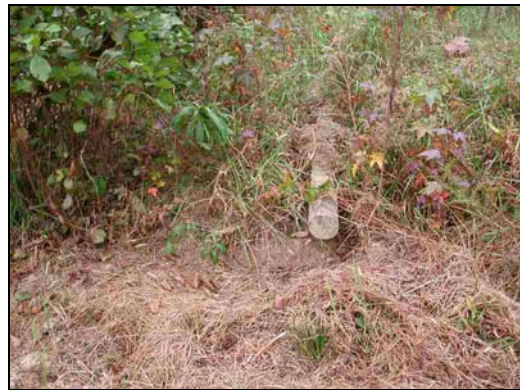
SPA4. Station 18+60. Fence pulled out by stress from debris jam at high flow.

Several problem areas are noted, including erosion and poor vegetation establishment. The problem areas need to be watched and remediation options developed if they get worse. At this time, the only repair recommended is of the fencing that is down in the vicinity of the crossing at Station 18+60 to 18+80. This fencing was pulled down by a mower operator who apparently misunderstood the landowner's intent.

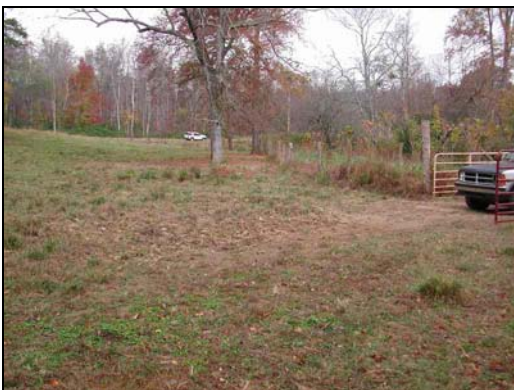
SPA5. Station 53+50. Poor drainage because of improper grading. Picture taken during severe drought.
