ANNUAL REPORT FOR 2006 (Year 3)

Caviness Mitigation Site
Randolph County
EEP Project No. 73

January 2007

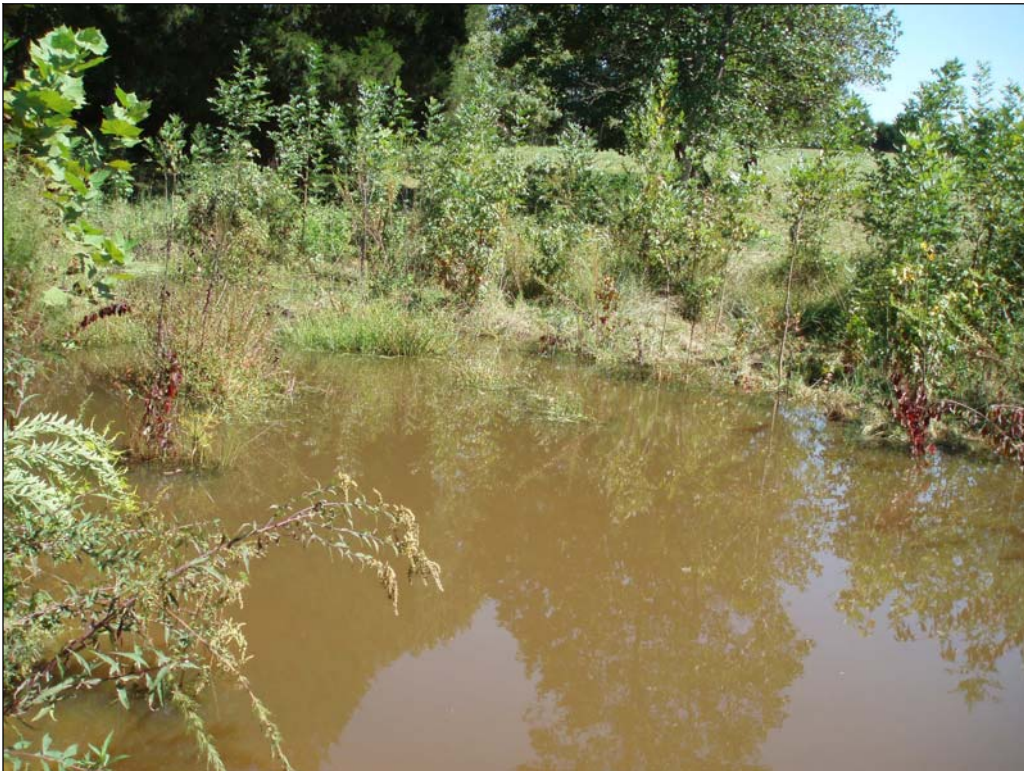
Beaver impoundment area near downstream end of project.

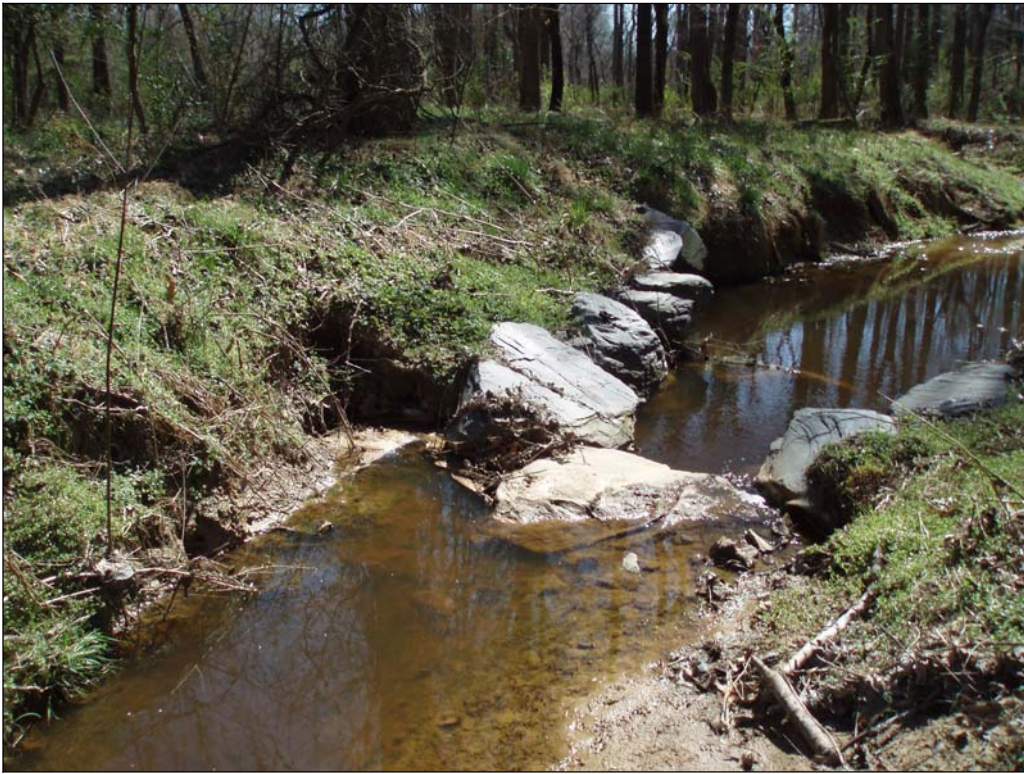
Caviness 2006, PA #1

Feature Issue	Station Numbers	Suspected Cause	Photo Number
Left bank erosion at cross vane, will lead to structure failure	27+90	Incorrect installation, lack of bank stabilization	PA #1
	25+40	Incorrect installation, lack of bank stabilization	PA #2
Left bank slumping into stream behind log vane	21+00	Lack of bank stabilization, incorrect structure installation	PA #3
Cattle fencing is damaged and not functioning	18+75	High flow events and improper fence installation	PA #4
Cross vane failure	51+28	Improper installation, header rock set at too high of an elevation, water flowing underneath header rock	PA #5

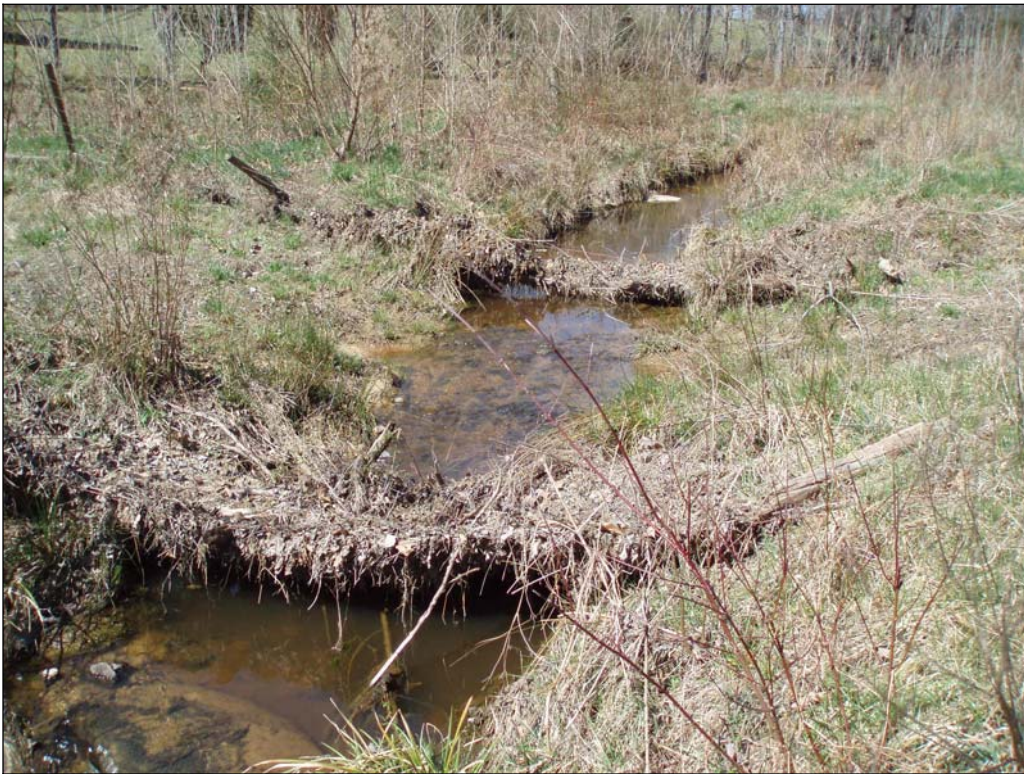
Caviness 2006, PA #4

Date of Data Collection	Date of Occurrence	Method	Photo # (if available)
September 2006	Unknown	Visual	PA #4, Appendix B

Visual evidence of a bankfull event was observed during the vegetation survey in September 2006. The evidence included extensive wrack lines and a damaged fence at a ford crossing. Photos of this area are included in Appendix B.

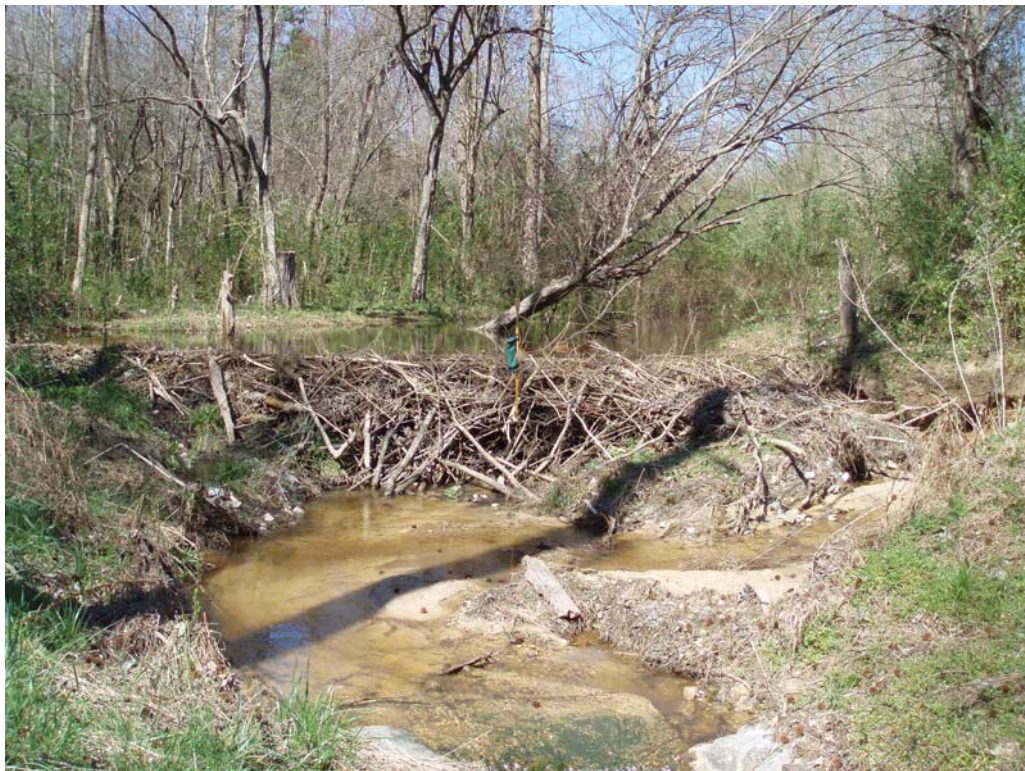
The stream channel was visually inspected biannually during the spring and fall of 2006. The channel appears mostly stable with herbaceous and woody vegetation covering the streambanks throughout the project reach. Five problem areas were noted (Appendix B). These areas will be visited again in spring 2007. Remedial actions may be necessary in upcoming years. There is evidence of beaver impacts to the stream that is causing a backwater effect on the lower end of the channel. Photos of the beaver dams are included in Appendix B.

Beaver impoundment, looking upstream (March 2006)

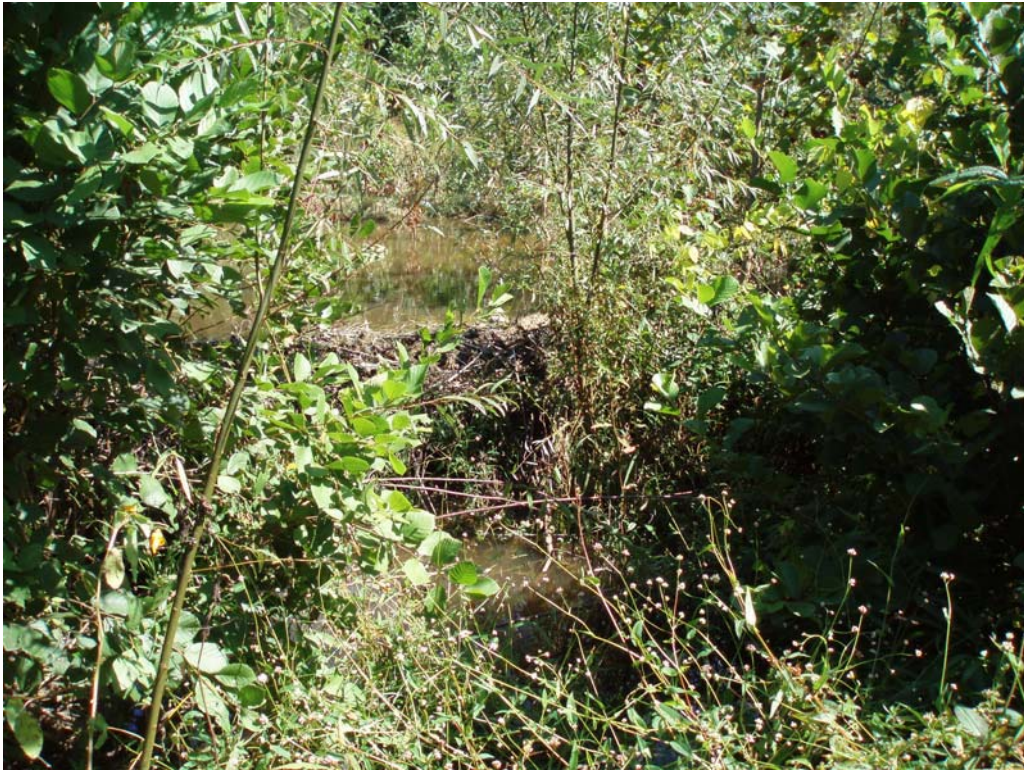
Beaver impoundment, looking upstream (September 2006)

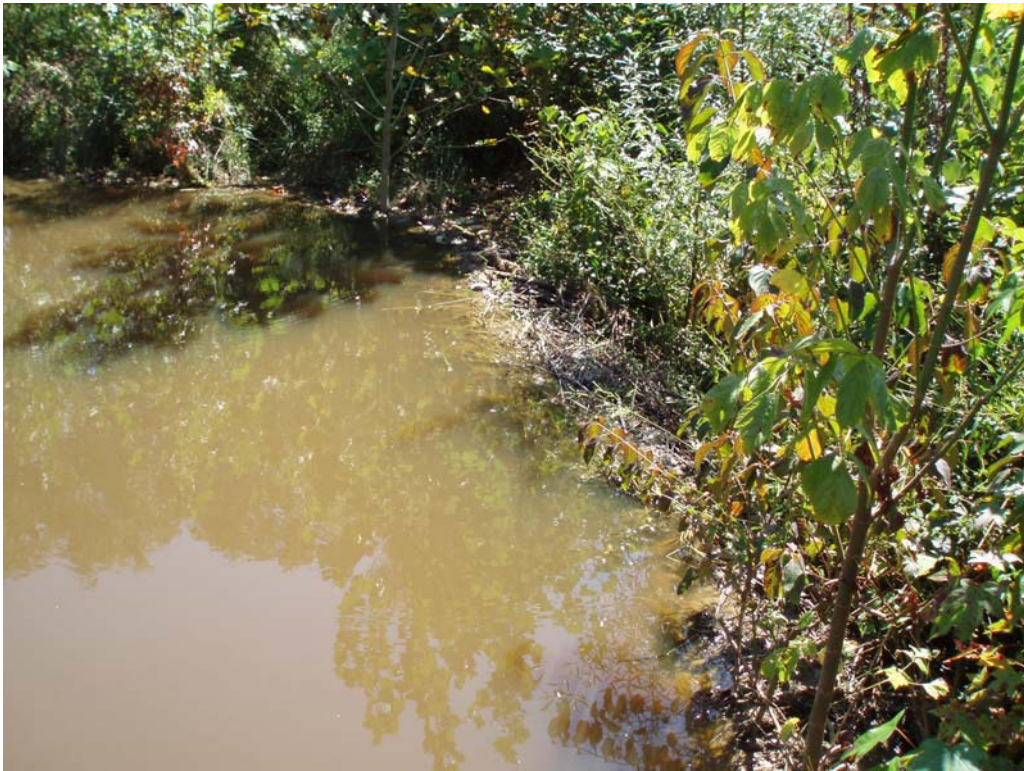
Beaver impoundment, looking downstream (September 2006)

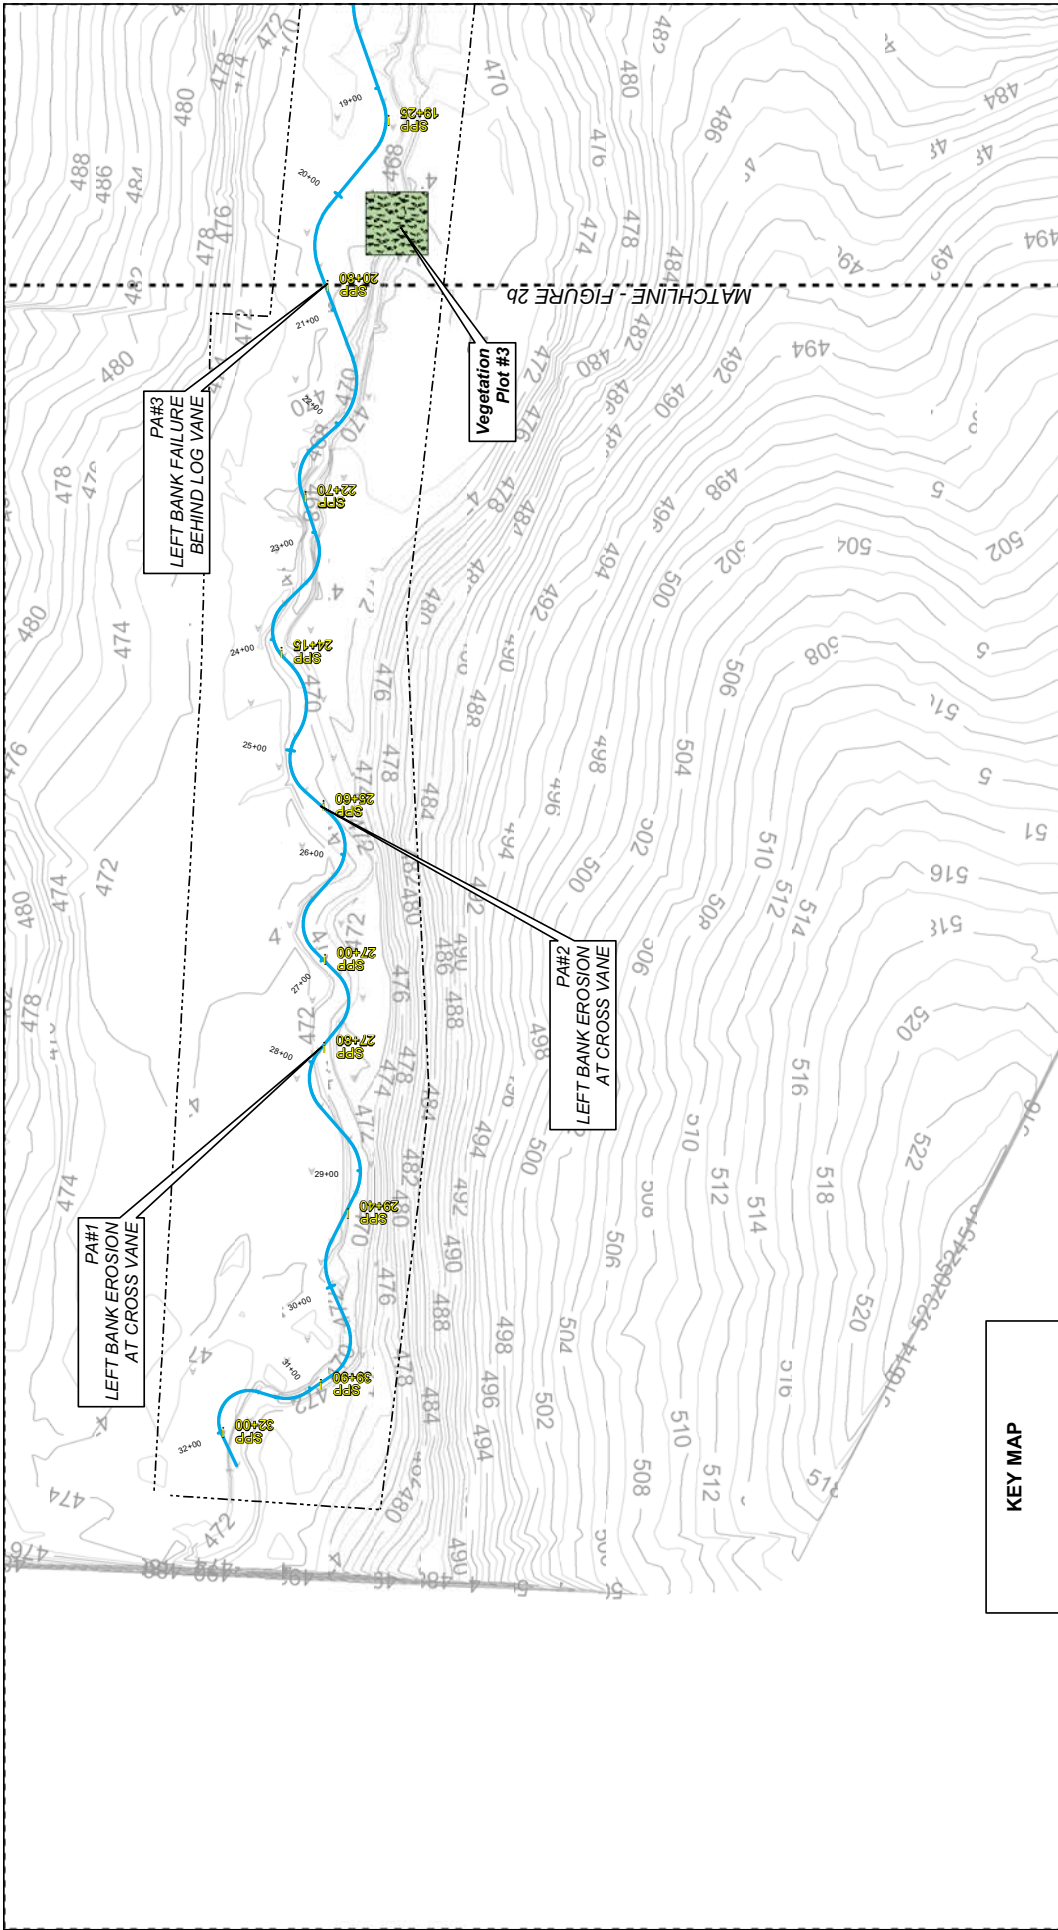
**INTEGRATED PROJECT PROBLEM AREAS
2006 (YEAR-3) PLAN VIEW
CAVINESS MITIGATION SITE**
Randolph County, North Carolina

PA#3
LEFT BANK FAILURE
BEHIND LOG VANE

PA#2
LEFT BANK EROSION
AT CROSS VANE

PA#1
LEFT BANK EROSION
AT CROSS VANE
