**Caviness Farm Stream Restoration Site
Randolph County, North Carolina**

**Year 4 Monitoring Report
EEP Project No. 73**

**CAVINESS FARM STREAM RESTORATION
2007 MONITORING REPORT**

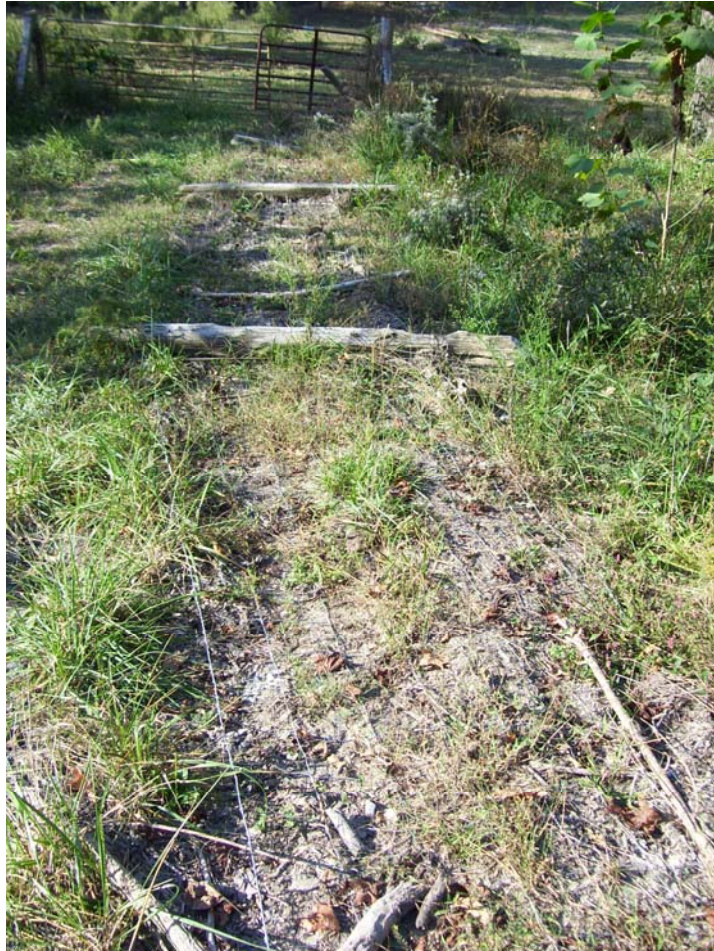
SPA 1. Damaged fence.

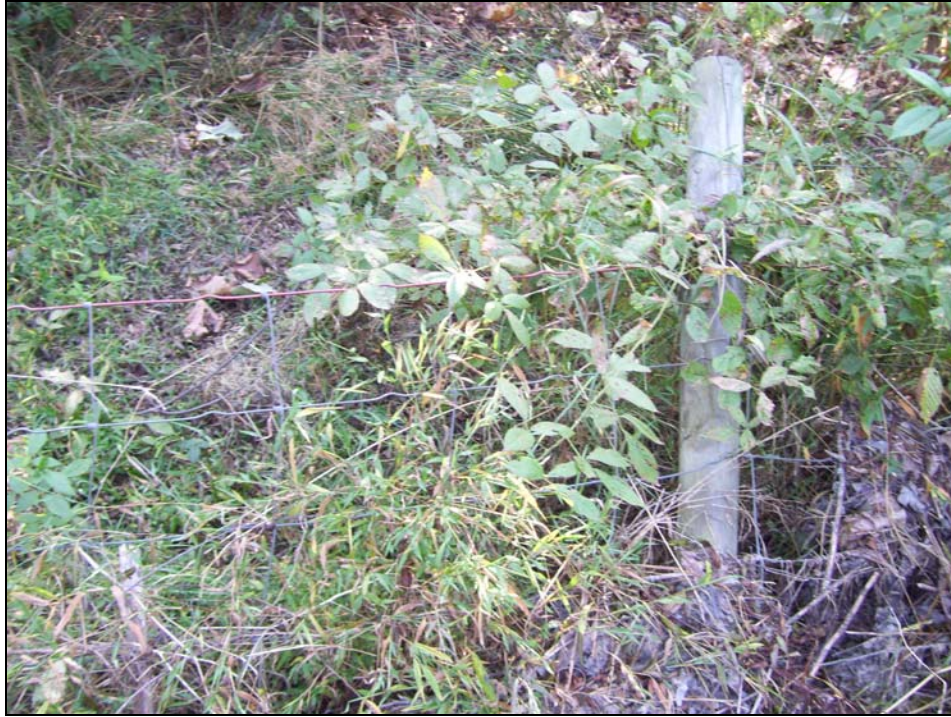
SPA 2. Damaged fence.

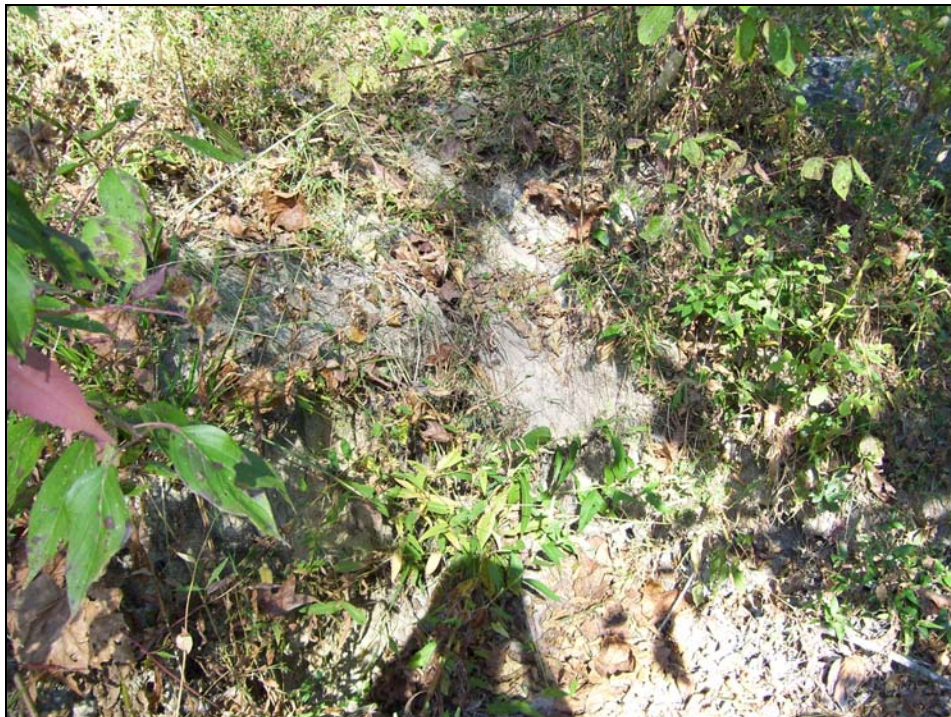
SPA 3. Right bank erosion.

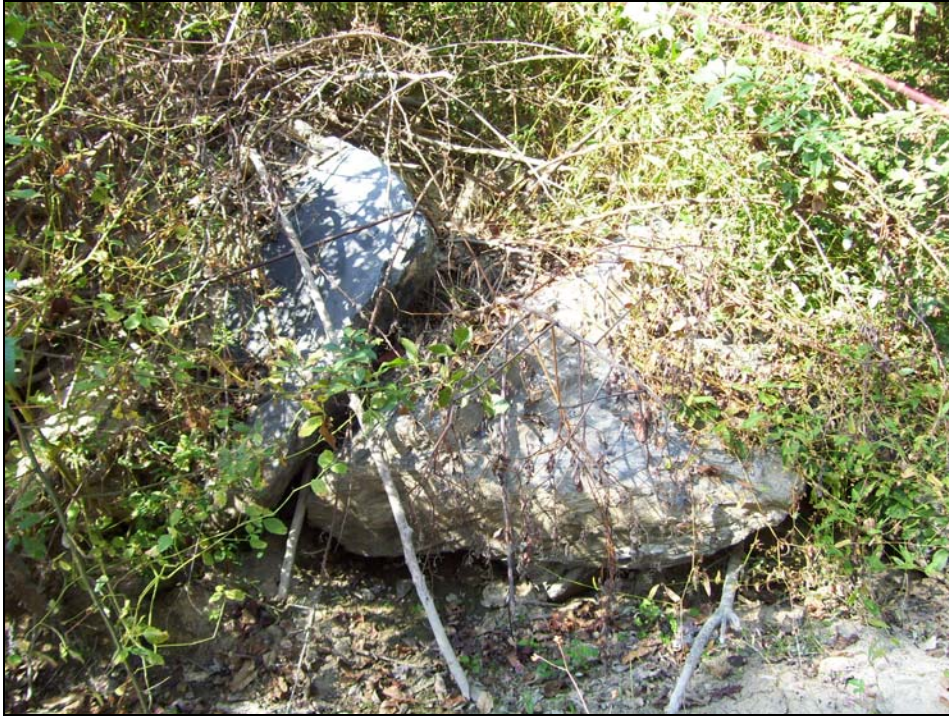
SPA 4. Erosion at cross vane.

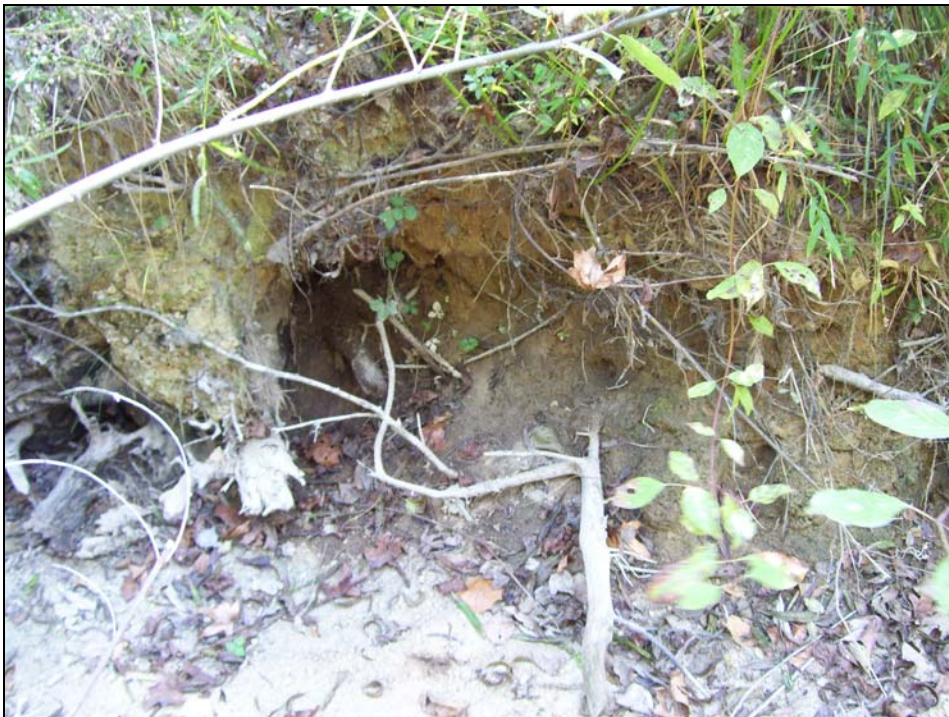
SPA 5. Left bank failure behind rock vane.

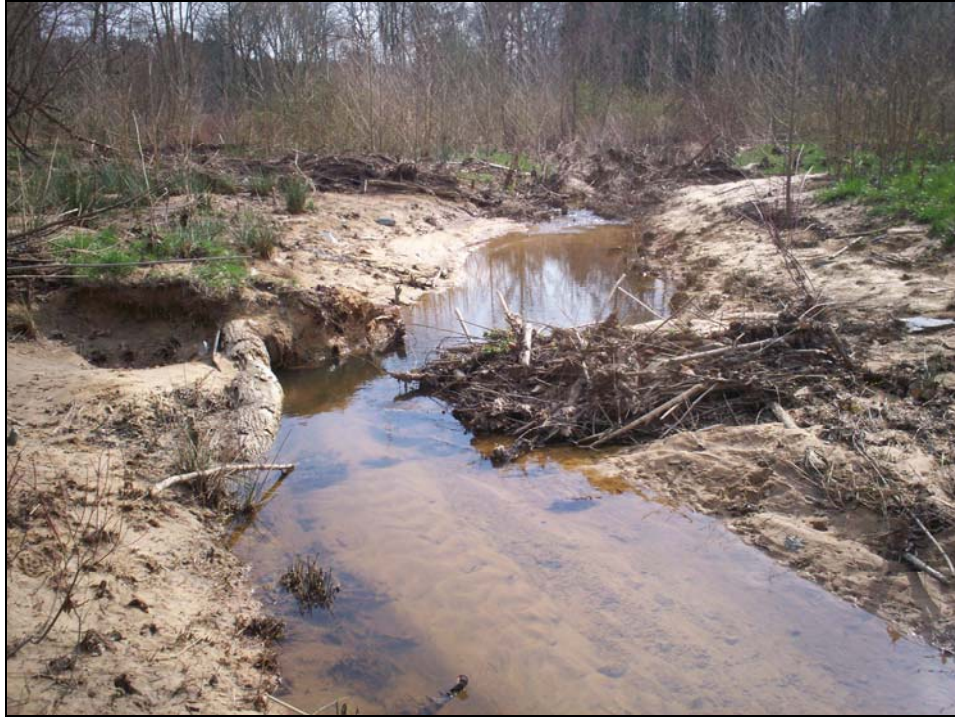
SPA 6. Bank failure behind rock vane.

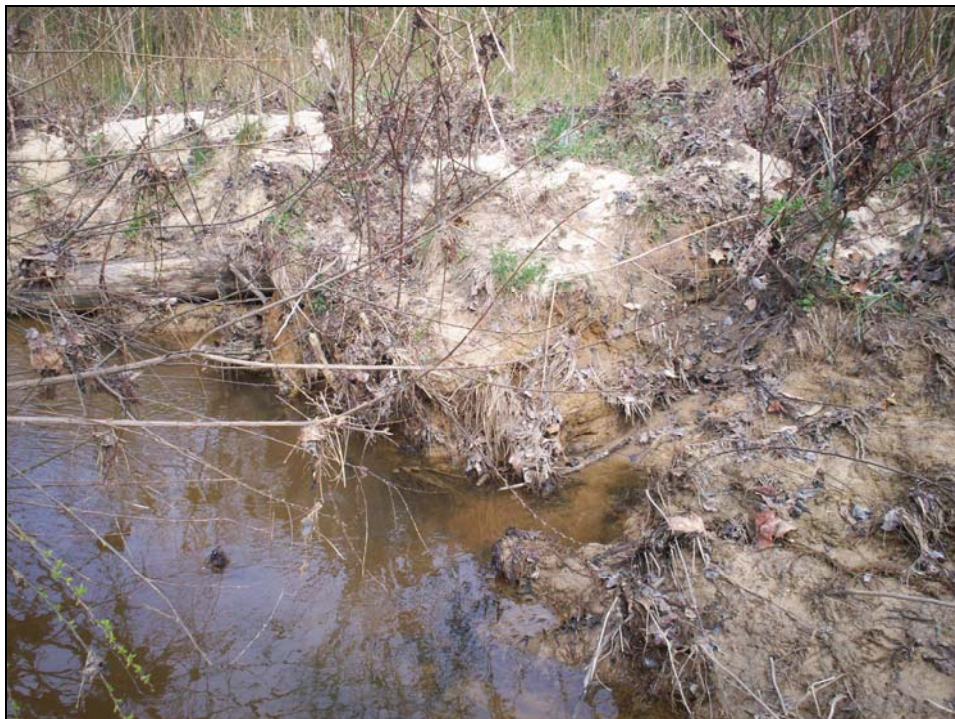
SPA 7. Bank failure behind log vane.

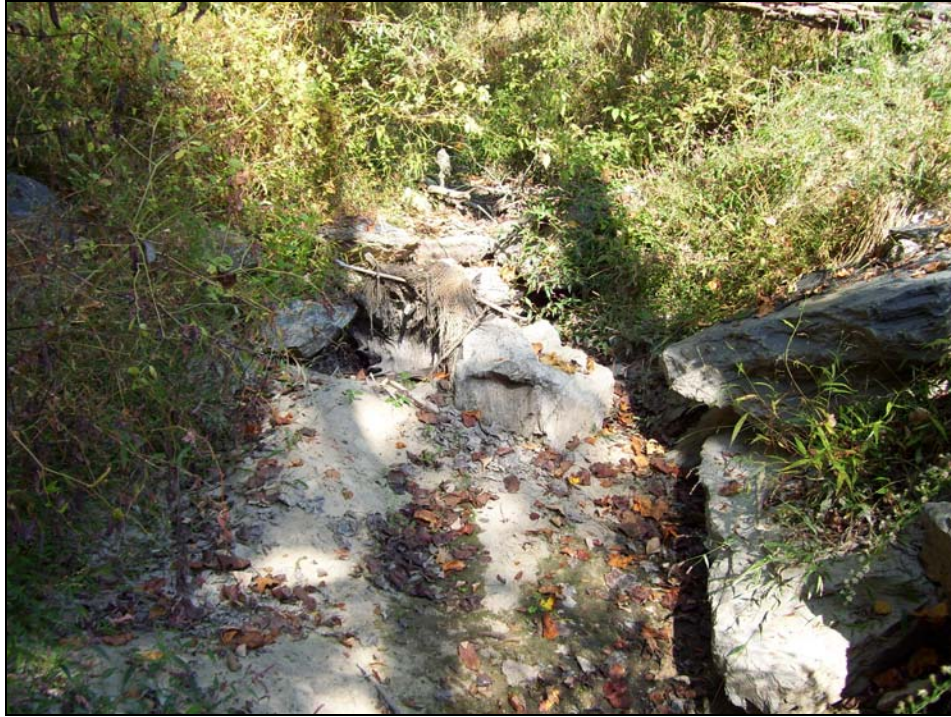
SPA 8. Left bank erosion at cross vane.

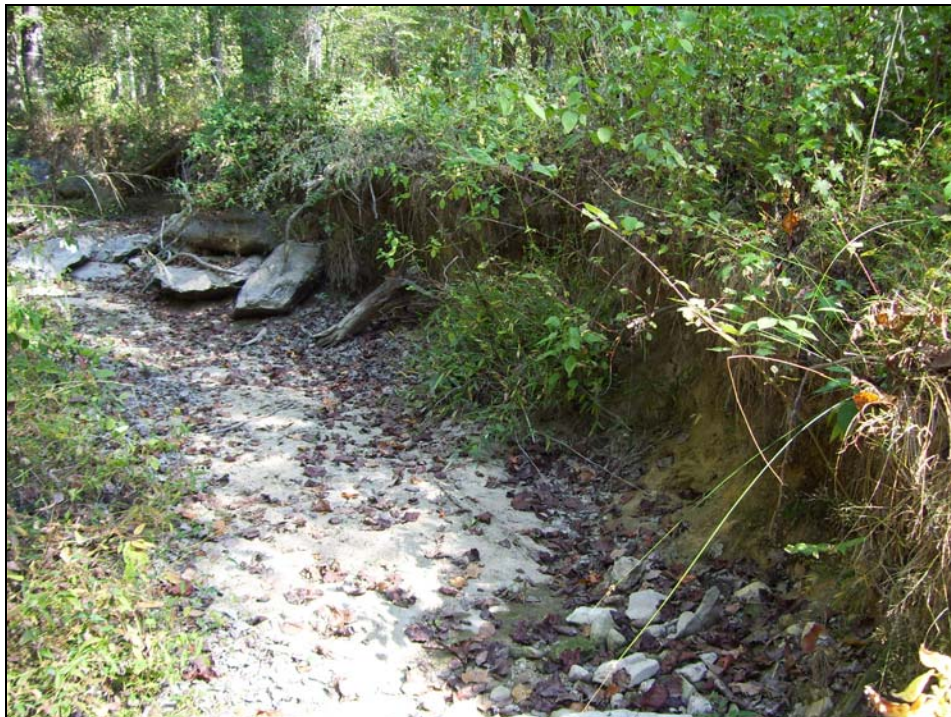
SPA 9. Bank erosion/Undercut bank.

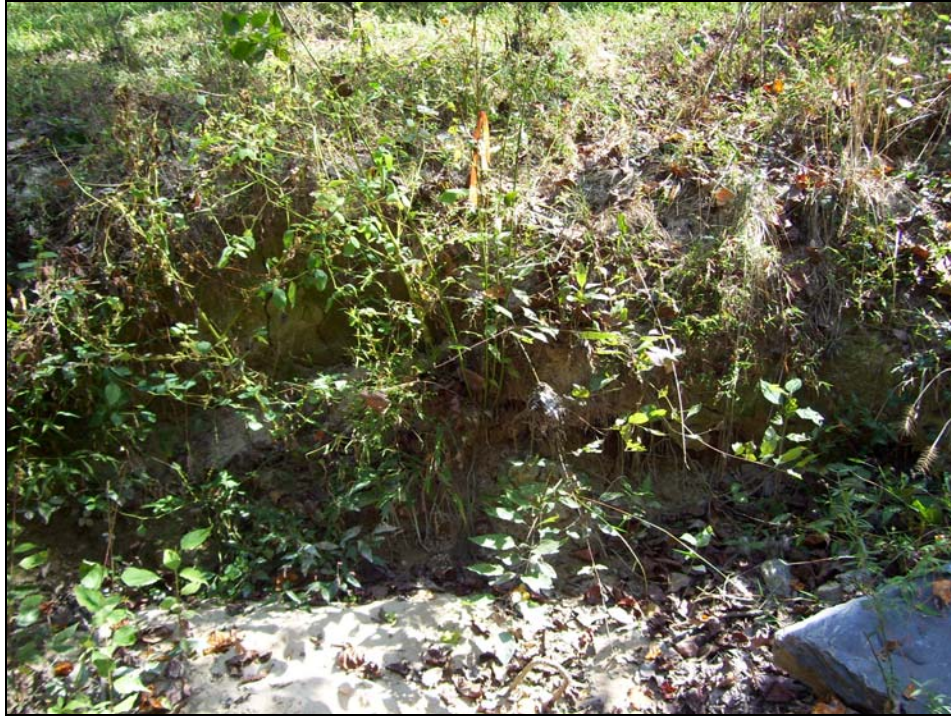
SPA 10. Left bank erosion at cross vane.

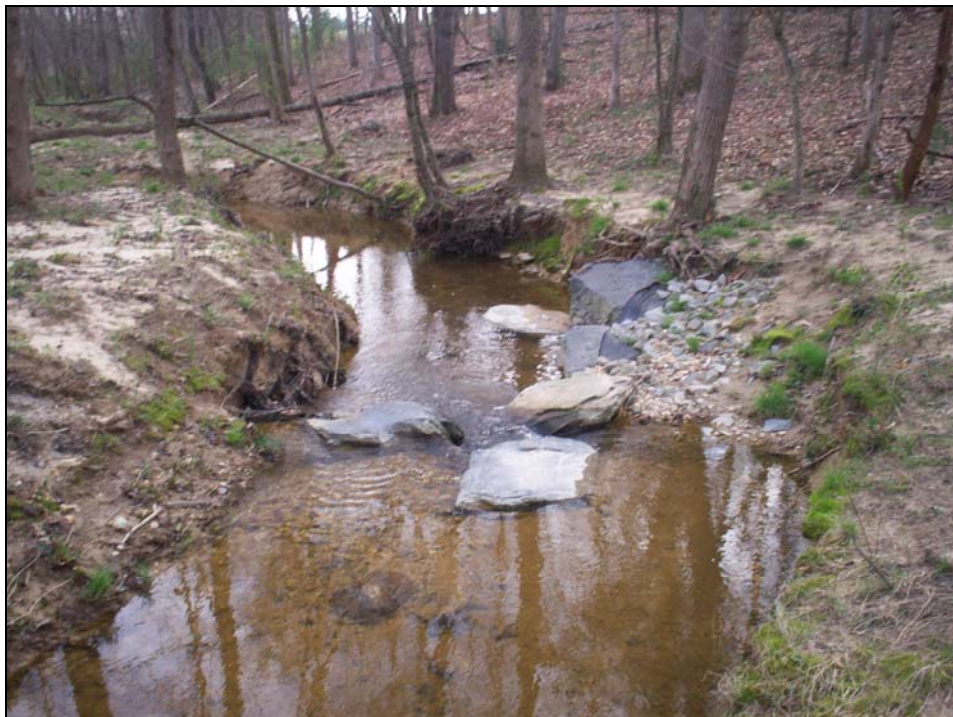
SPA 11. Bank failure.

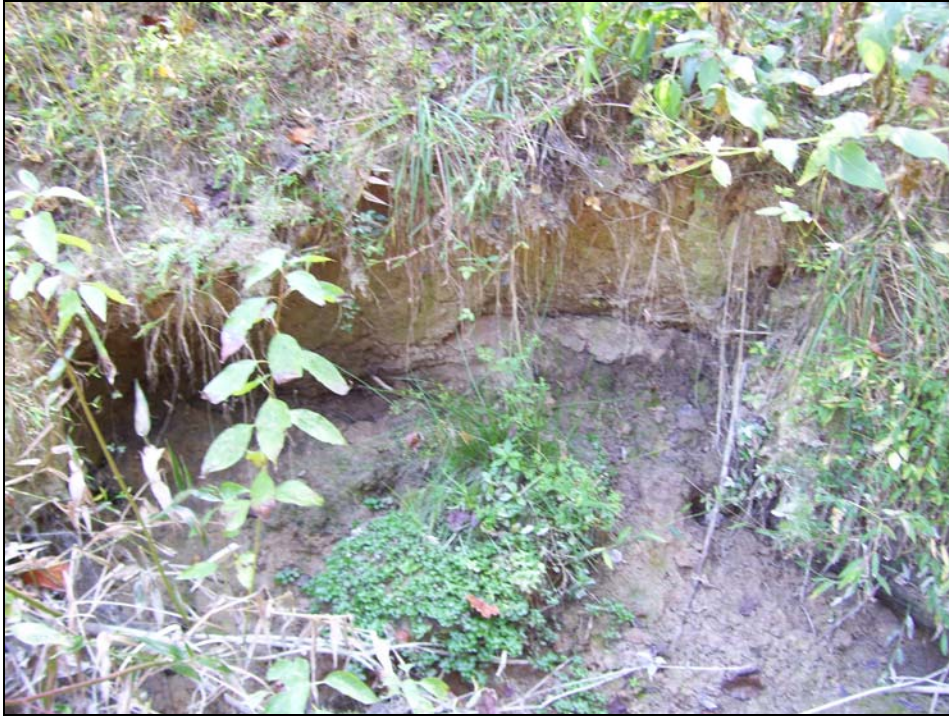
SPA 12. Bank failure at cross vane.

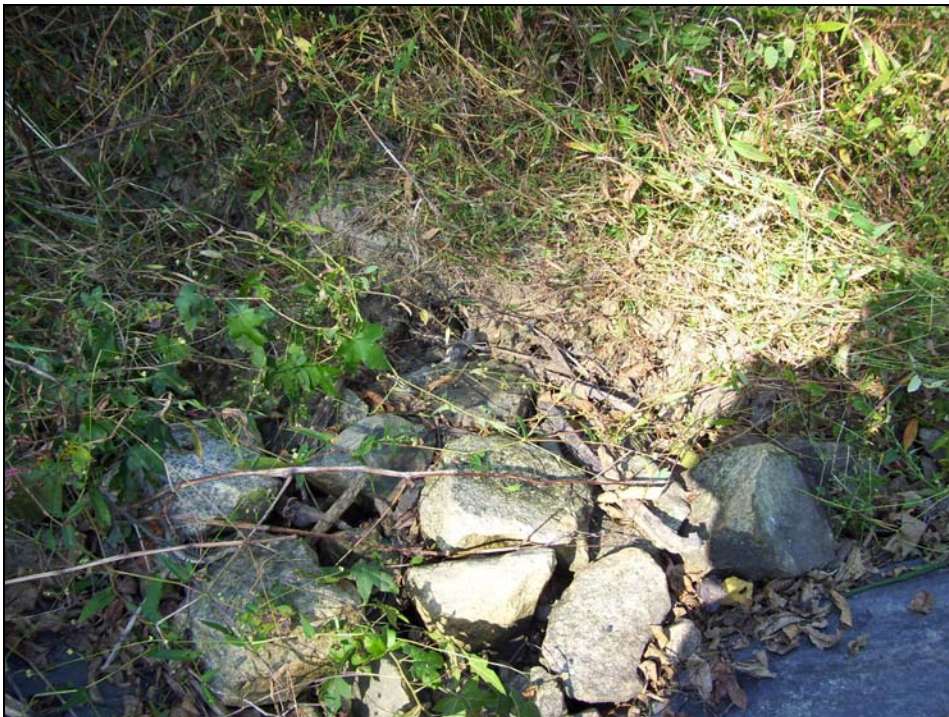
SPA 13. Cross vane failure.

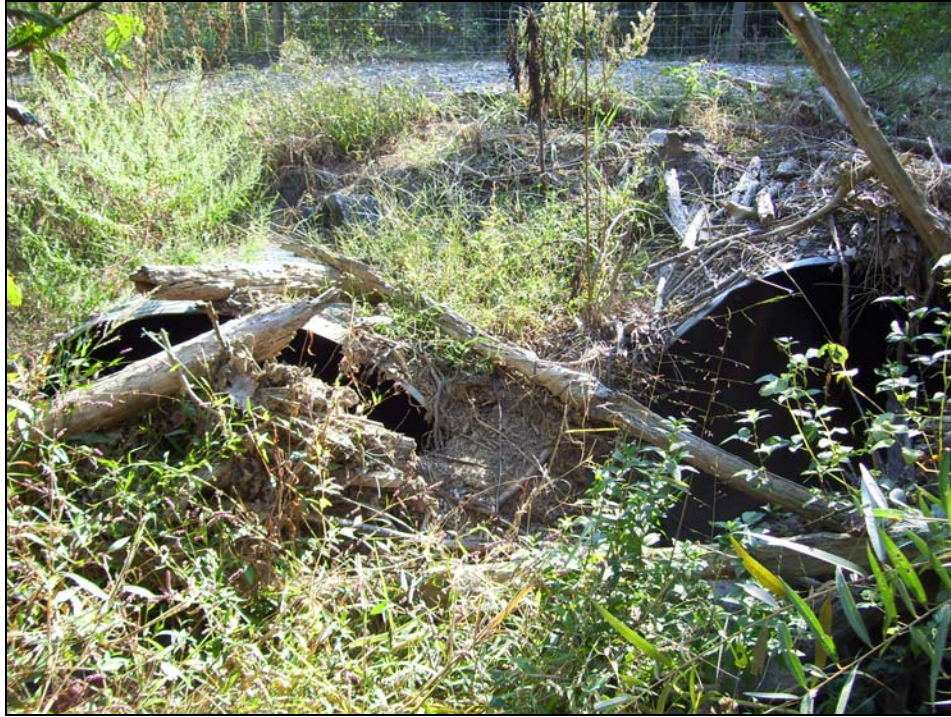
SPA 14. Debris jam.

It is recommended that PA #14 be investigated for effect on stream stability and possible removal.

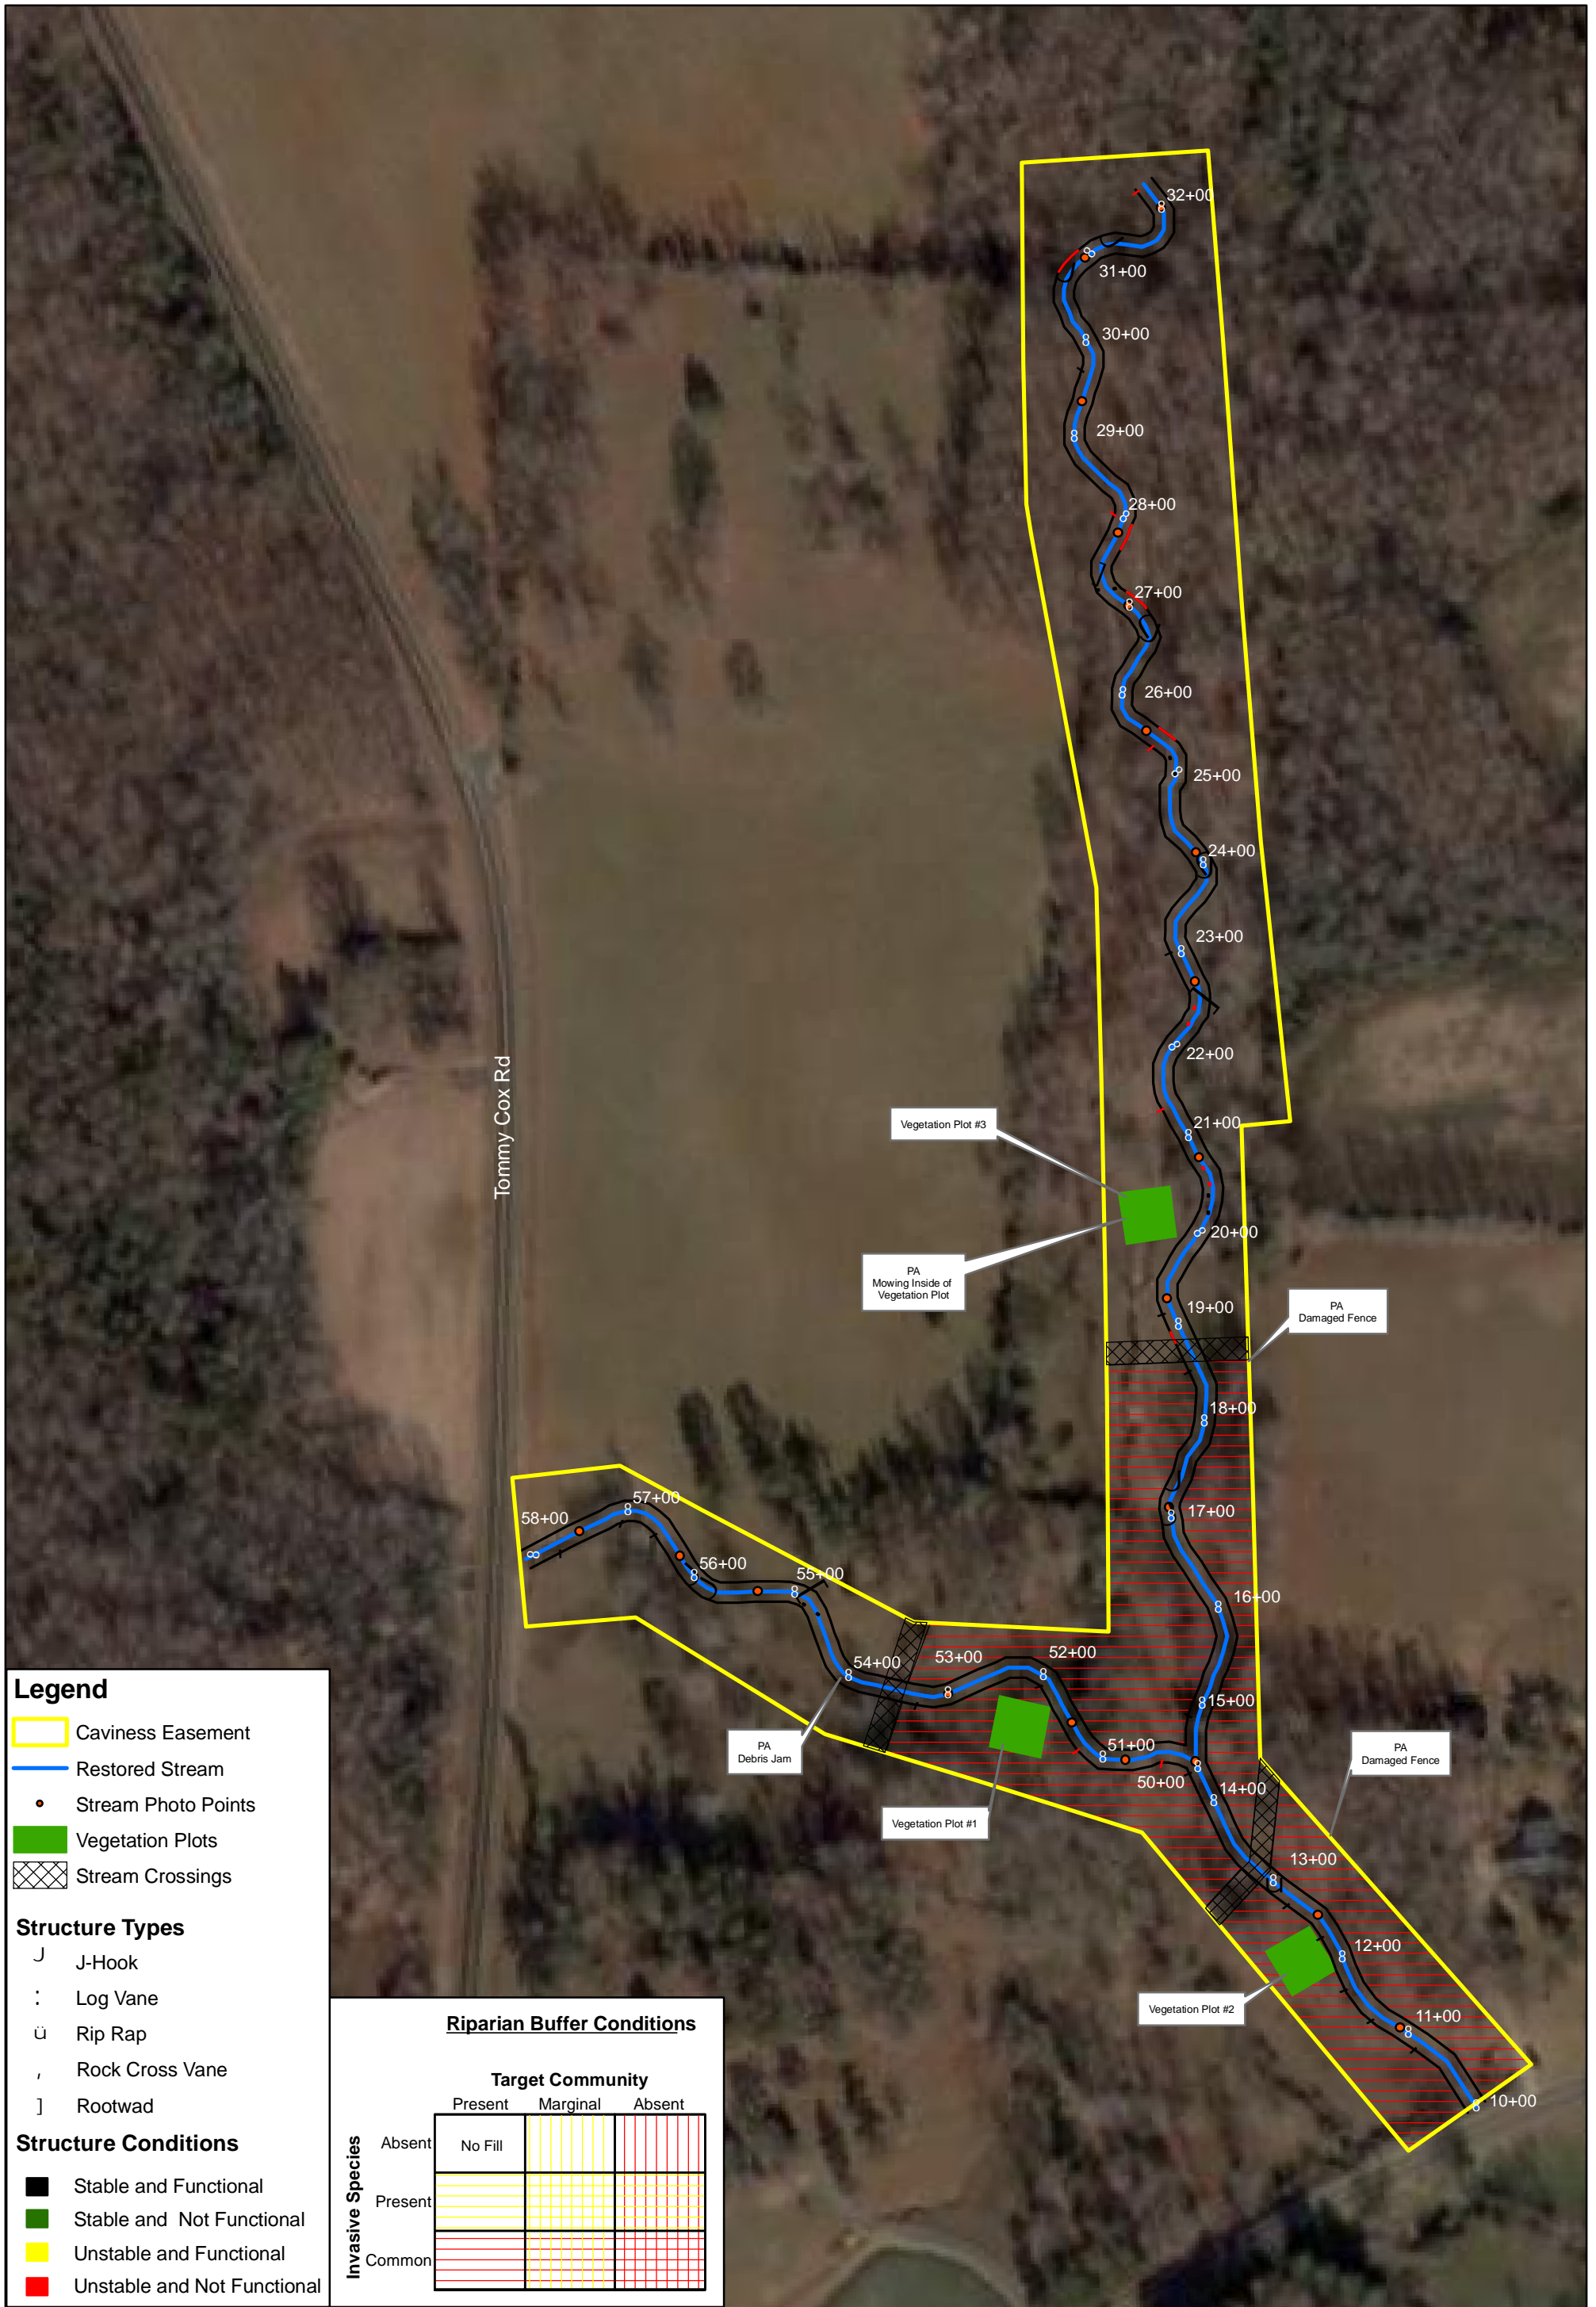
**Caviness Current Conditions Plan View
Year 4 Monitoring
November 2007**

Because the vegetation is poorly established from Station 24+00 to the downstream end every structure over much of this length is failing to some extent. Specific areas of bare banks and failures are marked on the Current Conditions Plan View in **Appendix B**. All vegetative problem areas and the vegetative plan view are provided are described in **Appendix A**.
