**Caviness Farm Stream Restoration Site
Randolph County, North Carolina
EEP Project No. 73**

**2008 Annual Monitoring Report
Monitoring Year 5**

March 2009

WK Dickson and Co., Inc.
720 Corporate Center Drive
Raleigh, NC 27607
(919) 782-0495

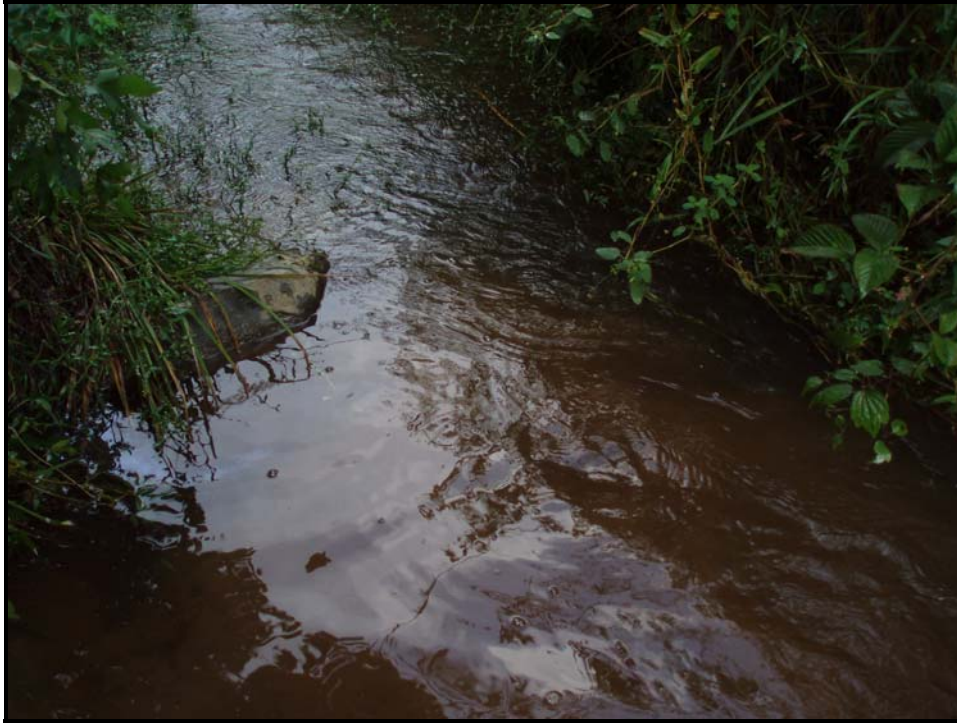
Feature Issue	Station Numbers	Suspected Cause	Photo Number	Structure Status
Erosion at Cross Vane	10+75	Incorrect installation, header rock displaced	PA #1	UN
Beaver Dam	11+00	Beaver activity	PA #2	--
Beaver Dam blocking Culvert	13+50	Beaver activity	PA #3	--
Beaver Dam	14+00	Beaver activity	PA #4	--
Damaged Fence	~14+00 on L Bank	Cattle; Improper fence installation	PA #5	--
Damaged Fence	18+50	Fence delimiting crossing has been removed	PA #6	--
Beaver Dam	20+80	Beaver activity	PA #7	--
Erosion undercut bank	24+25	Tree falling across channel	PA #8	--
L Bank Erosion Behind Log Vane	25+00	Lack of bank stabilization, incorrect structure installation	PA #9	UN
L Bank Erosion at Cross Vane	25+40	Lack of bank stabilization, incorrect structure installation	PA #10	UN
L Bank Erosion/Undercut Bank	26+50 to 27+00	Undercut Bank	PA #11	--
Erosion at J-hook	27+00	Incorrect installation, header rock displaced	PA #12	UN

PA #1 – Erosion at cross vane; header rock displaced. Sta. 10+75

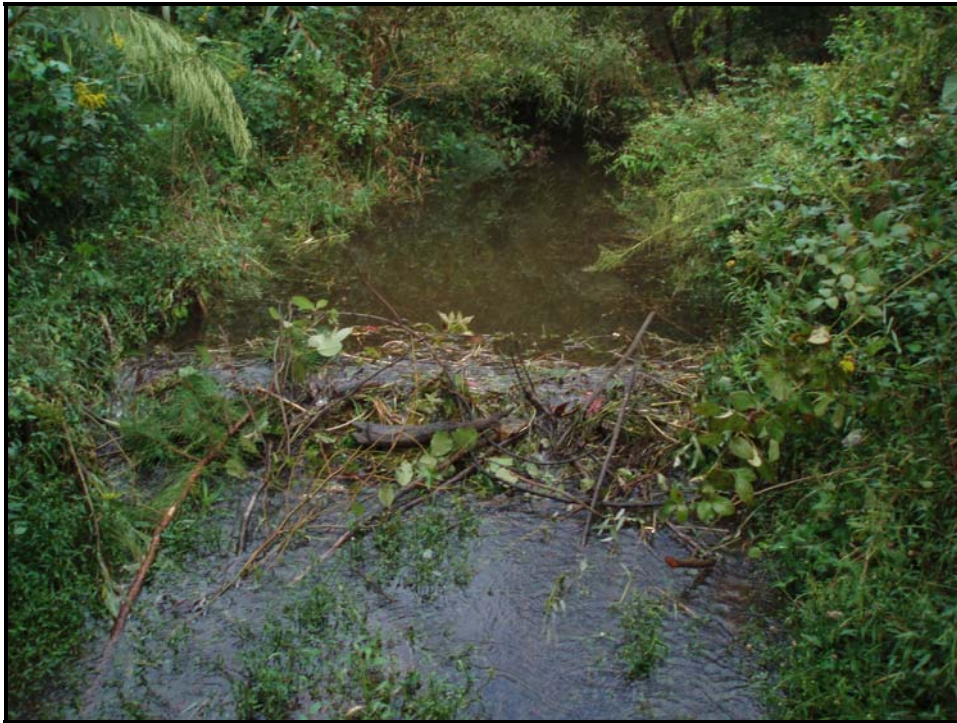
PA #2 – Beaver dam. Sta. 11+00

Seven structures exhibited loss of bank protection due to erosive forces, but remain stable. The debris jams and beaver dams present concern and it is recommended that they be removed. Some areas of damaged fences appear to have been repaired by the landowner. However, several areas show evidence of continued cattle damage. If the damage becomes worse, cattle could get into the easement and threaten the success of the site. It is recommended that the damaged fencing be repaired or replaced.

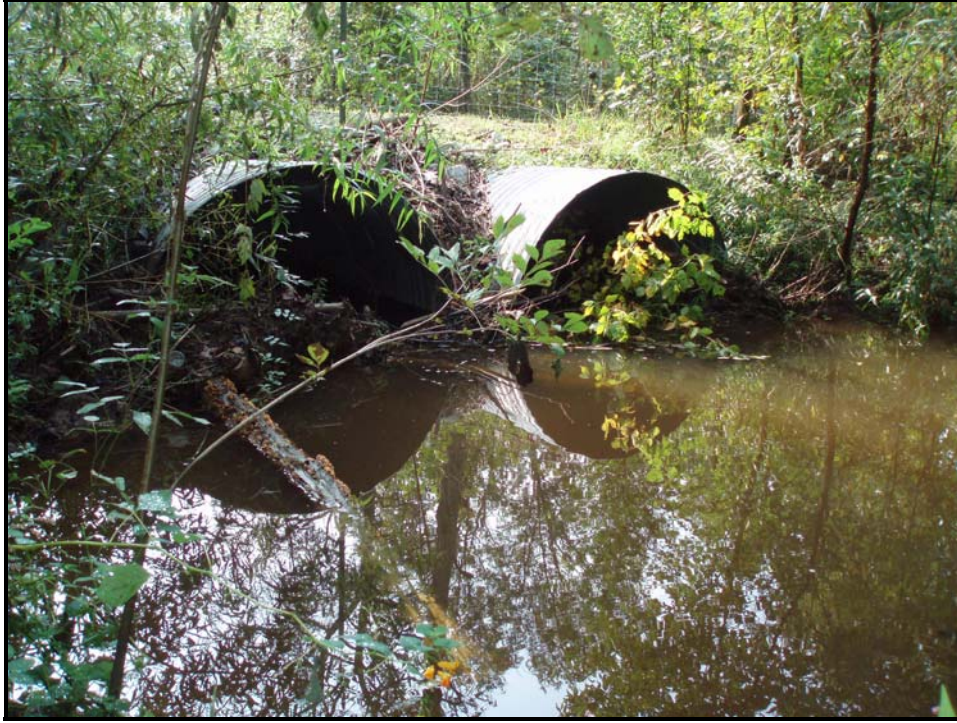
The beaver activity has partially blocked two culvert crossings. Without prompt maintenance, these areas could become blocked and potentially wash out the culvert crossings. The beaver dam at station 14+00 has obstructed the channel completely. Structures were not assessed where the channel is flooded because of lack of visibility. The displaced boulders from the rock cross vanes could create debris jams or other forms of bed erosion such as scouring and head cuts, but appear to pose not threat to the overall success of the project. Other minor areas of erosion and aggradation were noted during field investigations.

PA #3 – Beaver dam at culvert. Sta. 13+50

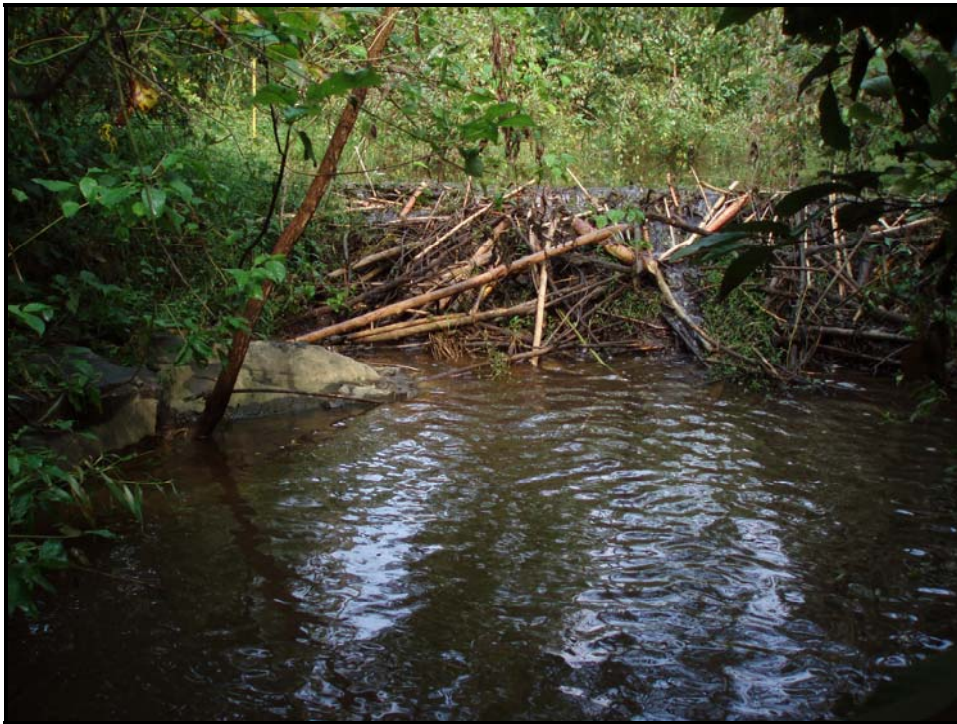
PA #4 – Beaver dam. Sta. 14+00

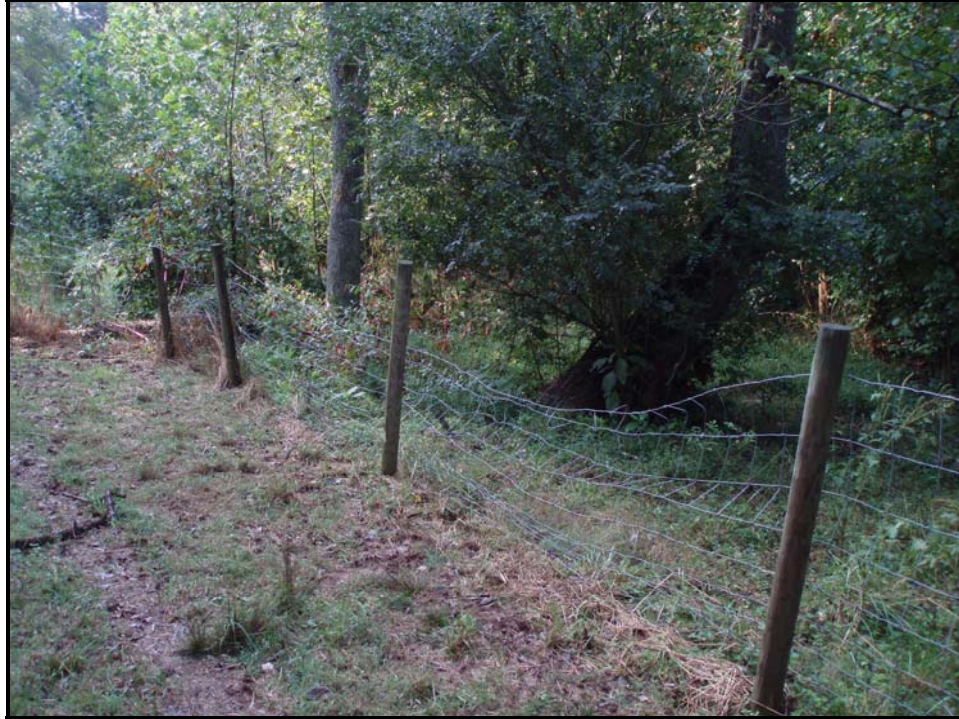
PA #5 – Damaged fence. Sta. 14+00

into the easement because of damaged fencing. It is recommended that the damaged fencing be repaired or replaced, and that the fencing be maintained over time.

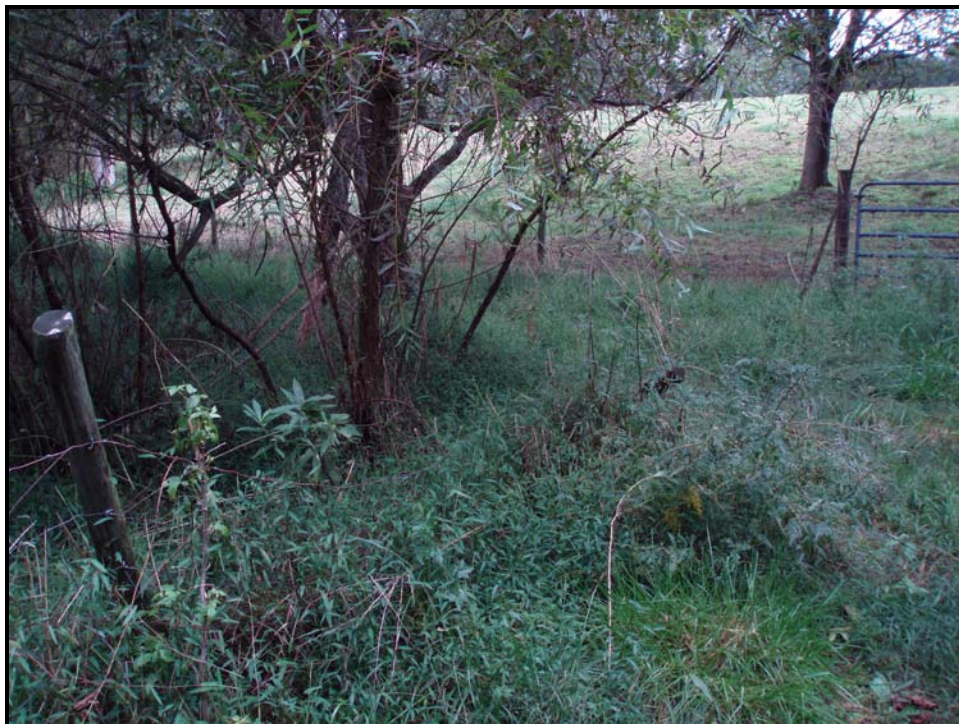
PA#6 – Damaged fence. Sta. 18+50

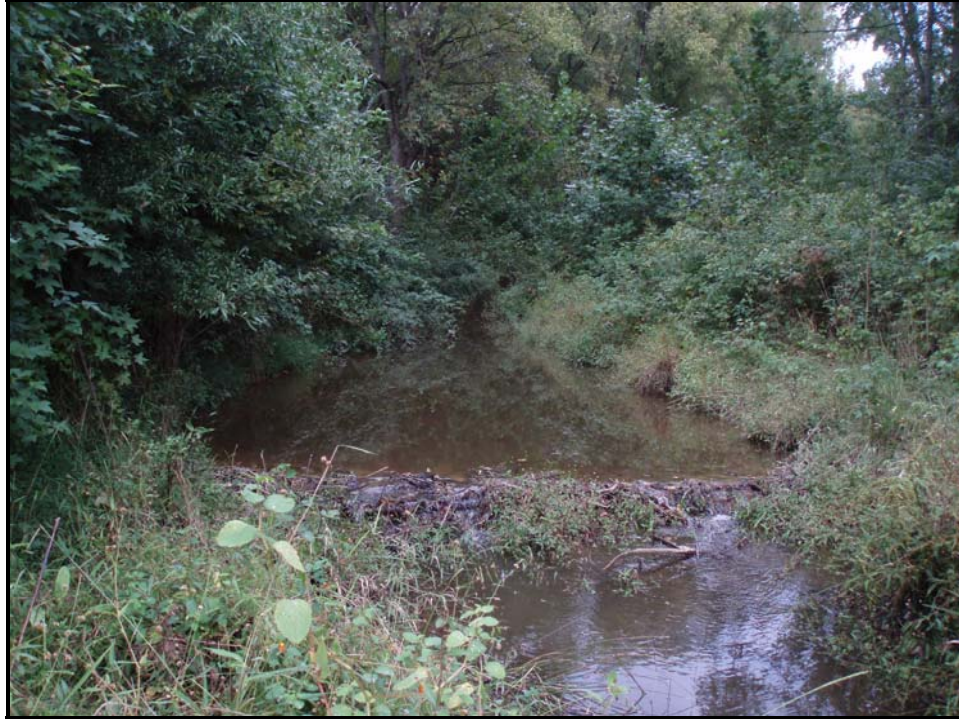
PA #7 – Beaver dam. Sta. 20+80

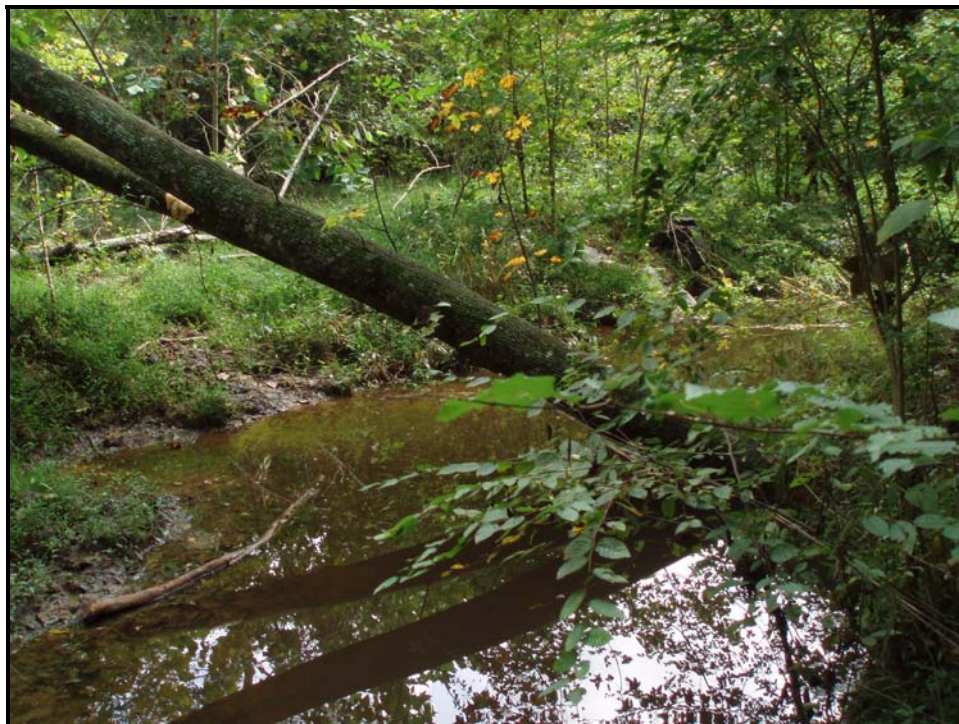
PA #8 – Bank erosion/tree falling across channel. Sta. 24+25

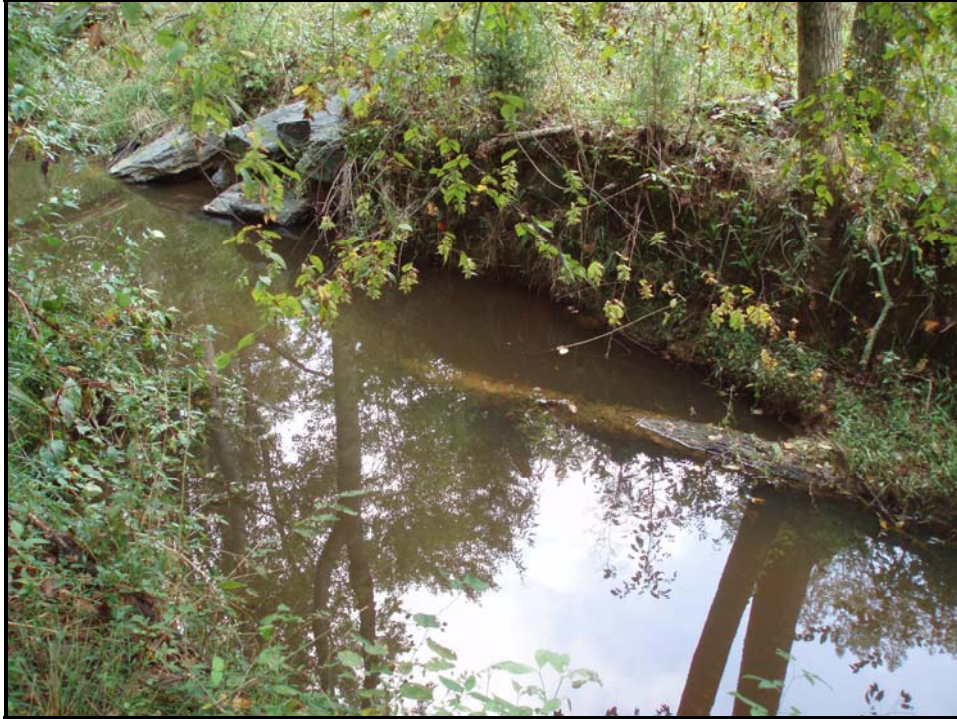
PA #9 – Left bank erosion behind log vane. Sta. 25+00

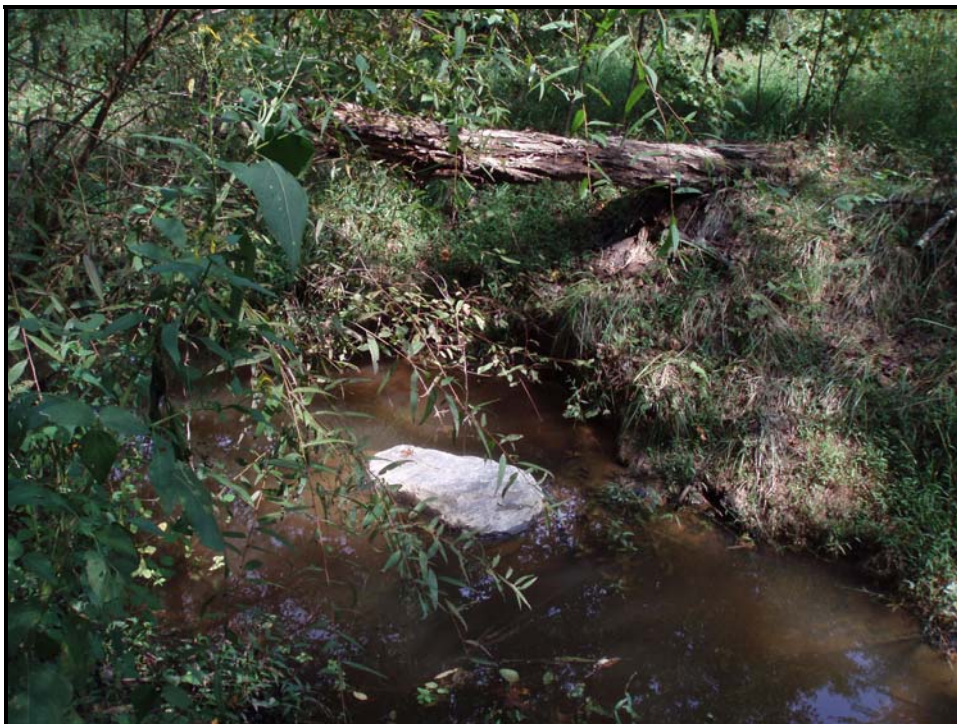
PA #10 – Left bank erosion at cross vane. Sta. 25+60

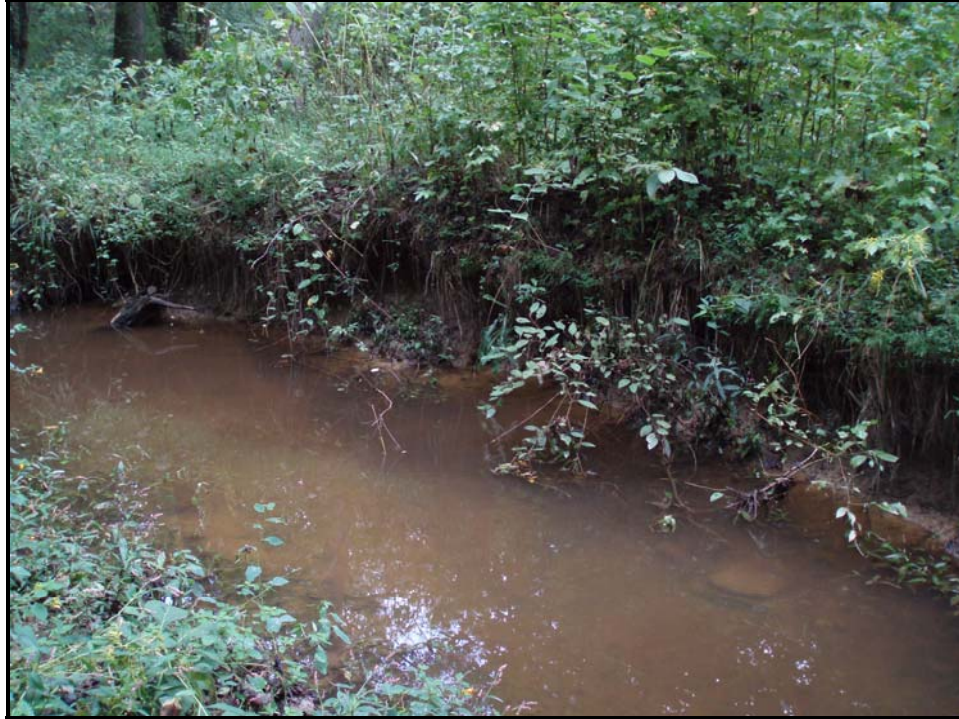
PA #11 – Left bank erosion/undercut bank. Sta. 26+50 to 27+00

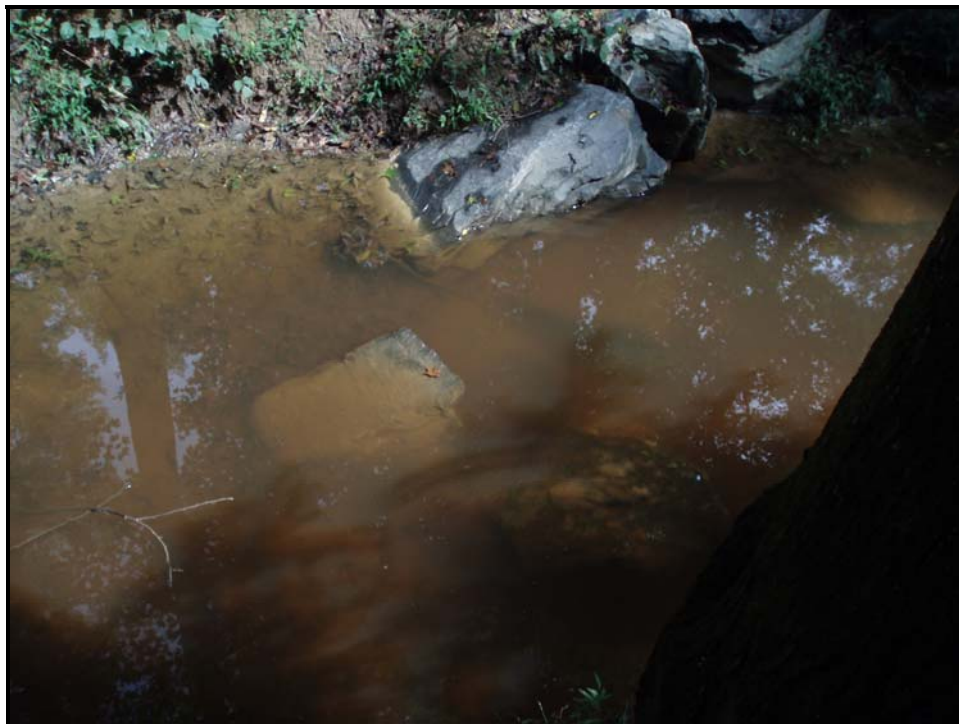
PA #12 – Erosion at J-hook; header rock displaced. Sta. 27+00

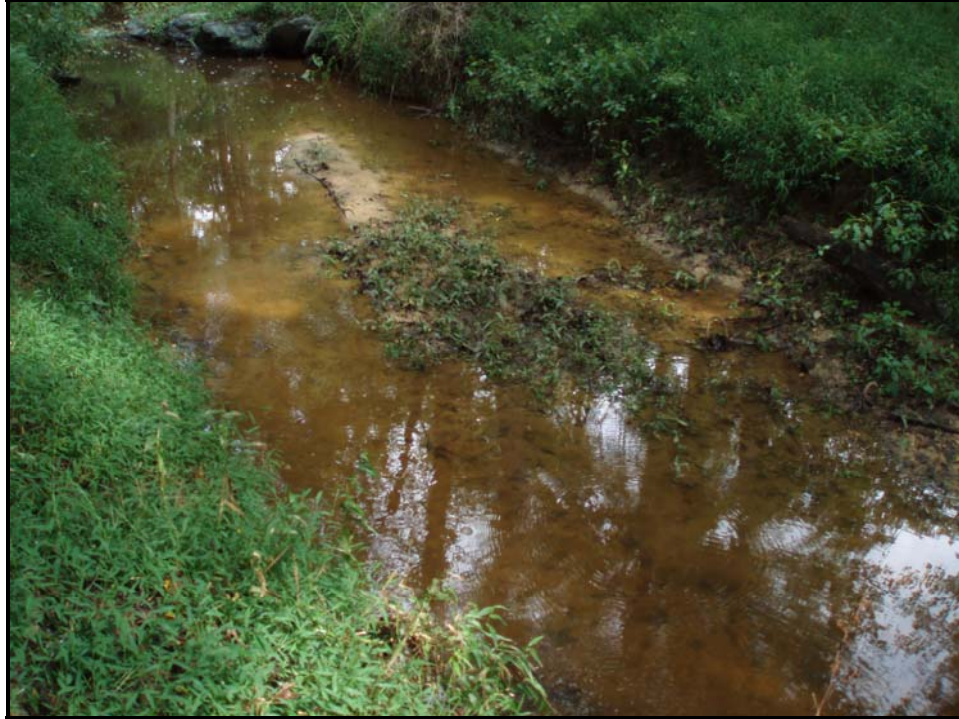
Mid-Channel Bar Forming	27+60	Channel is too wide	PA #13	--
L Bank Erosion/Undercutting at Cross Vane	27+80	Lack of bank stabilization, incorrect structure installation	PA #14	UF
L Bank Erosion Upstream of Cross Vane	29+40	Incorrect structure installation and tree undercut and in channel	PA #15	UF
R Bank Undercut	30+50	Undercut Bank	PA #16	--
Erosion at J-hook	30+80	Incorrect installation, header rock displaced	PA #17	UN
Bank Failure at Cross Vane	32+25	Lack of bank stabilization, incorrect structure installation	PA #18	UF
Beaver dam blocking culvert	53+25	Beaver activity	PA #19	--
Beaver dam	54+50	Beaver activity	PA #20	--

from 3.2 percent in 2007 to 4.8 percent in 2008, a relatively minor increase and well within normal tolerances. A mid-channel bar is forming where the channel is overly wide at Station 27+60.

PA #13 – Mid-Channel bar forming. Sta. 27+60

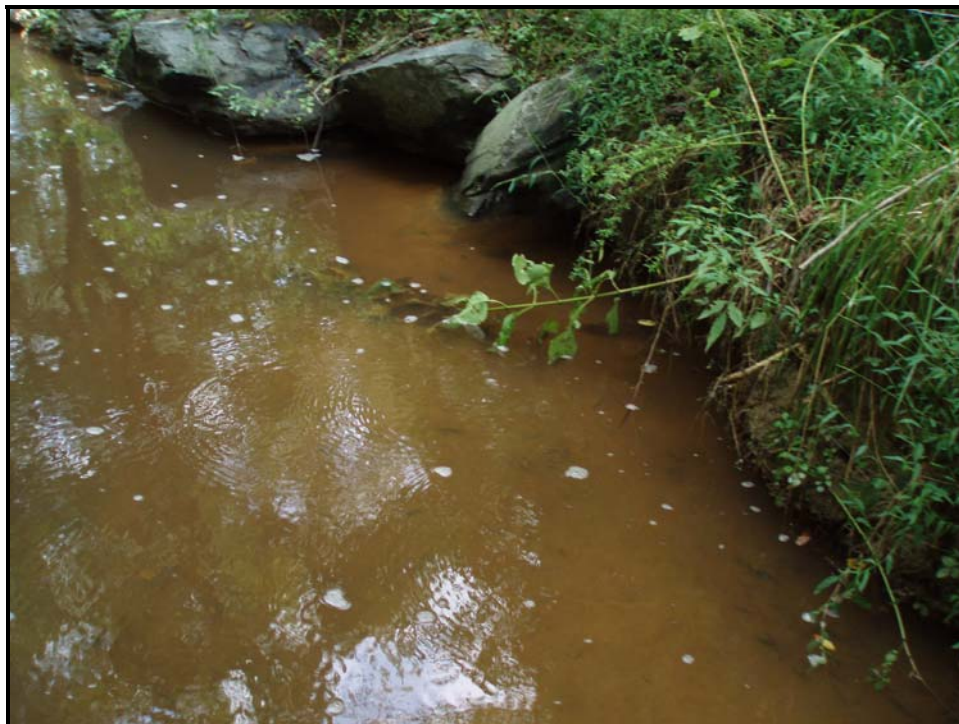
PA #14 – Left bank erosion/undercutting at cross vane. Sta. 27+80

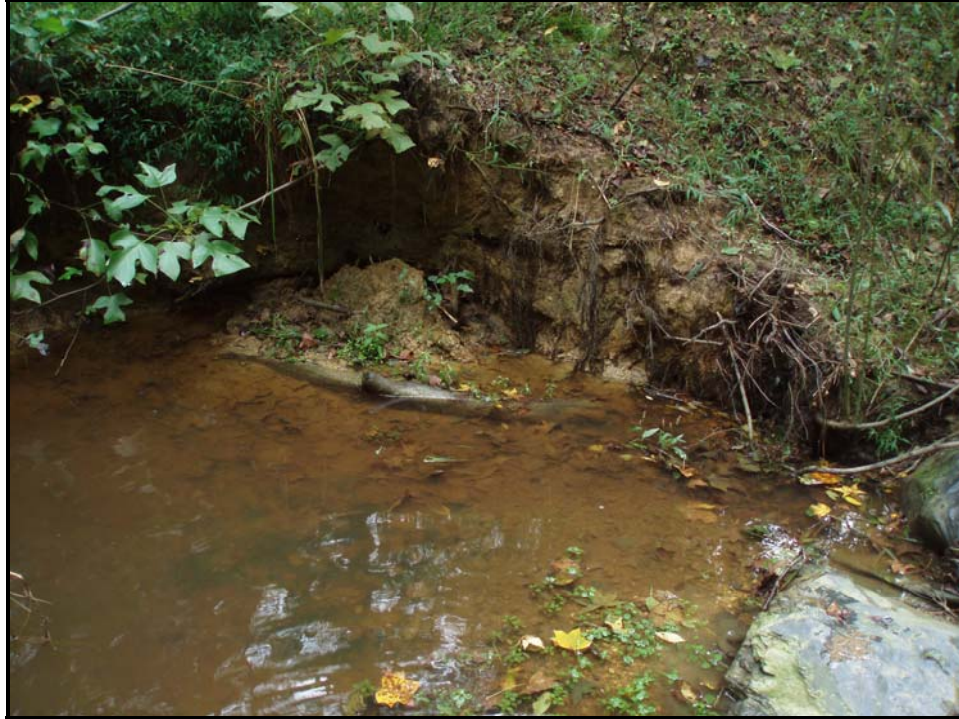
PA #15 – Left bank erosion upstream of cross vane. Sta. 29+40

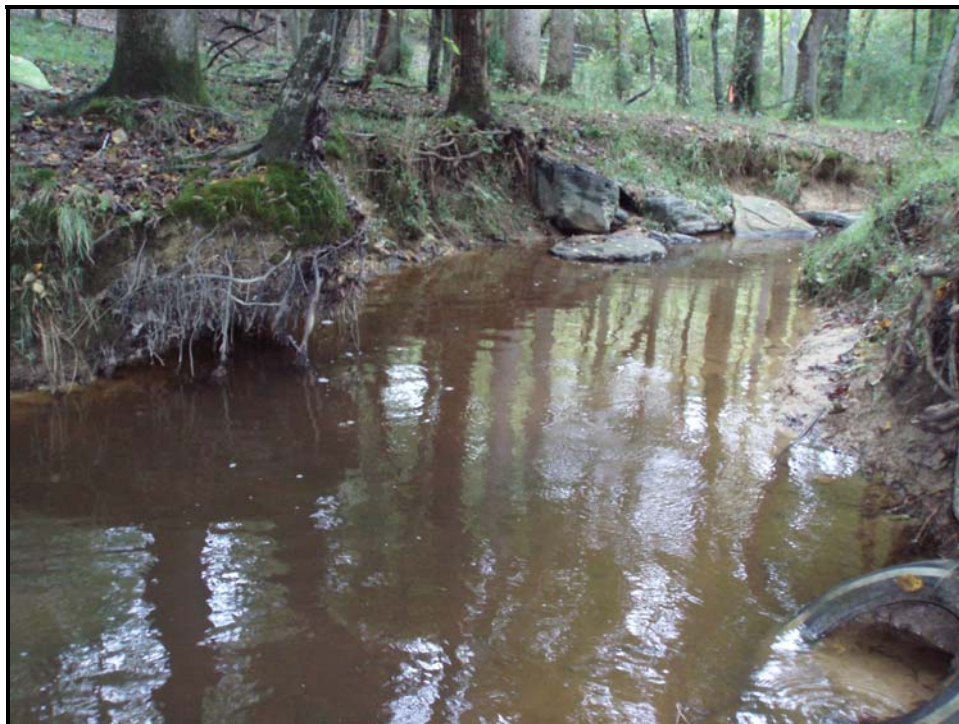
PA #16 – Right bank undercut. Sta. 30+50

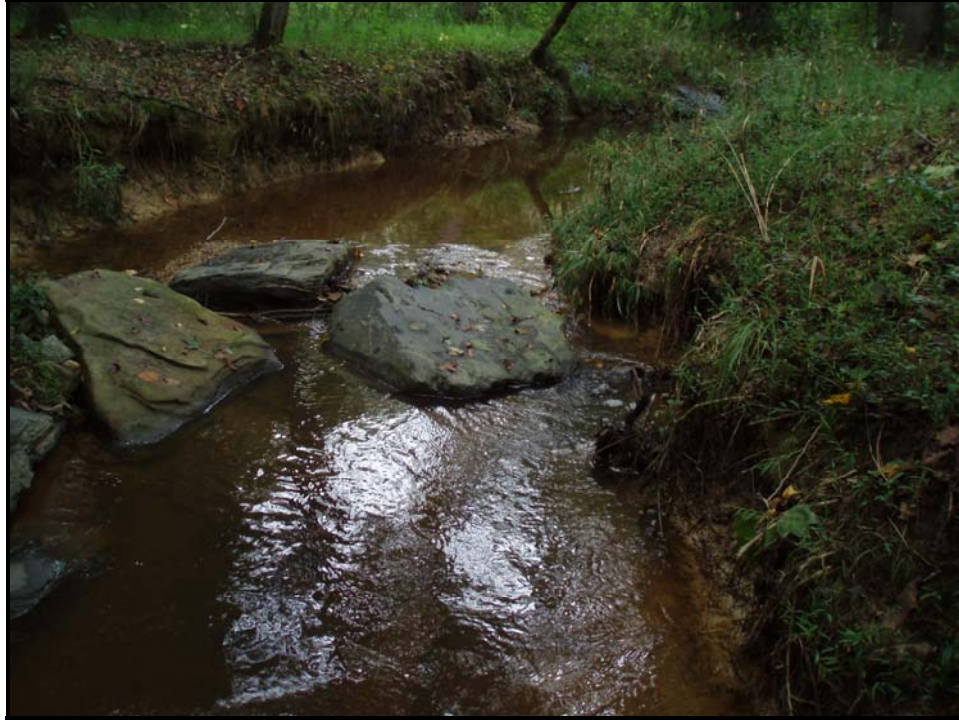
PA #17 – Erosion at cross vane. Sta. 30+80

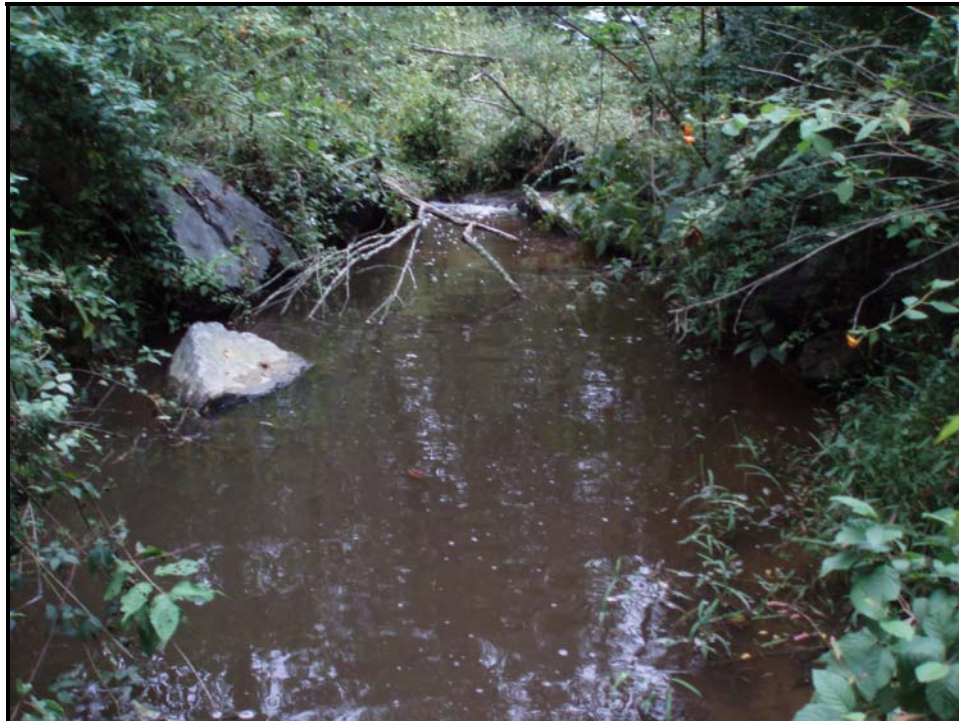
PA #18 – Bank failure at cross vane. Sta. 32+00

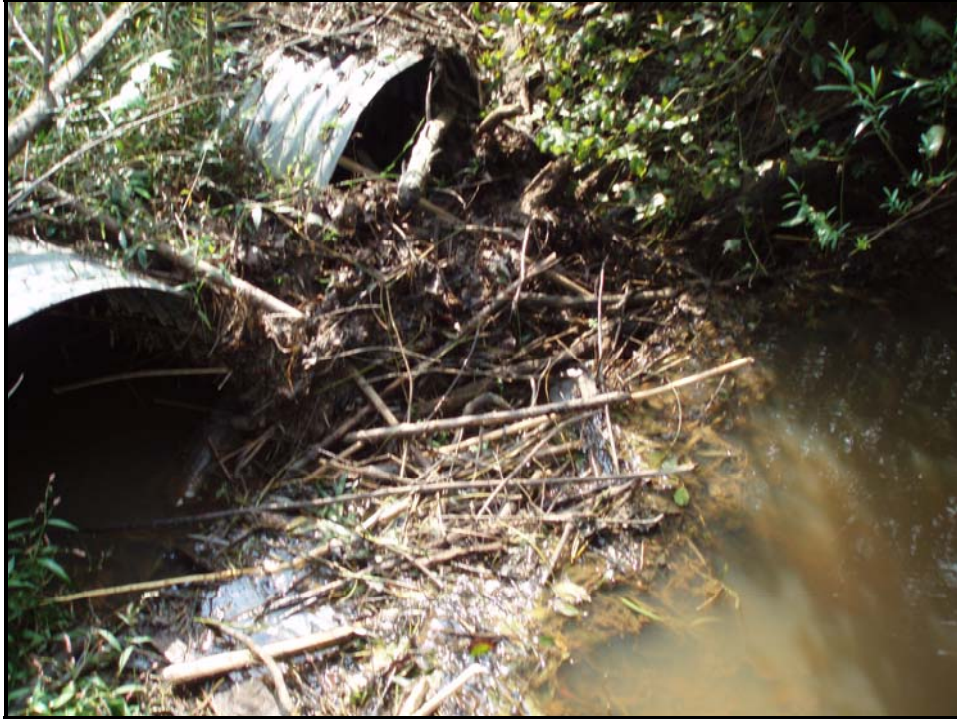
PA #19 – Beaver dam at culvert. Sta. 53+25

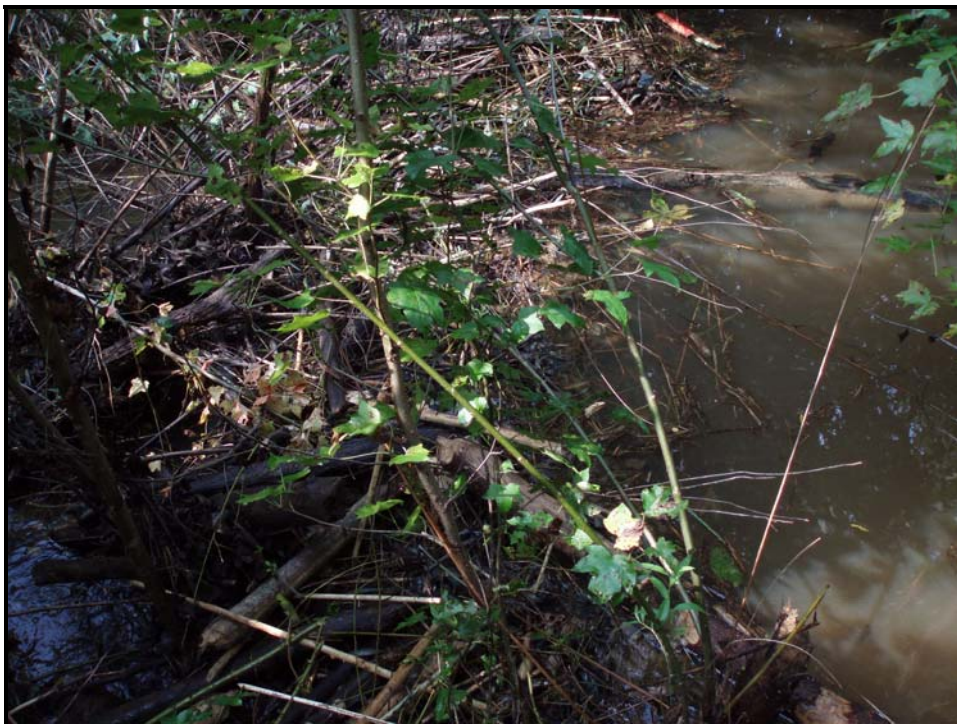
PA #20 – Beaver dam. Sta. 54+50
