Monitoring Report MY01

**Cedar Branch Restoration Site
Monitoring Year 01
DMS Contract 6598
DMS Project Number 97009**

**DWR #: 20150904
USACE Action ID: 2003-21395
Randolph County, North Carolina**

**Monitoring Data Collected: November 2018
Date Submitted: January 2019**

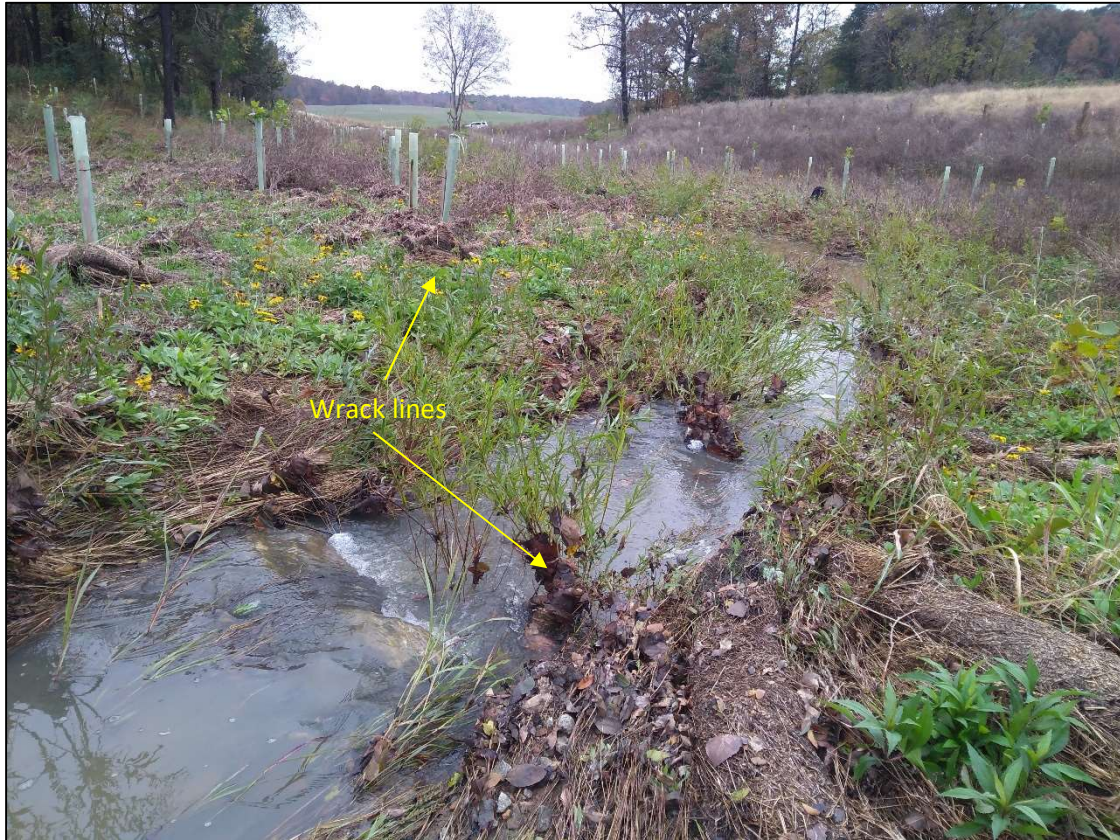
Photo 1. Wrack lines above bankfull, 11/5/2018
