Monitoring Report MY02

**Cedar Branch Restoration Site
Monitoring Year 02
DMS Contract 6598
DMS Project Number 97009**

**DWR #: 20150904
USACE Action ID: 2003-21395
Randolph County, North Carolina**

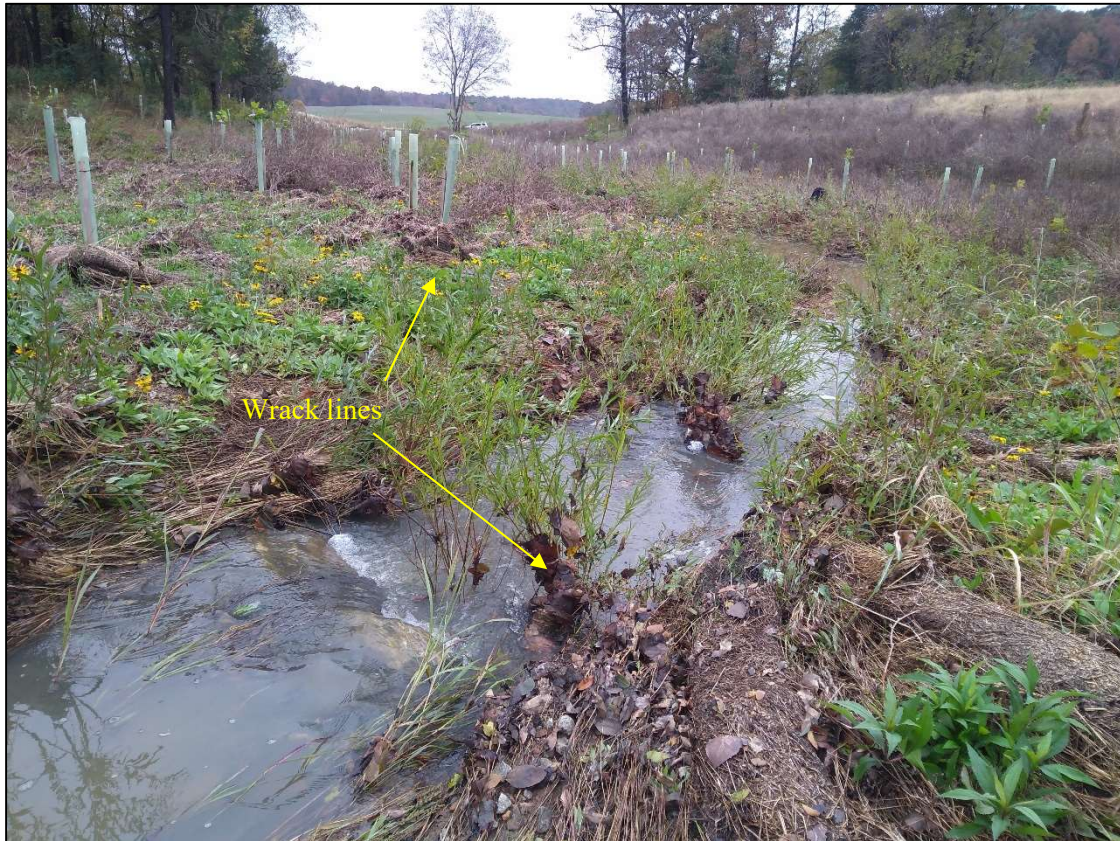
Photo 1. Wrack lines above bankfull, 11/5/2018
