# Monitoring Report MY06

**Cedar Branch Restoration Site**

**Monitoring Year 06**

**DMS Project Number 97009**

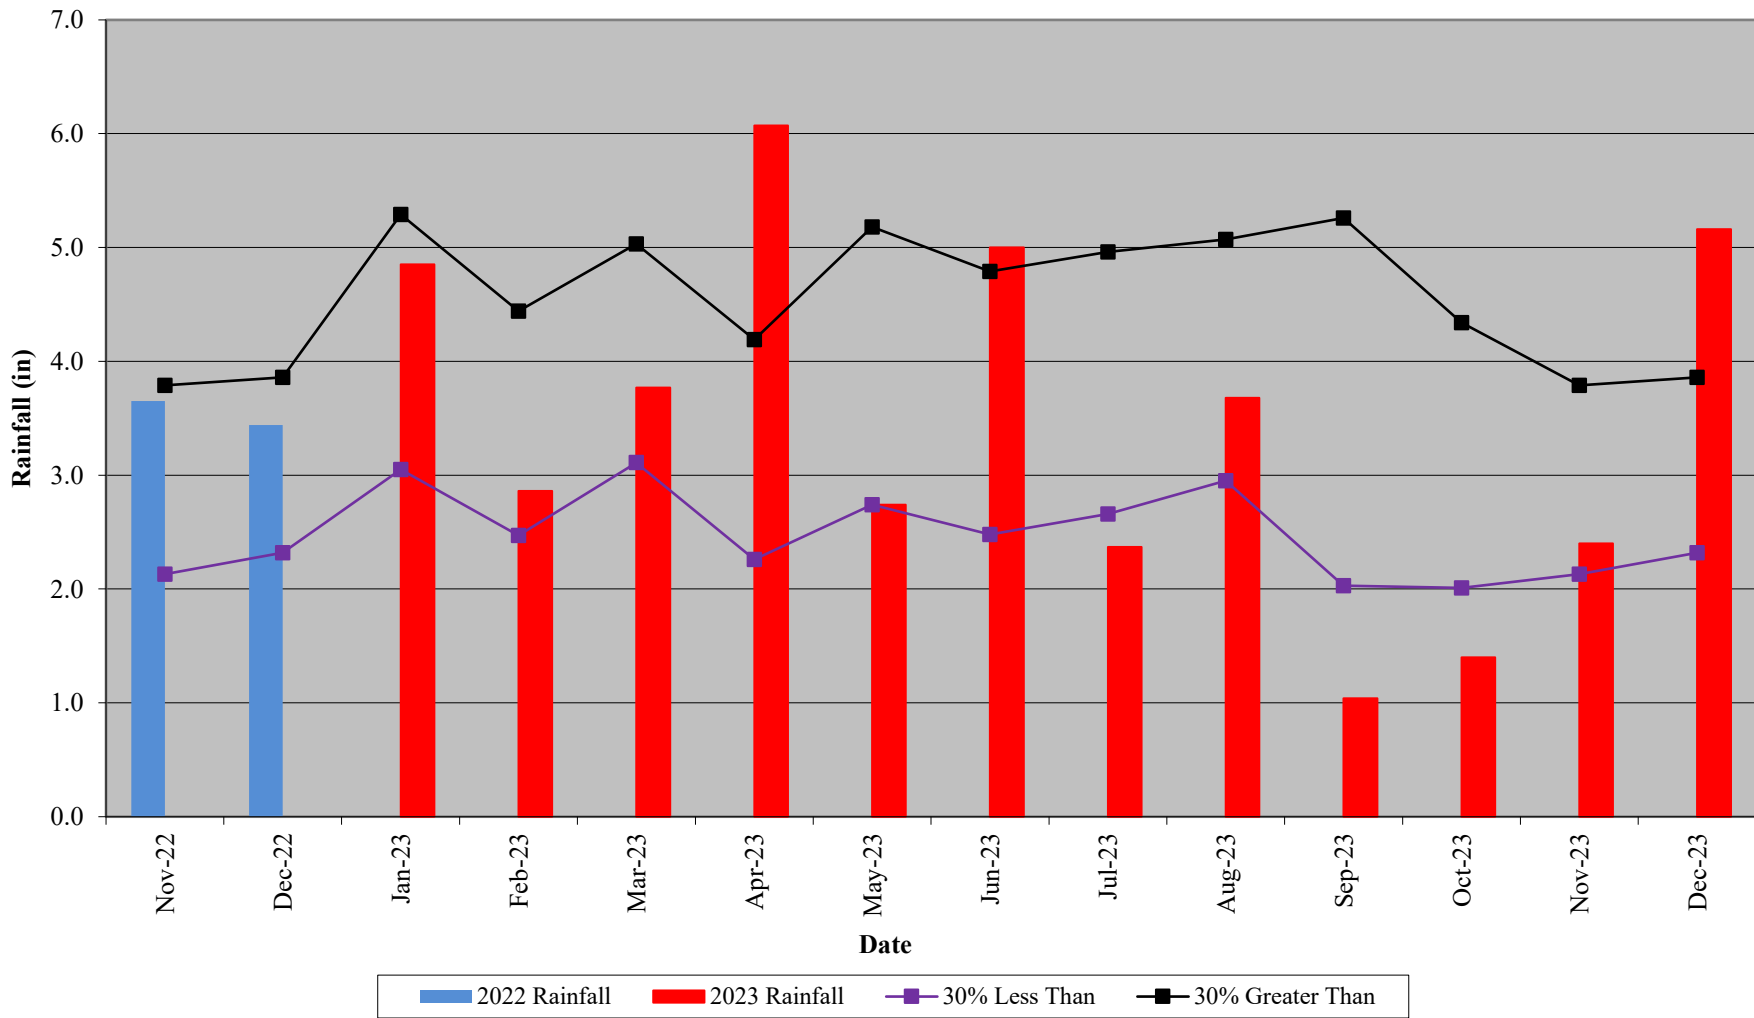
**Cedar Branch Restoration Site  
30-70 Percentile Graph  
WETS Station Name: Asheboro, NC**

- *The rainfall discussion should have indicated that the area experienced average rainfall during 2023. This error has been corrected and the appropriate rainfall totals have been added to the report.*
