**CEDAR CREEK STREAM AND WETLAND RESTORATION
PROJECT
MONITORING REPORT
MONITORING YEAR 1**

SAMPSON COUNTY, NORTH CAROLINA
CONTRACT NO. 005011 - PROJECT NO. 95718

March 2016

**Resource Environmental Solutions, LLC
302 Jefferson Street, Suite 110
Raleigh, NC 27605
919-209-1061**

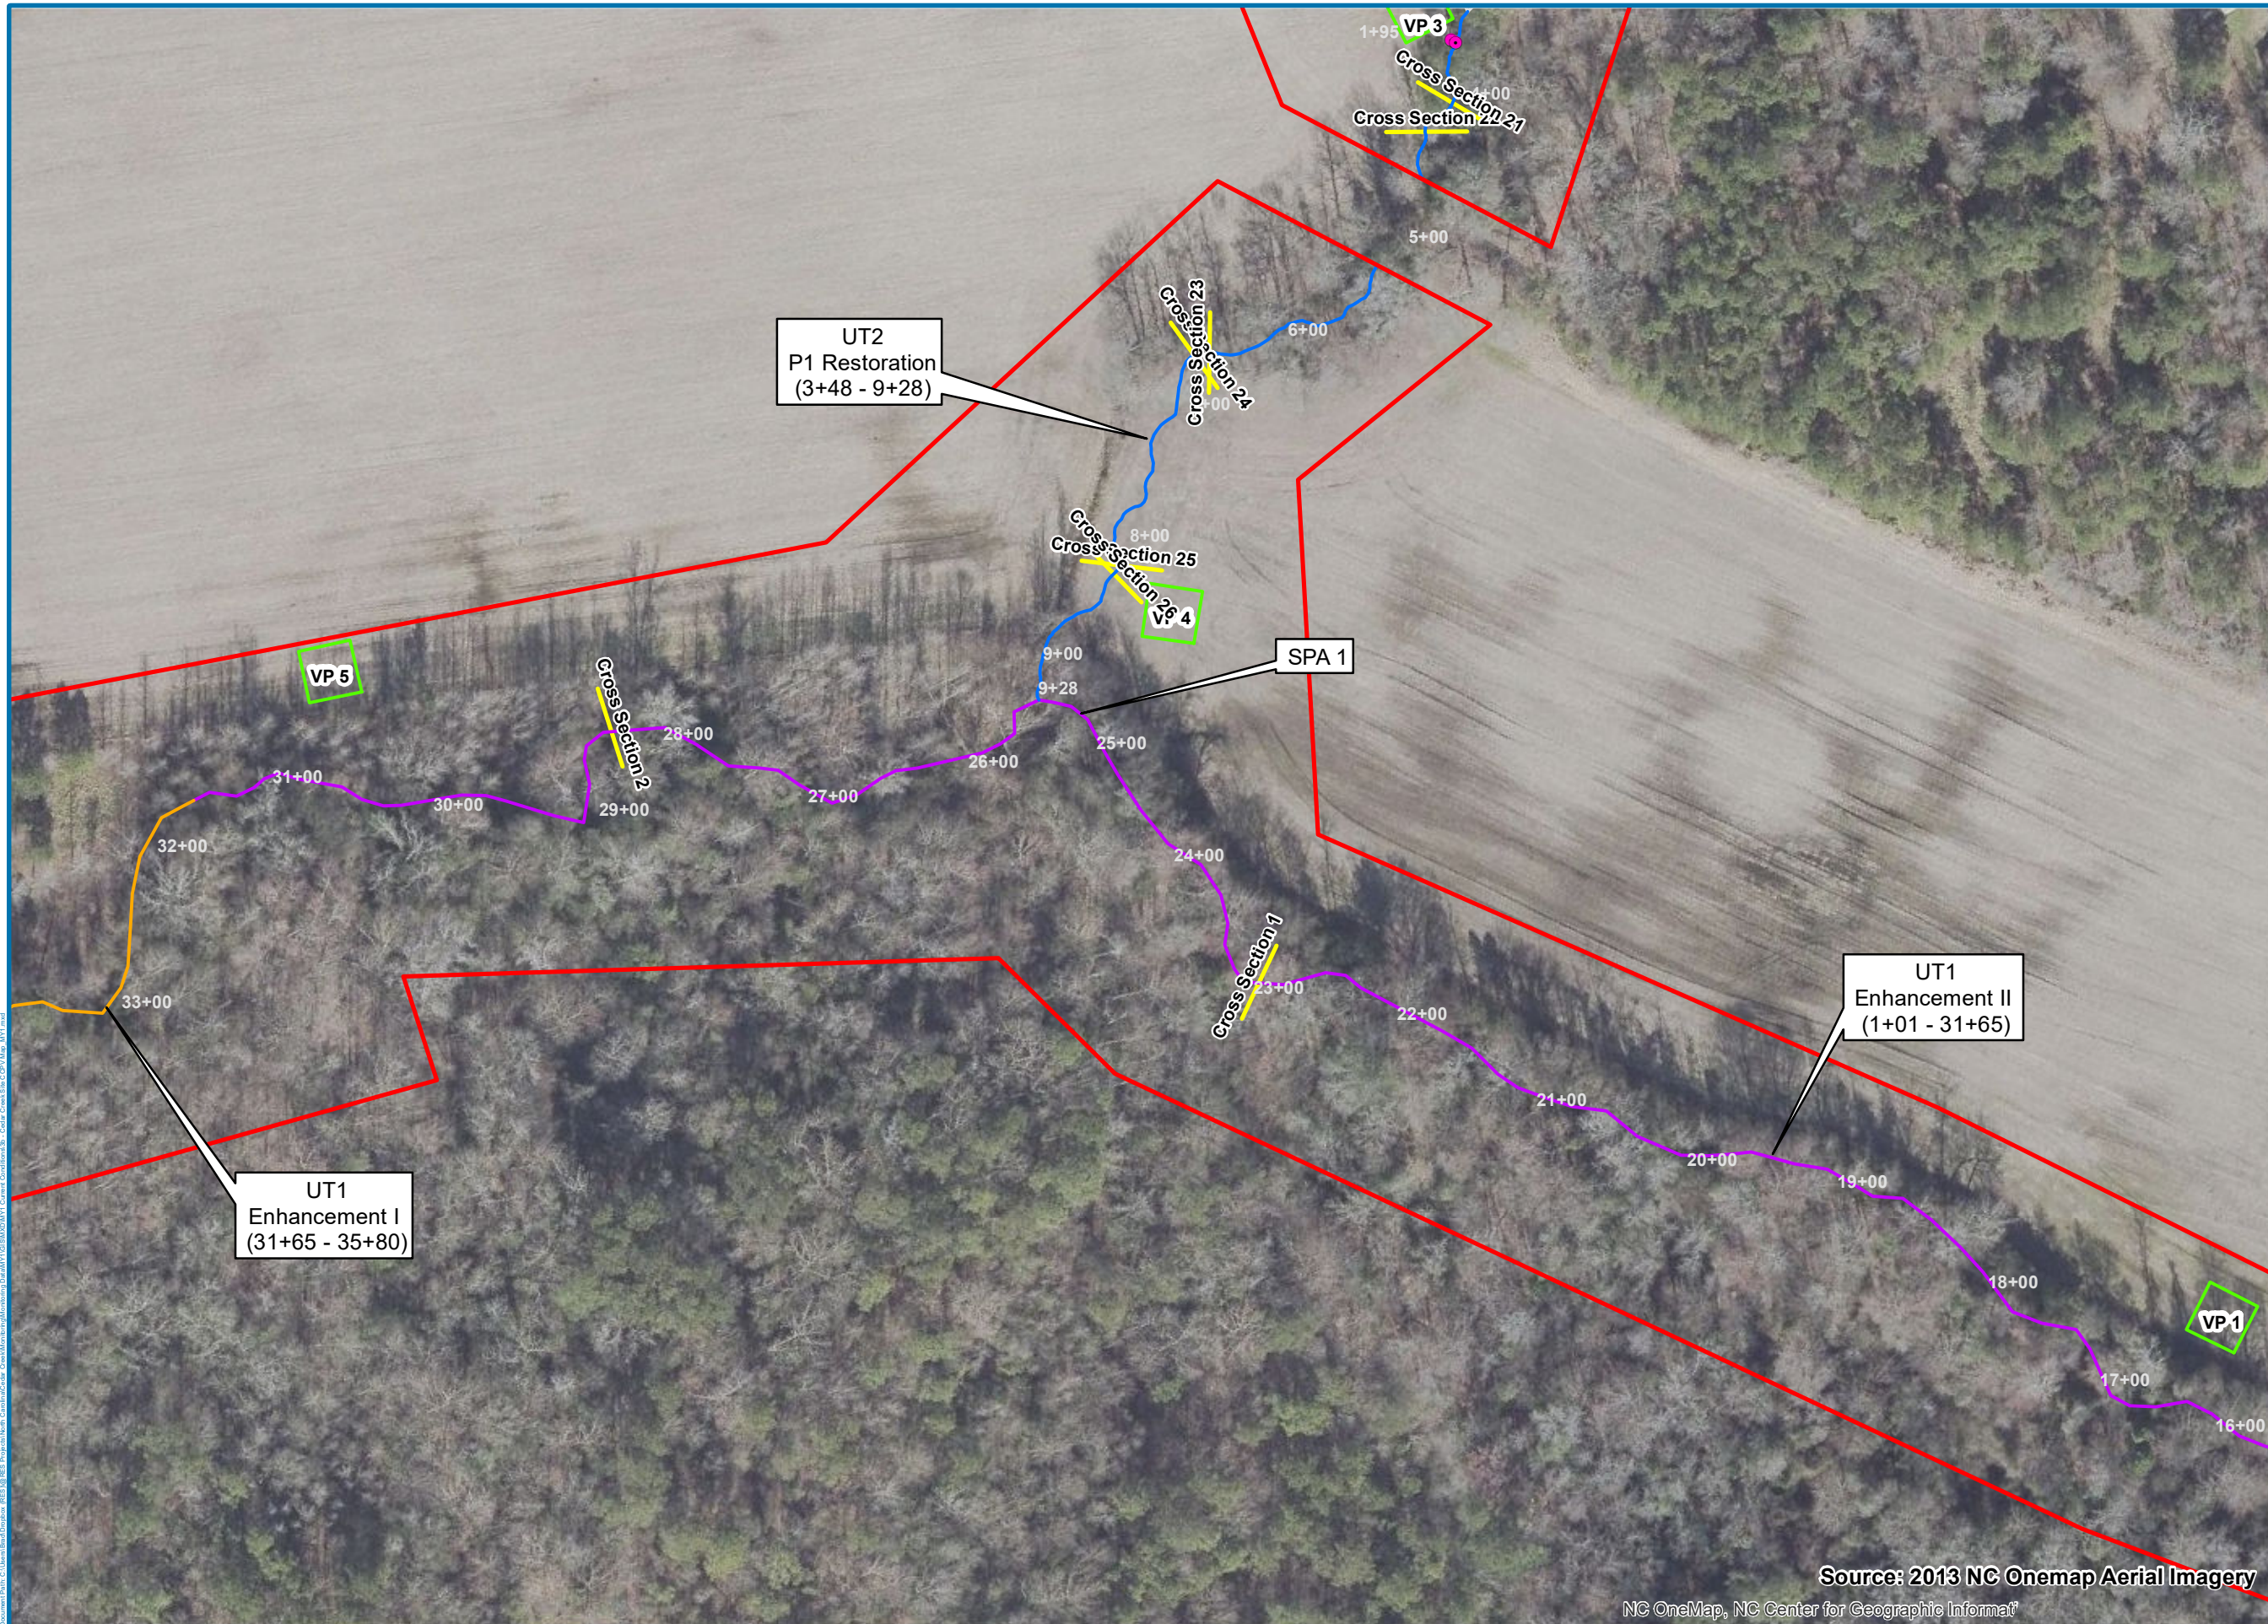
Figure 3b.
Cedar Creek
Restoration Project
UT1
Current Conditions
Plan View Map

One stream problem was identified during the Year 1 monitoring period and has been mapped on the Current Conditions Plan View (CCPV), specifically Figure 3b. The problem was noted on the right bank of Reach UT1, just before the confluence with Reach UT2 (Sta 25+50). The problem area consists of a tree that has fallen into the channel and associated bank erosion and scouring with the disturbed root system. Remedial action will include monitoring this area into the first half of the (MY2) monitoring year 2. If this problem continues to get worse, active measures will include flush cutting the base of the tree and anchoring the root mass into the bank to serve as a bank stabilization structure. Upon completion of repair, the area will be matted and livestaked.

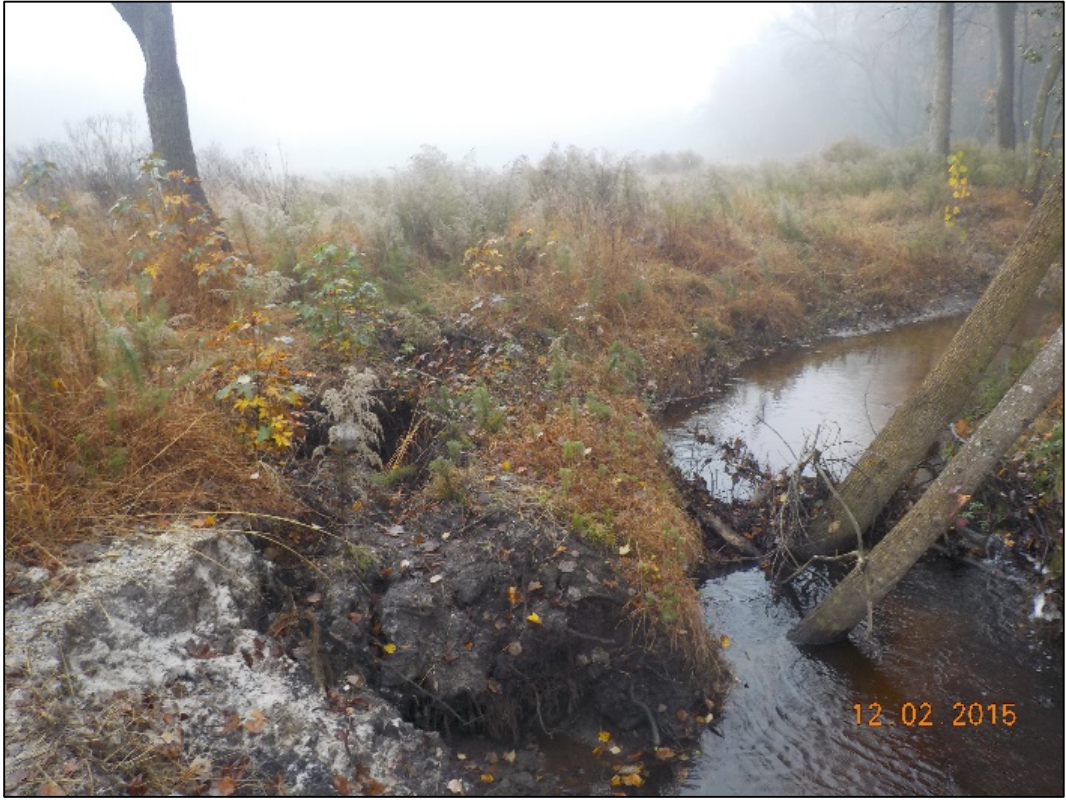
Table 7. Stream Problem Areas			
Cedar Creek Stream and Wetland Restoration Project - Project # 95718			
Feature Issue	Station # / Range	Suspected Cause; Repair	Photo Number
Bank failure/fallen tree	UT1 @ 25+00 to 25+50	Loose soil near base of tree; recommend flush cutting the tree and anchoring root mass into bank for stabilization- mat and livestock entire area	SPA1

SPA1- Bank Failure @ Sta 25+00 to 25+50
