**CEDAR CREEK STREAM AND WETLAND RESTORATION  
PROJECT  
MONITORING REPORT  
MONITORING YEAR 3  
FINAL**

SAMPSON COUNTY, NORTH CAROLINA  
CONTRACT No. 005011 - PROJECT No. 95718  
USACE ACTION ID No. 2012-00389 – NCDWR PROJECT No. 2013-0186

RE: Cedar Creek Stream and Wetland Restoration Site: MY3 Monitoring Report  
(NCDMS ID 95718)

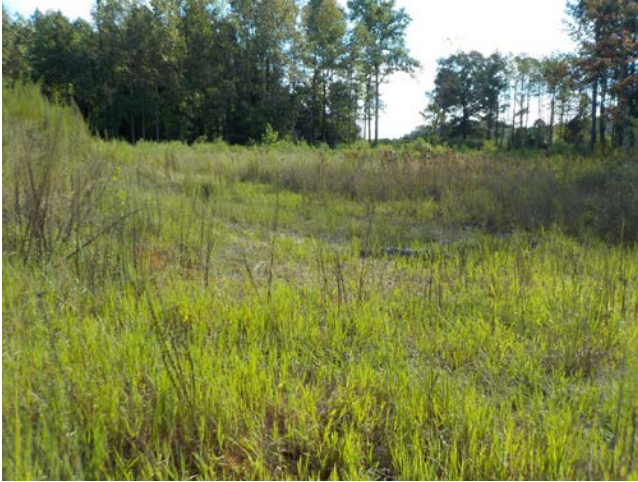
VPA2- Bare Area - UT2 @ Sta 4+00 to 4+66

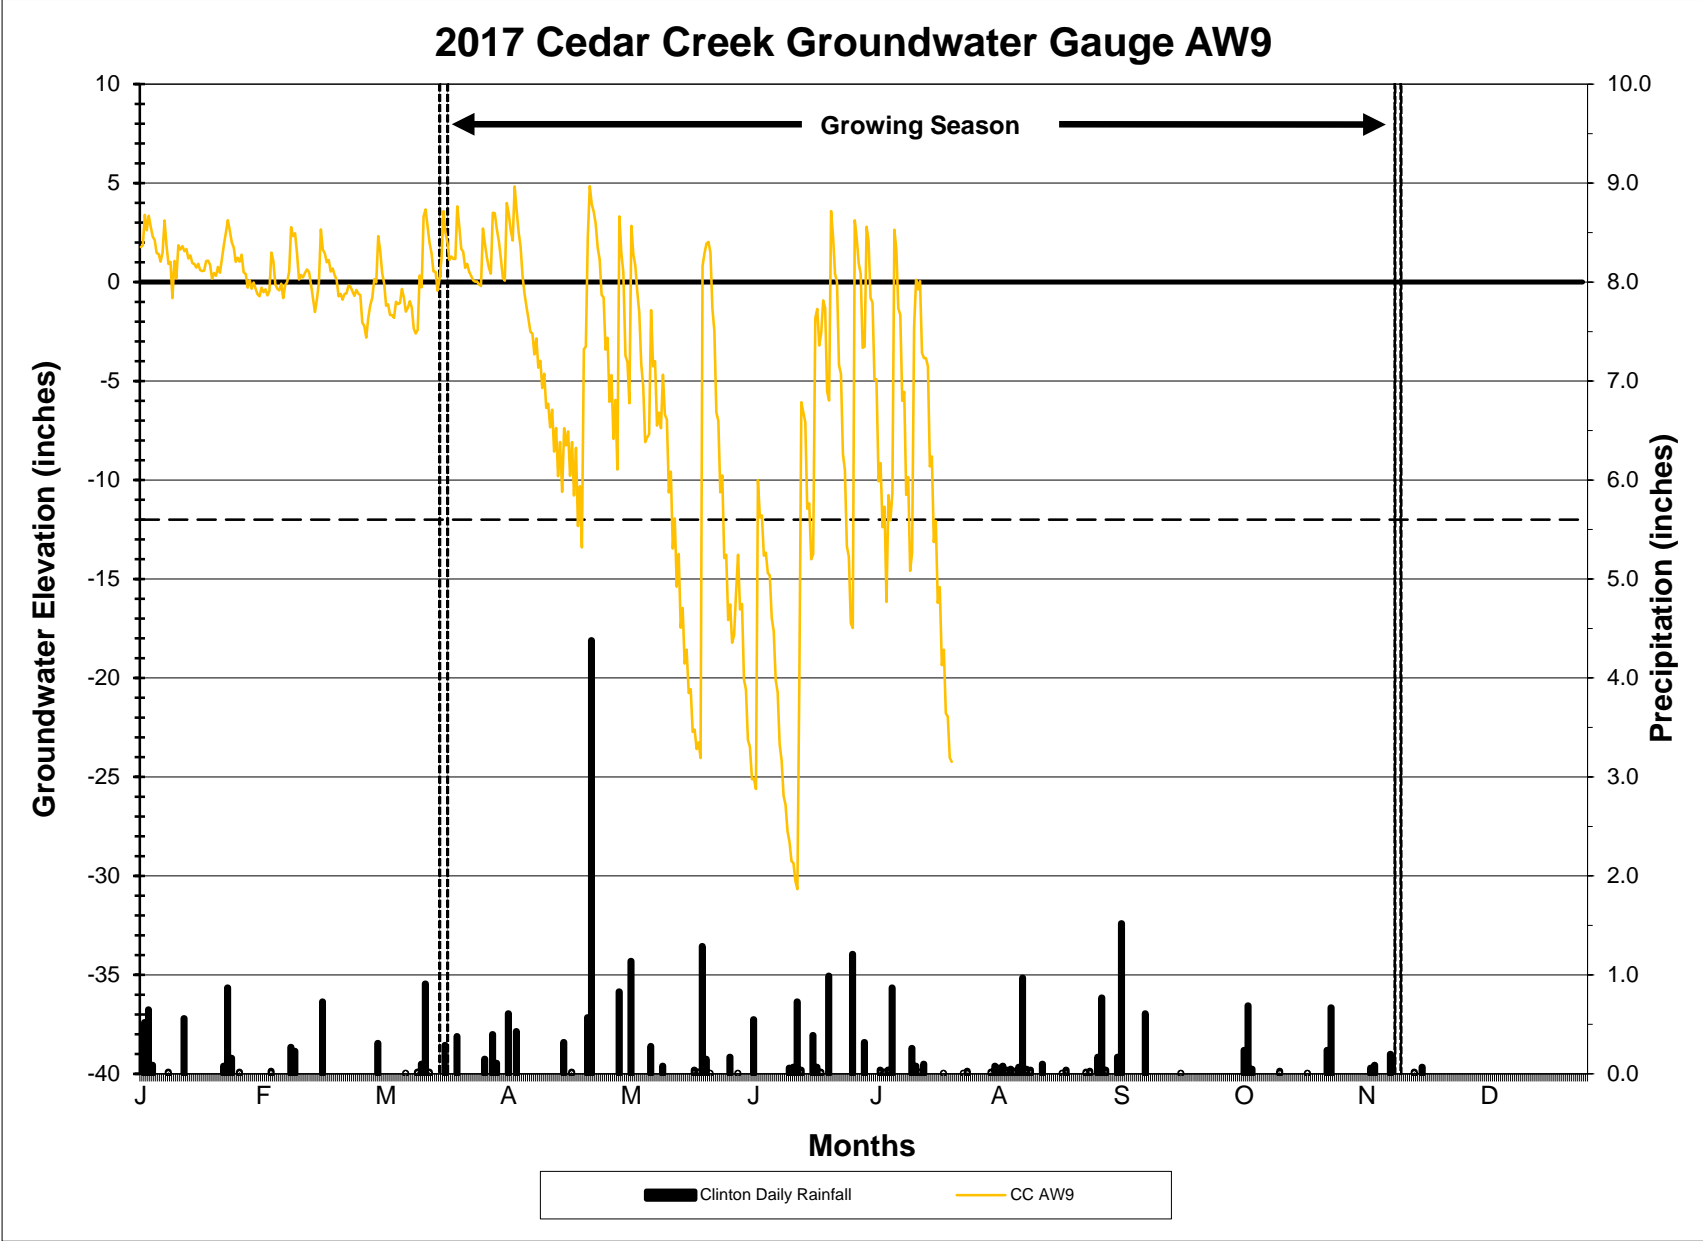
\*Groundwater gauge failed after July 25, 2017

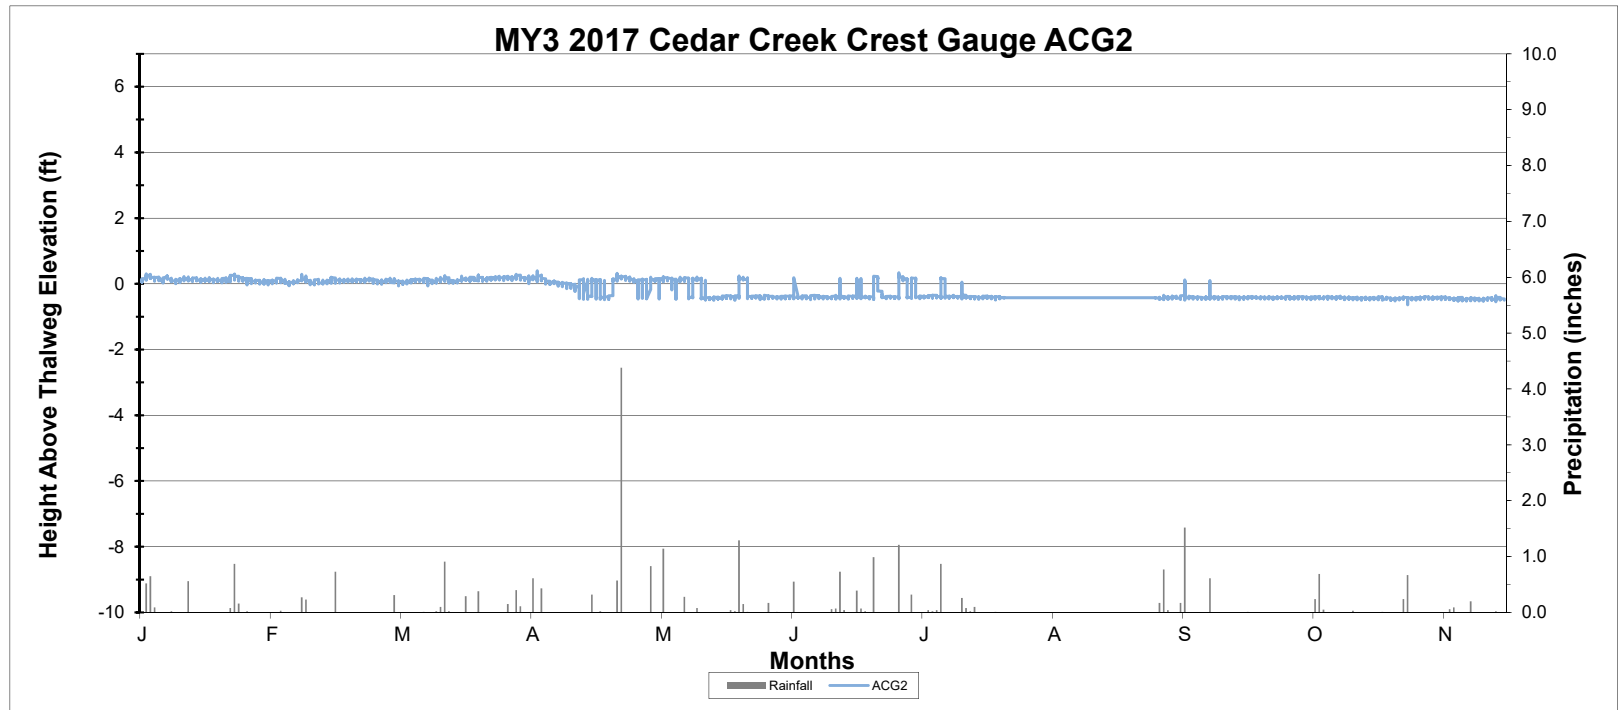
HOBO transducer did not collect data from 7/26/2017-8/30/2017
