**CEDAR CREEK STREAM AND WETLAND RESTORATION  
PROJECT  
MONITORING REPORT  
MONITORING YEAR 5  
FINAL**

SAMPSON COUNTY, NORTH CAROLINA  
CONTRACT No. 005011 - PROJECT No. 95718  
USACE ACTION ID No. 2012-00389 – NCDWR PROJECT No. 2013-0186

February 2020

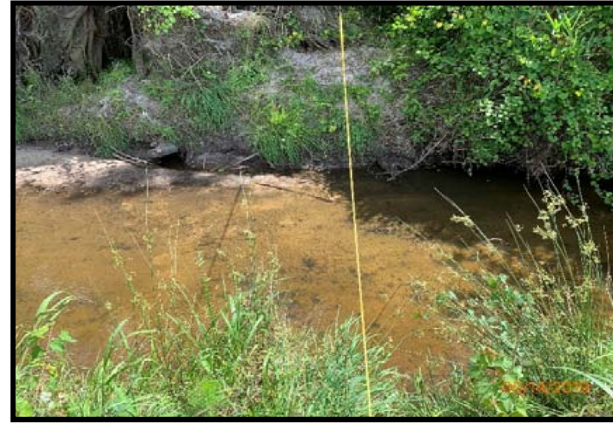
Left Bank \*Note Downed Tree

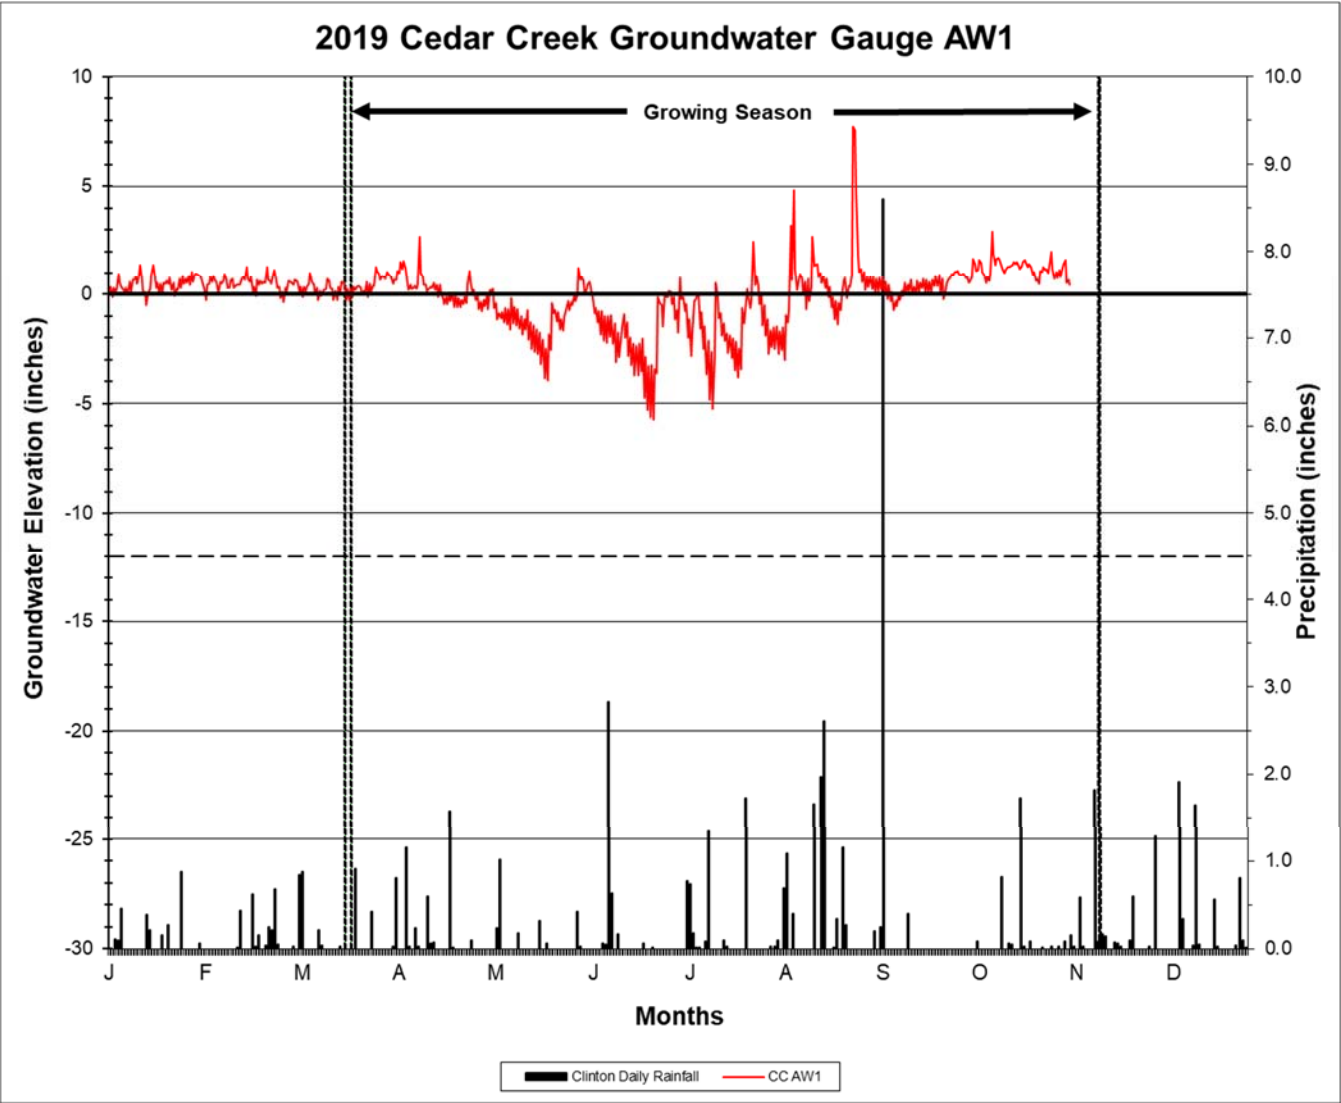
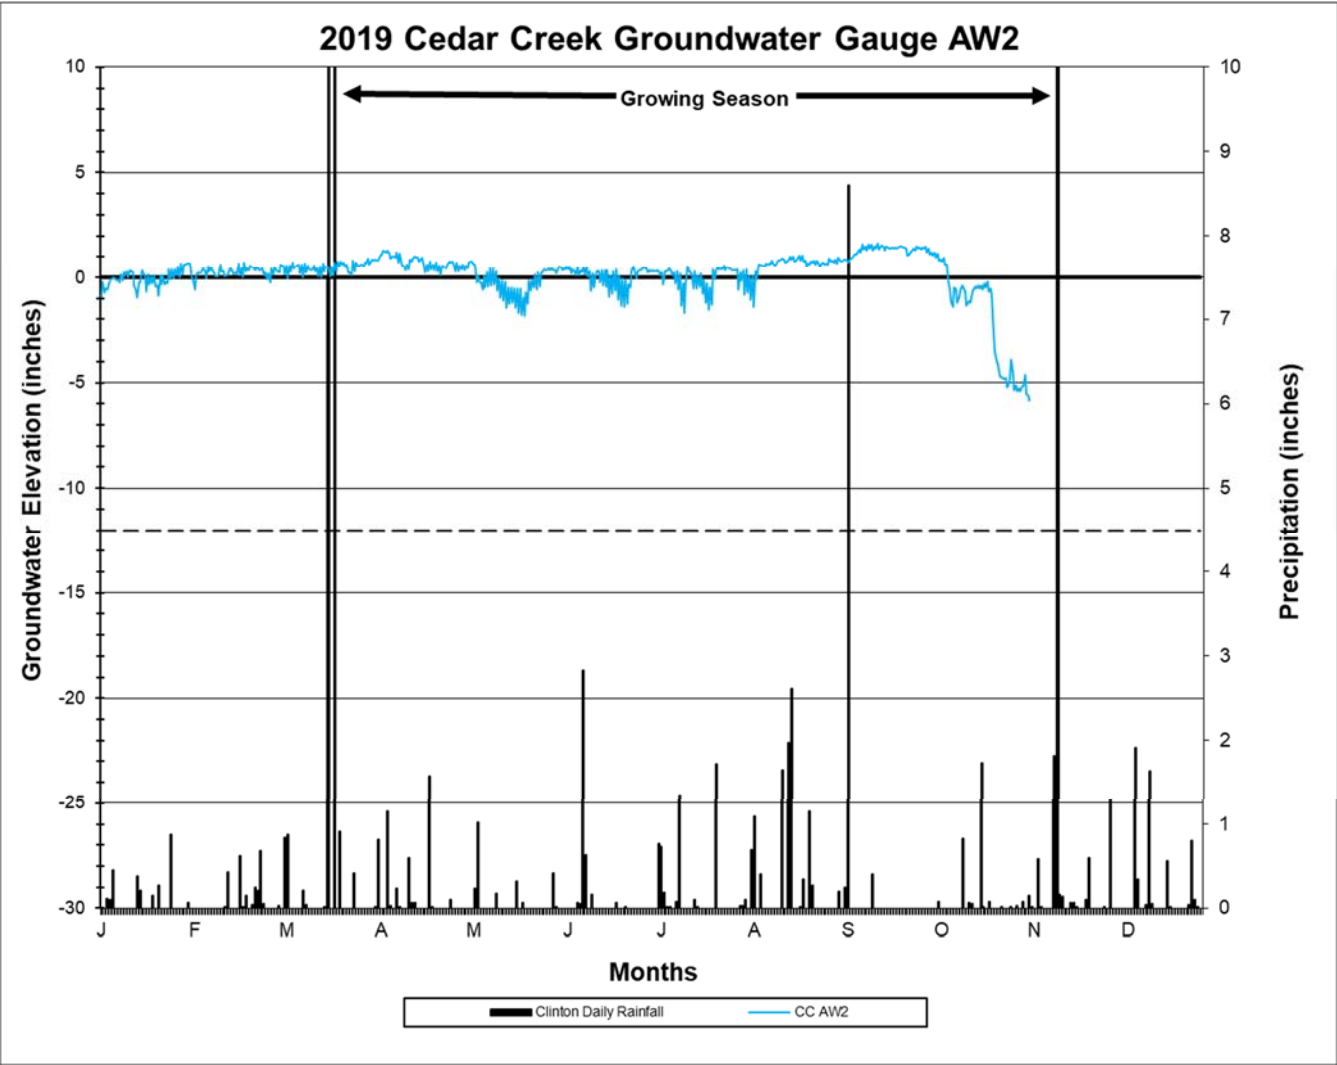
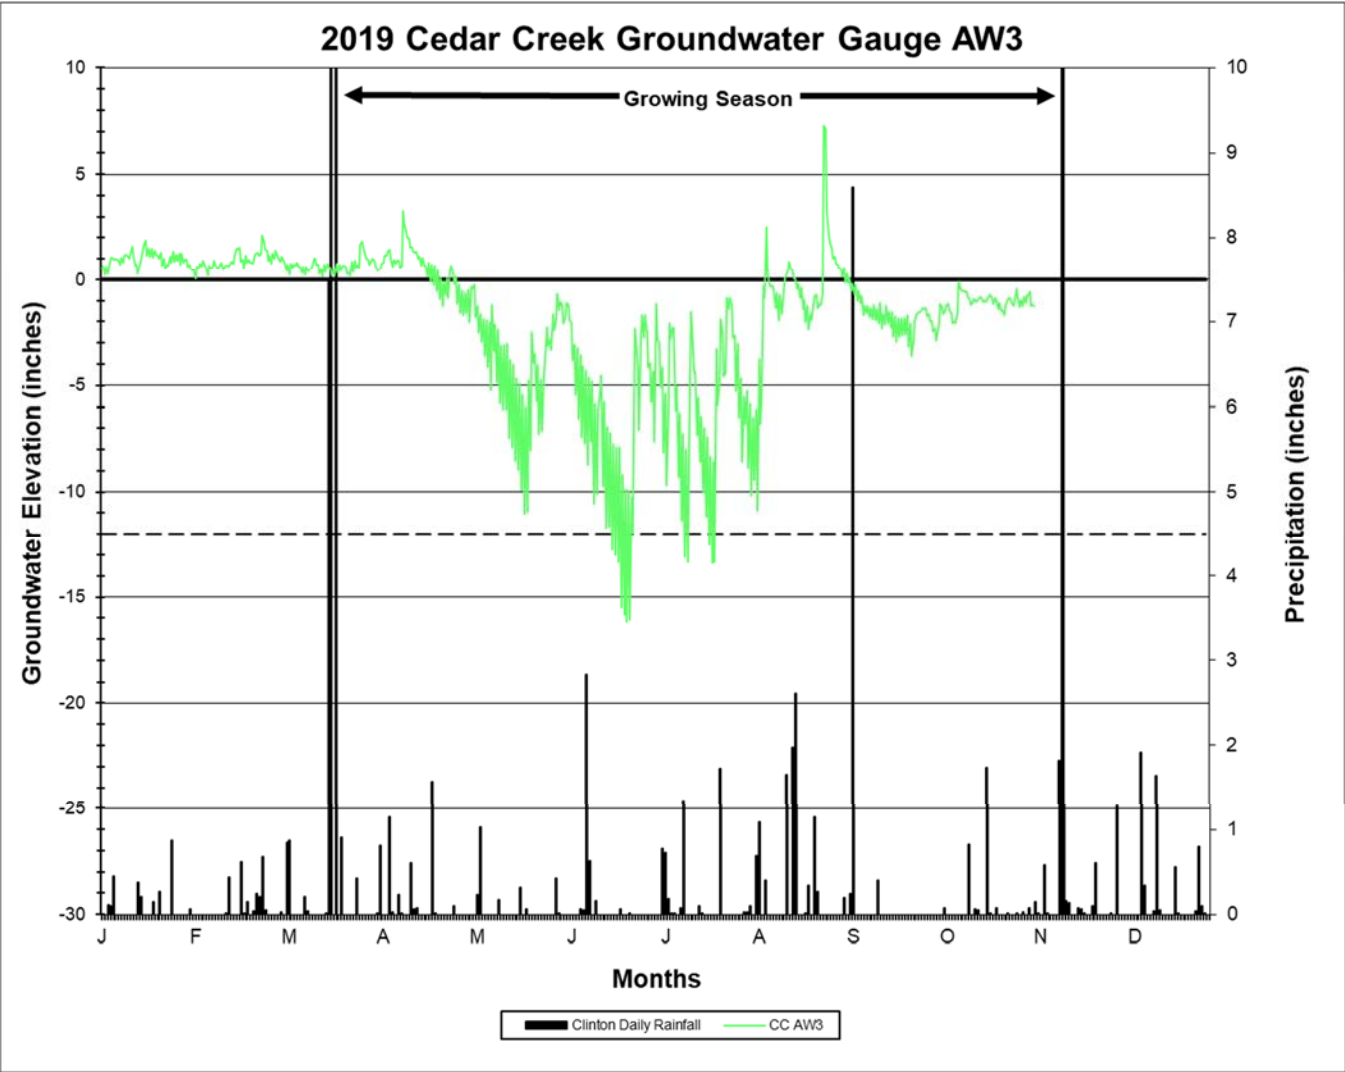
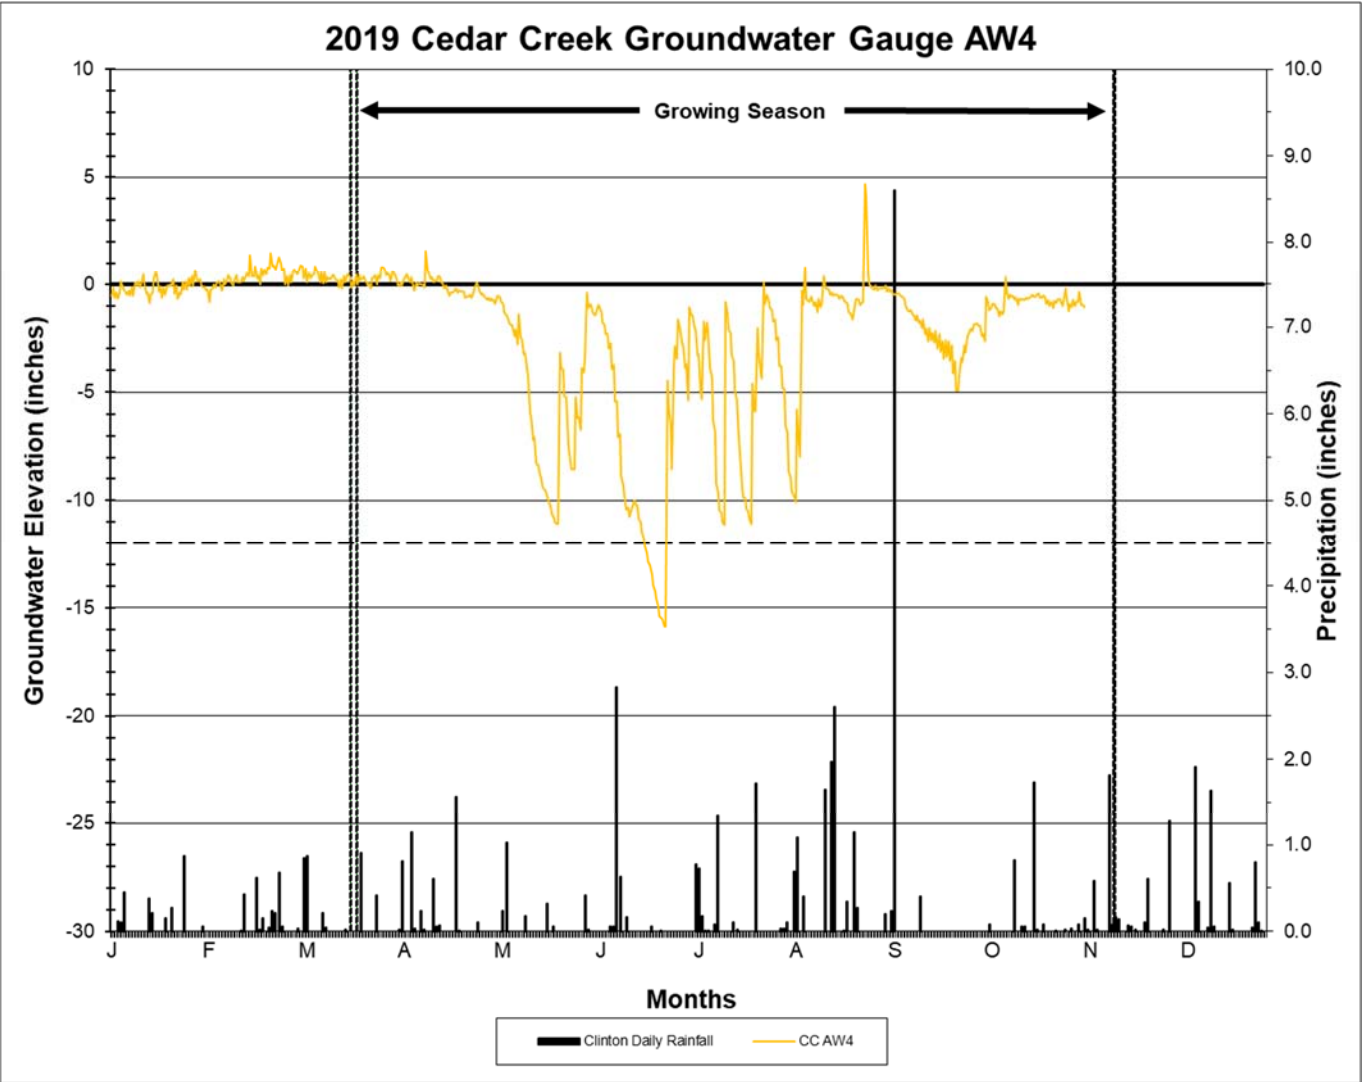
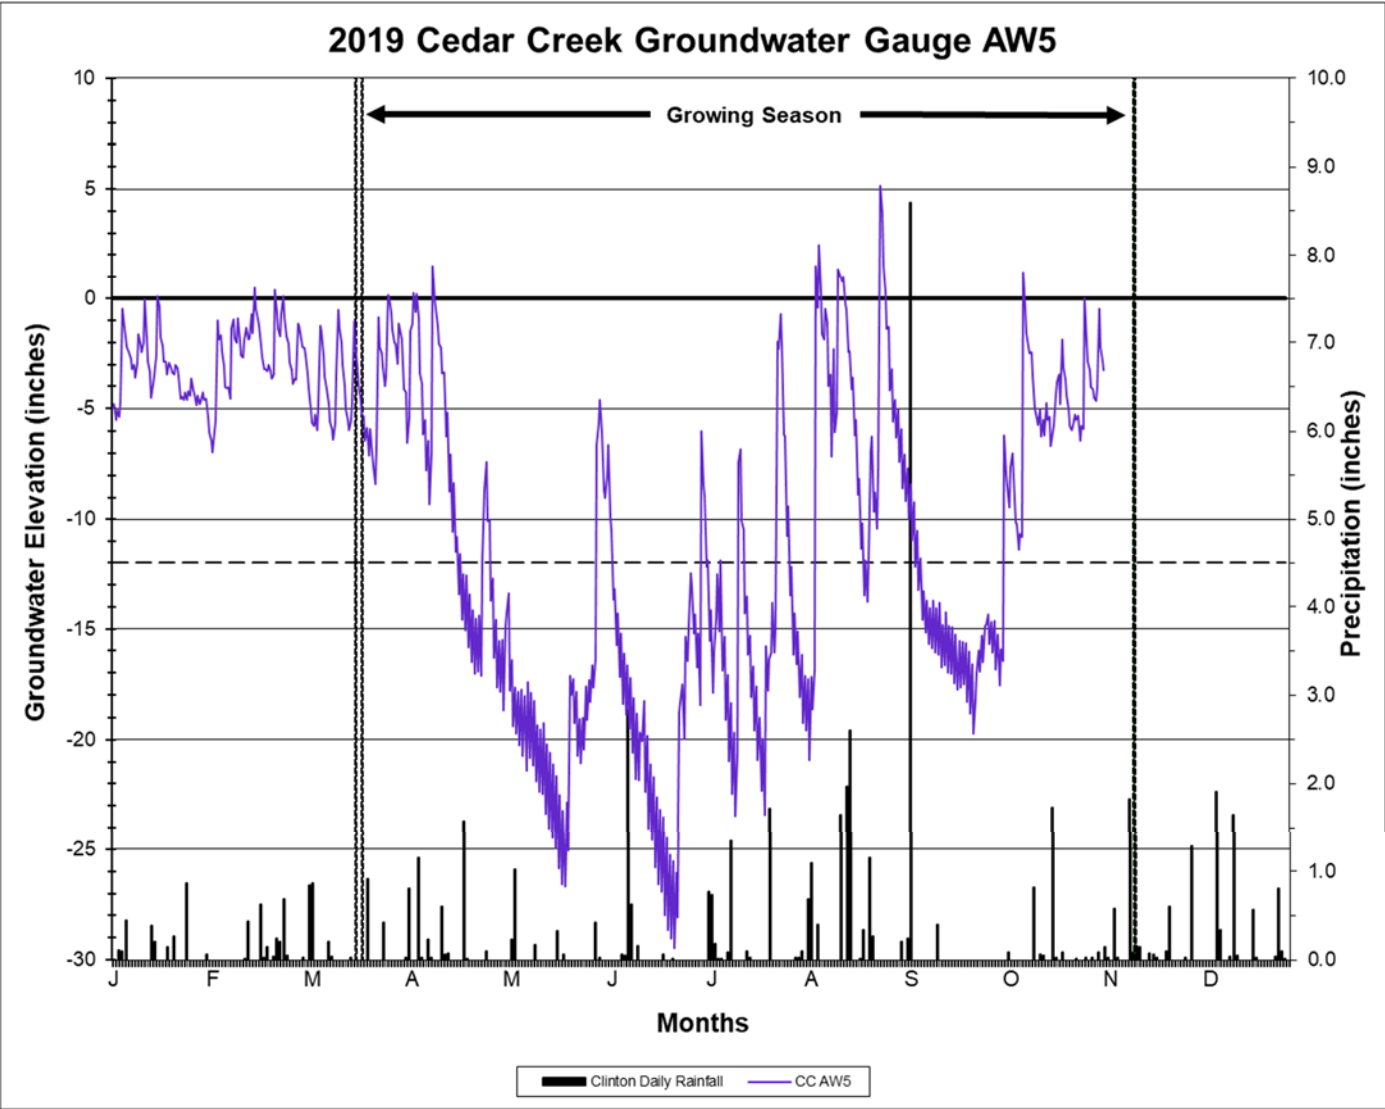
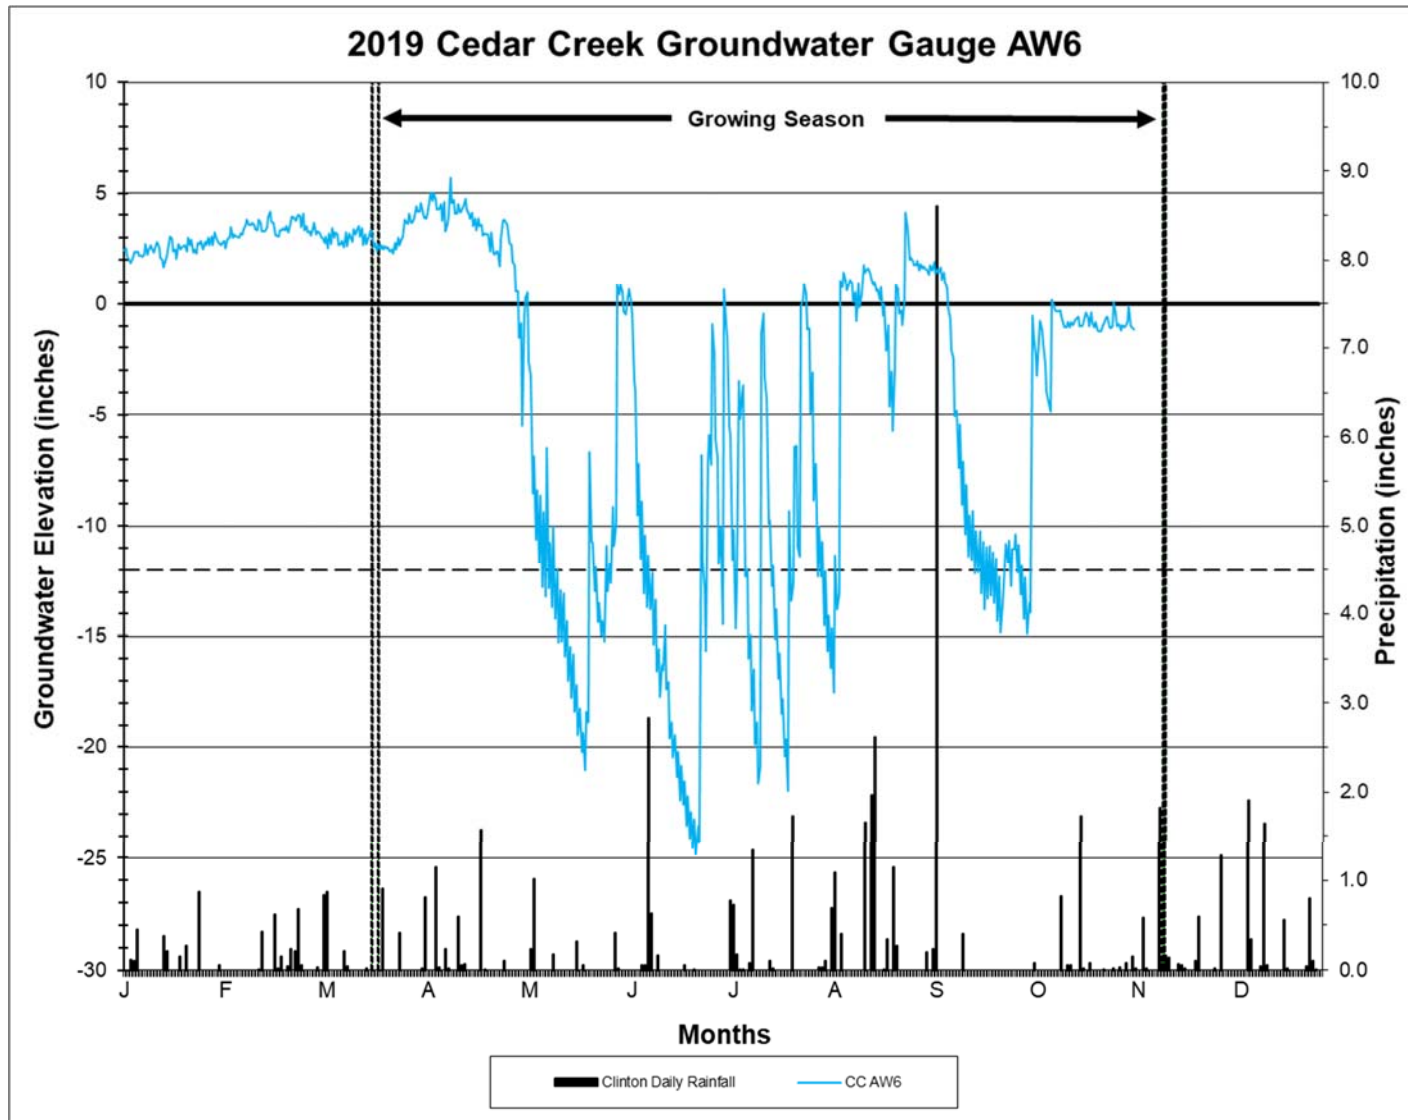
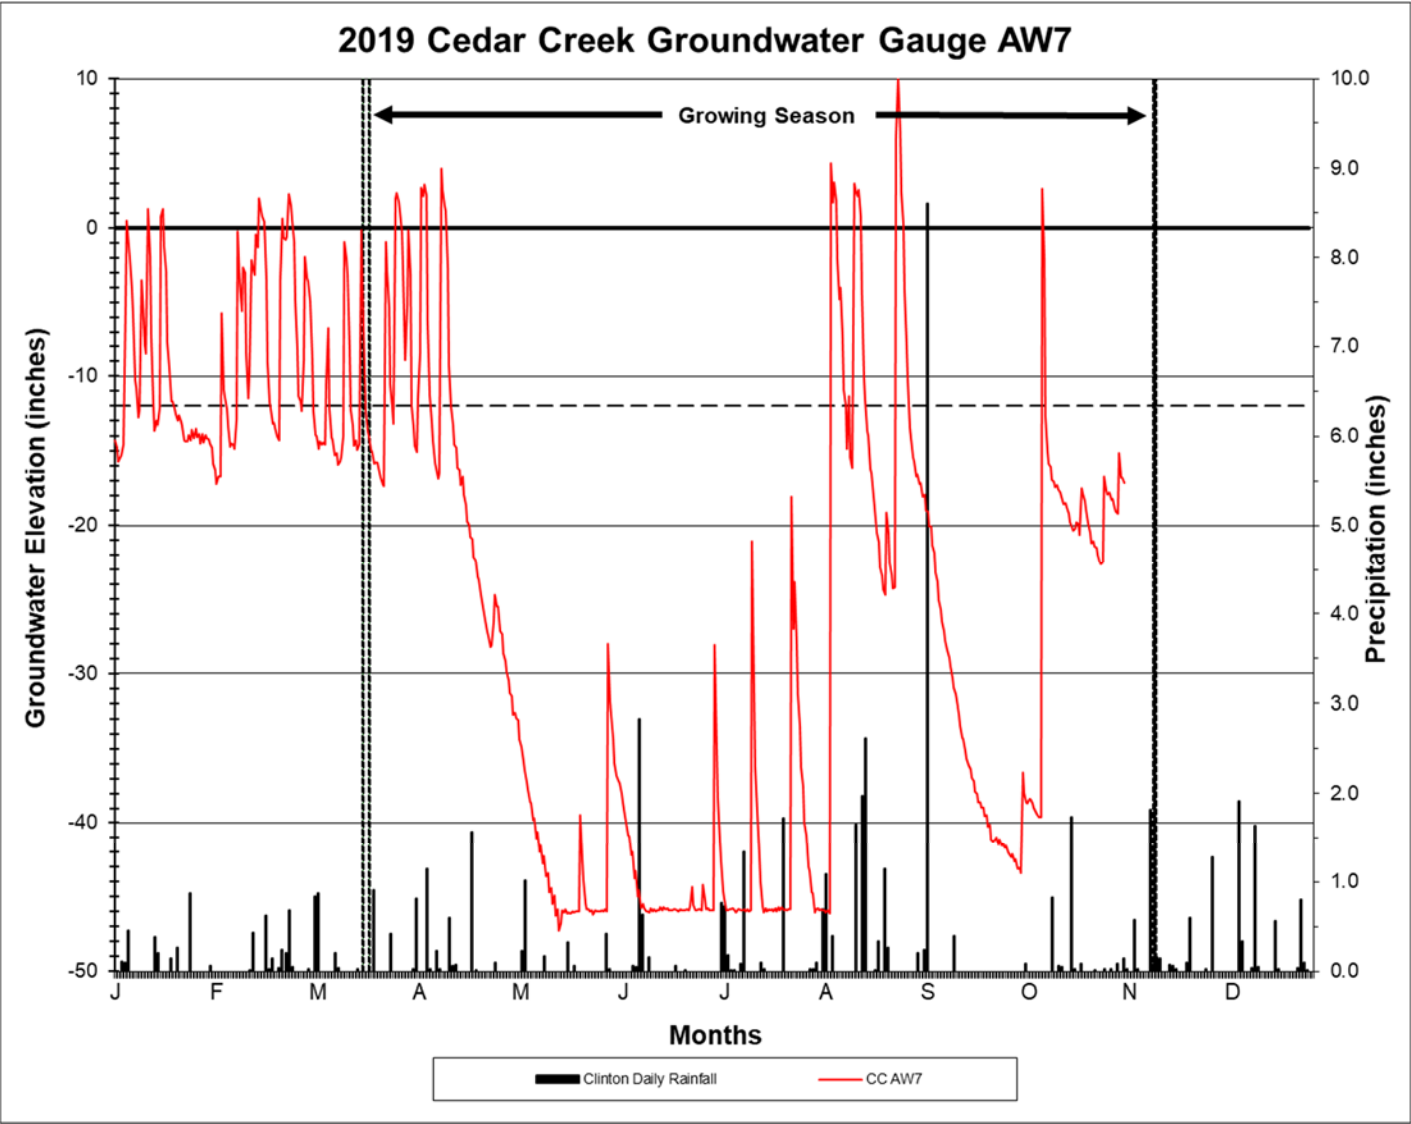
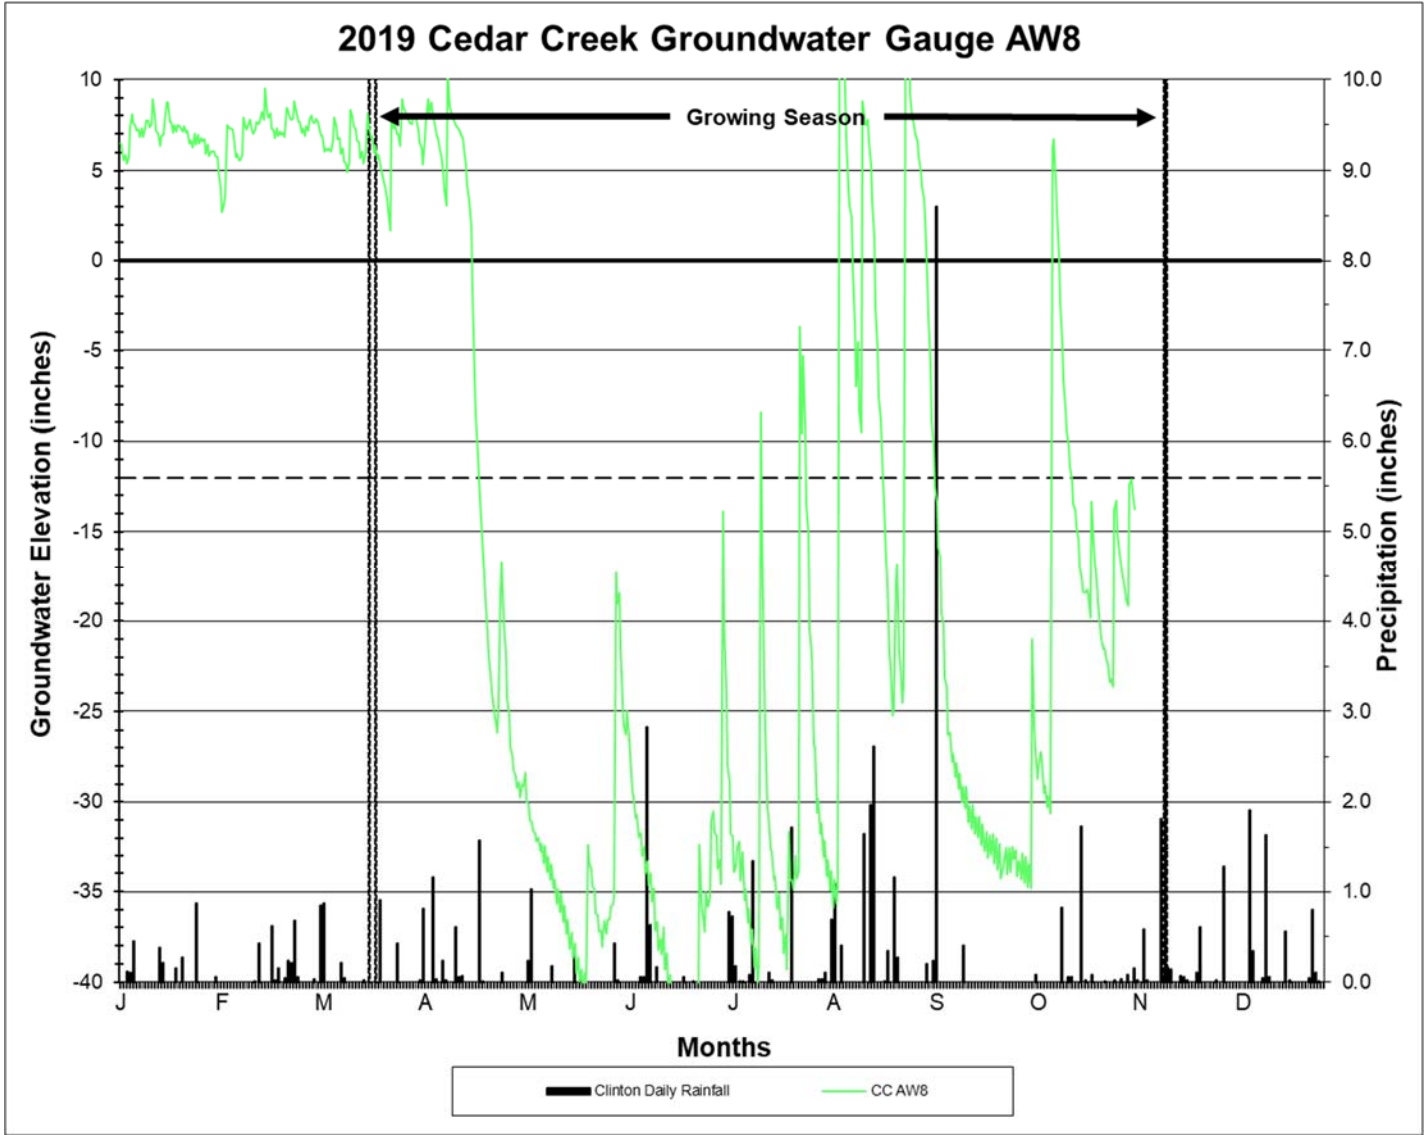
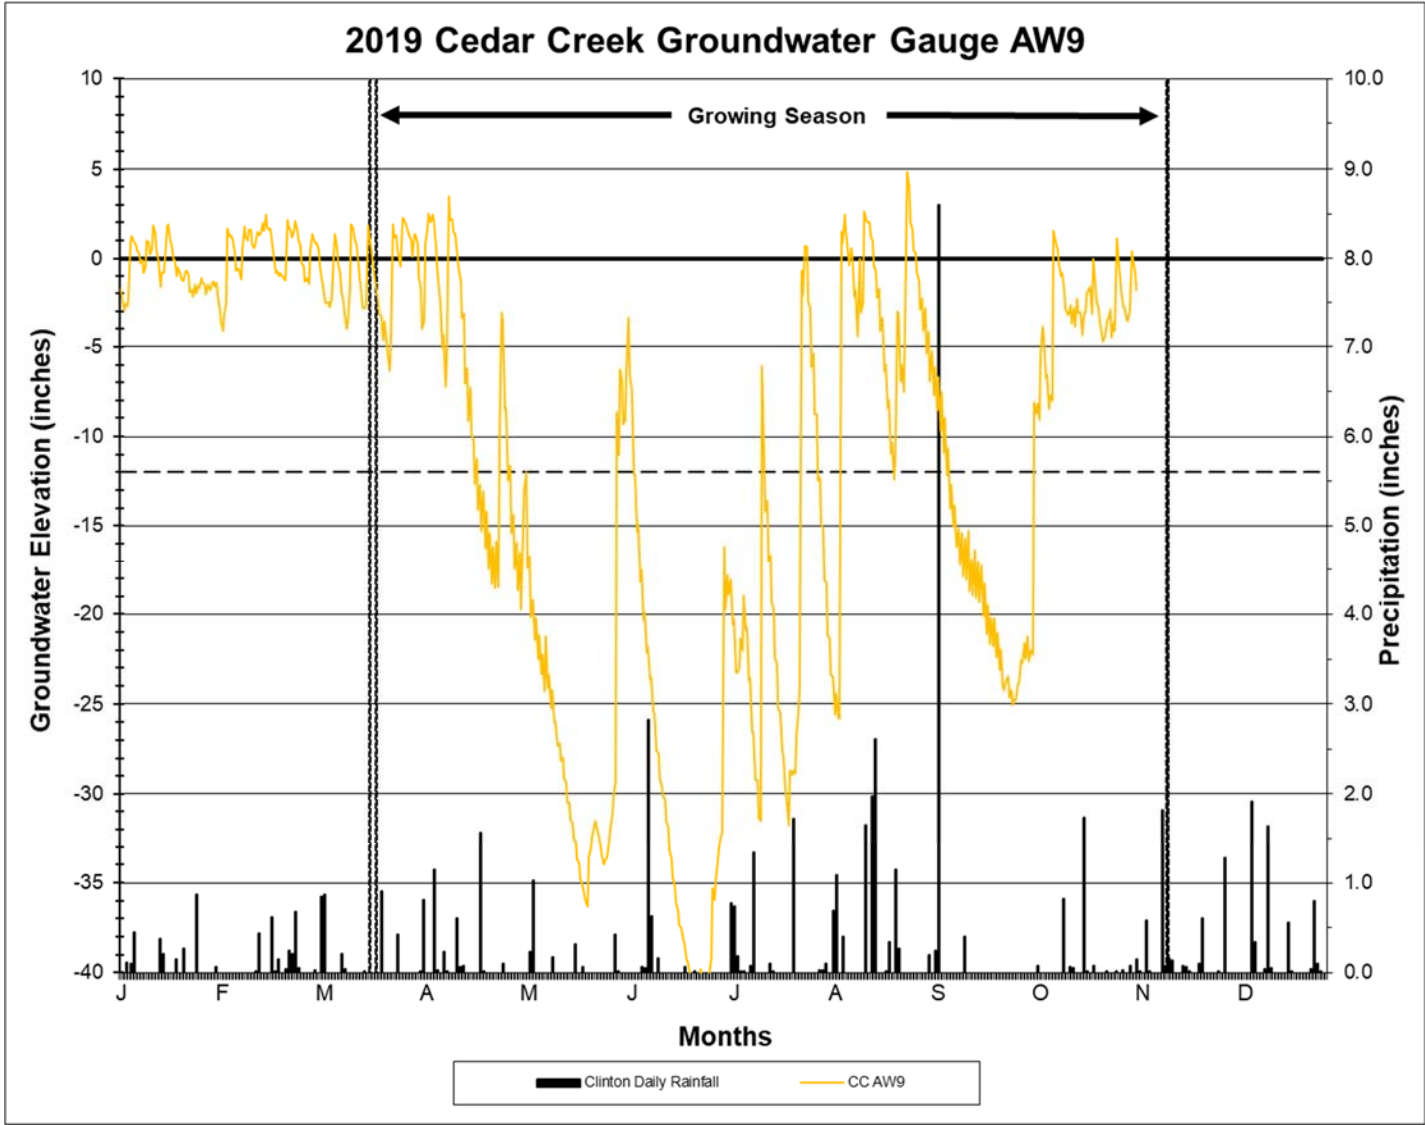
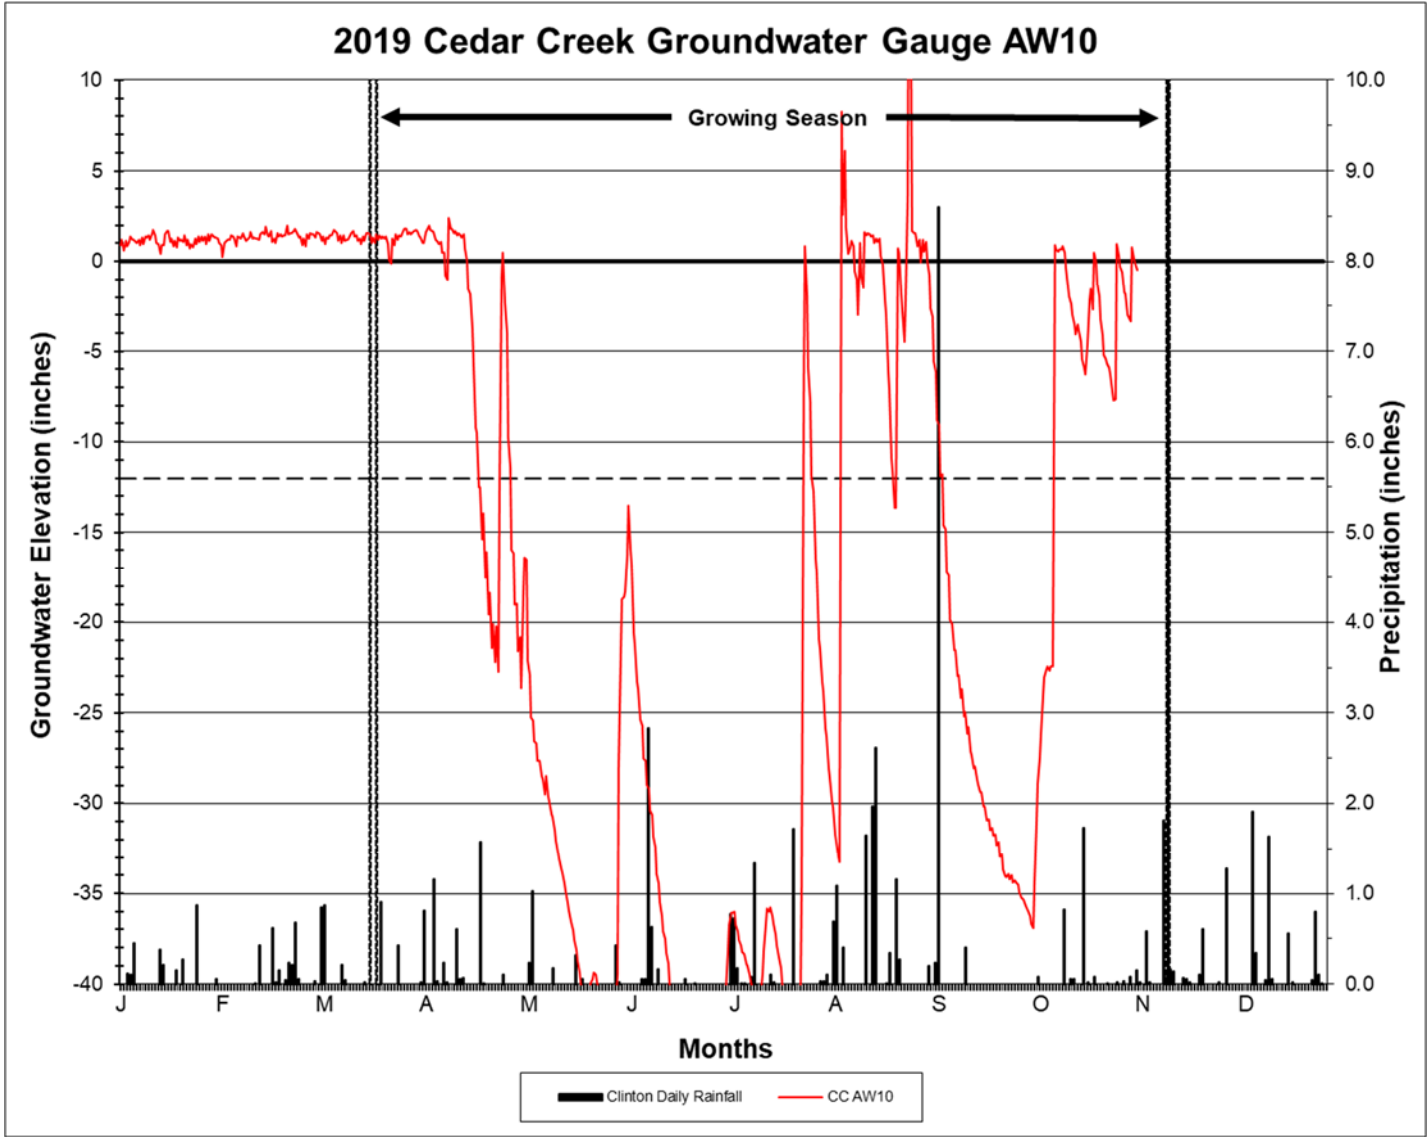
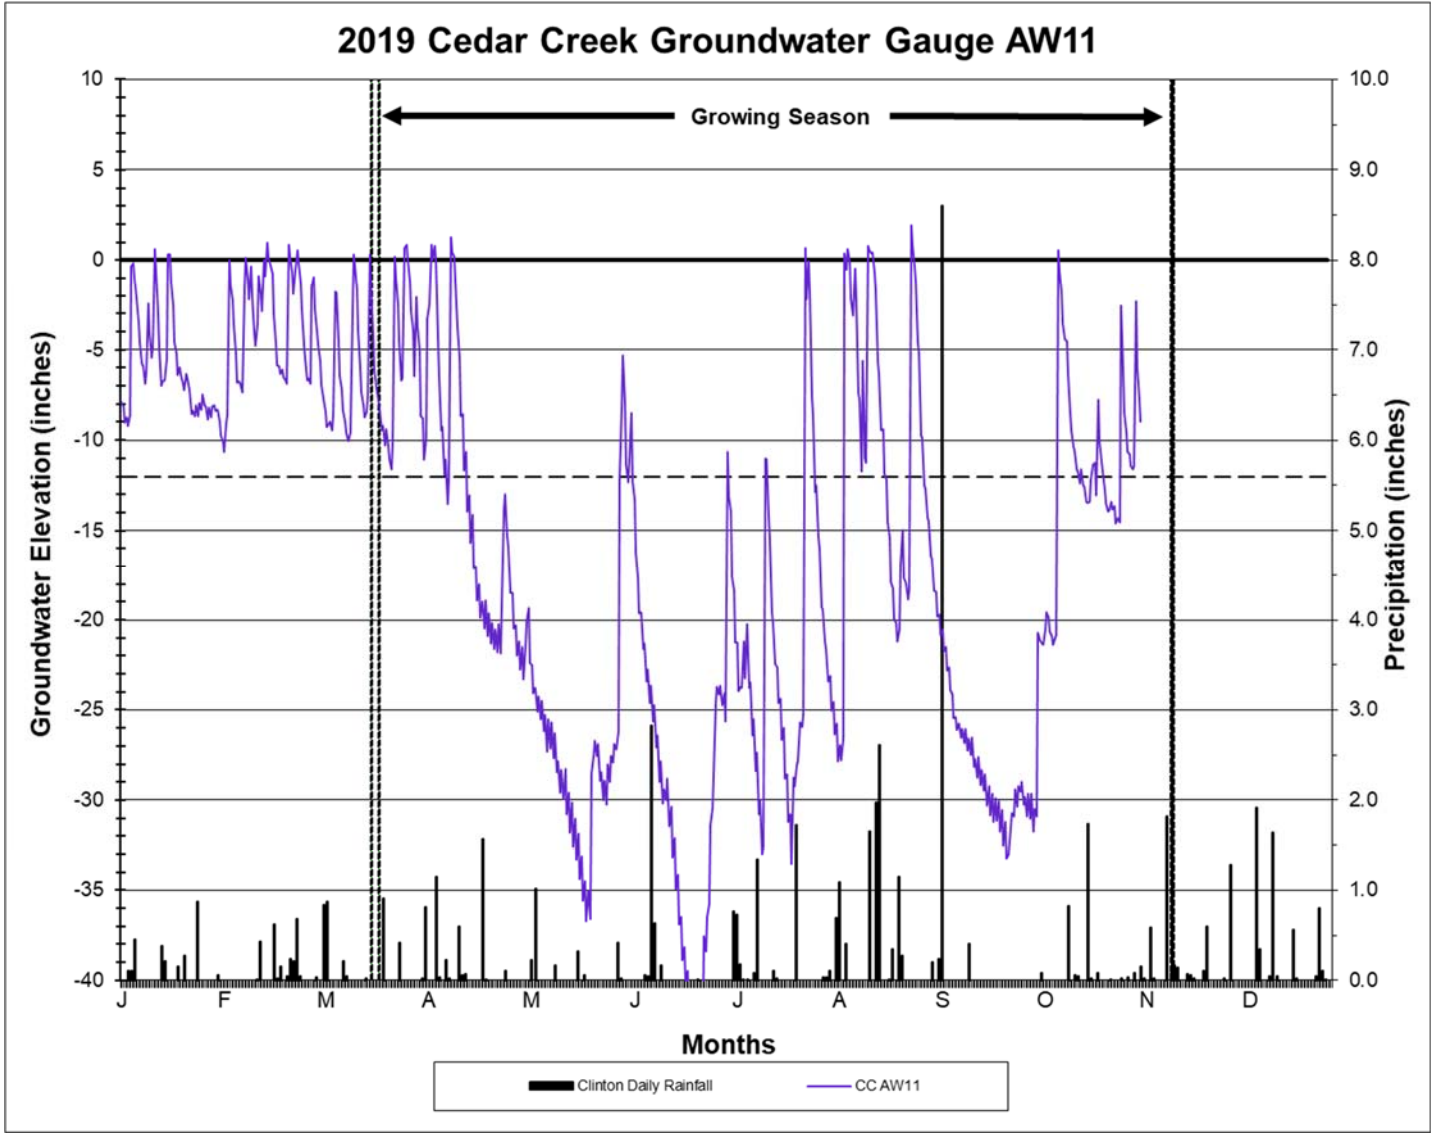
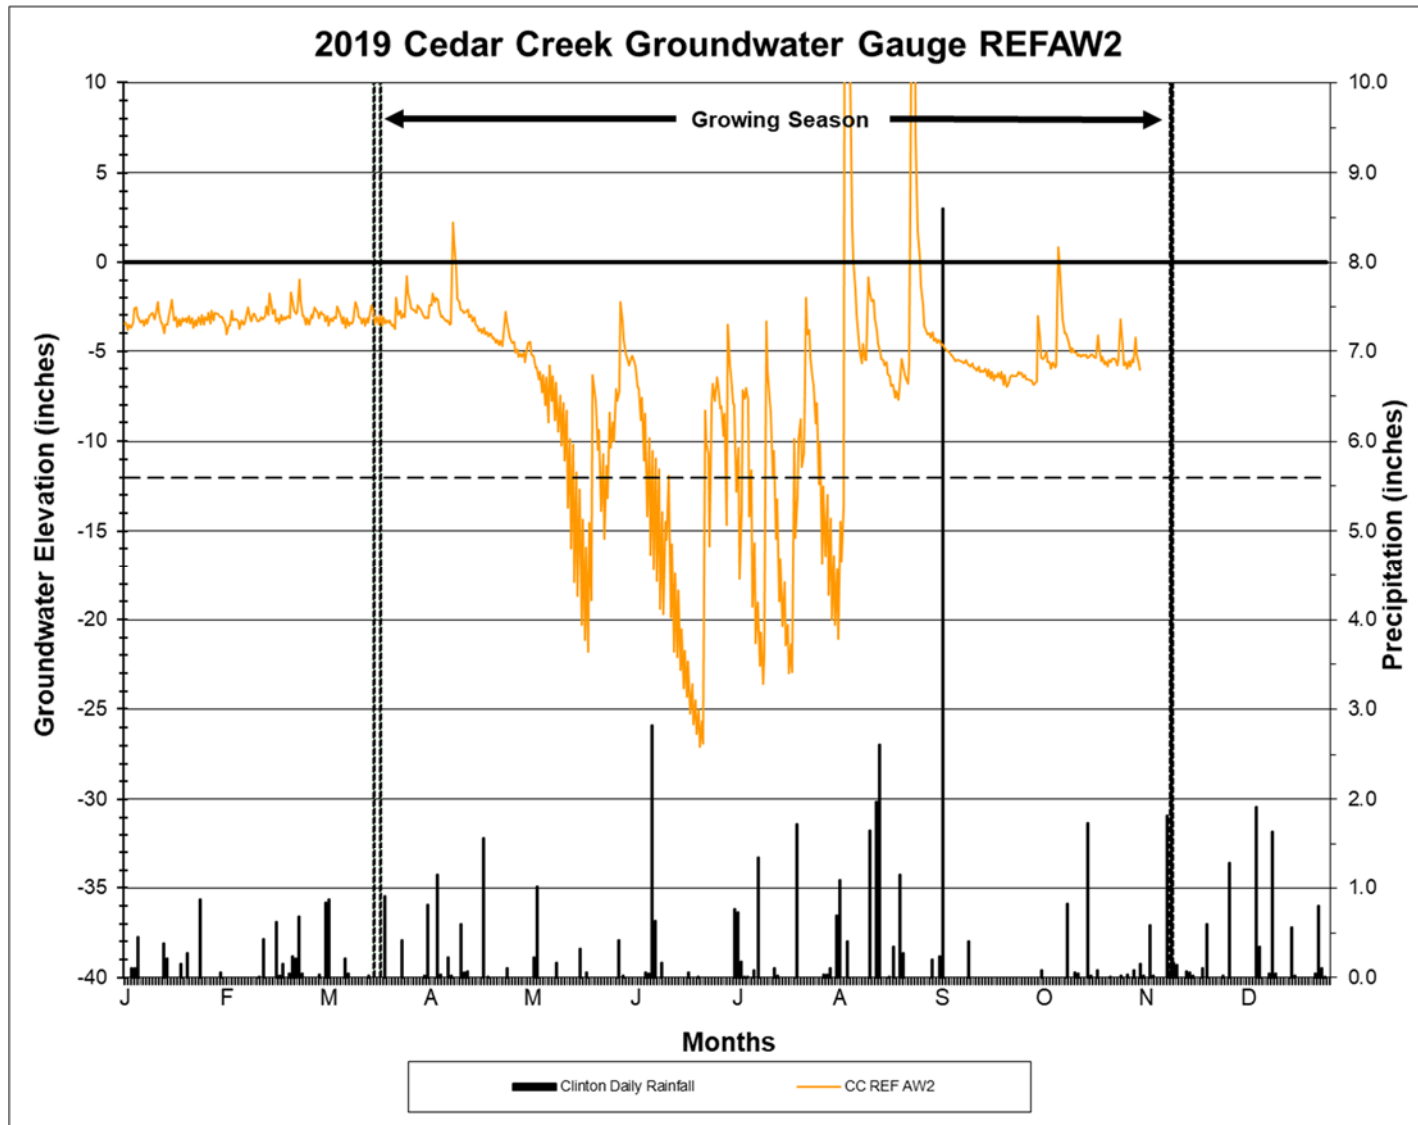
Figure 8. 2019 Cedar Creek Groundwater Monitoring Gauge Hydrographs

One wetland problem area was noted during the Year 5 monitoring period. The ditch between AW8 and AW7 was plugged in October 2018; however, AW7 did not meet success again in 2019. This is the fifth year in a row it did not meet success. If this well does not meet success in MY6, RES will perform a wetland delineation to remove the unsuccessful area from crediting.

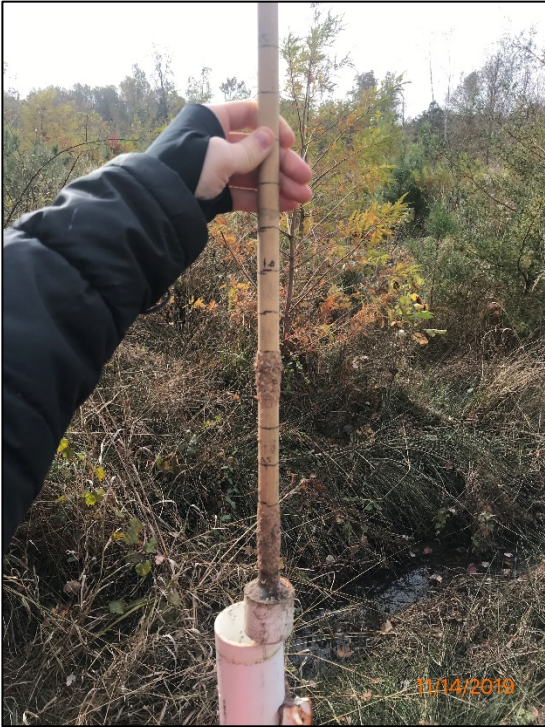
Crest Gauge 1 Reading 0.8 ft (09/06/2019)
