Chapel Creek Stream Restoration Project Orange County, North Carolina

EEP Project #77

MY-01 Monitoring Report - Final

Data Collected: September 2009

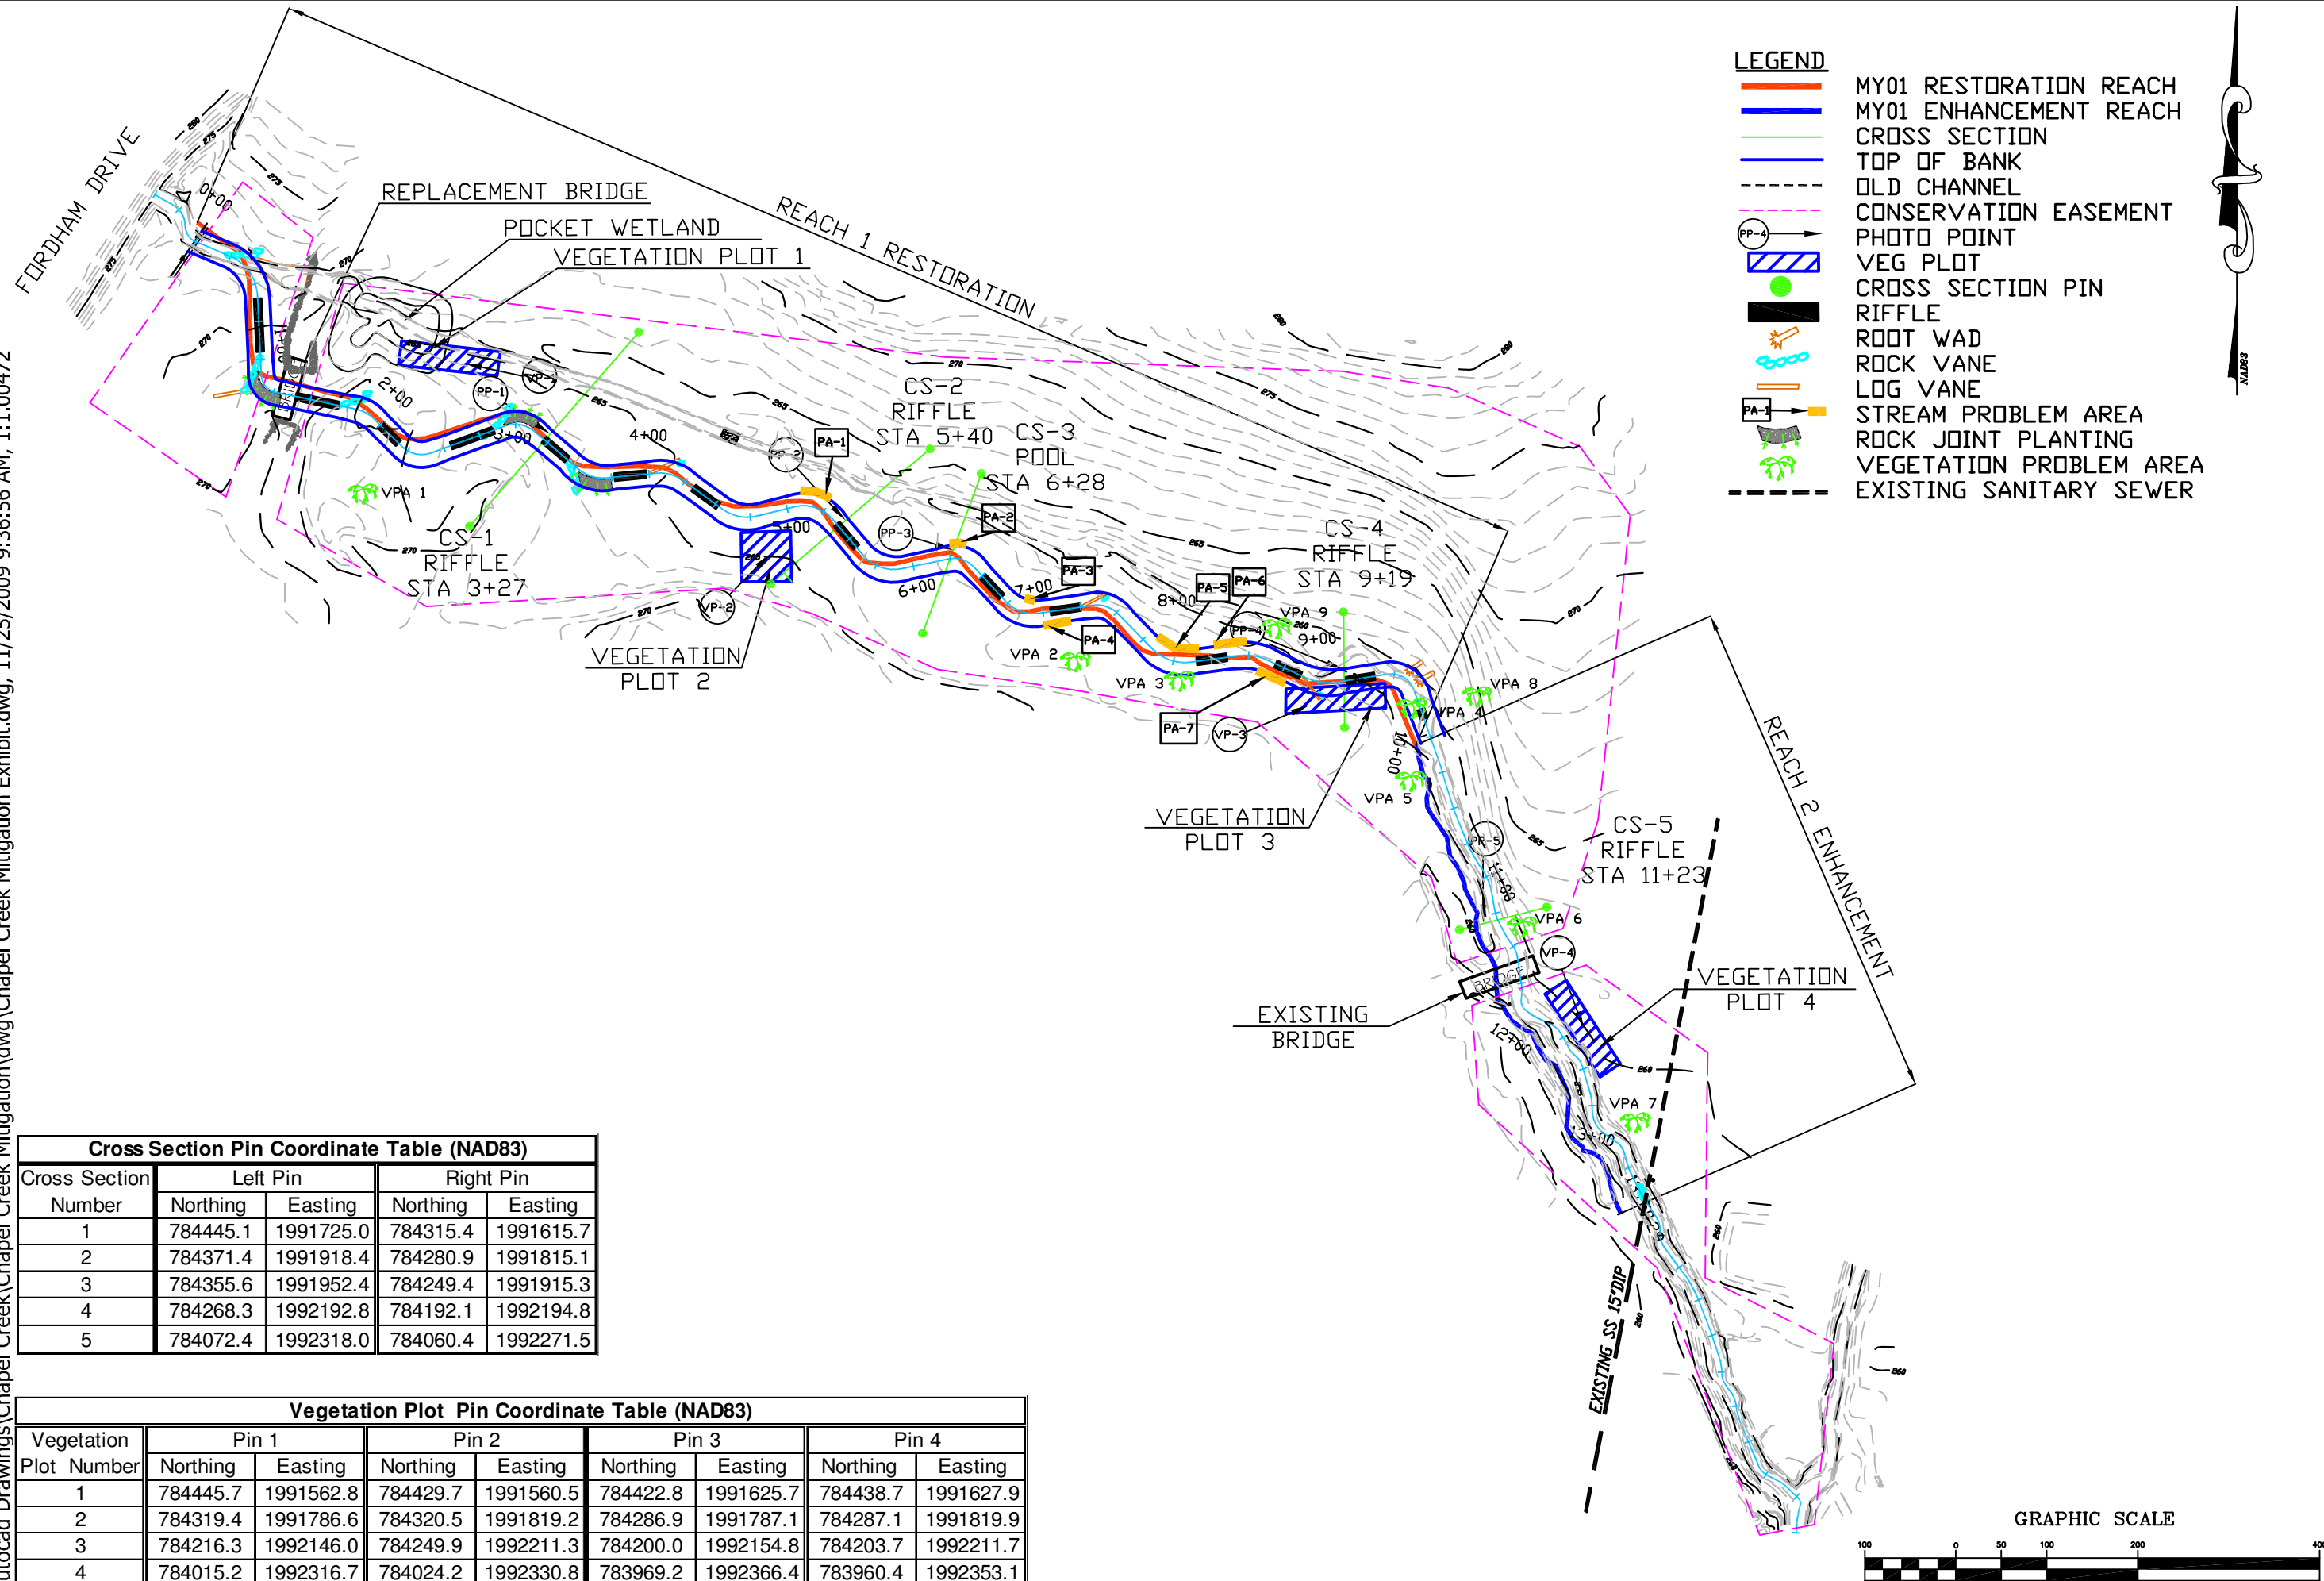
**CHAPEL CREEK CONSOLIDATED
 CURRENT CONDITIONS PLAN VIEW**

displacing native vegetation. Although these species have been given this rank, the functionality of the project is not expected to be impaired significantly. The vegetation problem areas consist of invasive exotic species present within the conservation easement. See Table - for vegetation problem area descriptions and figure – for their locations. See section - of Appendix - for representative photos of the vegetation problem areas observed within the conservation easement of Chapel Creek.
