**Chapel Creek Stream Restoration Project
Orange County, North Carolina
EEP Project #77**

MY-02 Monitoring Report - Final

Data Collected: October 6, 2010

**Ward Consulting Engineers, P.C.
Firm License Number C-2619
Project Manager: Becky Ward, P.E.
8368 Six Forks Road, Suite 104
Raleigh, NC 27615-5083
Ph: 919-870-0526
Fax: 919-870-5359**

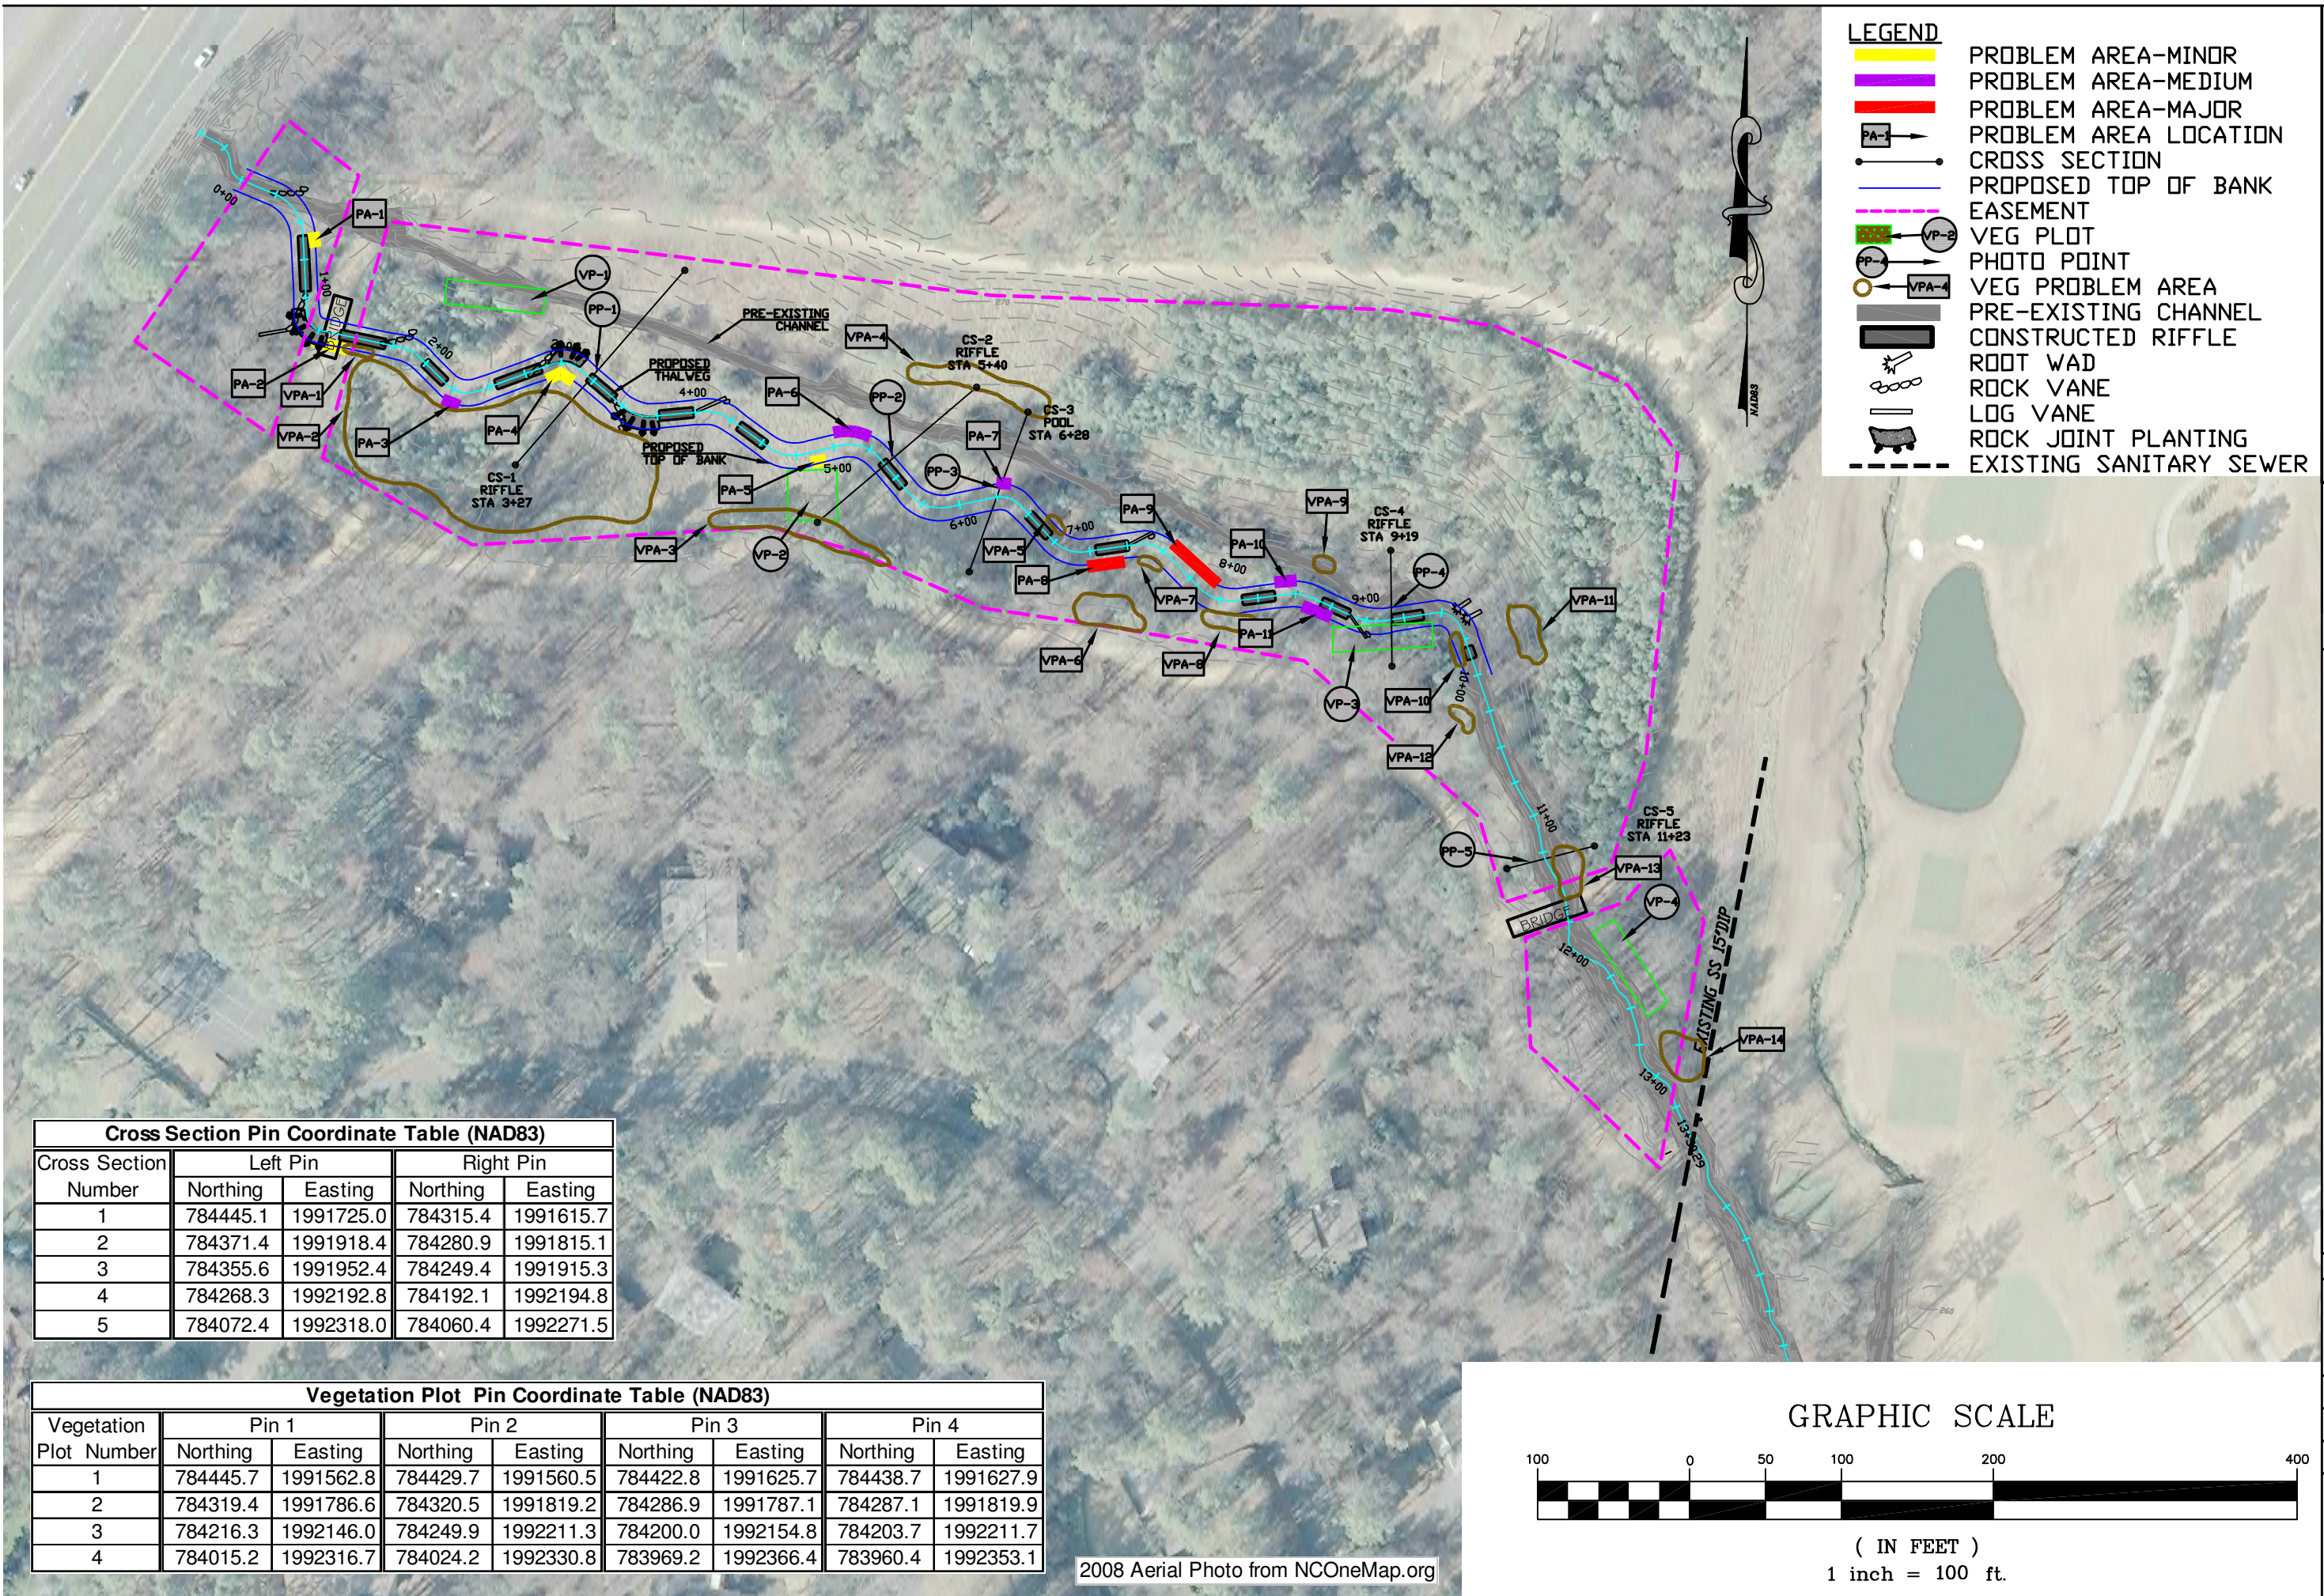
FIGURE 2

There are not any significant changes in the stream pattern, profile or dimension between MY-01 and the present monitoring year MY-02. One pool at station 6+75 in enlarging and should be watched for continued erosion trends next year. Overall, 100% of riffles and pools are stable and functioning as designed. The riffle pebble counts exhibit some fining in several of the cross sections primarily due to vegetation present in the bottom of the channel that has trapped these

finer sediments throughout the reach. Vegetation is present in the channel bottom due to the reduction of water in the channel from the dry weather, creating minor deposition in about 11% of the overall reach length. This minor deposition should be watched for impacts in riffle function and stream centering issues. A few constructed riffles along the reach are exhibiting minor centering issues. The stream cross sections compare well with the previous monitoring years and are maintaining their cross sectional areas with the exception of Cross Section 2. Cross Section 2 is not exhibiting any signs of destabilization however the area shows a 23% increase from the data collected last year. The section will be watched during the upcoming monitoring year. Several bank erosion areas, approximately 9% of the overall reach length, exist primarily on the outside stream bends, noted on Figure 2: Current Conditions Plan View. These outside bends lack vegetation and are therefore susceptible to continued erosion. The engineered structures are all stable and functioning as designed and showed no signs of piping or integrity issues.

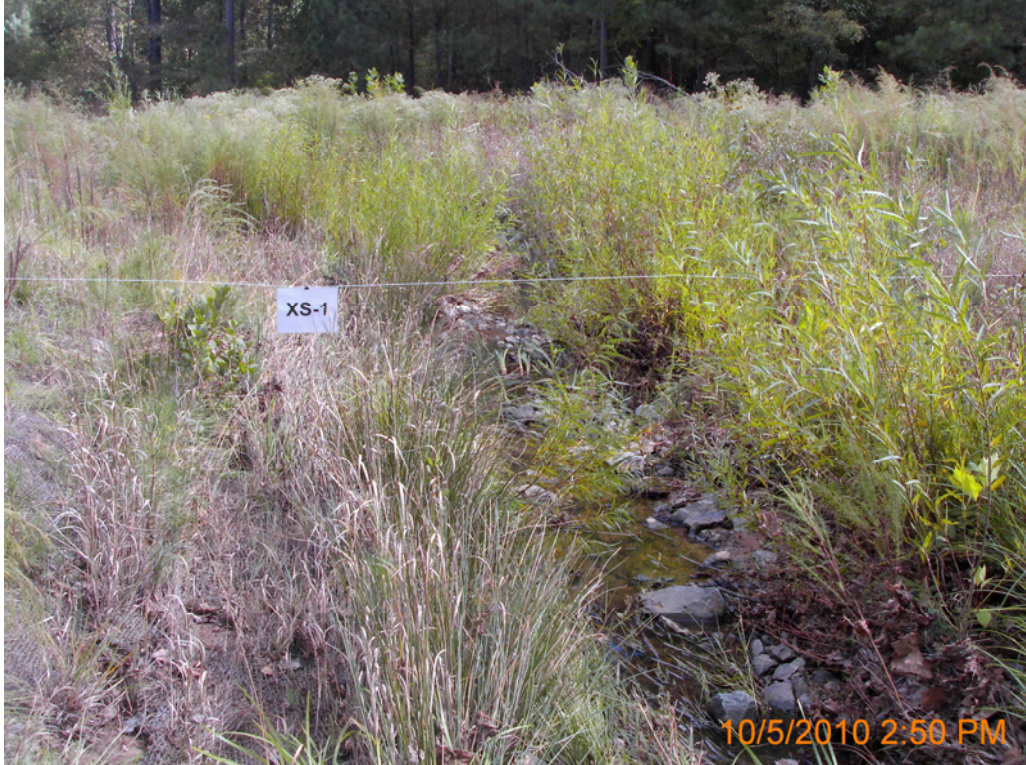
Photo 1. Looking downstream at XS-1

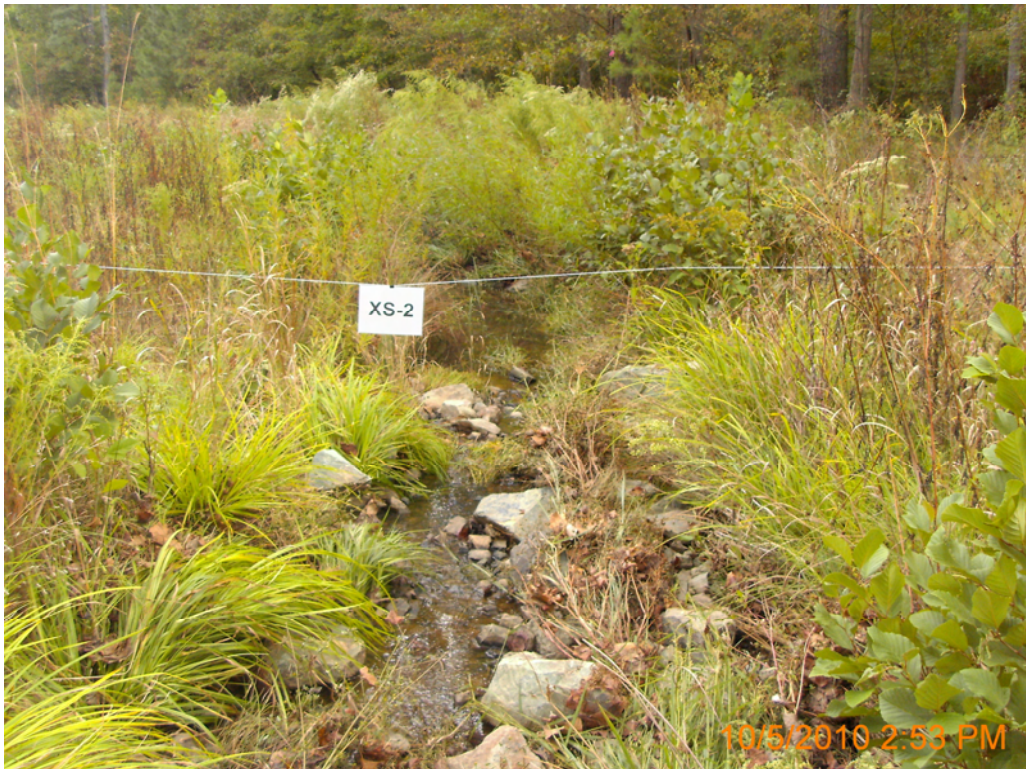
Photo 2. Looking downstream at XS-2

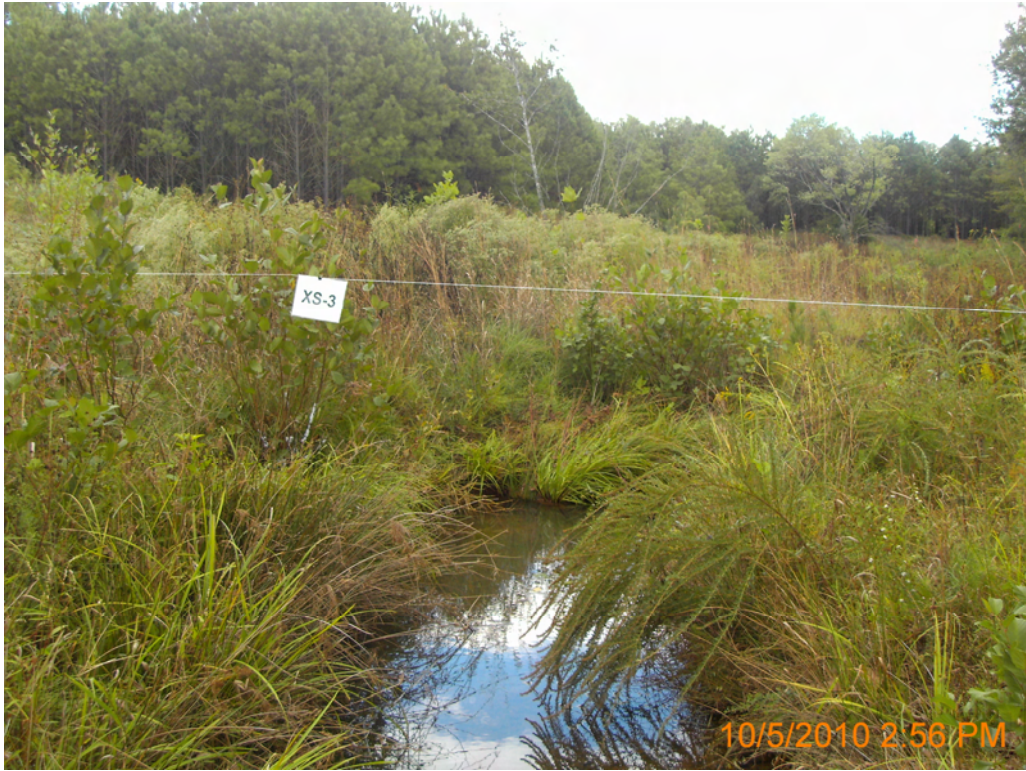
Photo 3. Looking downstream at XS-3

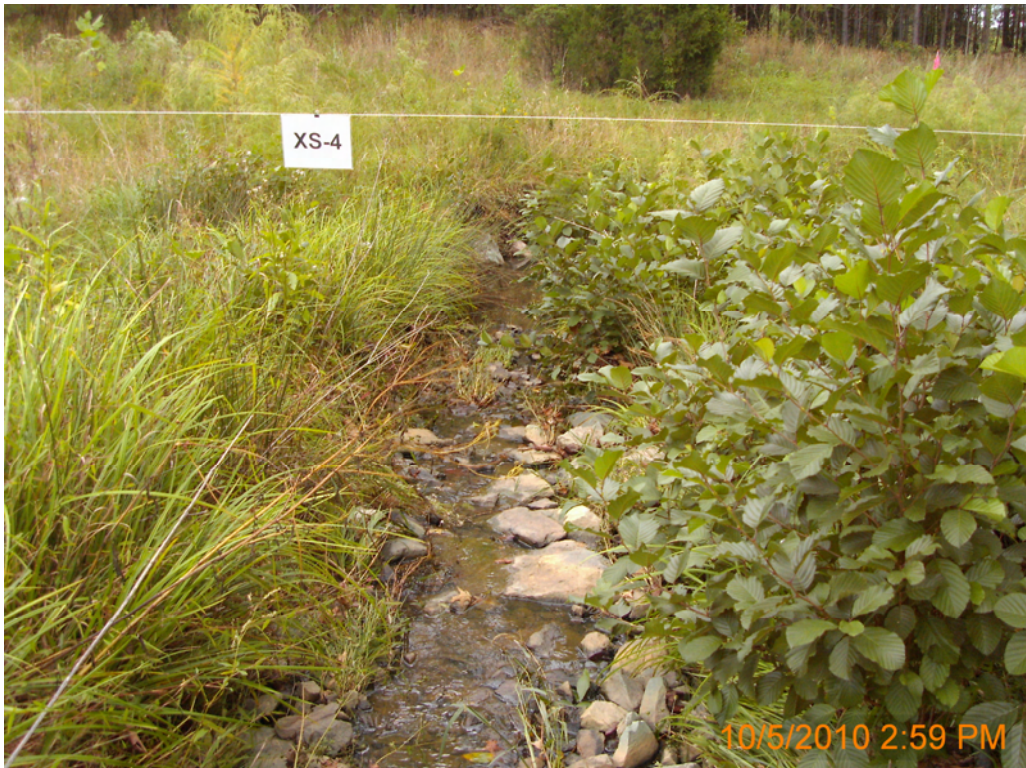
Photo 4. Looking downstream at XS-4

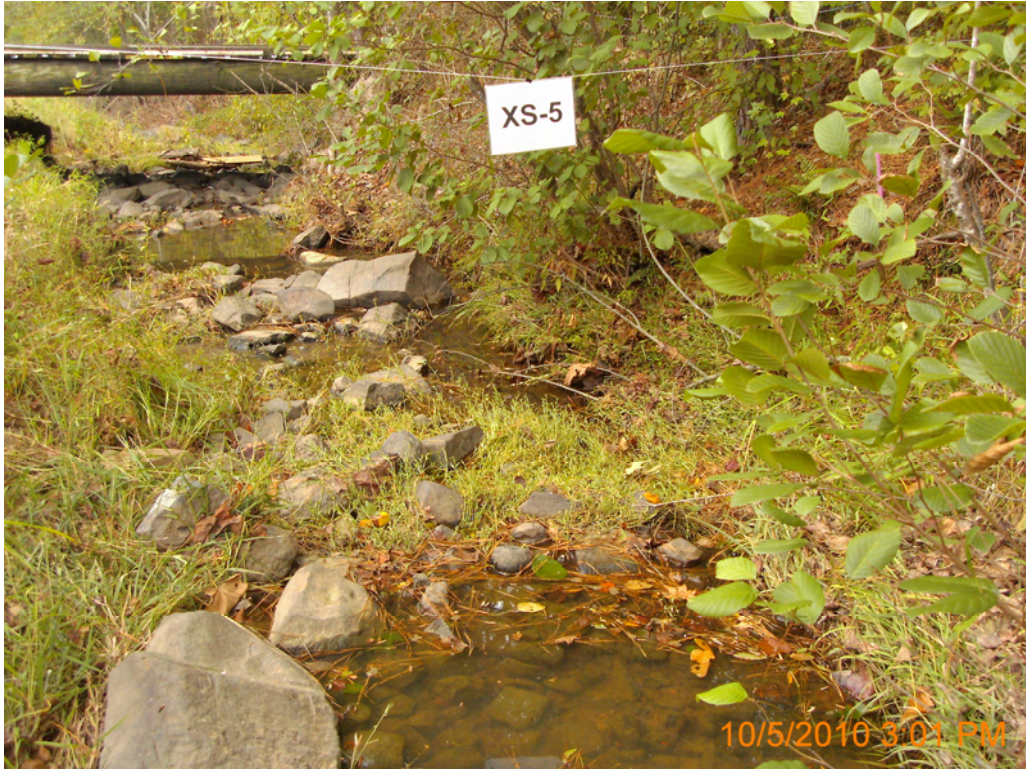
Photo 5. Looking downstream at XS-5

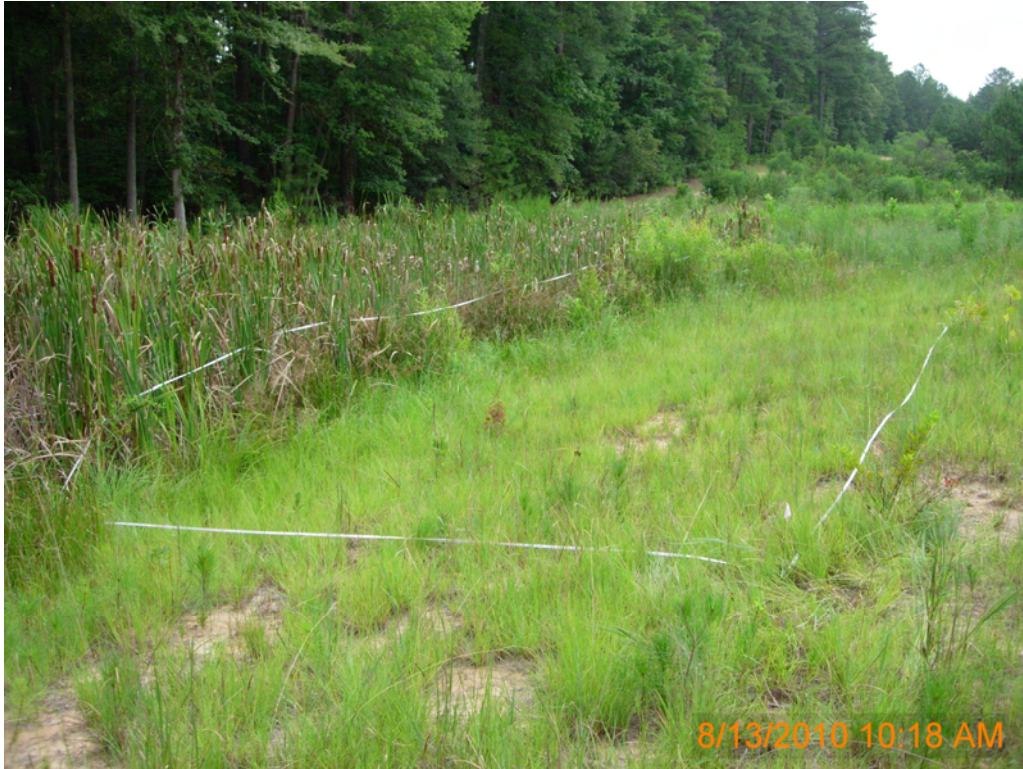
Photo 6. Vegetation Plot 1

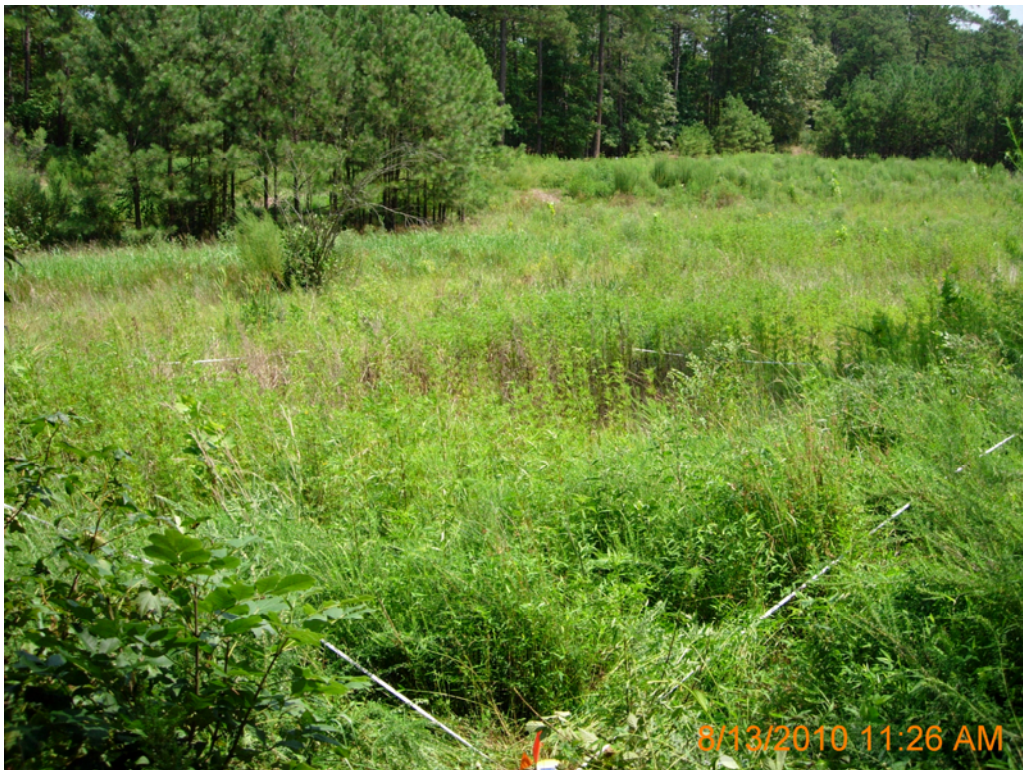
Photo 7. Vegetation Plot 2

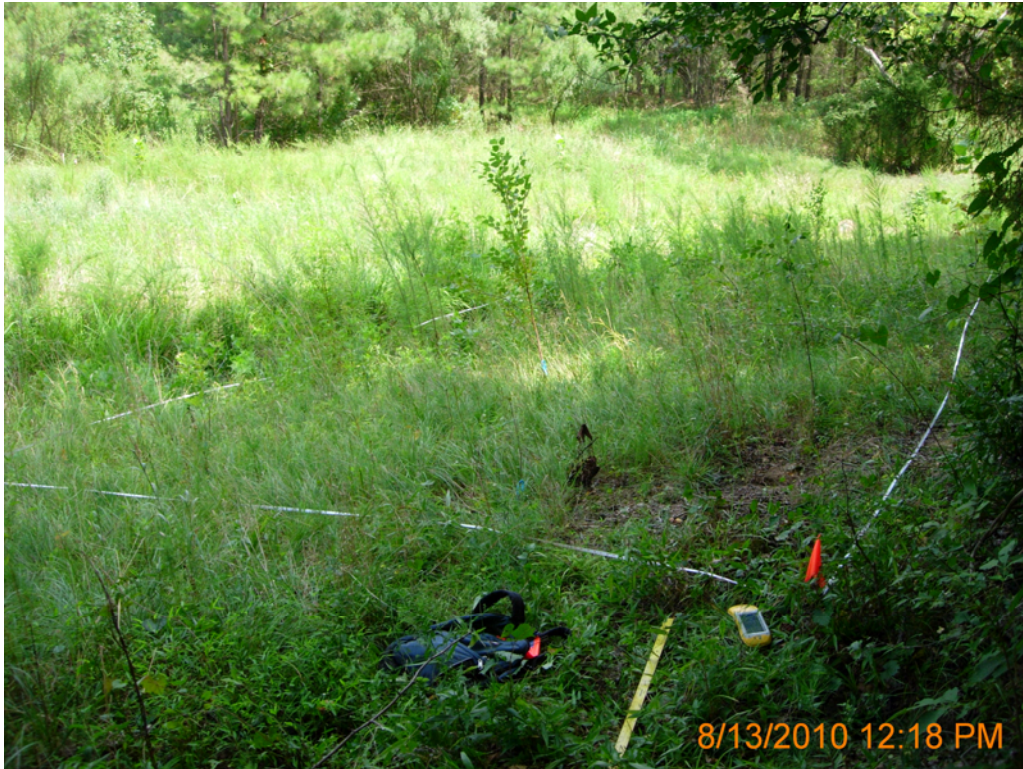
Photo 8. Vegetation Plot 3

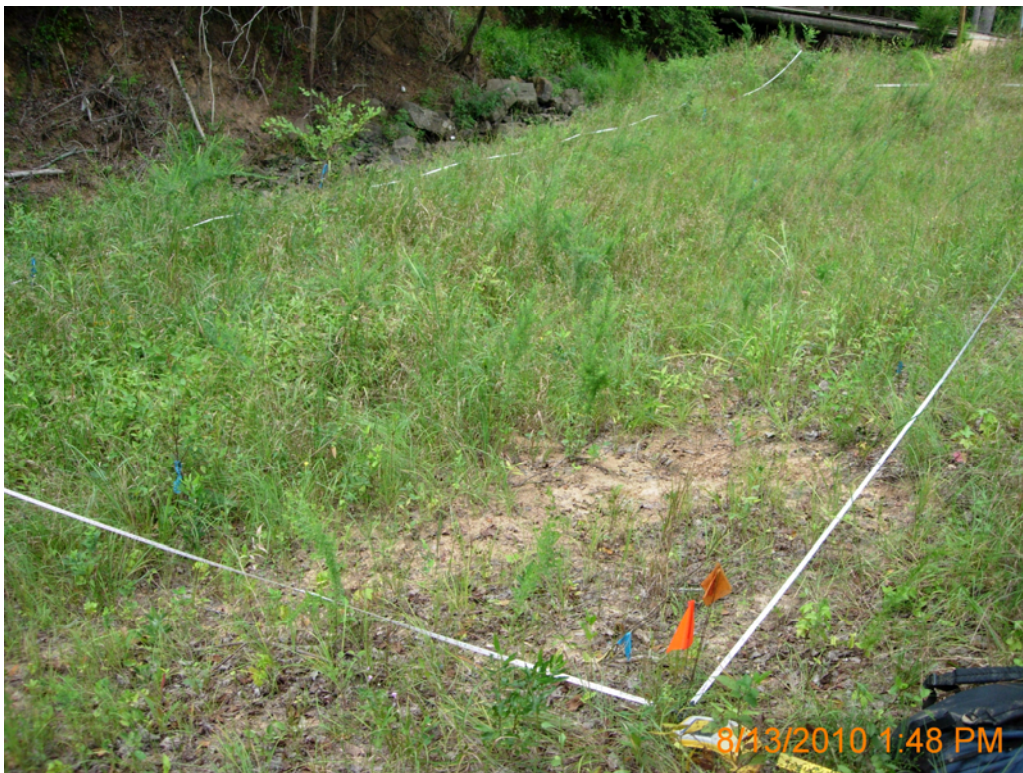
Photo 9. Vegetation Plot 4

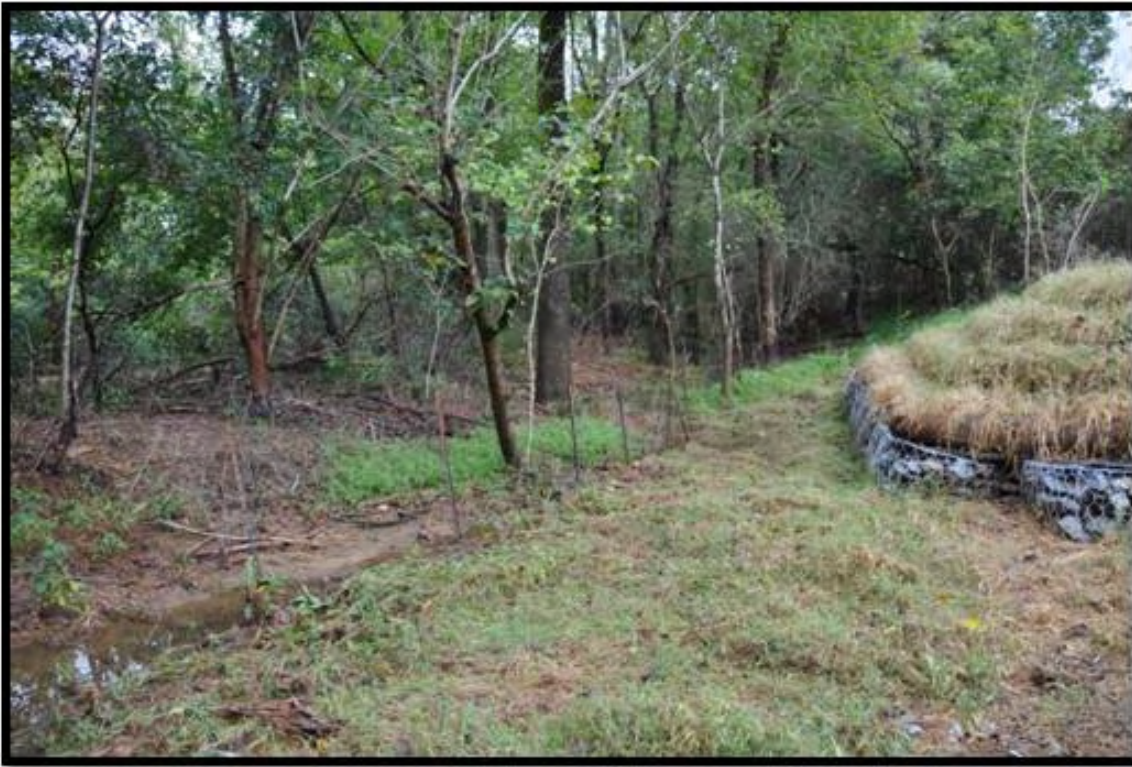
Morgan Creek berm openings 30 September, 2010. Arrow shows creek at ca. 6 feet. The maximum creek level (at ca. 7.8 feet) did not cause flow through the berm openings.
