FINAL
ANNUAL MONITORING REPORT
YEAR 4 (2012)
CHAPEL CREEK STREAM RESTORTION SITE
ORANGE COUNTY, NORTH CAROLINA
(EEP Project No. 77, Contract No. 004806)
Construction Completed July 2008

Prepared by:
Axiom Environmental, Inc.
218 Snow Avenue
Raleigh, North Carolina 27603

January 2013

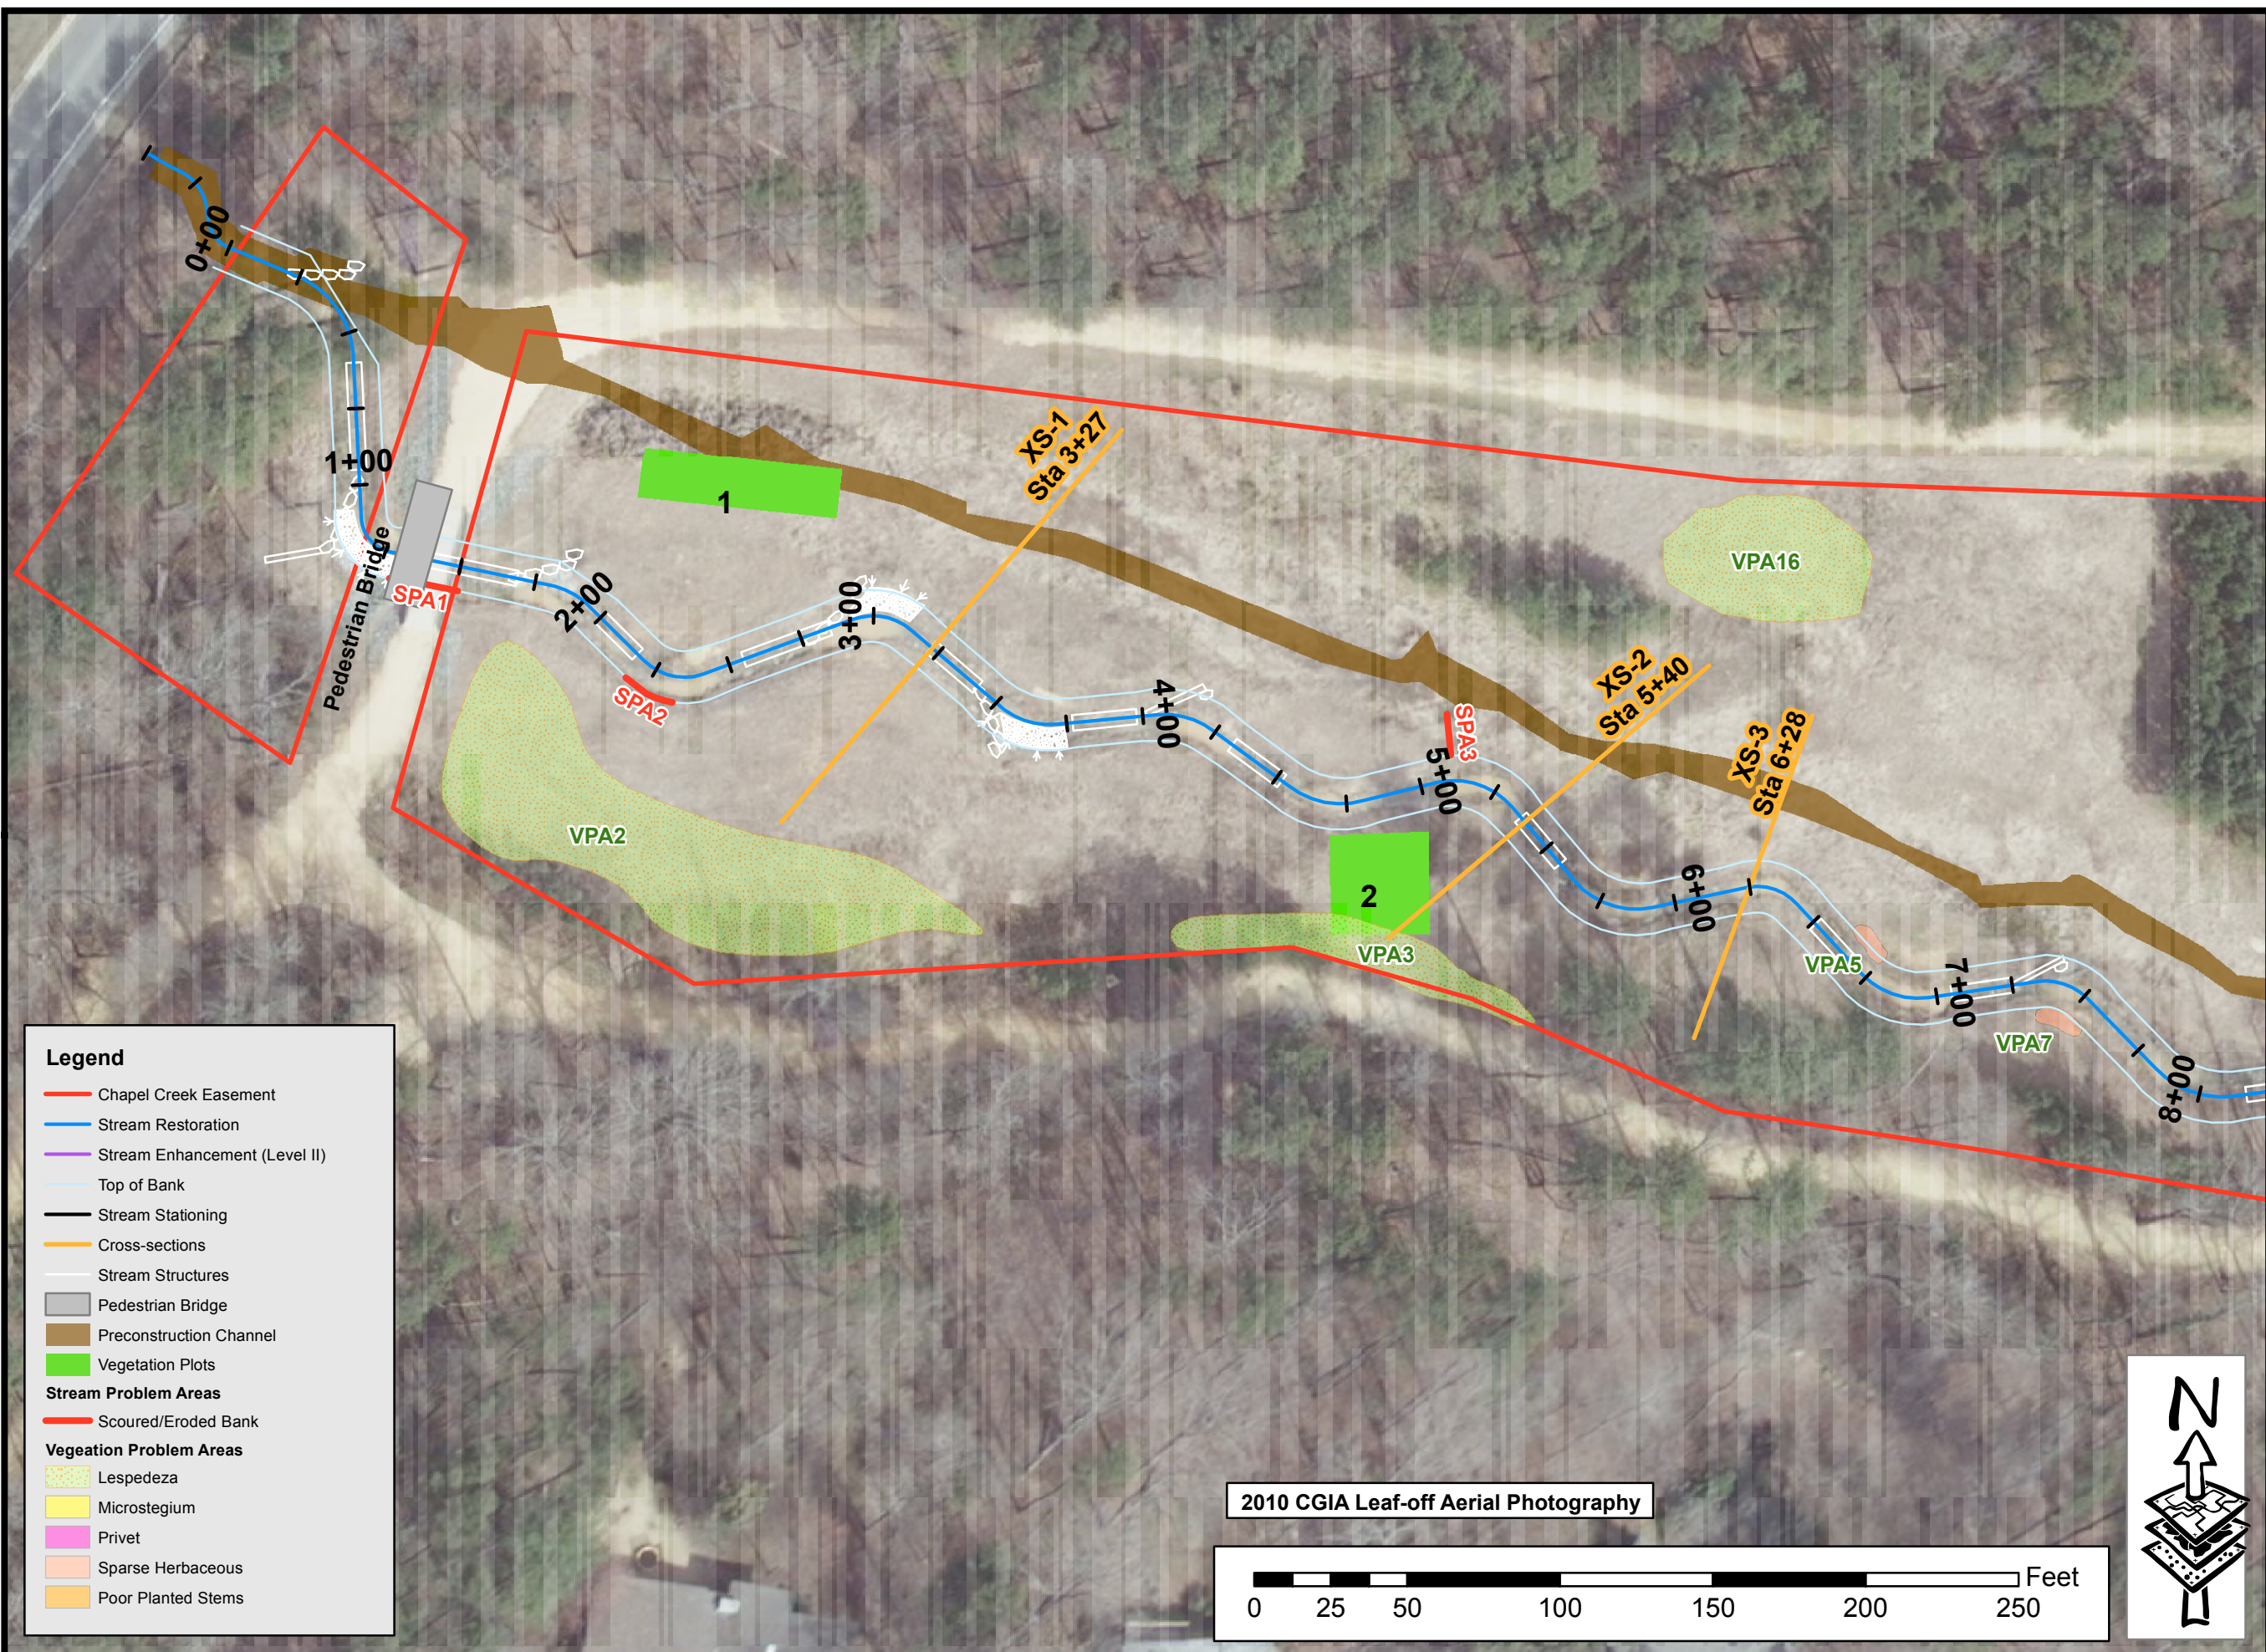
2A

Map Label*	Notes
VPA2	Lespedeza, planted trees and natural recruits are present
VPA3	Lespedeza, planted trees and natural recruits are present
VPA5	Sparse herbaceous
VPA7	Sparse herbaceous with numerous pine trees
VPA 9	Lespedeza
VPA10	Microstegium established where bench was excavated
VPA 11	Poor planted stems with some natural recruits of sweetgum and sycamore
VPA 12	A few privet present
VPA 14	Some lespedeza, mostly pine trees with elms and river birch
VPA 15	Chinese privet with scattered lespedeza, numerous river birch and iron wood present in this area
VPA 16	Lespedeza

Map Label*	Station	Notes
SPA1	1+40	Erosion and sedimentation under pedestrian bridge
SPA2	2:25	Minor erosion and undercut bank on right bank; vegetation is establishing
SPA3	5+10	Minor erosion on outer/right bank; vegetation is establishing

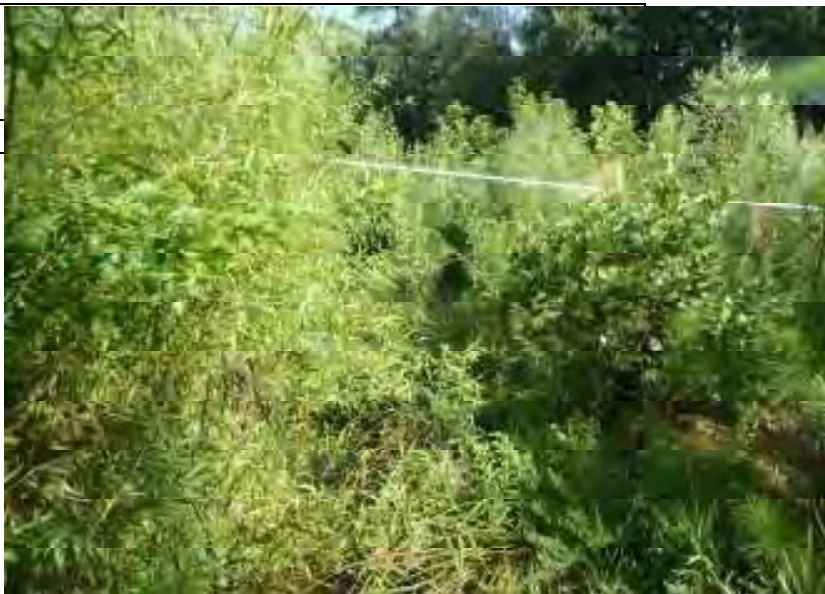
Photo of XS-1, looking in the downstream direction

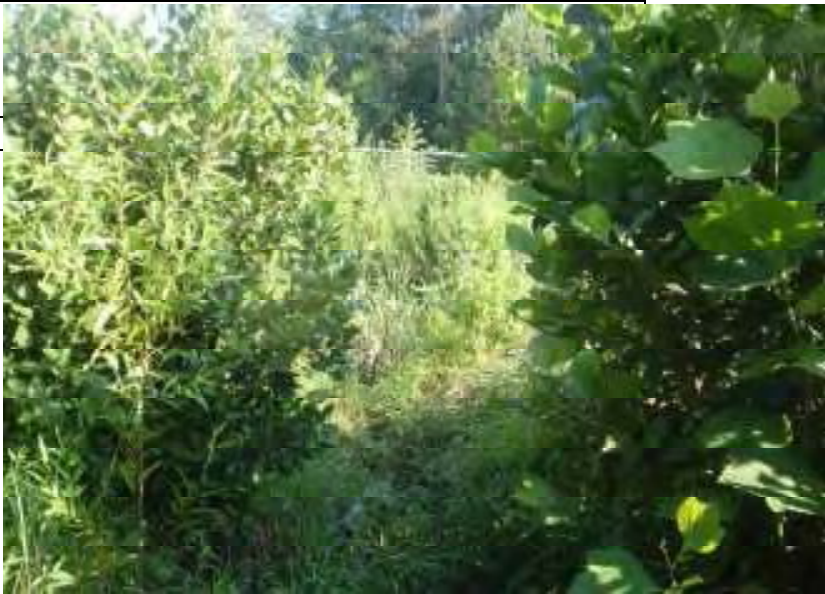
Photo of XS-2, looking in the downstream direction

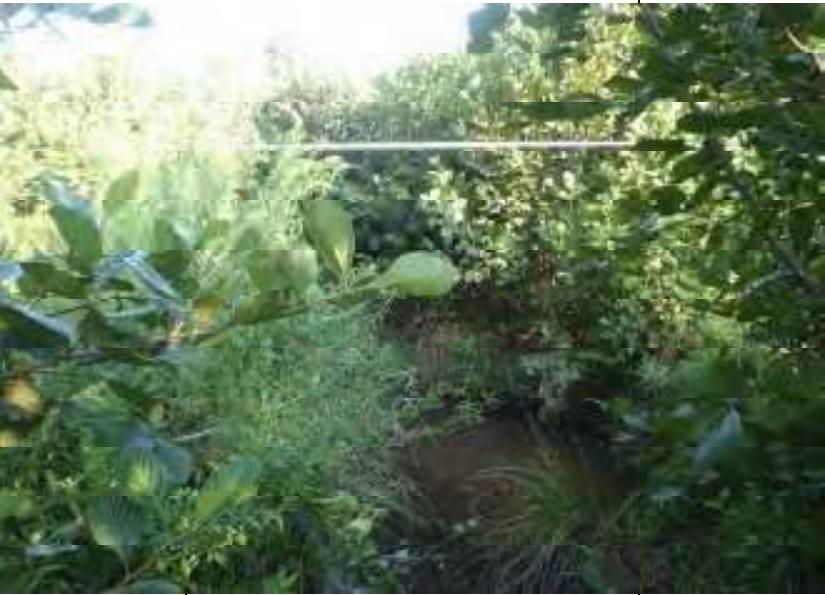
Photo of XS-3 looking in the downstream direction

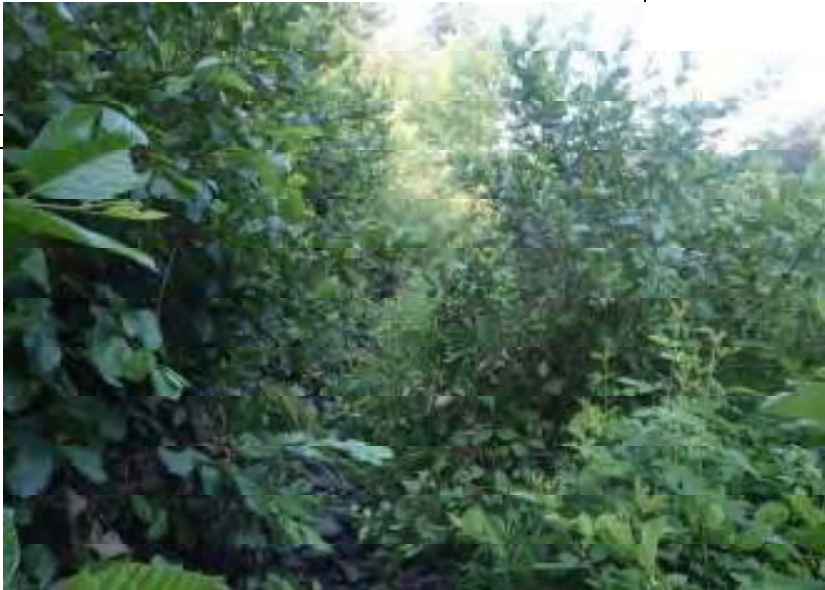
Photo of XS-4, looking in the downstream direction

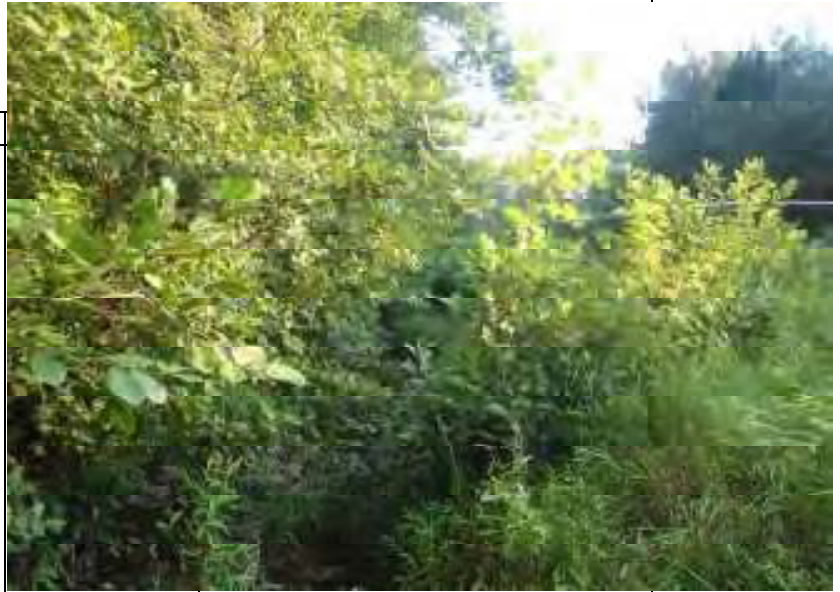
Photo of XS-5, looking in the downstream direction

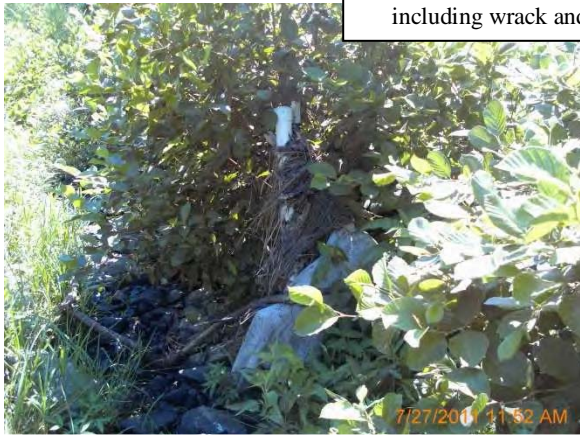
Bankfull Photo 1: Evidence of overbank including wrack and debris on crest gage.

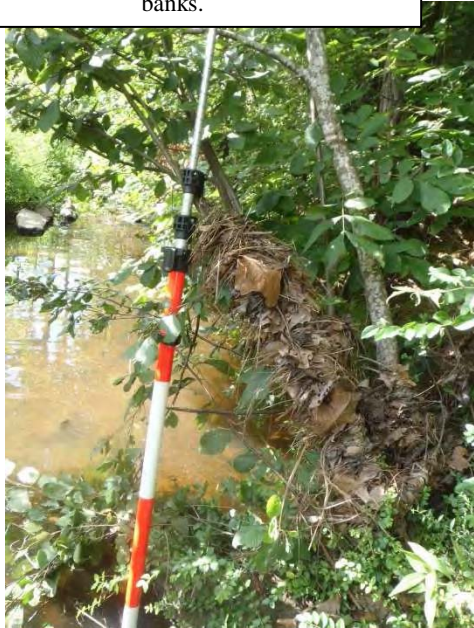
Bankfull Photo 2: Evidence of overbank including wrack and debris in trees and on banks.
