FINAL
ANNUAL MONITORING REPORT
YEAR 5 (2013)
CHAPEL CREEK STREAM RESTORTION SITE
ORANGE COUNTY, NORTH CAROLINA
(EEP Project No. 77, Contract No. 004806)
Construction Completed July 2008

Prepared by:
Axiom Environmental, Inc.
218 Snow Avenue
Raleigh, North Carolina 27603

January 2014

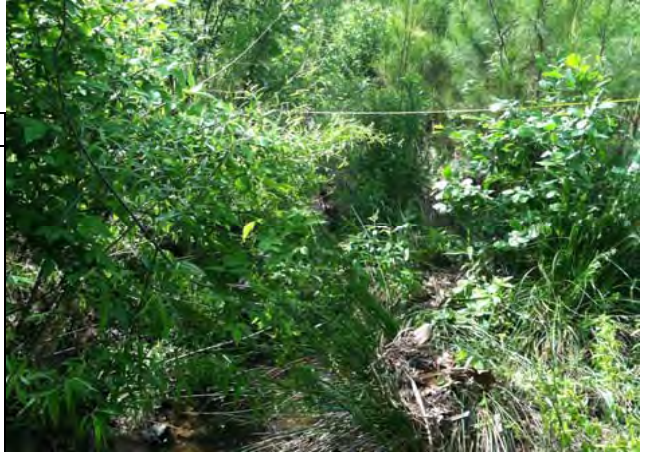
Cross Section 1

Photo of XS-1, looking in the downstream direction

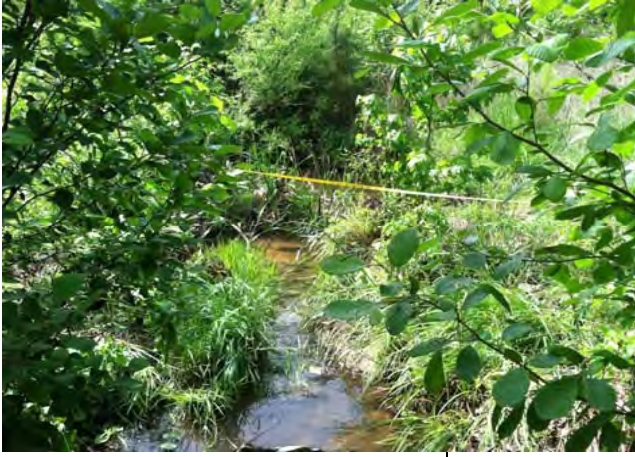
Cross Section 2

Photo of XS-2, looking in the downstream direction

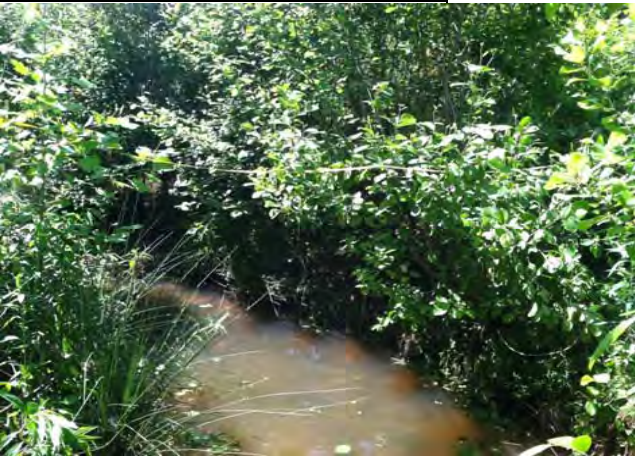
Cross Section 3

Photo of XS-3 looking in the downstream direction

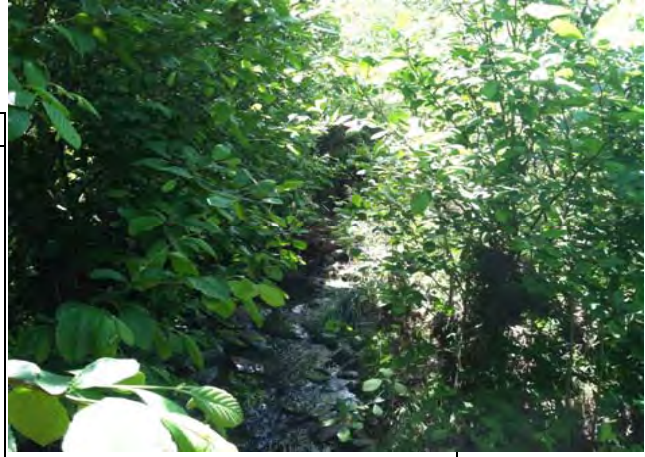
Cross Section 4

Photo of XS-4, looking in the downstream direction

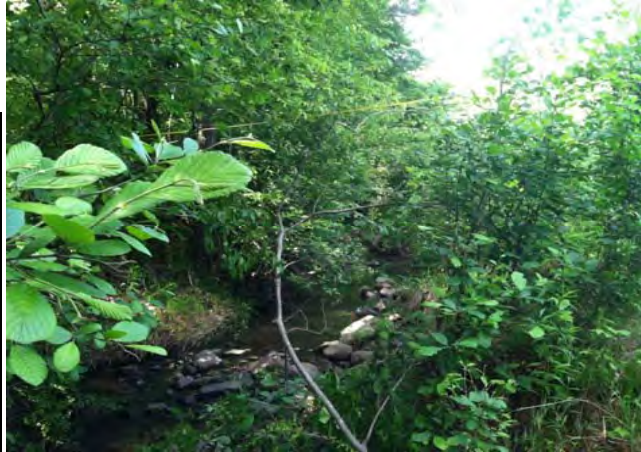
Cross Section 5

Photo of XS-5, looking in the downstream direction

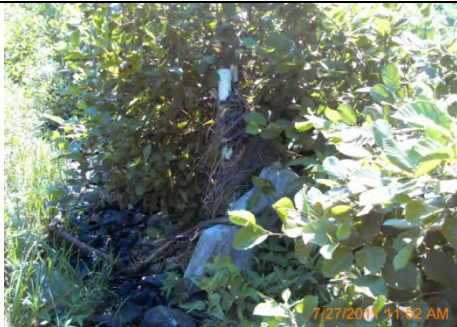
Bankfull Photo 1: Evidence of overbank including wrack and debris on crest gage.

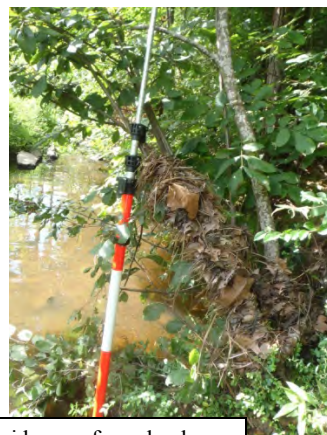
Bankfull Photo 2: Evidence of overbank including wrack and debris in trees and on banks.

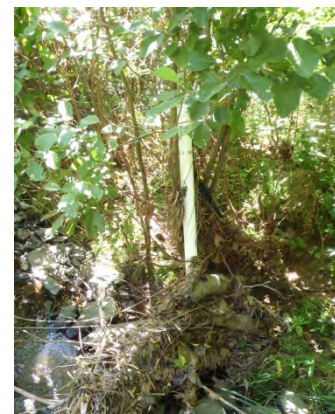
Bankfull Photo 3: Evidence of overbank including wrack and debris on crest gage.
