**As-built report for the Charles/McGinnis  
Mitigation Site, South Fork Big Pine  
Creek, Madison County**

**North Carolina Wildlife Resources Commission**

**October 17, 2000**

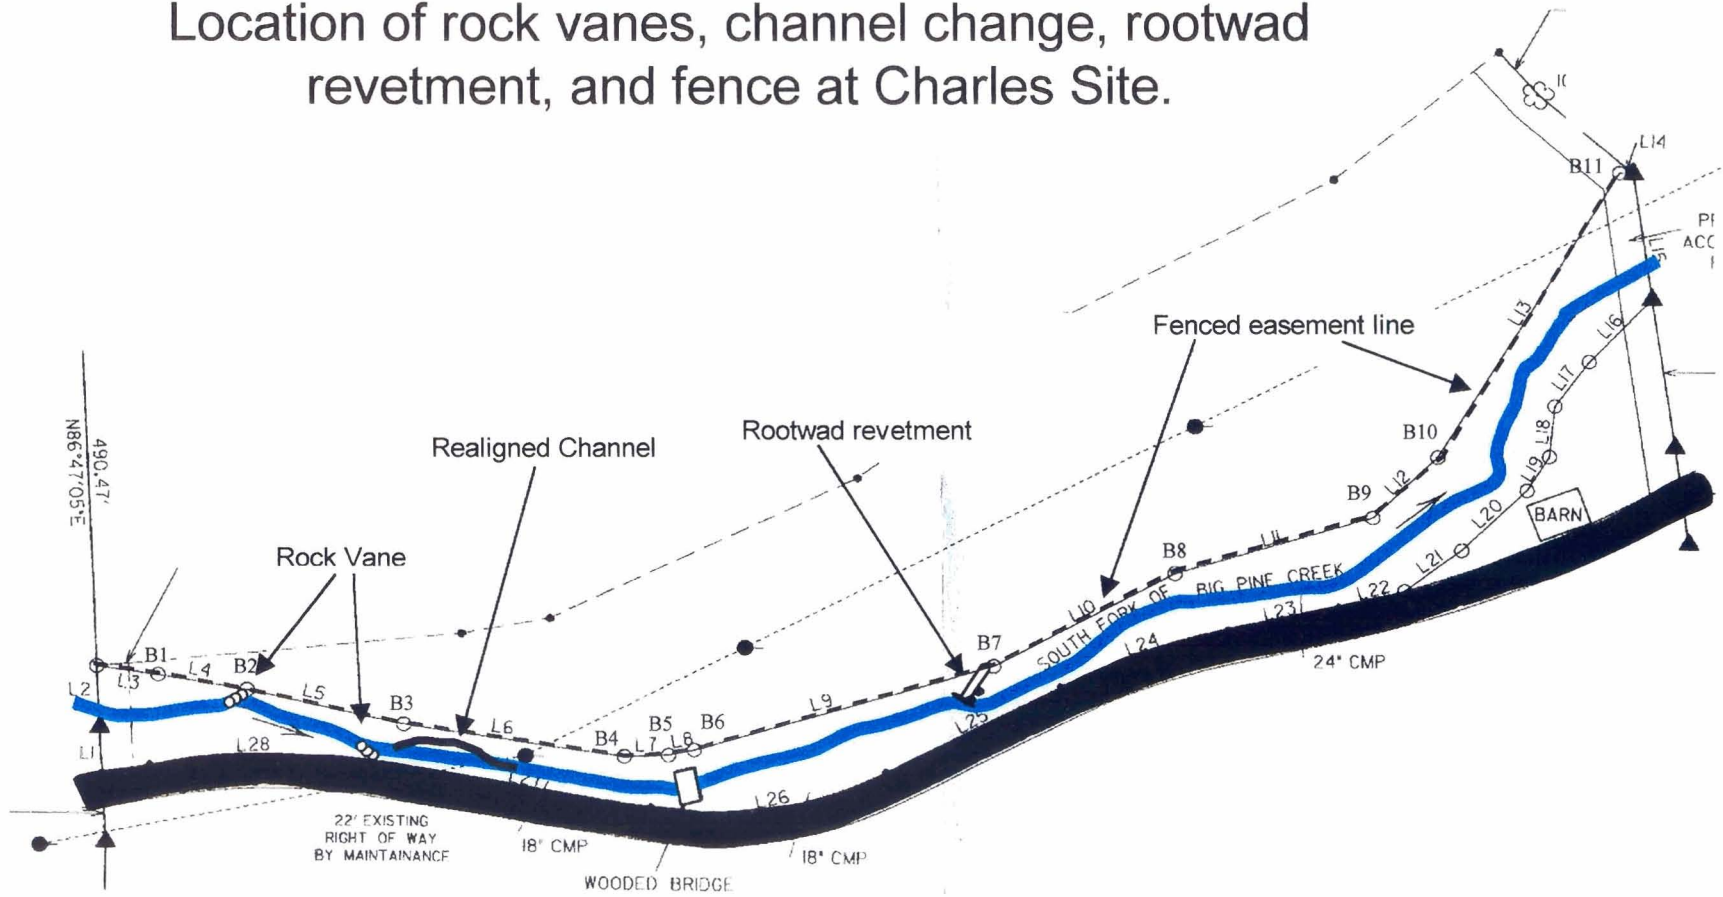
# Location of rock vanes, channel change, rootwad revetment, and fence at Charles Site.

Two rock vanes and one rootwad revetment were installed at this site to control erosion of the stream bank on the outside of small meanders (see the attached map for the location of all structures). Rock for the vanes was obtained on site, as the banks of the stream were sloped. The top vane was built on the left bank to turn water off of a 5-foot high bank that was nearly vertical. The lower vane was built on the right bank to turn water off of an area that was eroding into the road right-of-way and extended downstream for about 15 feet. To eliminate this problem the vane was built and the channel was changed so that it meandered to the left side of the easement alignment. The old channel was filled to an elevation equal to the interberm and seeded with native vegetation. A rootwad revetment was installed downstream of the bridge at a site where the stream bends sharply right and the bank was eroding. The revetment was constructed out of materials obtained on site during bank sloping. Throughout the entire reach the interberm was maintained, enhanced or created as channel modifications were installed. It was felt that this feature was developing naturally and that it benefited the stream by slowing high water. As this feature was enhanced or created it was seeded and protected with a jute erosion control fabric.

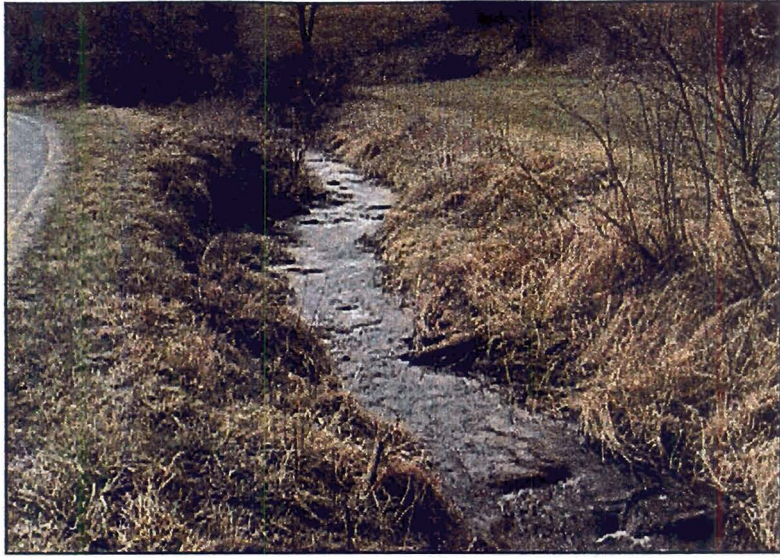
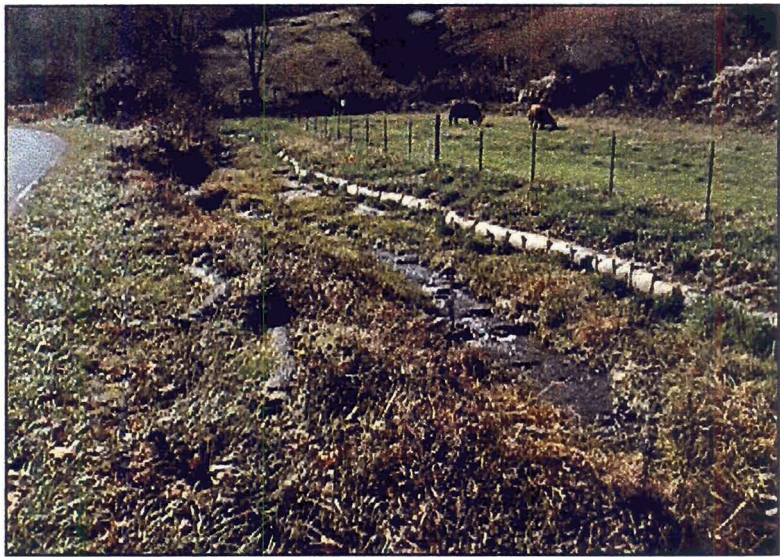
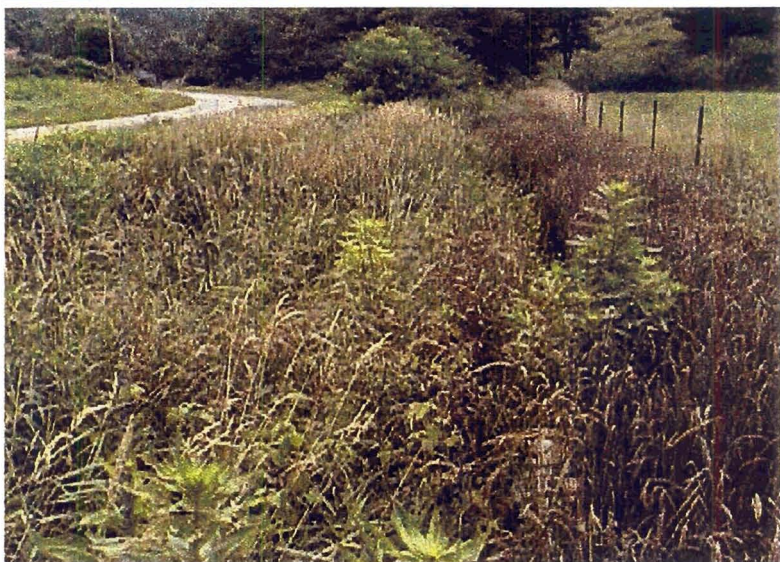
Looking upstream from power pole, showing sloping, erosion controls, vegetation and fencing. Top photo shows reach before construction, middle photo shows constructed channel and lower photo shows the same site 10 months after construction.

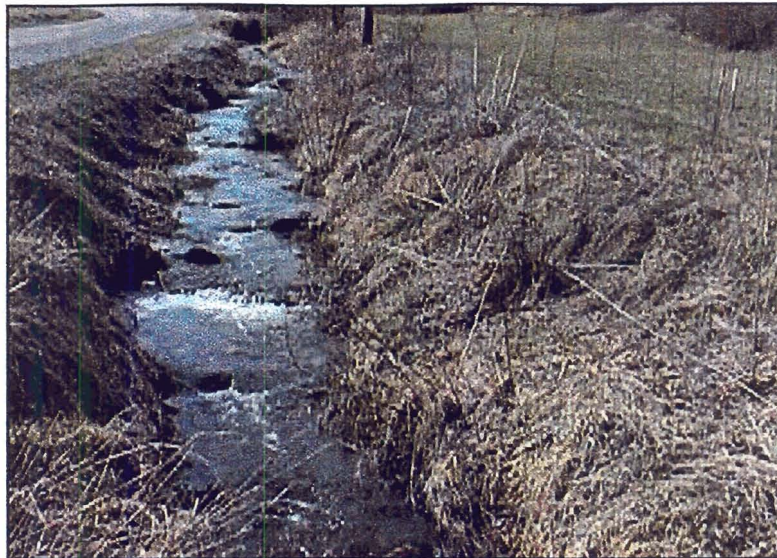
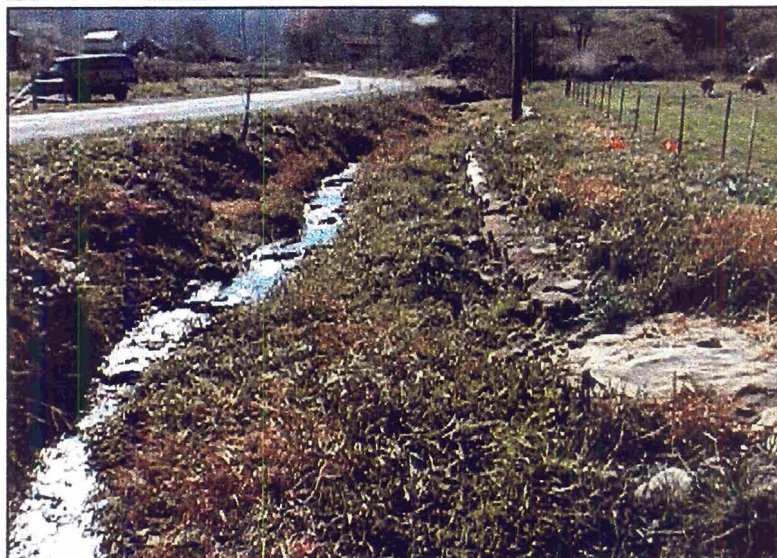
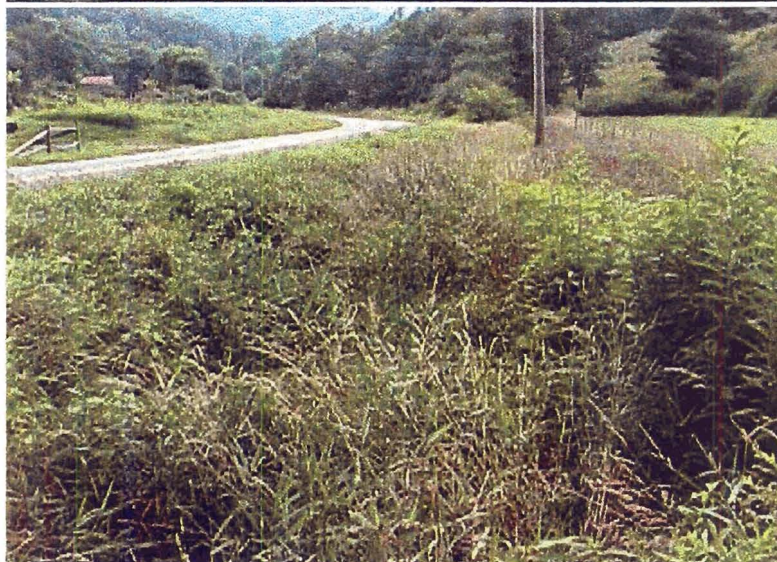
Looking upstream from the wooden bridge, top photo showing preconstruction condition of the channel. Middle photo shows channel after construction and lower photo shows the same channel 10 months after construction.

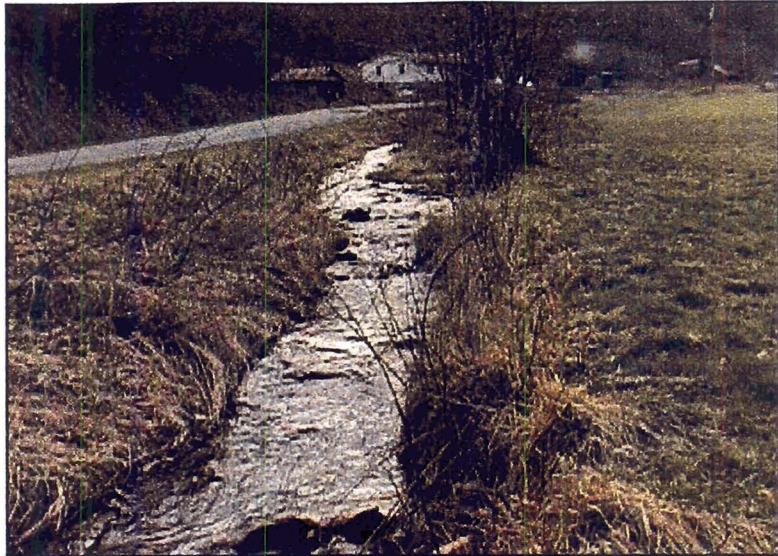
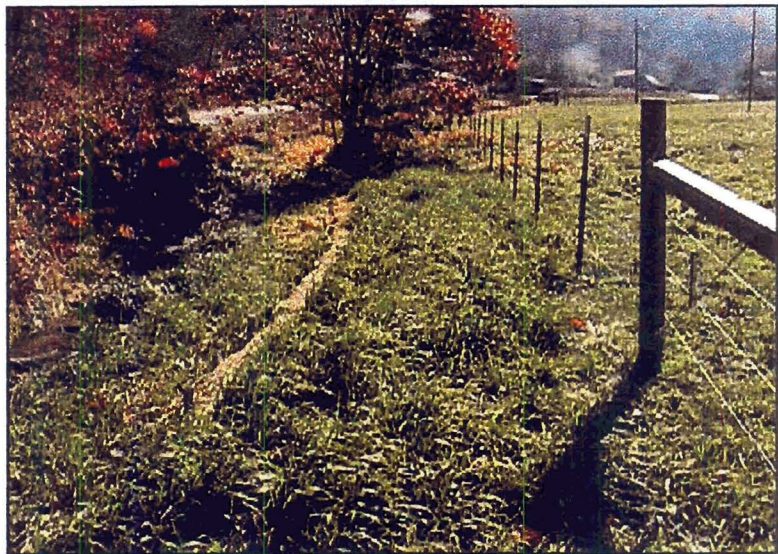
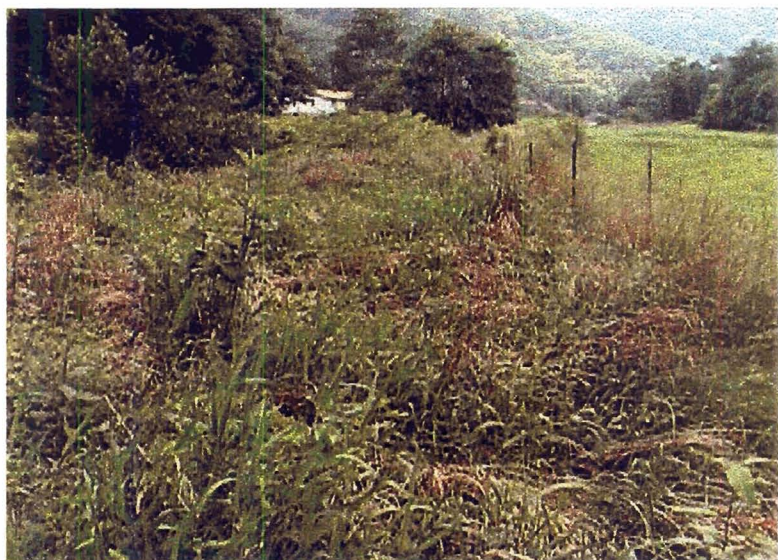
Looking upstream from point F7 in the top two photos and from point F9 in the bottom photo showing fencing and growth of ground cover. Bottom photo shows the same general reach after 10 months.

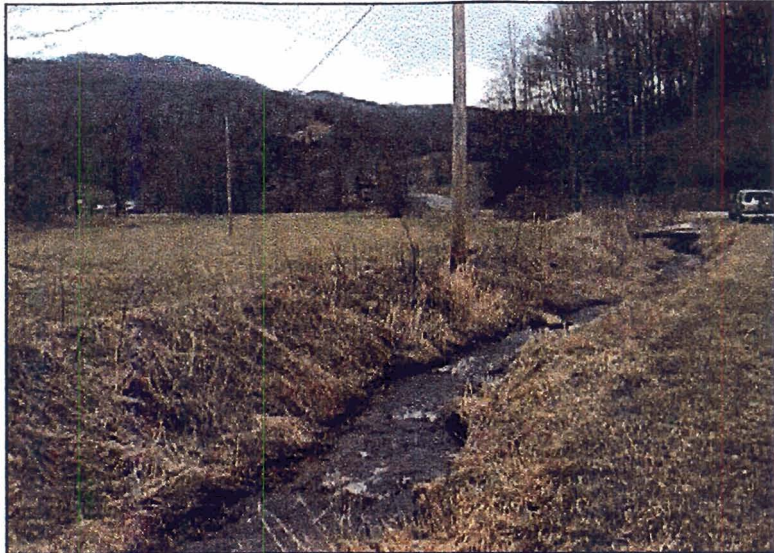
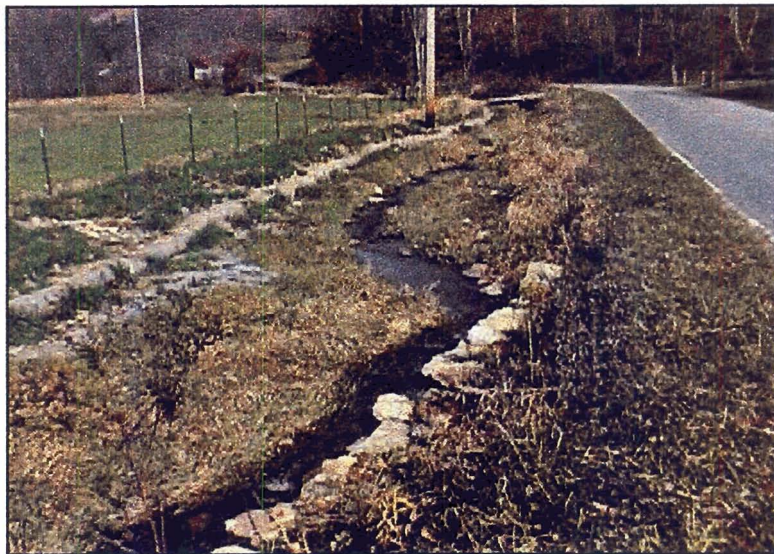
Looking downstream from road showing vane 1 and small channel change.

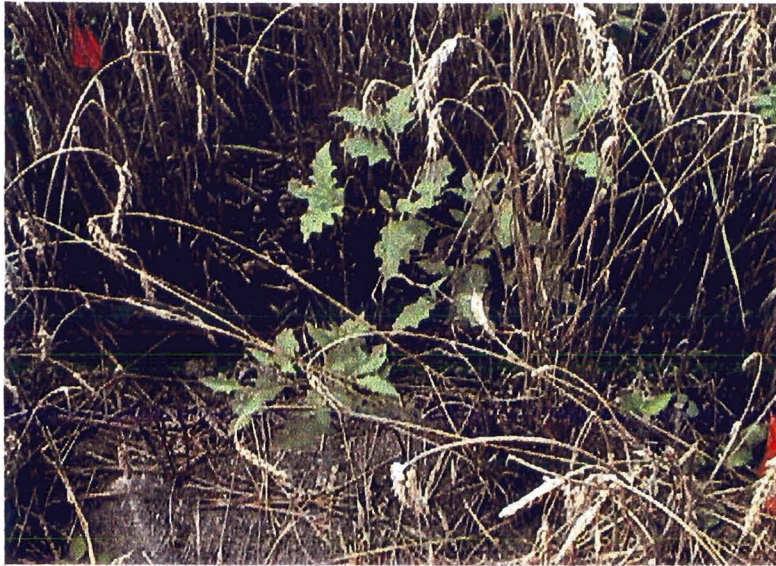
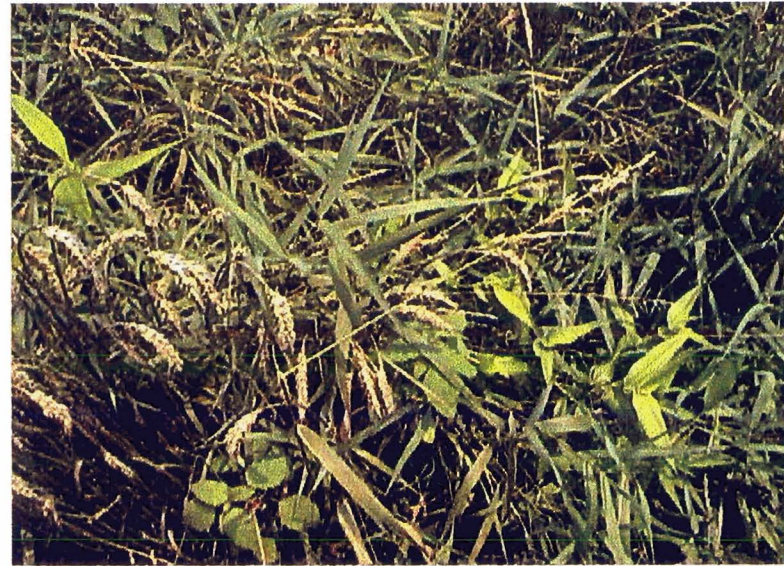
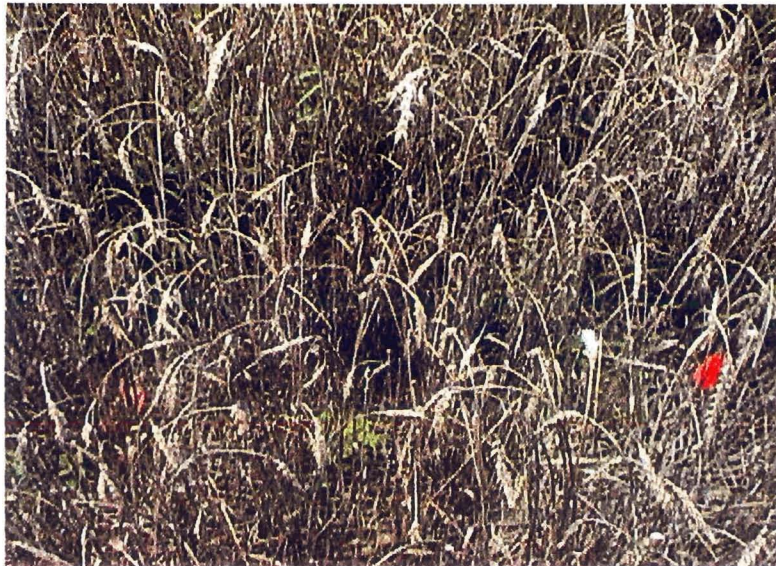
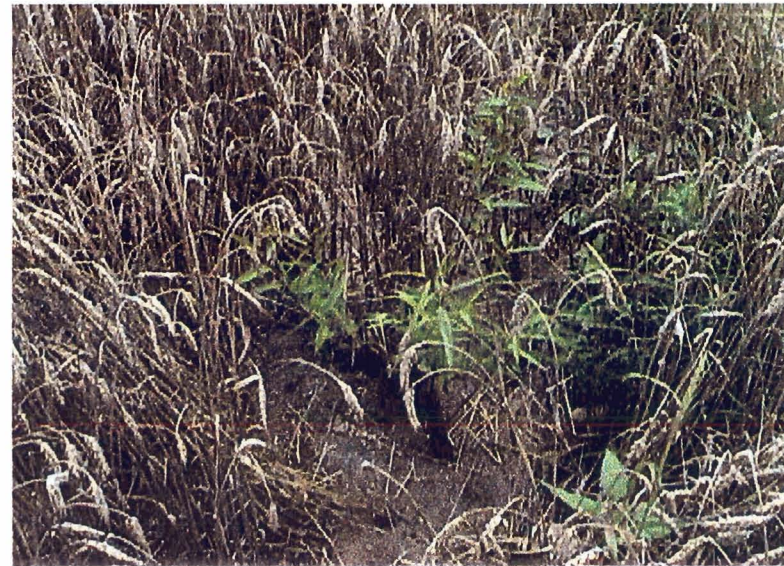
Four photos showing ground cover within the easement area. The two photos on the left are survival plots showing good vegetative cover through the erosion control blanket. Top right photo shows the diversity of grasses seeded and growing below the coir log. The lower right photo shows a live stake that has sprouted and is growing vigorously.
