**ANNUAL REPORT FOR 2003**

**South Fork Big Pine Creek Stream Mitigation Site  
(Charles/McGinnis Site)  
Madison County  
WBS Element 32573.4.1  
TIP No. A-10WM**

Prepared By:  
Office of Natural Environment & Roadside Environmental Unit  
North Carolina Department of Transportation  
December 2003

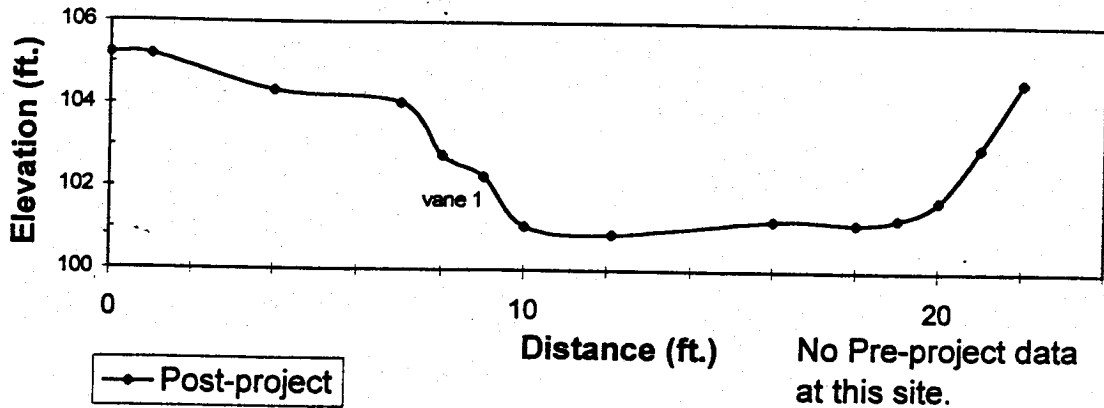
### Cross-section 1

- ◆ Station 0+96 at Cross Section #1. The existing coir log along the left streambank (facing downstream) has been undermined and may fail. This area should be assessed during the next monitoring period to determine remedial actions.

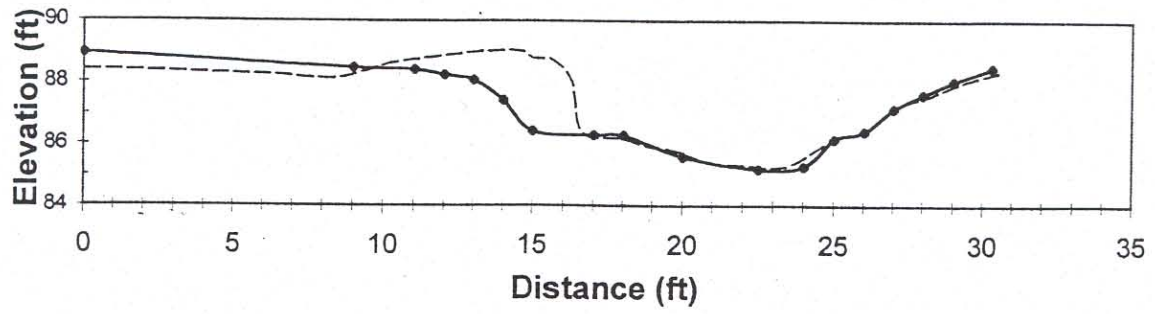
### Cross-section 4

- ◆ Station 5+99 at Cross Section #4. Active erosion is present along outside of meander bend. This meander bend experienced erosional problems during the summer of 2003. NCDOT maintenance crews were forced to repair the outside of this bend due to severe erosion along the roadway embankment. As a result, one rootwad was removed and not replaced.

4. Several rock vanes may be needed in the vicinity of Cross Section #4 to help stabilize the outside of the meander bend.
5. Cross Section #5 appears to be degrading. Placement of cross vanes through this section (from Stations 7+67 to 8+00) would help with grade control issues. It will also assist with stabilizing the adjacent stream banks.

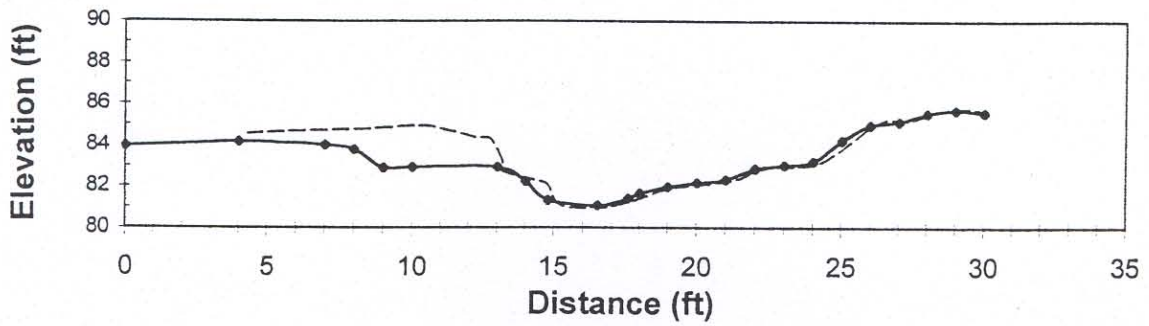
### Cross-section 5

The majority of the cross sections remain intact aside from Cross Sections #4 and #5. Based on the comparison of cross section survey results with the as-built sections, Cross Sections #1, #2, #3, and #4 appear to be slightly aggrading while Cross Section #5 has degraded over one foot in elevation. Survey data will vary depending on actual location of

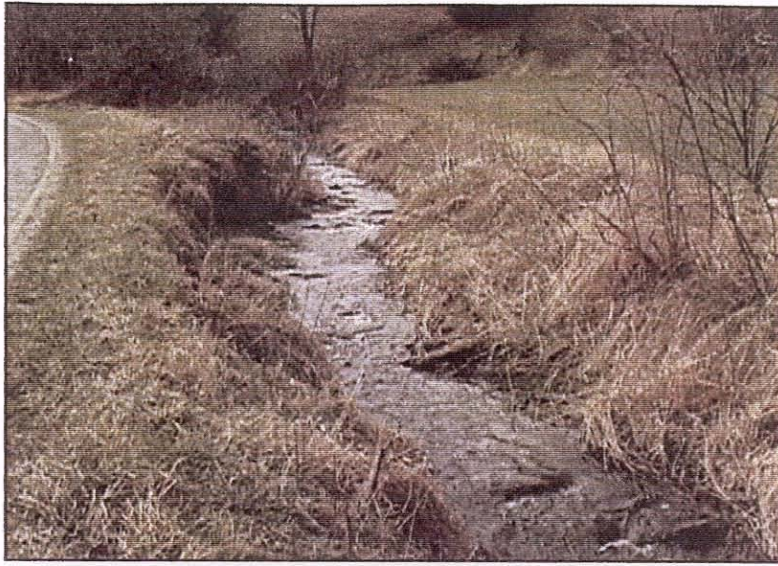
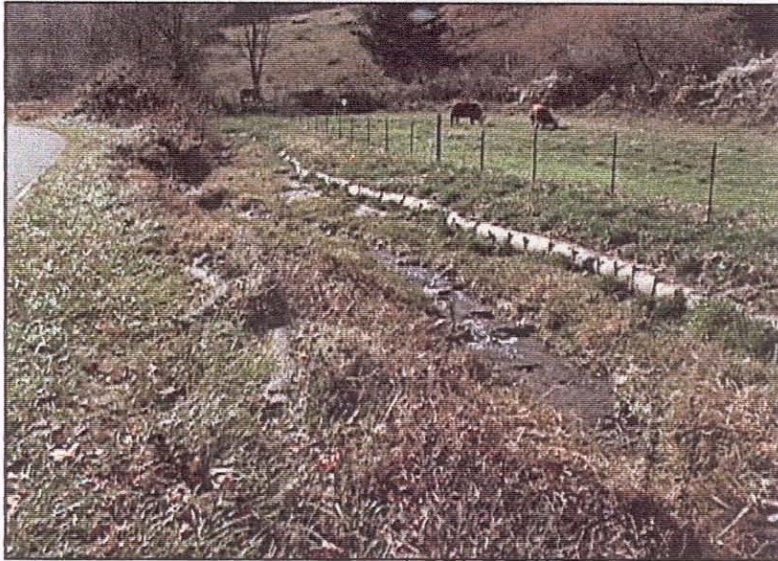
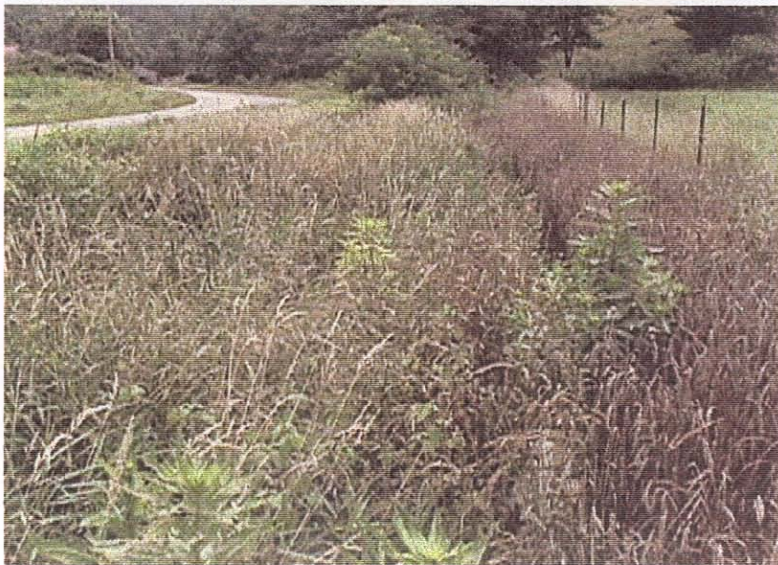
Looking upstream from power pole, showing sloping, erosion controls, vegetation and fencing. Top photo shows reach before construction, middle photo shows constructed channel and lower photo shows the same site 10 months after construction.

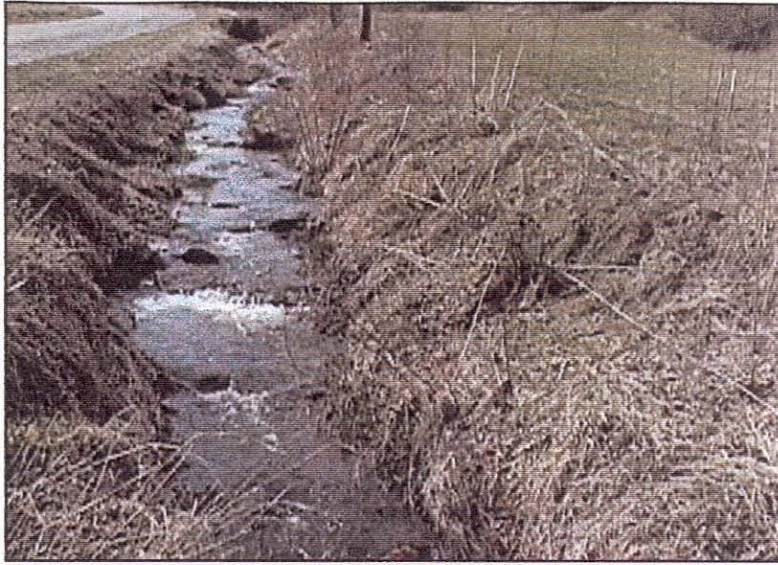
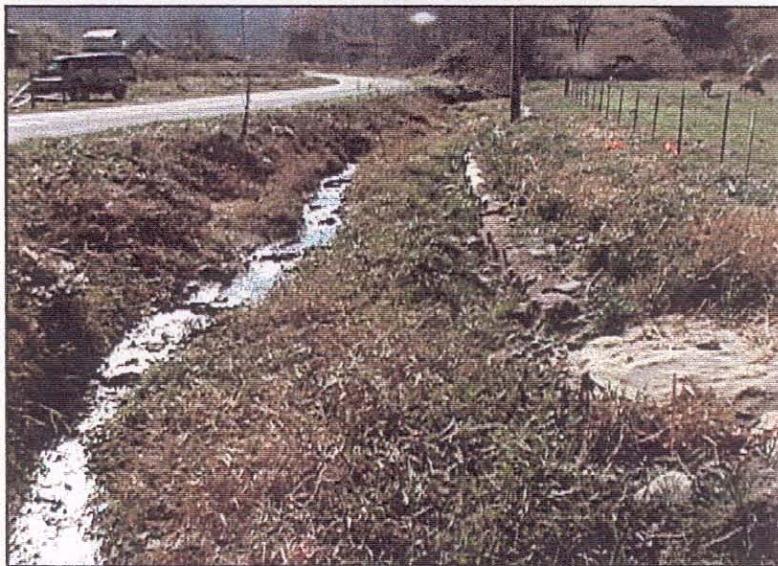
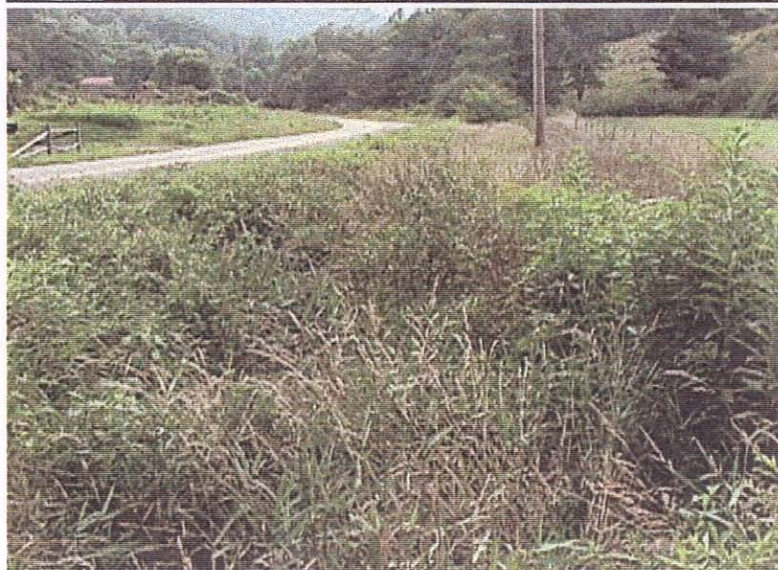
Looking upstream from the wooden bridge, top photo showing preconstruction condition of the channel. Middle photo shows channel after construction and lower photo shows the same channel 10 months after construction.

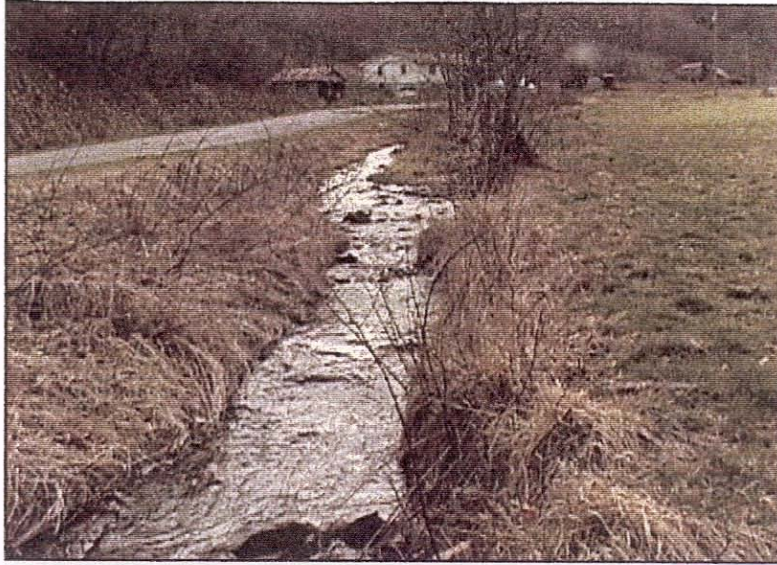
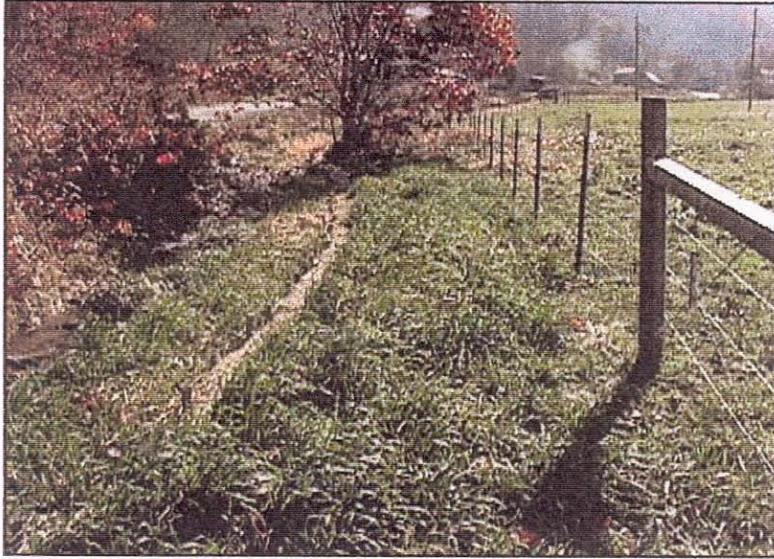
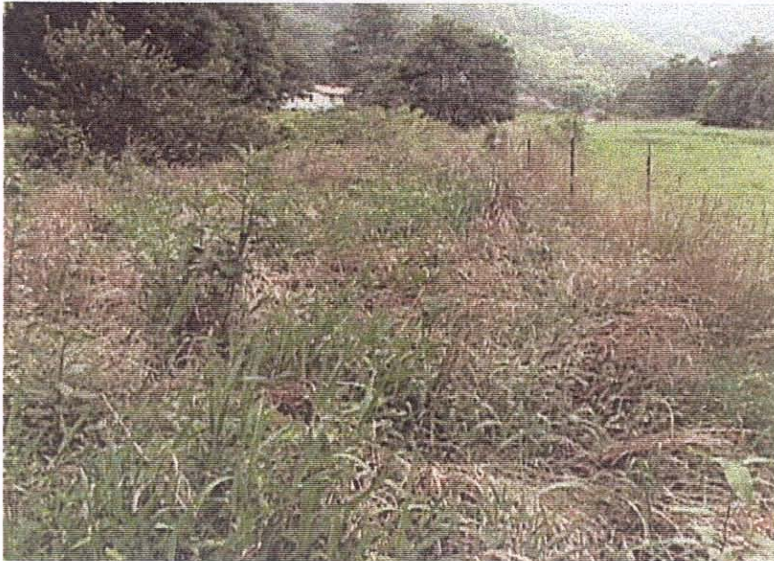
Looking upstream from point F7 in the top two photos and from point F9 in the bottom photo showing fencing and growth of ground cover. Bottom photo shows the same general reach after 10 months.

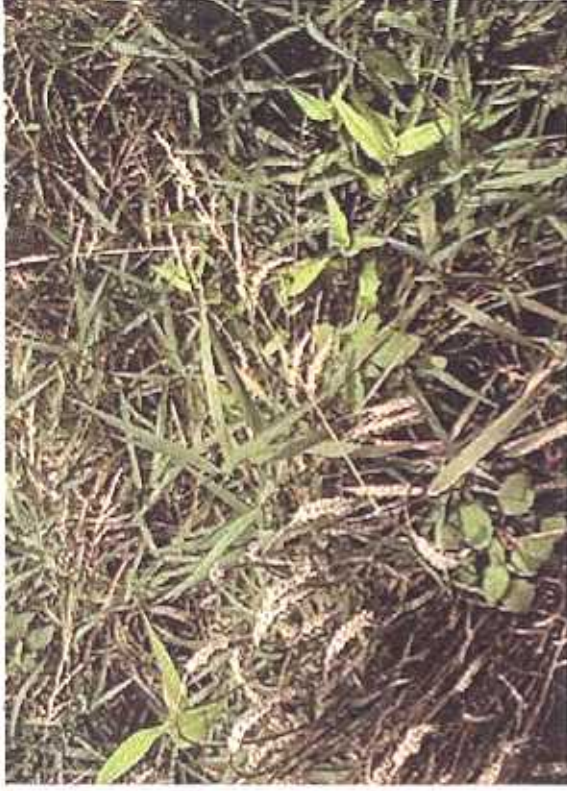
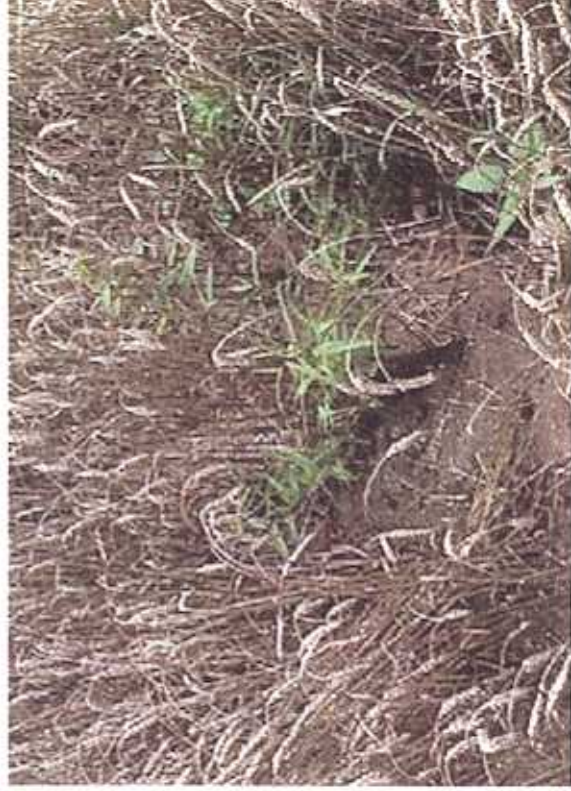
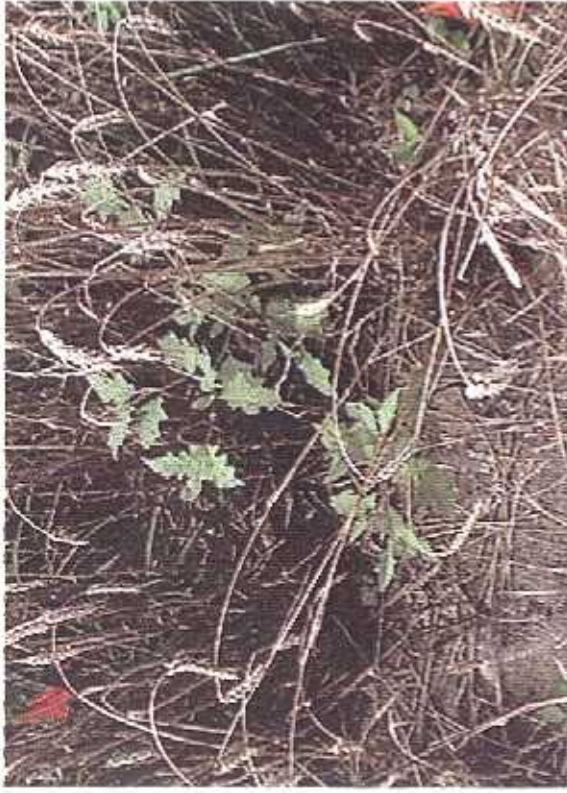
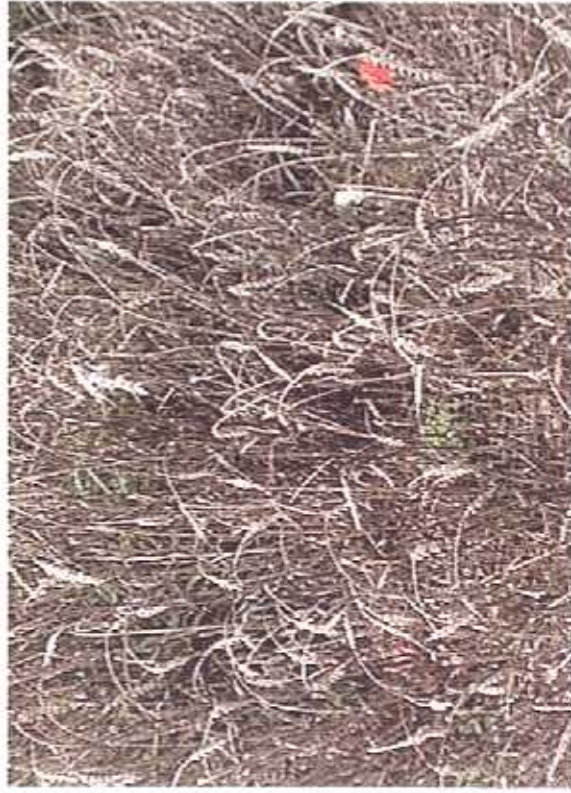
Four photos showing ground cover within the easement area. The two photos on the left are survival plots showing good vegetative cover through the erosion control blanket. Top right photo shows the diversity of grasses seeded and growing below the coir log. The lower right photo shows a live stake that has sprouted and is growing vigorously.

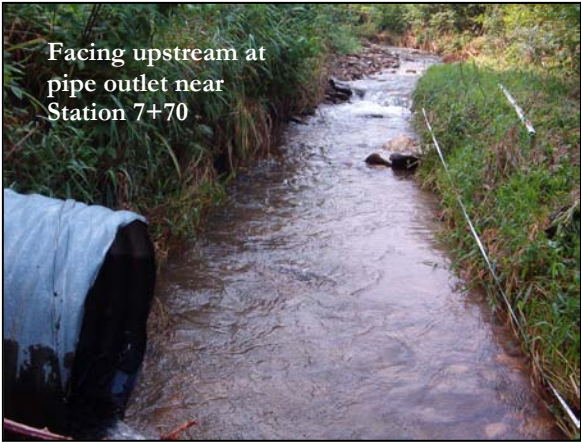
- ◆ Stations 7+67 through 8+00. Active erosion was noted at and around the pipe outlet entering from the right side.
- ◆ Stations 9+00 through 10+00. The right streambank is actively eroding.

Facing upstream at  
pipe outlet near  
Station 7+70

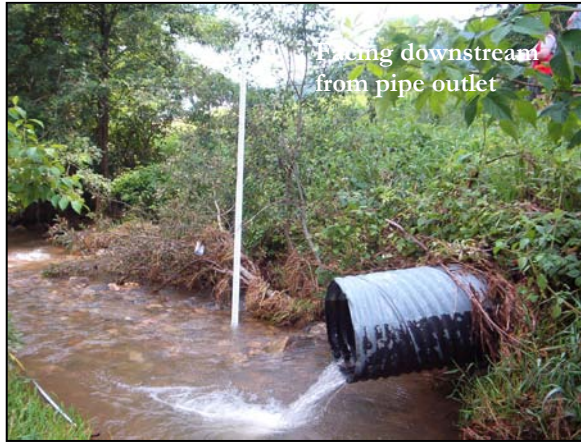
Facing downstream  
from pipe outlet

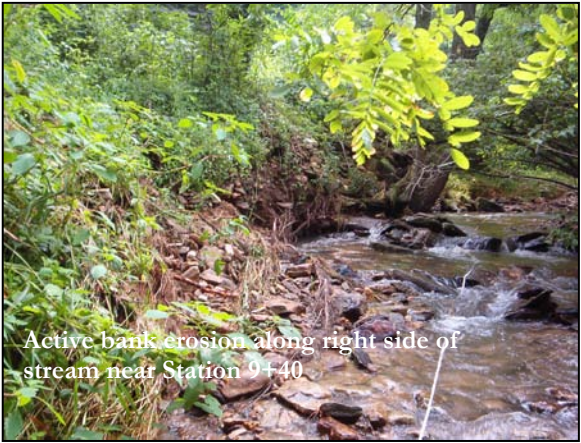
Active bank erosion along right side of  
stream near Station 9+40

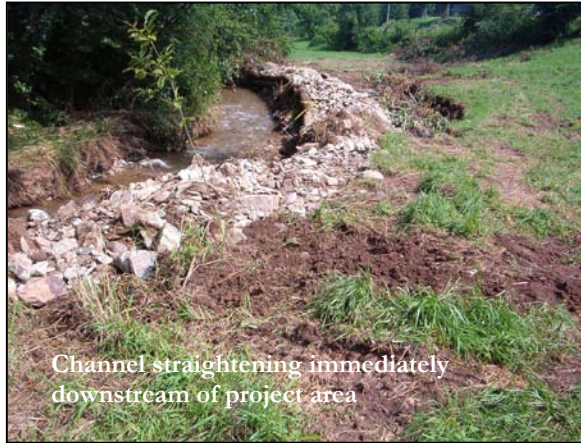
Qualitative investigations were conducted on the adjacent property downstream of the project area to assess the applicability of a source for the head cutting. One area was identified approximately 100 feet (30.5 meters) downstream of the project area. The adjoining property owner had straightened a meander bend during the spring/summer of 2003. A log crib wall was placed on the outside of the reach for bank protection. This straightening has resulted in the conversion of a pre-existing pool to a riffle thus, increasing the overall slope of the channel through this area. It is anticipated that as the stream equalizes, additional destabilization of the substrate will occur upstream through the project area.

Channel straightening immediately  
downstream of project area

Additional substrate destabilization occurring from the noted downstream source will be monitored to determine the overall effect on the project. Pending the outcome of this assessment, the NCDOT may request the downstream landowner to remedy the problem.
