YEAR 3 MONITORING and CLOSEOUT REPORT
for
CHARLES/McGINNIS MITIGATION SITE
SOUTH FORK BIG PINE CREEK,
MADISON COUNTY, NORTH CAROLINA

EEP PROJECT NUMBER 92701

December 2008

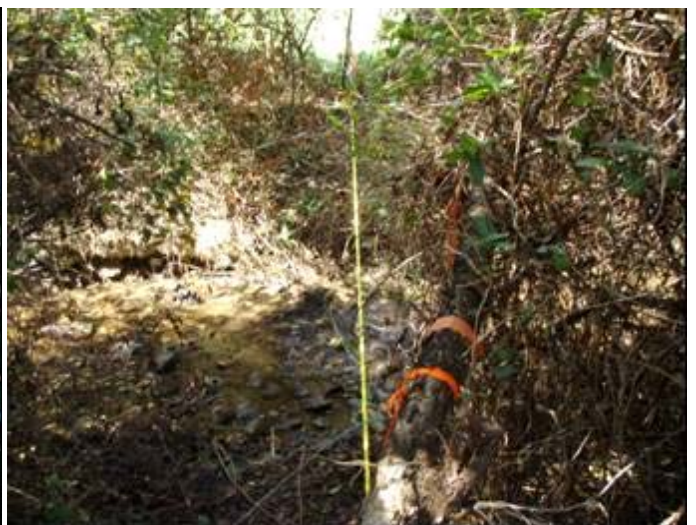
Cross-section 1, Riffle (Appendix Table A.1.1).—There has been little change in this cross-section between MY0 (as-built) and MY3. This cross-section has remained stable with no lateral

movement (bank erosion) observed along either streambank. The left bank is under cut at the waters edge; however, the bank is stable and well vegetated. The channel bottom has shown some minor aggradation.

Cross-section 1, right bank to left bank, October 2007.

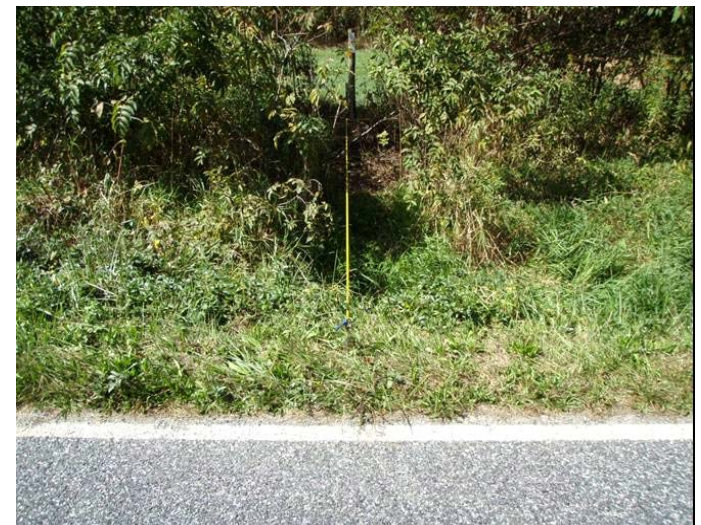
Cross-section 2, Run (Appendix table A.1.2).—The right bank of this cross-section is adjacent to SR 1158 and has been susceptible to erosion during high flow events in the past. The SR 1158 road shoulder between cross-section 2 and 3 has been repaired with large boulders and rip-rap at least twice after flood events. Aggradation on the left bank, from the water's edge up to easement fence line, is likely resulting from the vegetation capturing bed material during flood events. At the time of the MY3 survey, both the right and left banks were stable, and the left bank vegetation was well established.

Cross-section 2, right bank to left bank, September 2007.

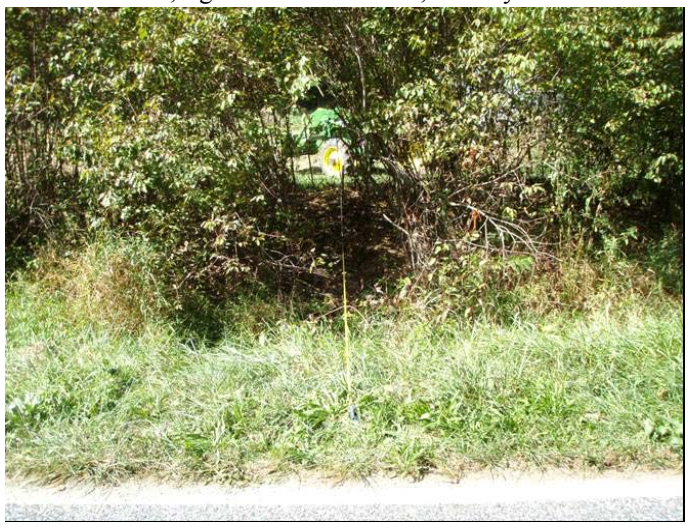
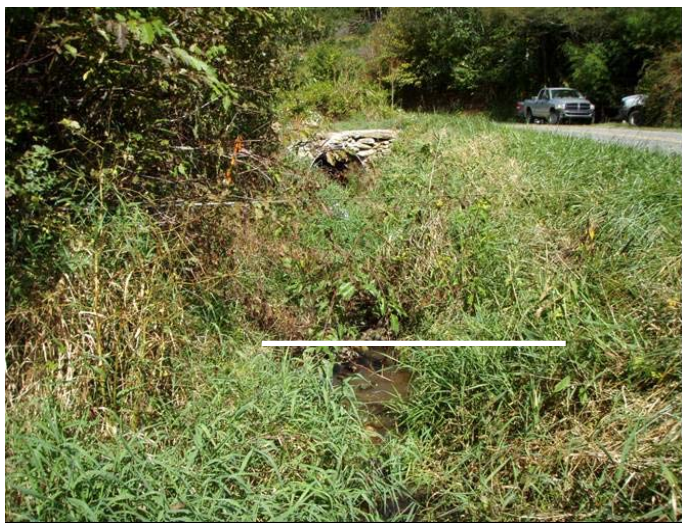
Cross-section 3, Riffle (Appendix Table A.1.3).—The right bank of this cross-section is adjacent to SR 1158. The right bank has been susceptible to erosion during high flow events in the past. The SR 1158 road shoulder between cross-section 2 and 3 has been repaired with large boulders and rip-rap at least twice following flood events. The thalweg has shifted towards the right bank when compared with its location following construction. The left bank is stable and well vegetated.

Cross-section 3, right bank to left bank, September 2007.

Cross-section 3, upstream to downstream, September 2007.

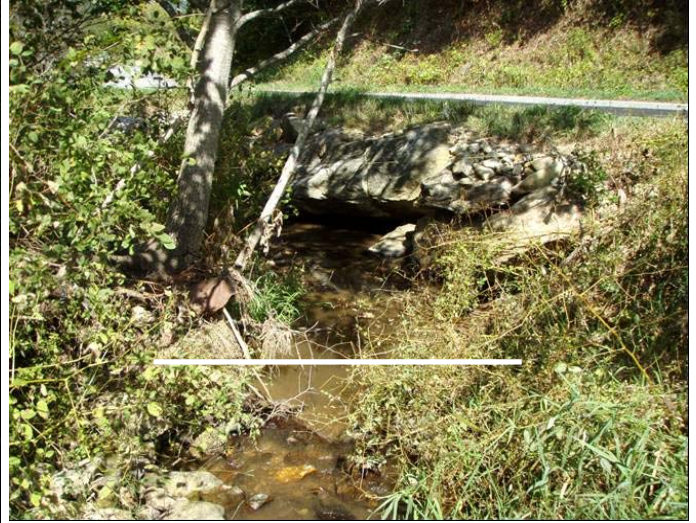
Cross-section 4, Riffle (Appendix Table A.1.4).—The right bank of this cross-section is adjacent to SR 1158 and has been susceptible to erosion during high flow events in the past. The SR 1158 road shoulder has been repaired with large boulders and rip-rap at least twice following flood events. This cross-section is located in a slight meander (to the left) that creates near bank stress against the right bank and road shoulder during high flows. The thalweg has deepened (± 0.8 ft) since the as-built survey; likely resulting from stream energy scouring the stream bed due to the confining of the channel laterally (on the right) by the large boulders used to stabilize the road shoulder. The root mass from an oak tree (present before construction) has protected the left bank from damage during flood events. That root mass combined with the reestablished woody plants should aid in keeping the left bank stable.

Cross-section 4, looking downstream, September 2007.

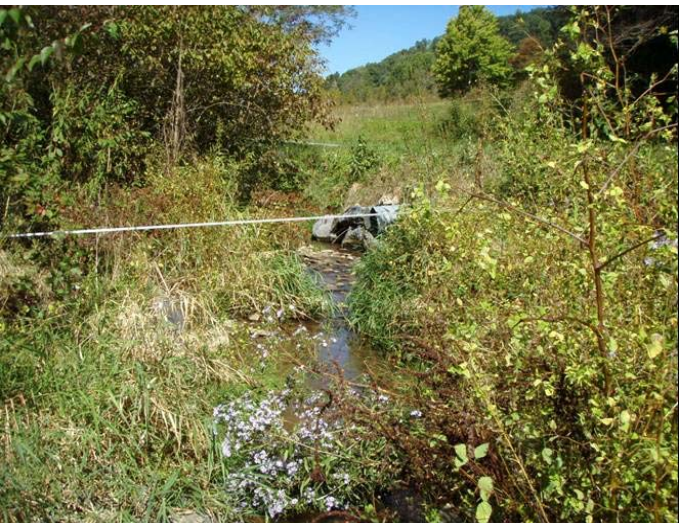
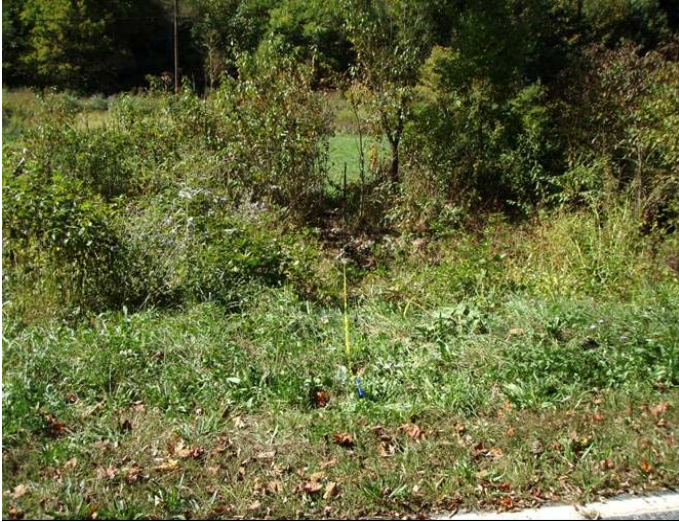
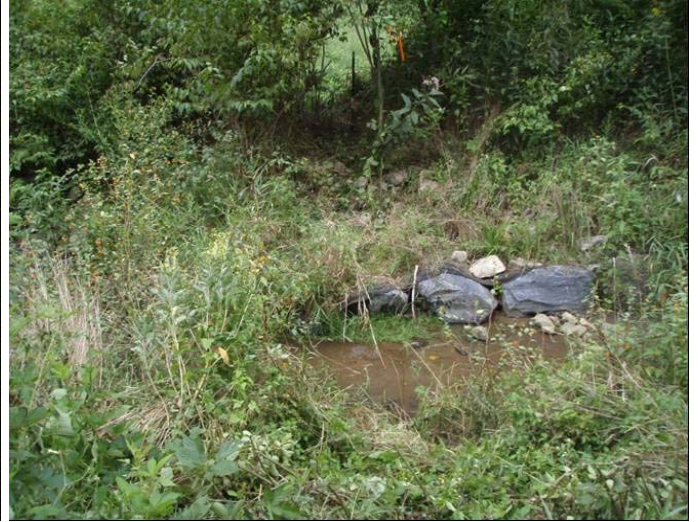
Cross-section 5, Riffle (Appendix Table A.1.5).—Cross-section 5 was the only location where the width/depth ratio (13.9) exceeded that of an E stream type. Although the bankfull width of cross-section 5 (14.1 ft) was within the range of the other cross-sectional bankfull widths (10.4–16.9 ft), the bankfull mean depth (1.0 ft) was low, resulting in the B stream type classification. Also note, the survey was conducted during a year of record low rainfall, which resulted in reduced baseflow that was revealed by the presence of a shallower mean stream depth.

The left end of this cross-section was changed when repairs to the stream channel were made following high flow events caused by the remnants of two hurricanes in the fall of 2004. A short section of the left bank was excavated to the bankfull elevation and a single arm rock vane constructed. This is likely the cause for the noticeable shift (to the left) of the thalweg and the lower elevation of the left bank. This cross-section has stabilized since the repair work was completed; the vegetation on the left bank is now well established.

Cross-section 5, looking downstream, September 2007.

Cross-section 5, right bank to left bank, September 2007.

Cross-section 5, right bank to left bank, September 2007

Additionally, Emergency Watershed Protection (EWP) funds were used to conduct repair work following the 2004 hurricane floods. As part of the EWP work, a single arm rock vane also was installed on the left bank to address a scour problem occurring at station 7+70, cross section 5 (Appendix A.1.5).

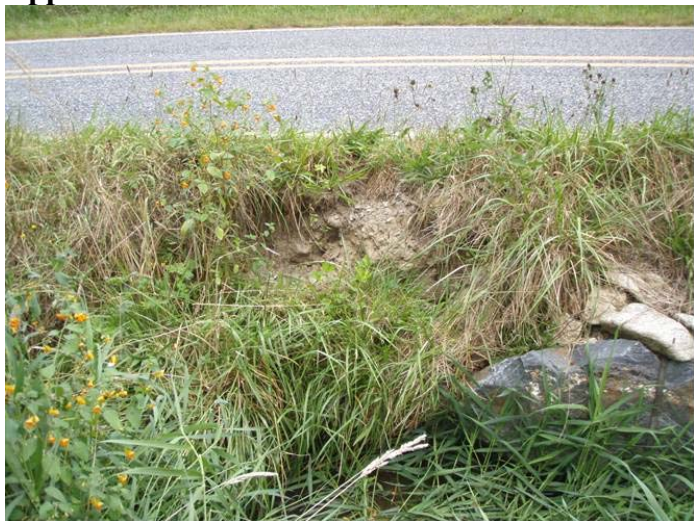
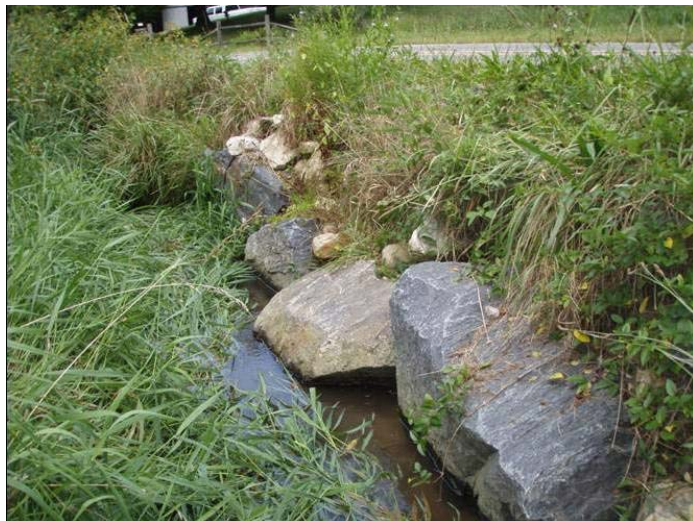
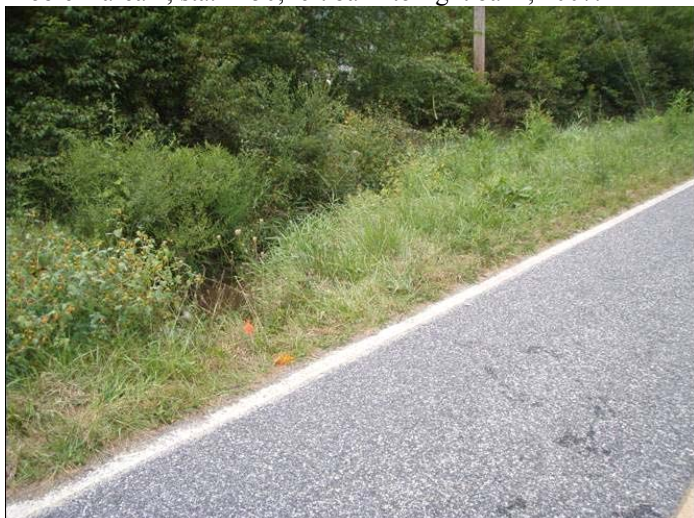
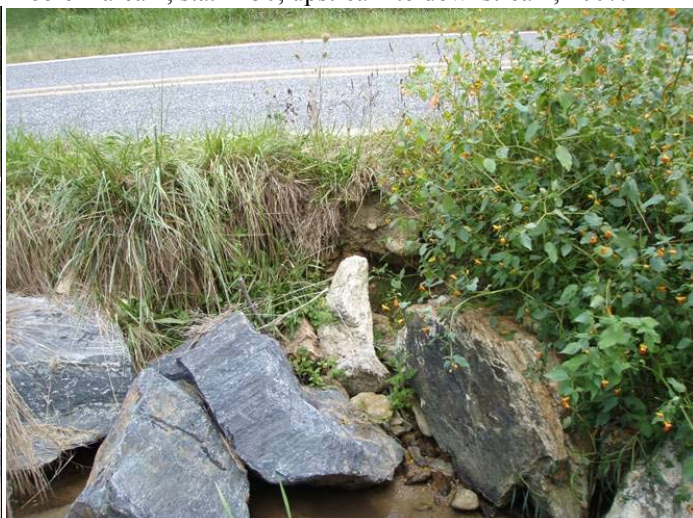
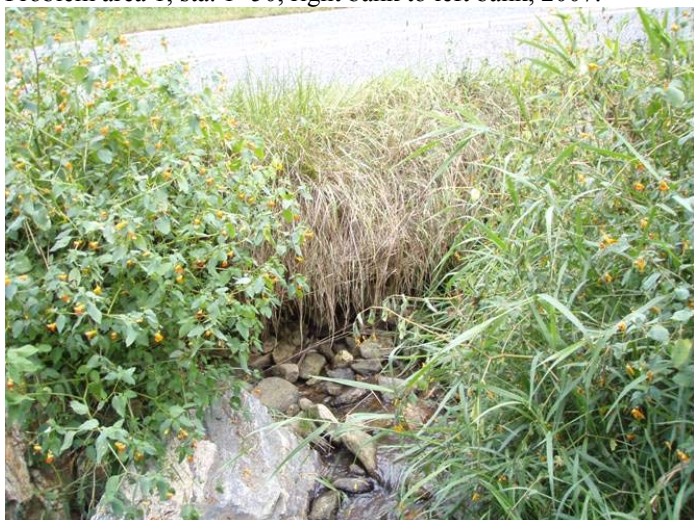
Two chronic problem areas exist along the stream channel that are susceptible to scouring at high flows (Appendix A.7). Both areas are adjacent to SR 1158, and were noted as problem areas before project construction due to their proximity to the road shoulder (<3 ft from the active channel) (NCWRC 1998). Problem area one (sta. 1+50 to 3+50) was addressed during construction by installing a single arm rock vane on the right bank in an attempt to reduce bank stress during high flows. A short section (<50 ft) of channel also was moved away from the road right-of-way at this location (NCWRC 2000). The second problem area (sta. 5+50 to 6+50) is a channel bend adjacent to SR 1158 that includes cross section 4. This meander bend has migrated closer to SR 1158 since project completion. Much of this lateral movement occurred during the 2003 and 2004 flood events (Appendix A.1.4). Both of these problem areas have been repaired on multiple occasions by NCDOT. They have armored the road shoulder and channel bank with large boulders and rip-rap following each of the scouring events.

Problem Areas.—Although two problem areas (sta. 1+50 to 3+50, 5+50 to 6+50) were noted during MY3, these areas were of concern before the project was constructed as both areas are adjacent to SR 1158. Whenever high flow events have scoured the channel banks to the degree where the integrity of the road shoulder and surface is jeopardy of failing, NCDOT has repaired the problem by installing large boulders and rip-rap to armor the channel bank and stabilize the road bed.

Problem area 1, sta. 1+50, left bank to right bank, 2007.

Problem area 1, sta. 1+50, upstream to downstream, 2007.

Problem area 1, sta. 1+50, right bank to left bank, 2007.

Problem area 1, sta. 1+50, left to right bank, 2007.
