Chavis Park Stream Restoration (Garner Branch of Walnut Creek) 2004 Annual Monitoring Report

February, 2005

2004 Chavis Park Monitoring Abstract

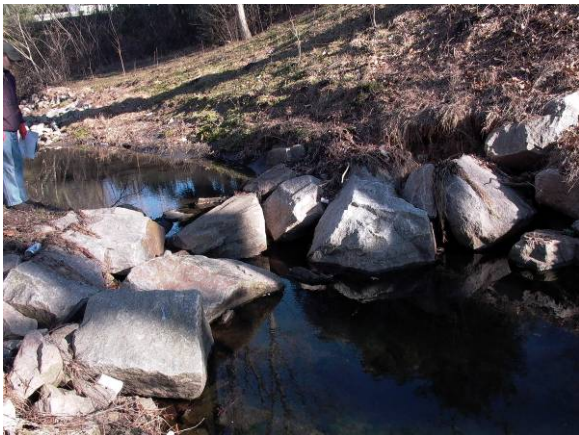
Issue Photo 1. Arm Scour left bank STA: 0+95, STA: 4+75 & STA 14+75

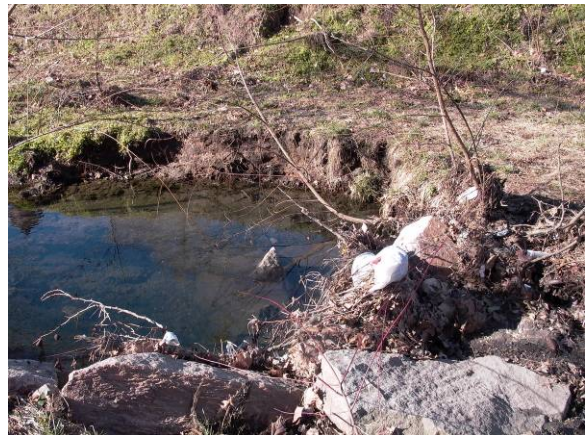
Issue Photo 2. Bank Erosion Due to Urban Debris Blockage

- There are two areas of major bank erosion due to the in-channel shearing forces of stream at station 4+75 and station at 14+75
 - At station 4+75 there is a blow out and severe bank erosion most likely due to a urban debris jam occurring at the cross vane directly upstream. The debris jam caused a high near bank stress on the right bank, to fix this erosional issue the debris should be removed from the stream on a regular basis and possible rebuild the blown out bank with a geo-grid, brush mattress, or by regrading

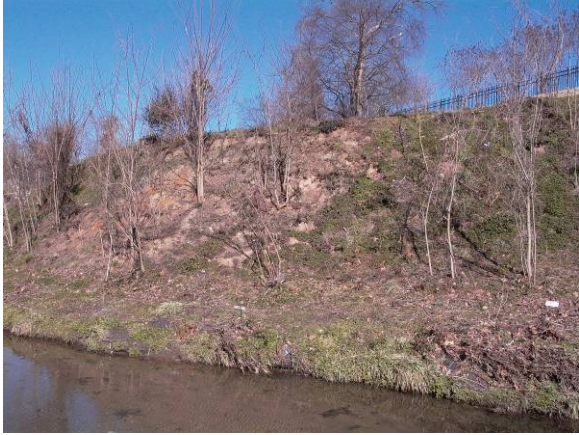
**Issue Photo 3 Hillslope Sheet/rill erosion
At STA: 15+50 & 16+50**

- Hillslope sheet erosion occurred on the left bank above the bankfull elevation at stations 16+50 and 15+50 each area of erosion is less than 50 sqft. Possible repairs would include preparing these areas and seeding with a tackafier and straw mulch

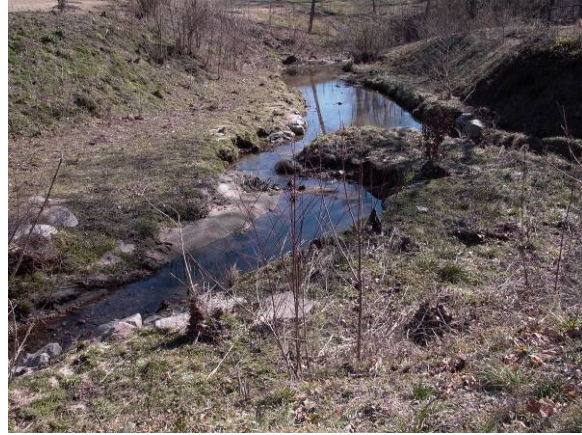
Issue Photo 4 Bank Erosion at STA: 14+75

- The area of bank has had approximately 15 tons of soil eroded from the bank since construction
 - The bank is now vertical with unconsolidated fill as the existing bank face this bank has a Very High Bank Erosion Hazard Index of 41

- The meander bend could be stabilized with a brush mattress, live stake cuttings and a single vane to help turn the water. Another repair option would be to cut a new channel based on the direction of flow over the cross vane, which would include 150 tons of excavation and placement of a new structure

- All of this area should be able to be reached with a CAT 325c type tracked excavator without entering into the floodplain
- Areas lacking stream feature

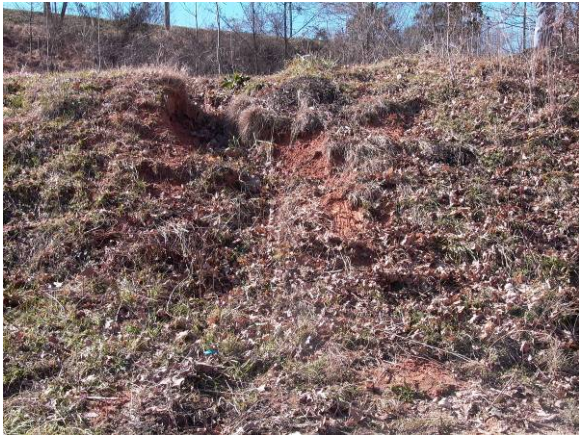
**Issue Photo 5 Hillslope Gully erosion
At STA: 17+00**

- Hillslope gully erosion occurred on the right bank above bankfull elevation at station 17+00 this area is about 15sqft. Possible repairs would include regarding the gully, preparing this area and seeding with a tackafier and straw mulch

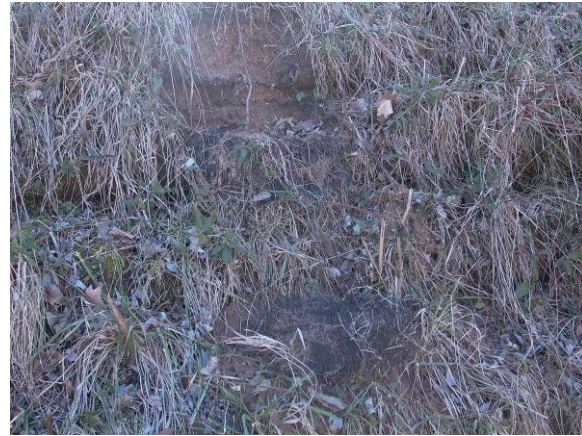
**Issue Photo 6 Geo-Grid brake-down at STA:
15+00 on right bank of UT**

the project. Cross-section UT is a riffle with a current cross sectional area is 12.0 square feet located on the tributary to Garner Branch just upstream of the confluence. Cross section UT is fairly stable, has low near bank stress and a low bank erosion hazard due to the use of geo-grid on the banks that are greater than a 1:1 slope. This first cross section classifies as a B4c channel with an ER of ~1.8, and is 35 ft upstream of a stable rock cross vane. The geo-grid is breaking down but the banks are also fairly well vegetated

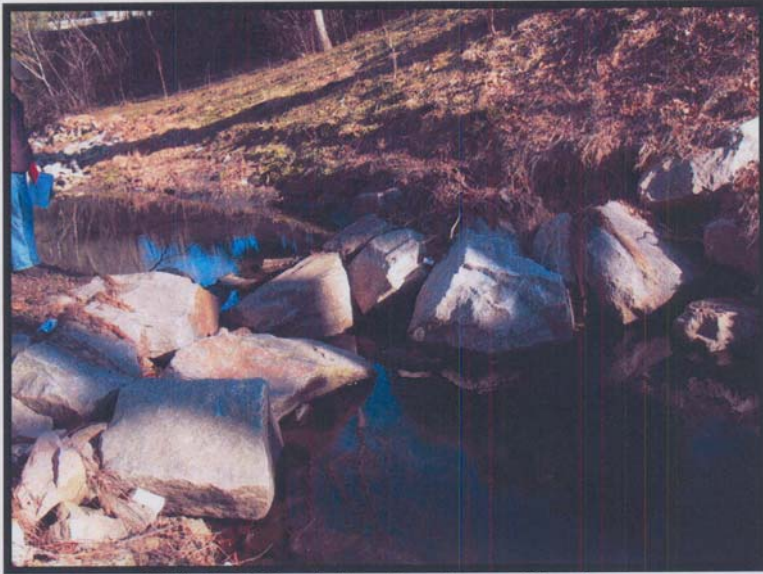
STA 0+95 Bank Arm Erosion on Structure

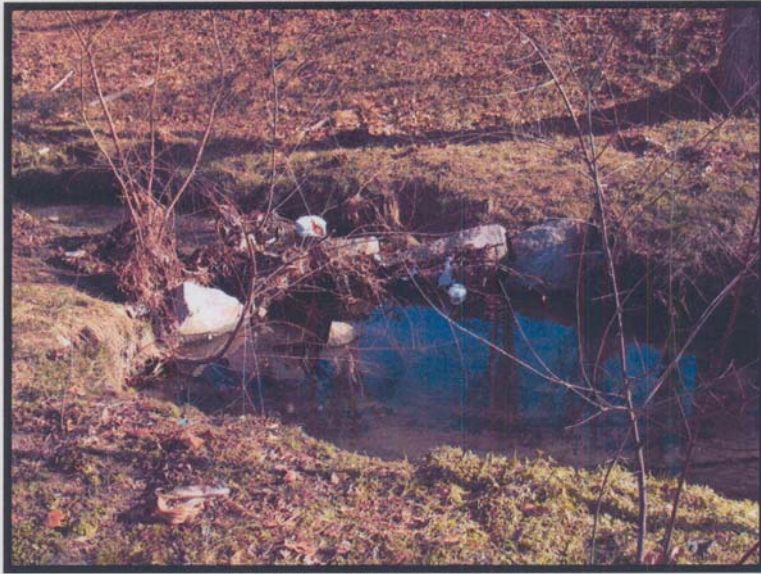
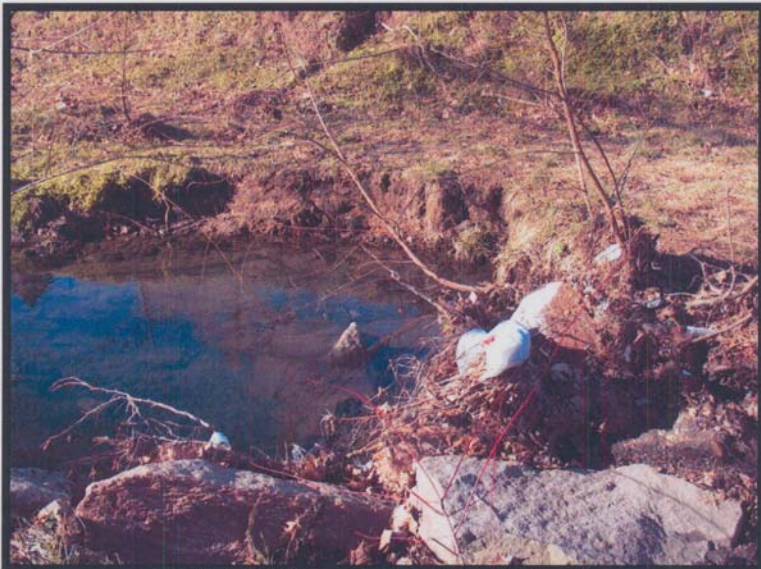
STA 4+75 Blow Out and Bank Erosion

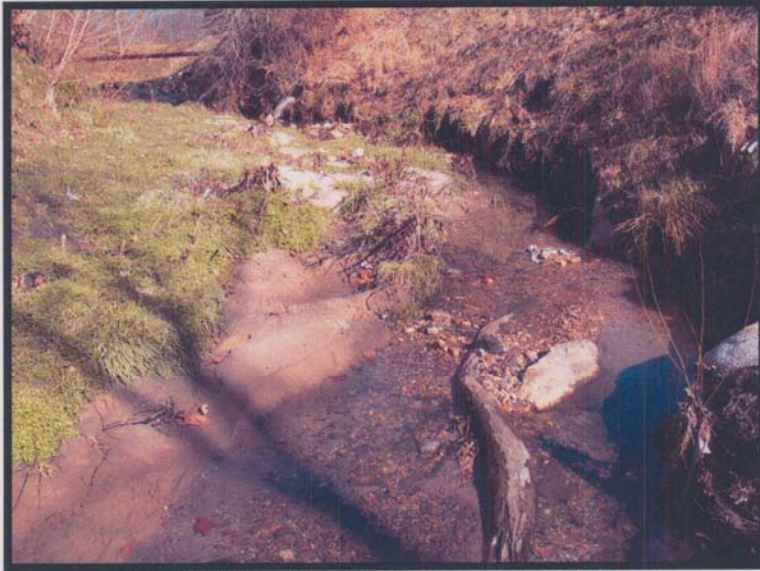
STA 13+25 Looking Upstream at Trash in Pool

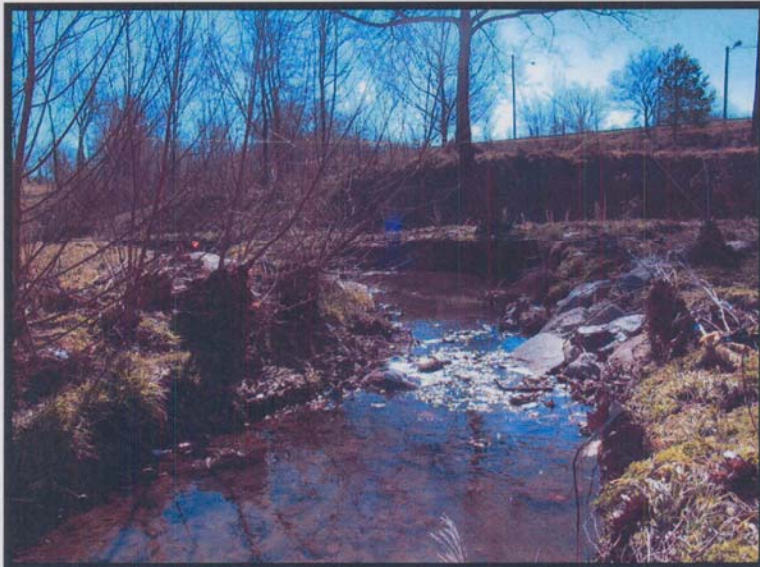
STA 14+00 Misdirected Cross Vane and Bank Erosion

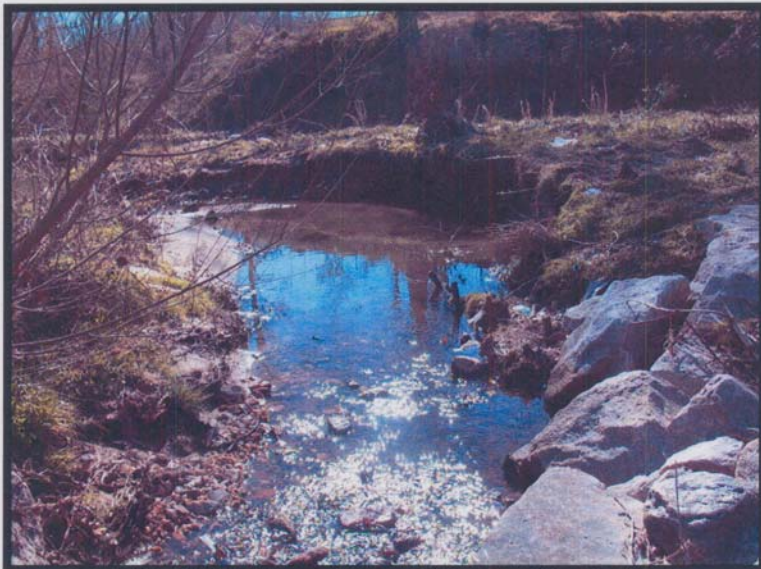
STA 14+25 Misdirected Cross Vane and Bank Erosion

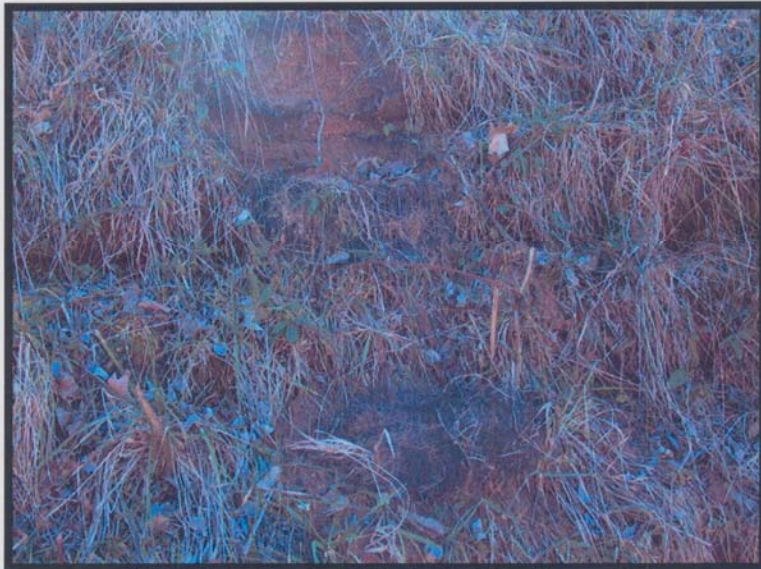
STA 15+00 GeoGrid Bank Stabilization on UT

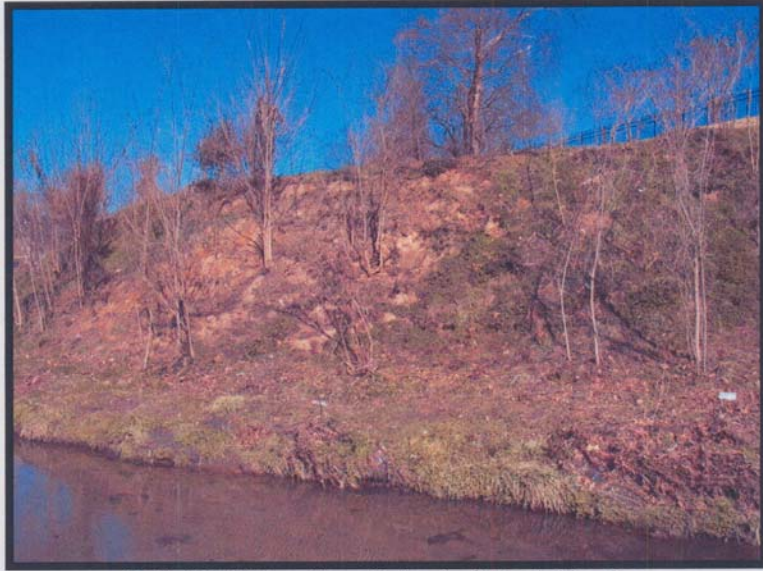
STA 15+50 Looking At the Left Bank Erosion

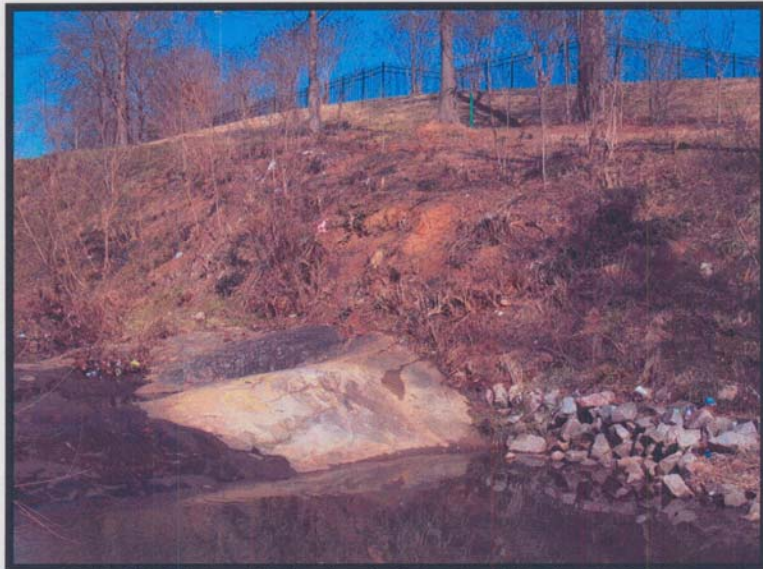
STA 16+50 Bank Erosion Left bank at Bedrock Outcrop

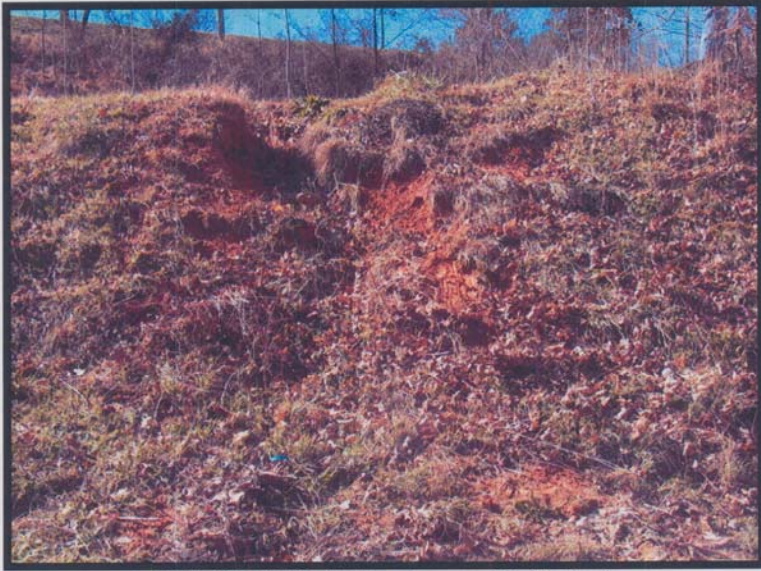
STA 17+00 Gully Erosion on Right Bank
