**Chavis Park (Garner Branch) Stream
Restoration Monitoring Report
EEP Project # 87
Monitoring Year – 02
2005**

**CHAVIS PARK (GARNER BRANCH)
MONITORING PLAN VIEW
WAKE COUNTY
EEP PROJECT NUMBER 87 - MY02
STATION 00+00 TO STATION 17+64**

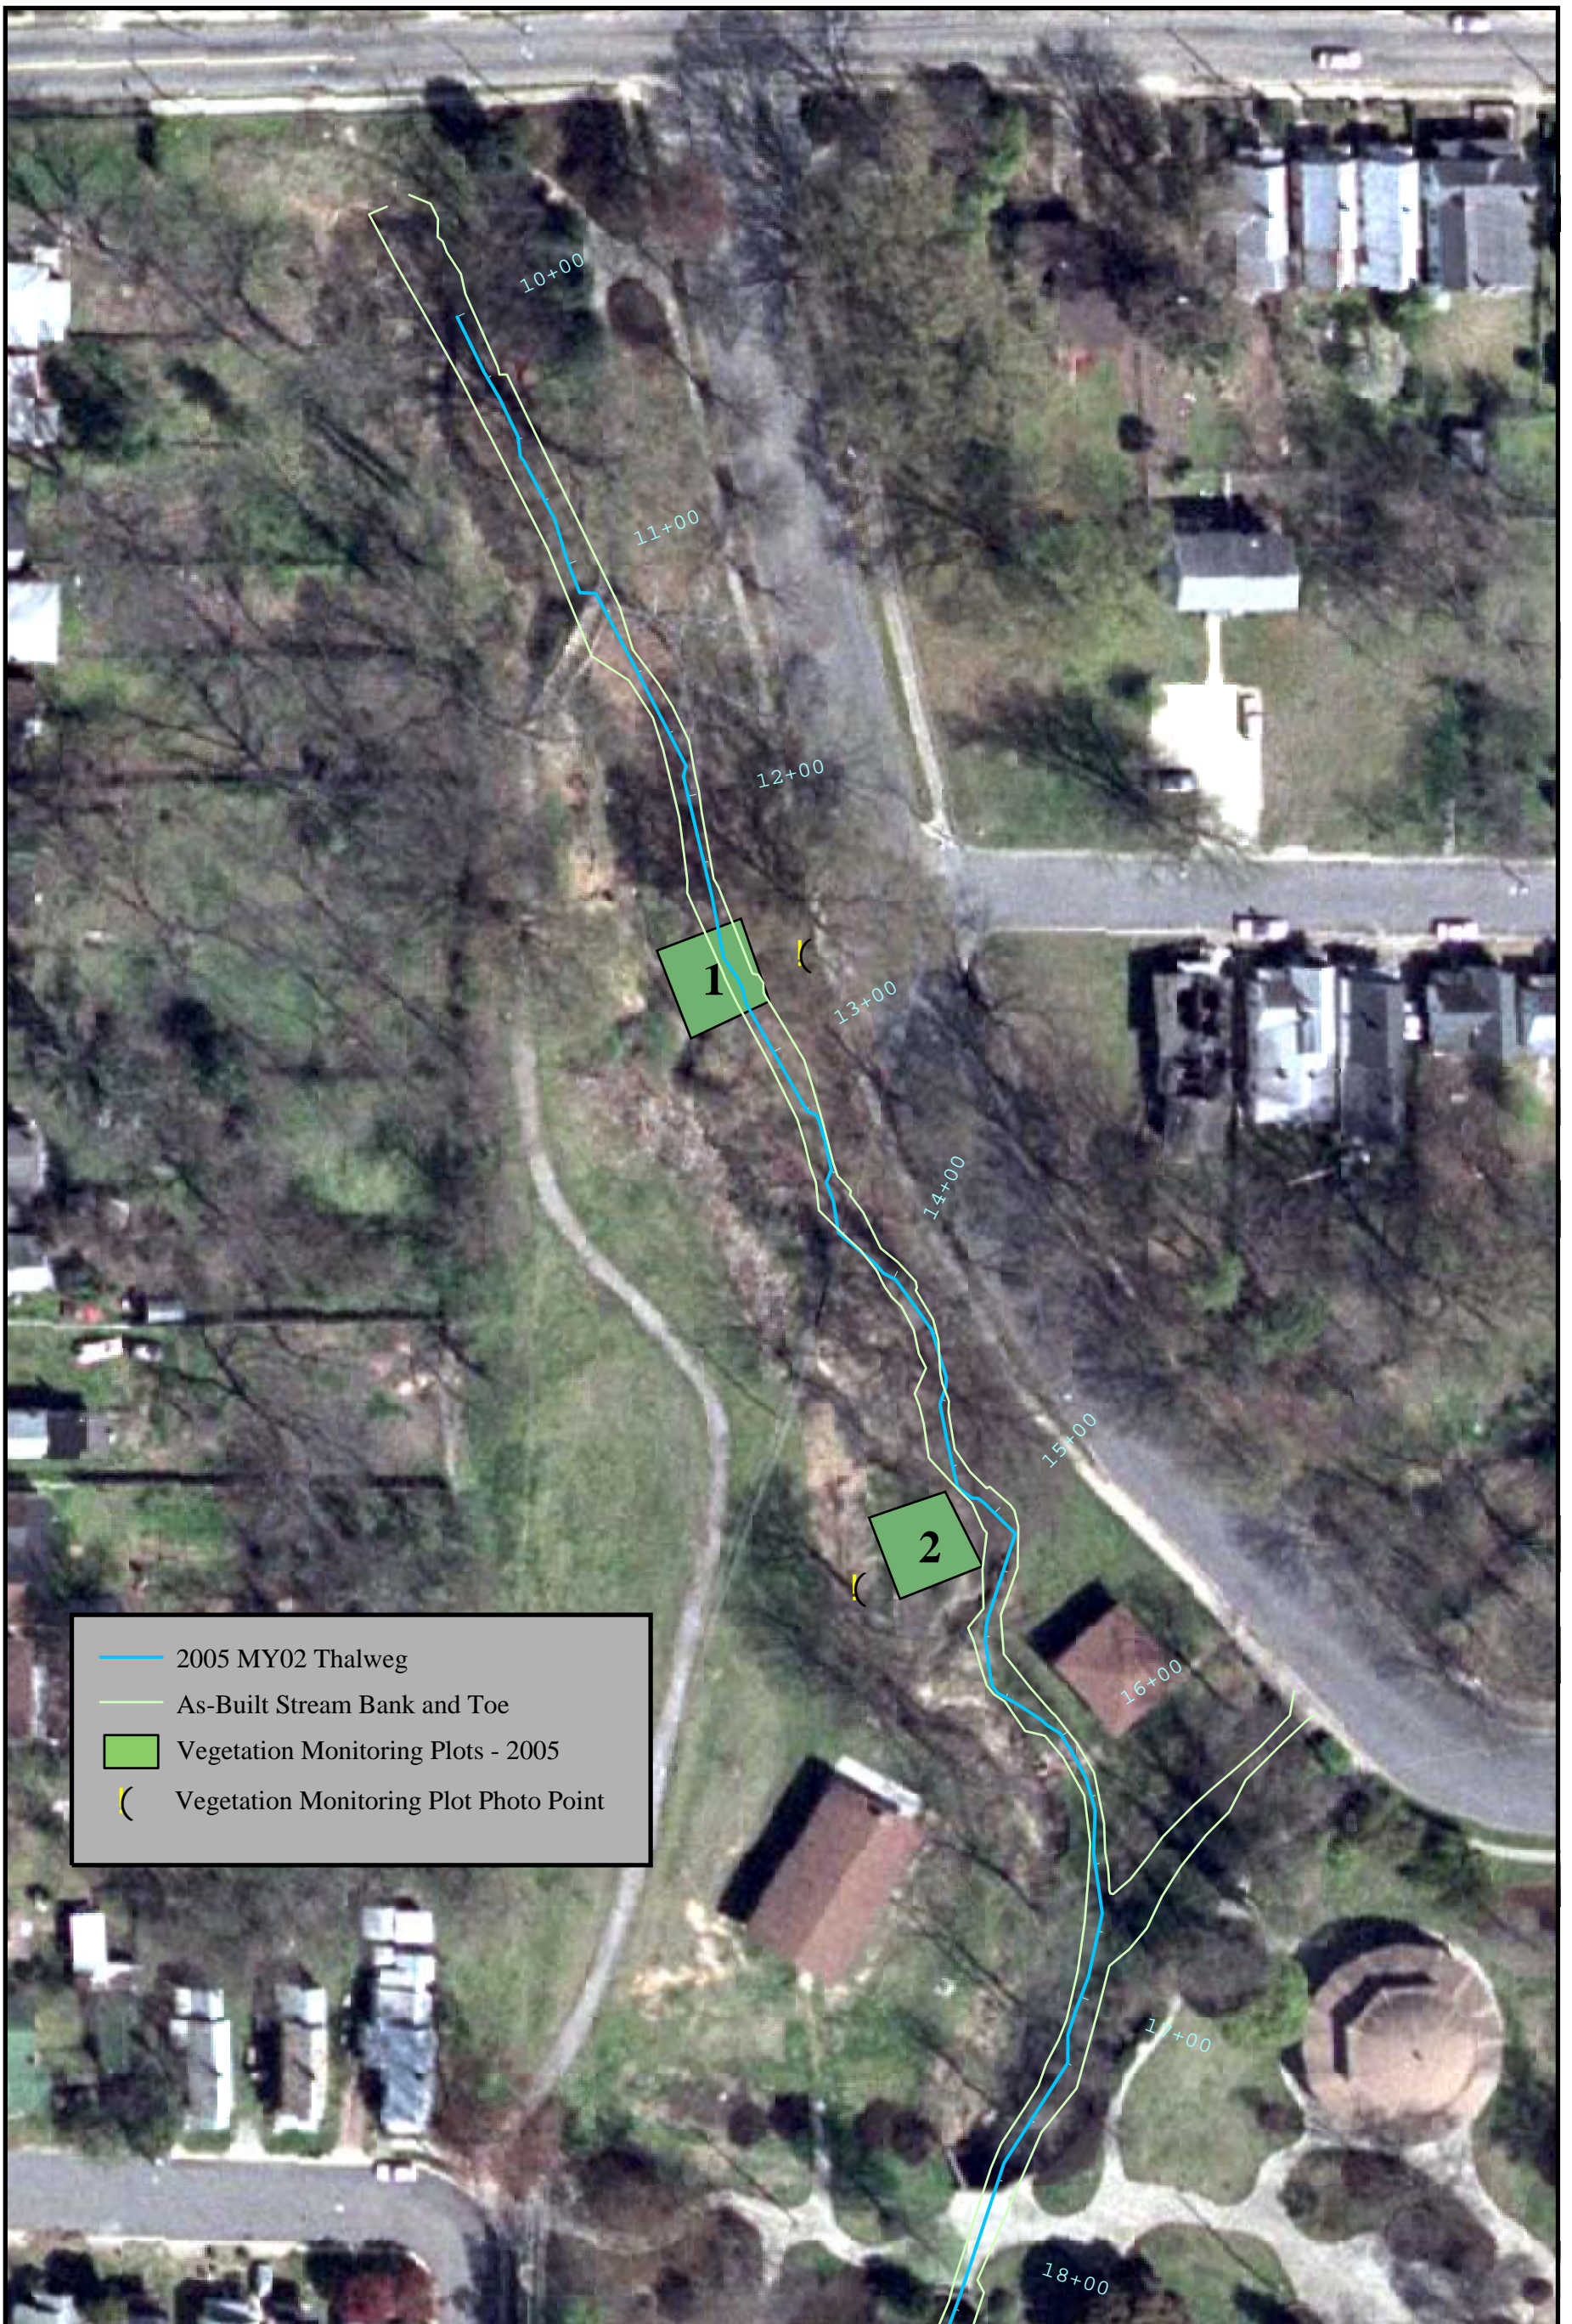
Appendix A2a: Vegetative Problem Area Plan View
 Chavis Park, Wake County, EEP Project Number 87 - MY02

Date: 10-10-05
 Note: No significant vegetative problem areas other than scattered invasive species.
 Source: USGS High Resolution Orthoimage, Raleigh-Durham, NC, 2003.

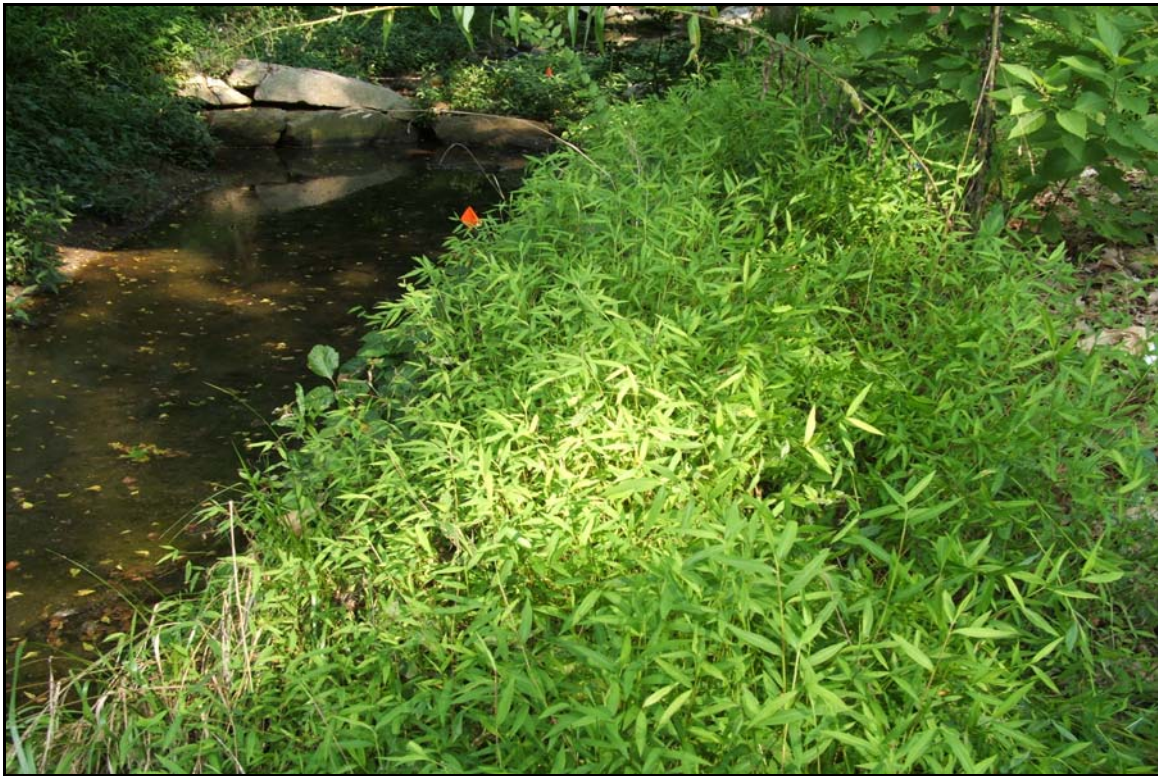
VP1 – Microstegium on stream bank continues sporadically throughout site. Photo taken near station 01+50. 8/16/05 - MY 02

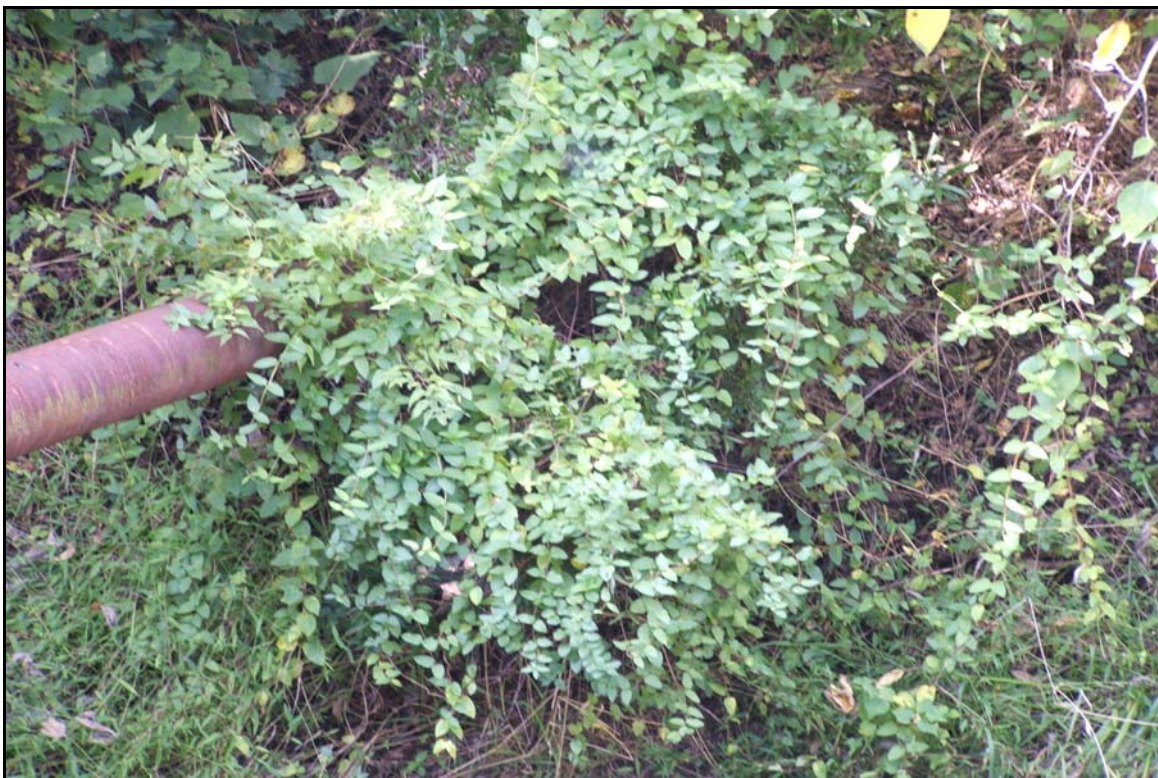
VP2 – Japanese honeysuckle (*Lonicera japonica*) on stream bank and sewer pipe. Photo taken near station 22+00. 10/13/05 - MY 02

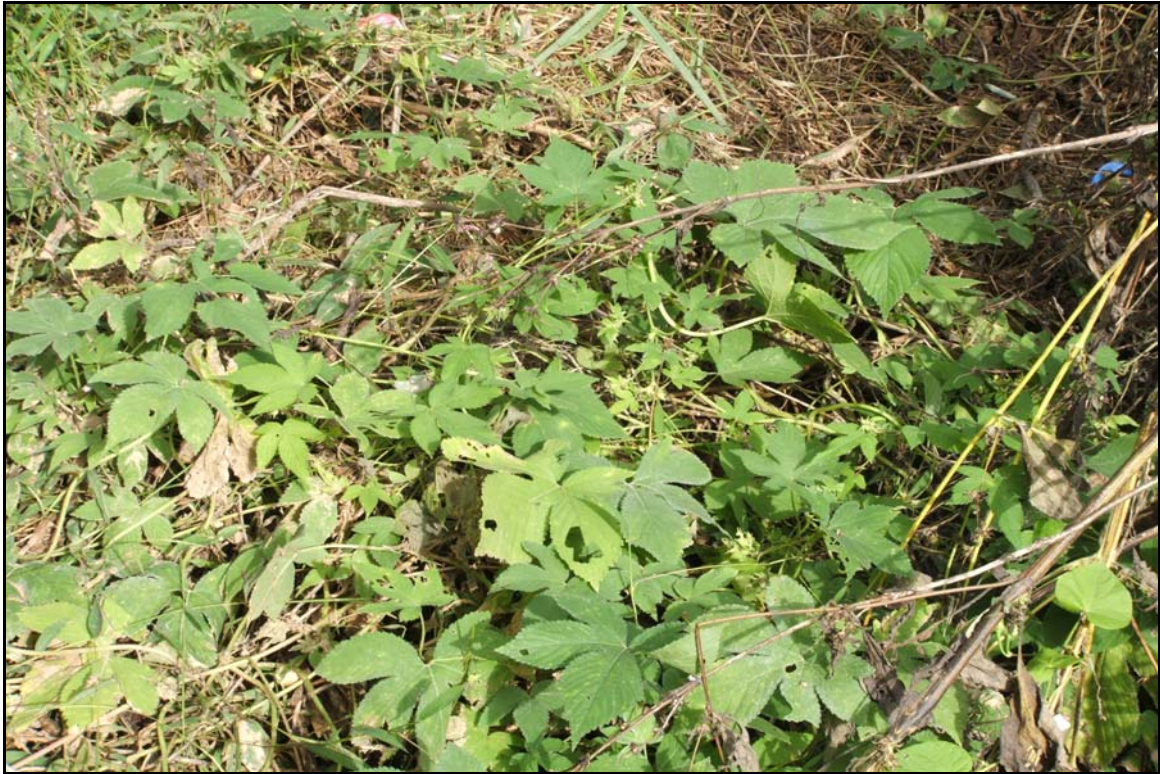
VP3 – Japanese hops (*Humulus japonicus*) on stream bank. Photo taken near station 23+50. 10/13/05 - MY 02

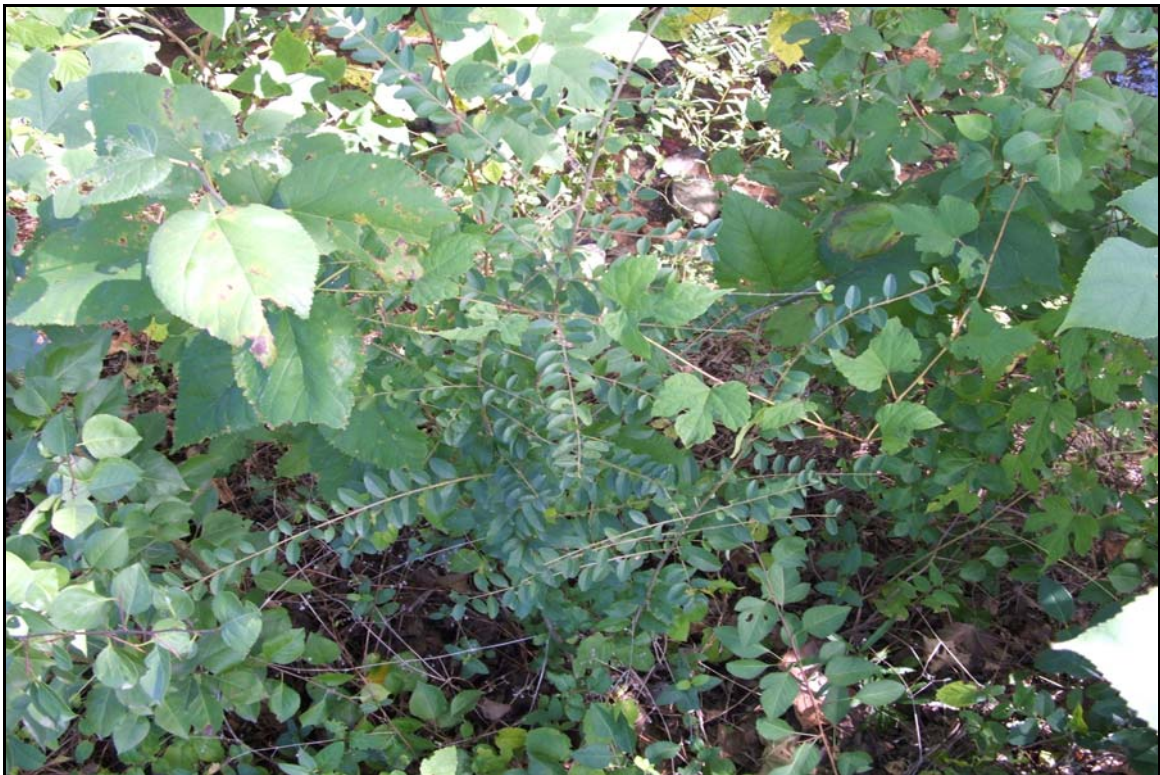
VP4 – Chinese privet (*Ligustrum sinense*) on stream bank. Photo taken near station 24+00. 10/13/05 - MY 02

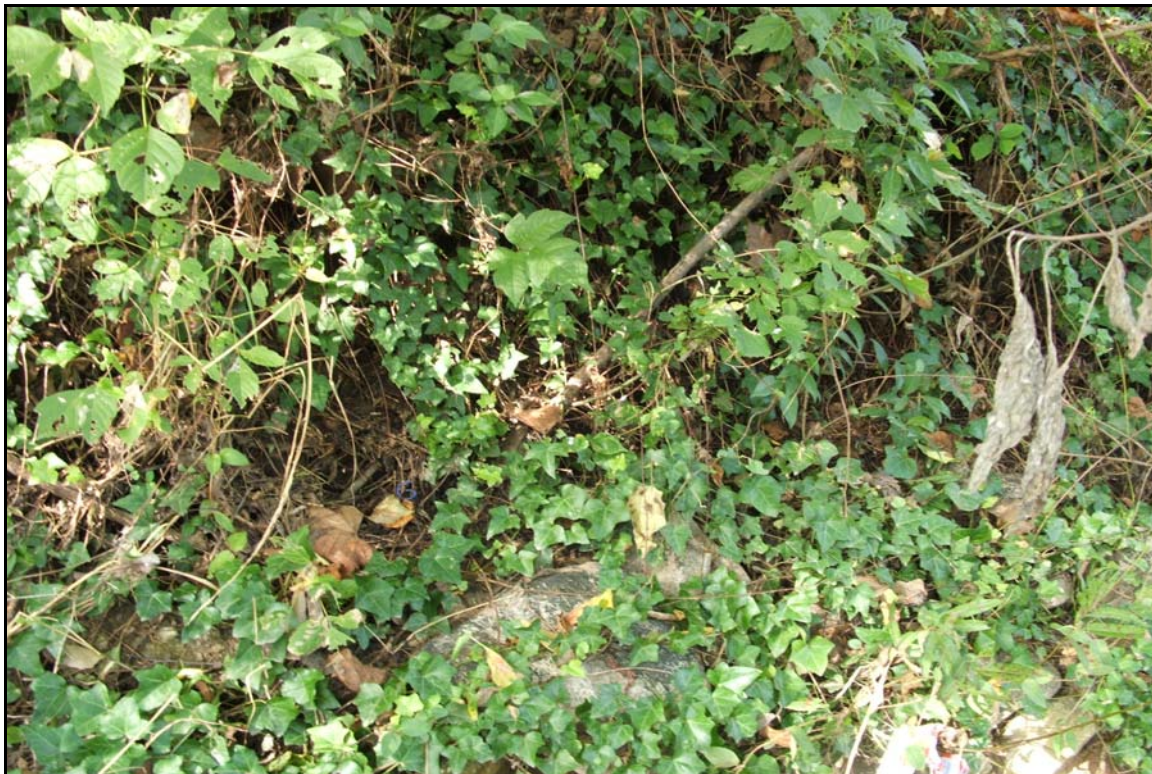
VP5 – English ivy (*Hedera helix*) on stream bank. Photo taken near station 20+75. 10/13/05 - MY 02

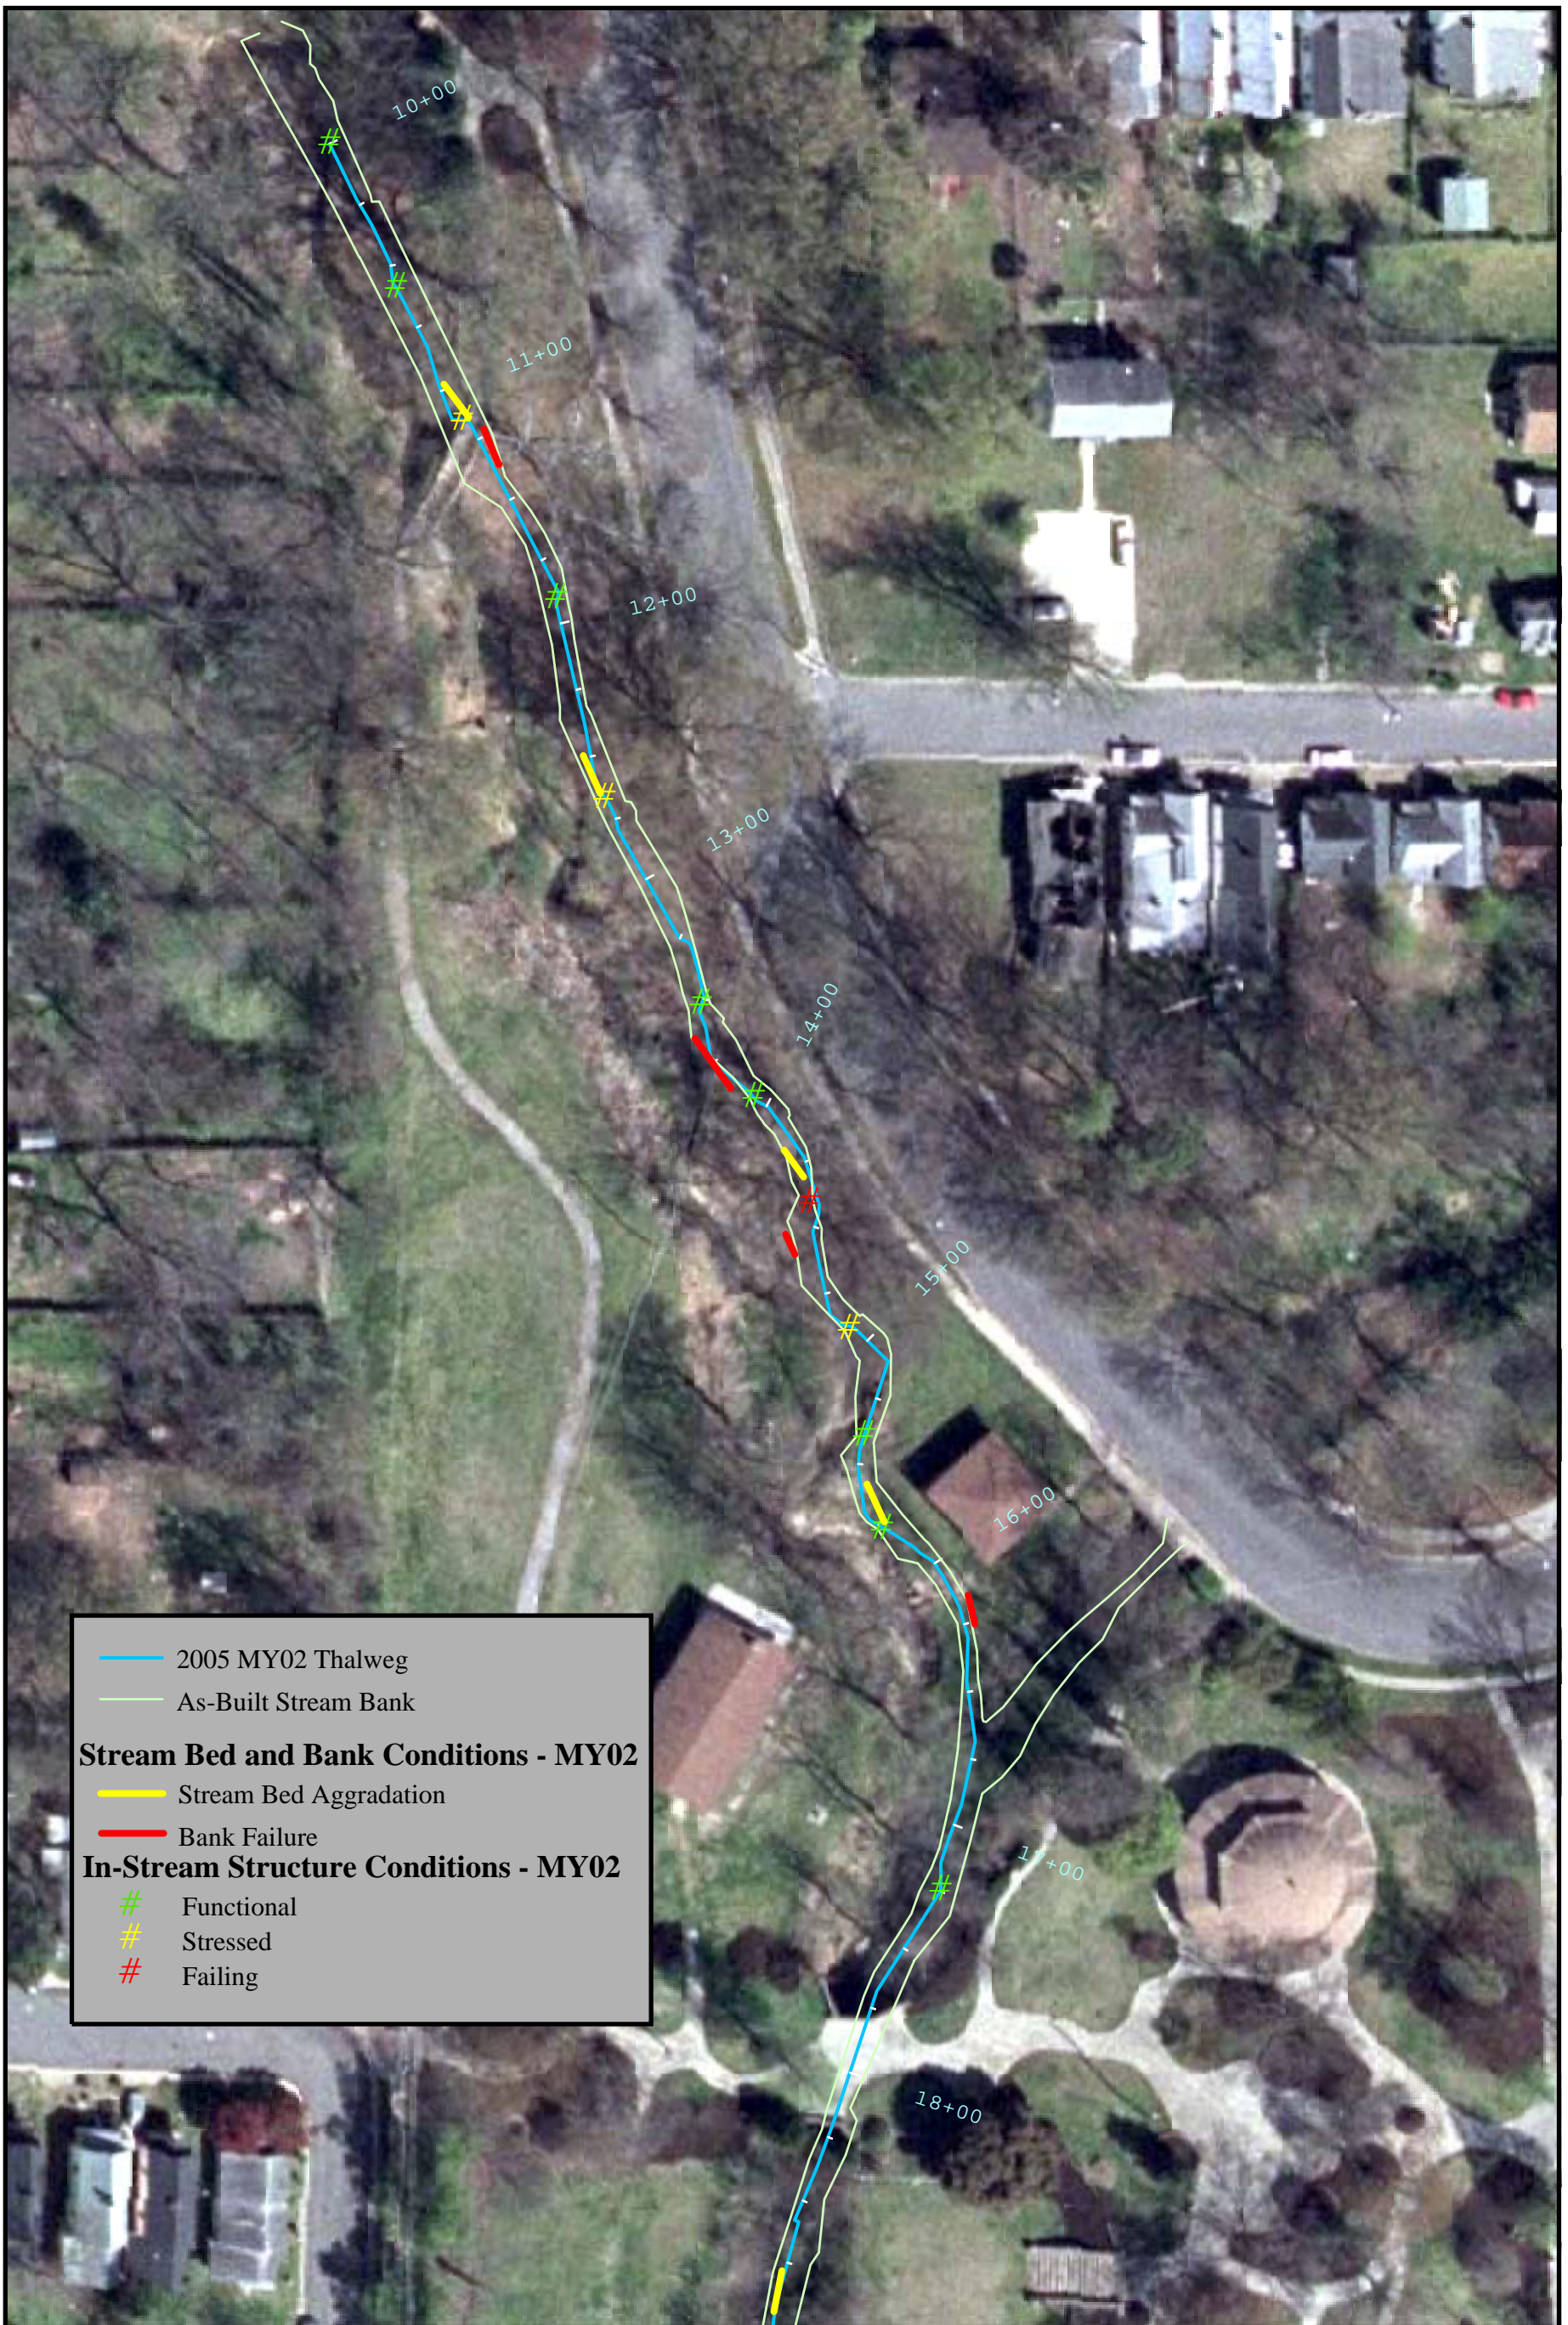
Appendix B1a: Stream Problem Area Plan View
 Chavis Park, Wake County, EEP Project Number 87 - MY02

Date: 10-10-05
 Note: Length of bank and aggradation problems approximated.
 Source: USGS High Resolution Orthoimage, Raleigh-Durham, NC, 2003.

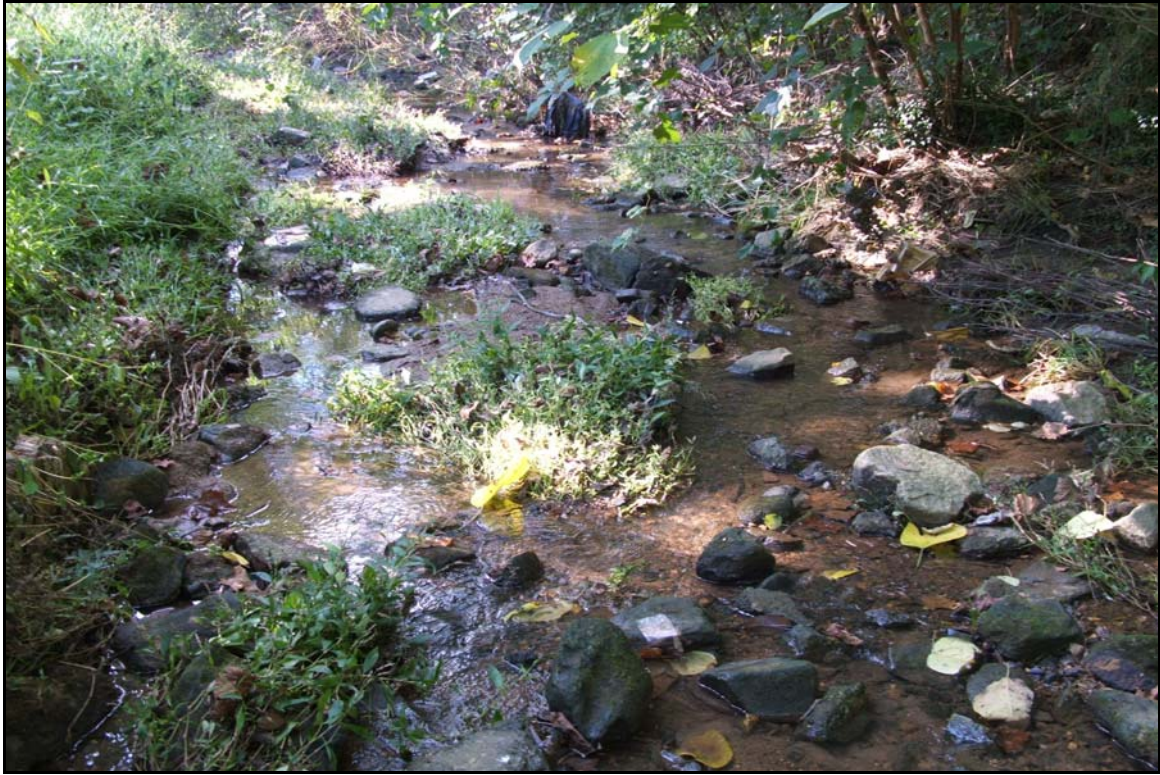
SP1 – Mid-channel bar forming. Photo taken near station 18+90. 10/13/05 - MY 02

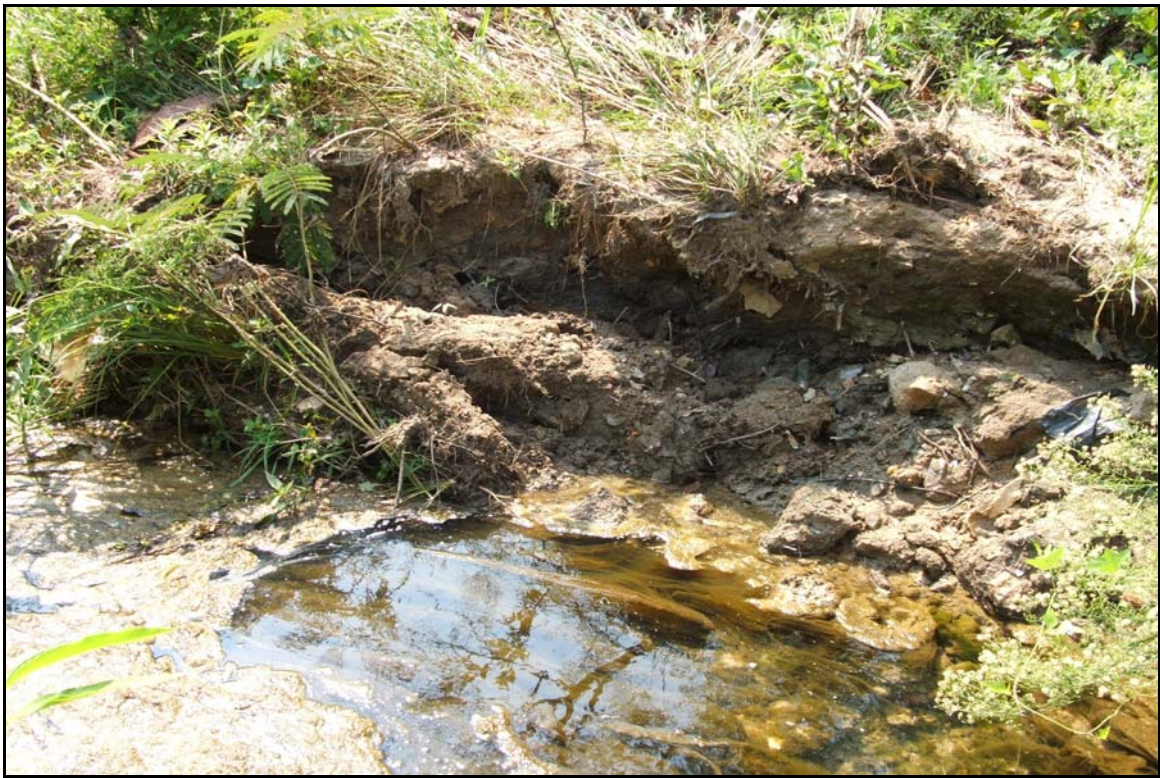
SP2 – Bank erosion/slumping. Photo taken near station 24+50. 8/16/05 - MY 02

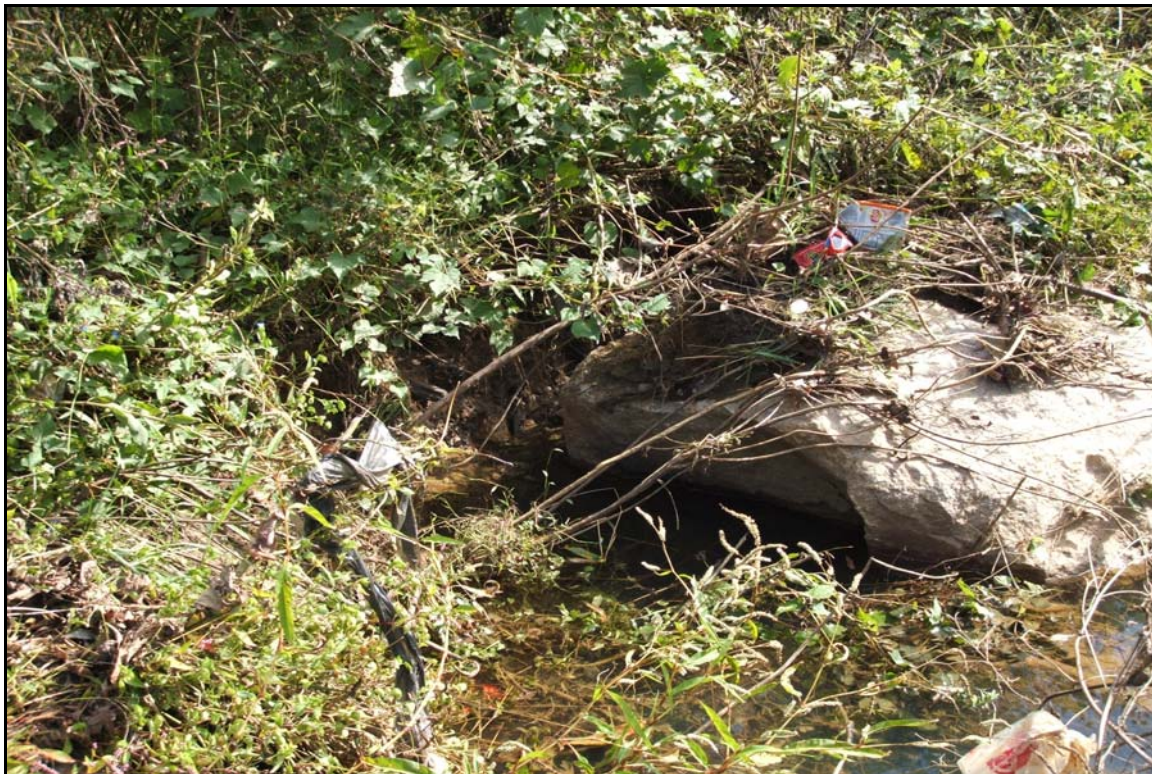
SP3 – Back arm scour on cross vane. Photo taken near station 24+90. 10/13/05 - MY 02

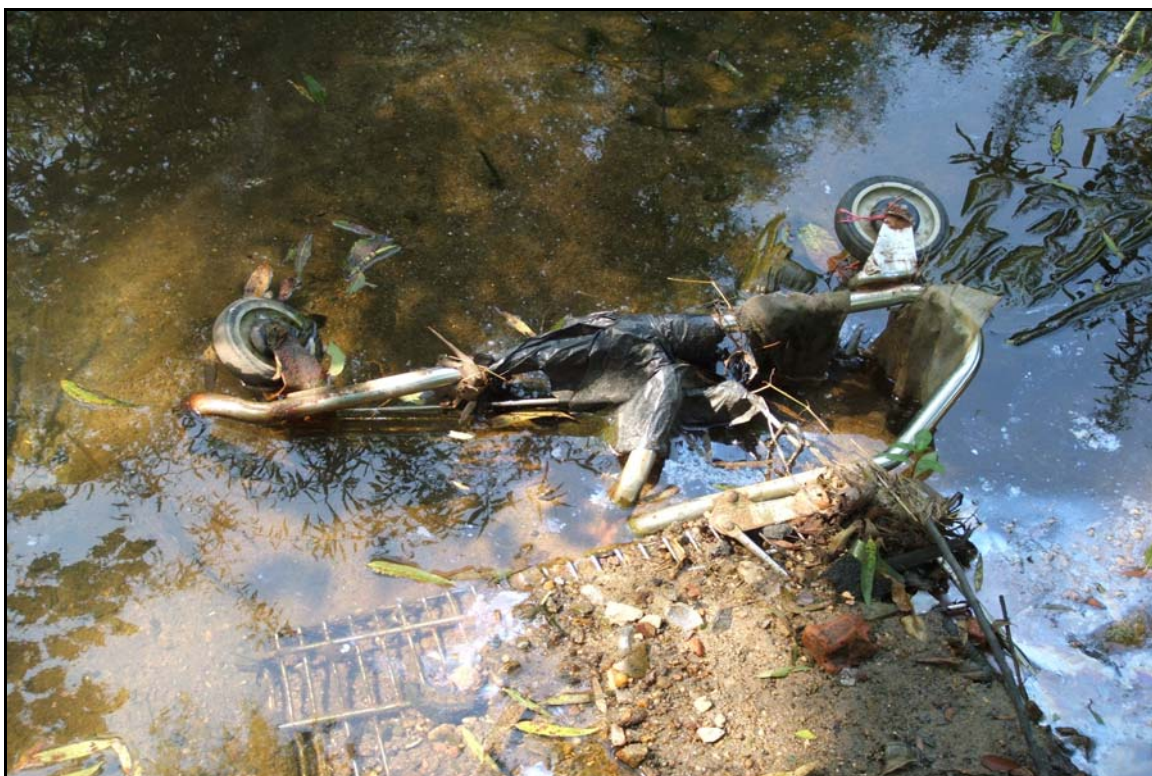
SP4 – Excessive trash, shopping cart and caught trash and debris filling pool. Photo taken near station 14+40. 8/16/05 - MY 02
