**Chavis Park (Garner Branch) Stream
Restoration Monitoring Report
EEP Project # 87
Monitoring Year – 03
2006**

January 2007

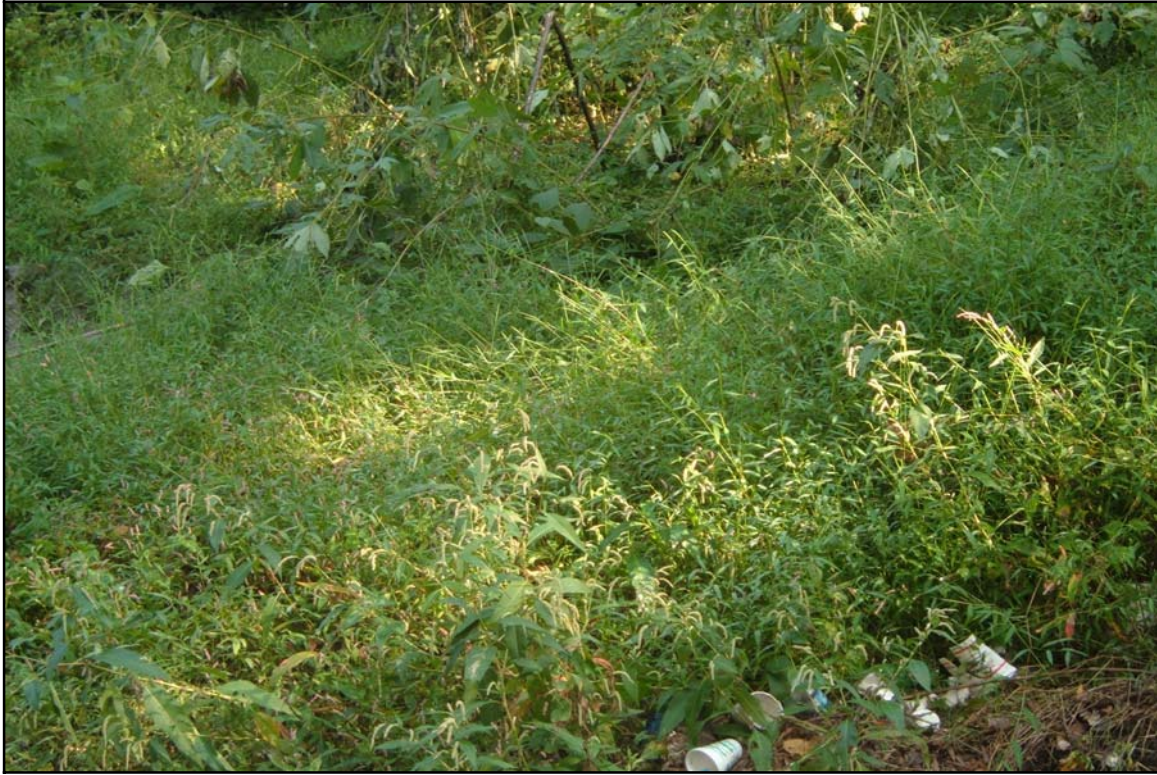
VP1 – *Microstegium* on stream bank continues sporadically throughout site. Photo taken near station 10+25. 10/3/06 - MY 03

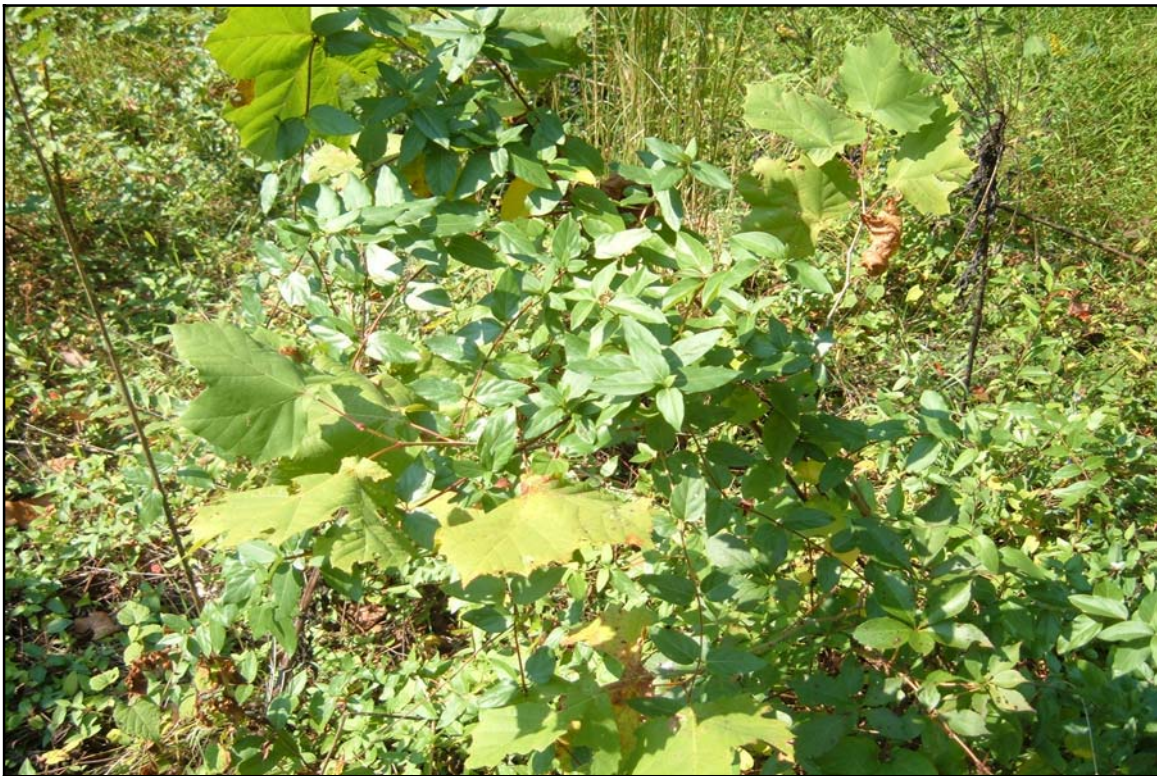
VP2 – Japanese honeysuckle (*Lonicera japonica*) on stream bank and sewer pipe. Photo taken near station 21+10. 10/3/06 - MY 03

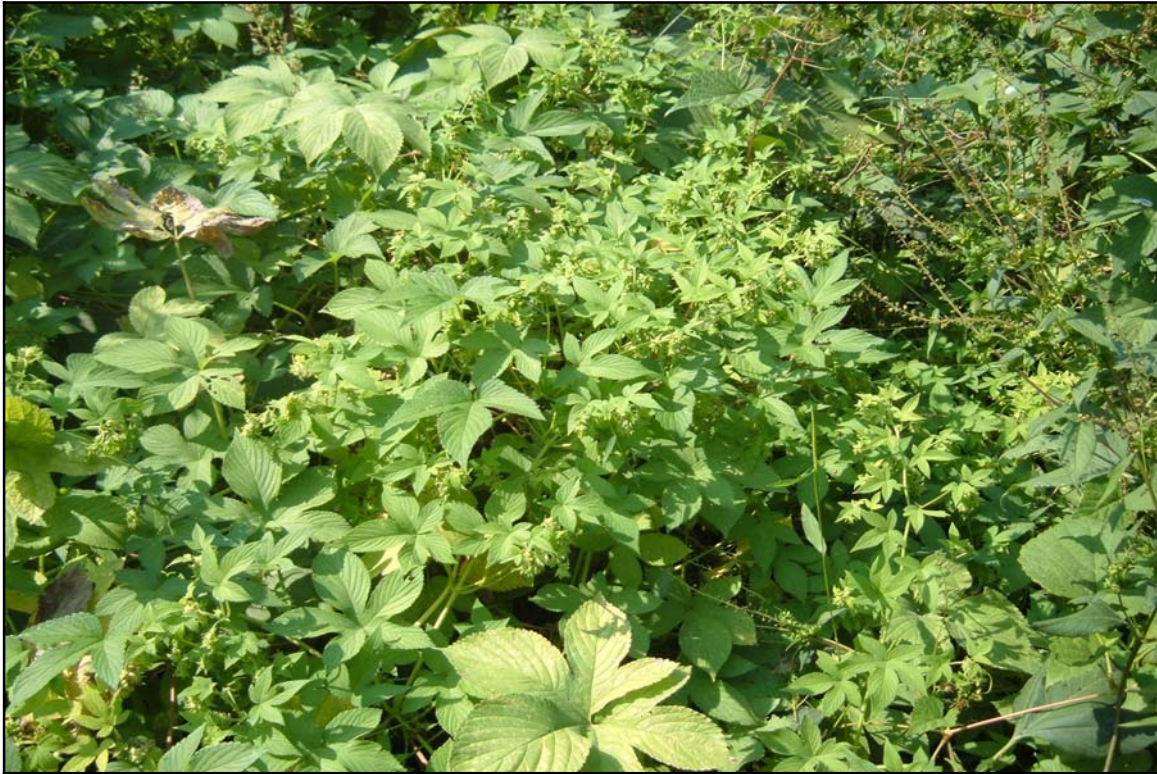
VP3 – Japanese hops (*Humulus japonicus*) on stream bank. Photo taken near station 24+50. 10/3/06 - MY 03

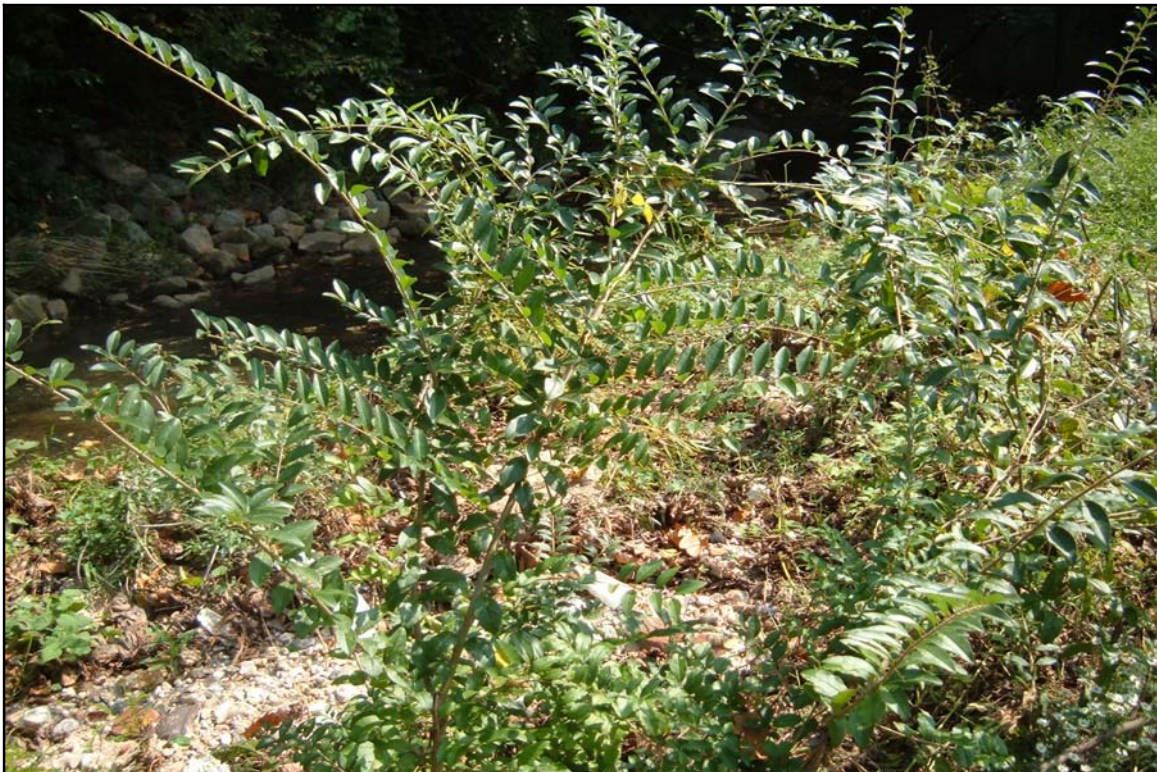
VP4 – Chinese privet (*Ligustrum sinense*) on stream bank. Photo taken near station 27+00. 10/3/06 - MY 03

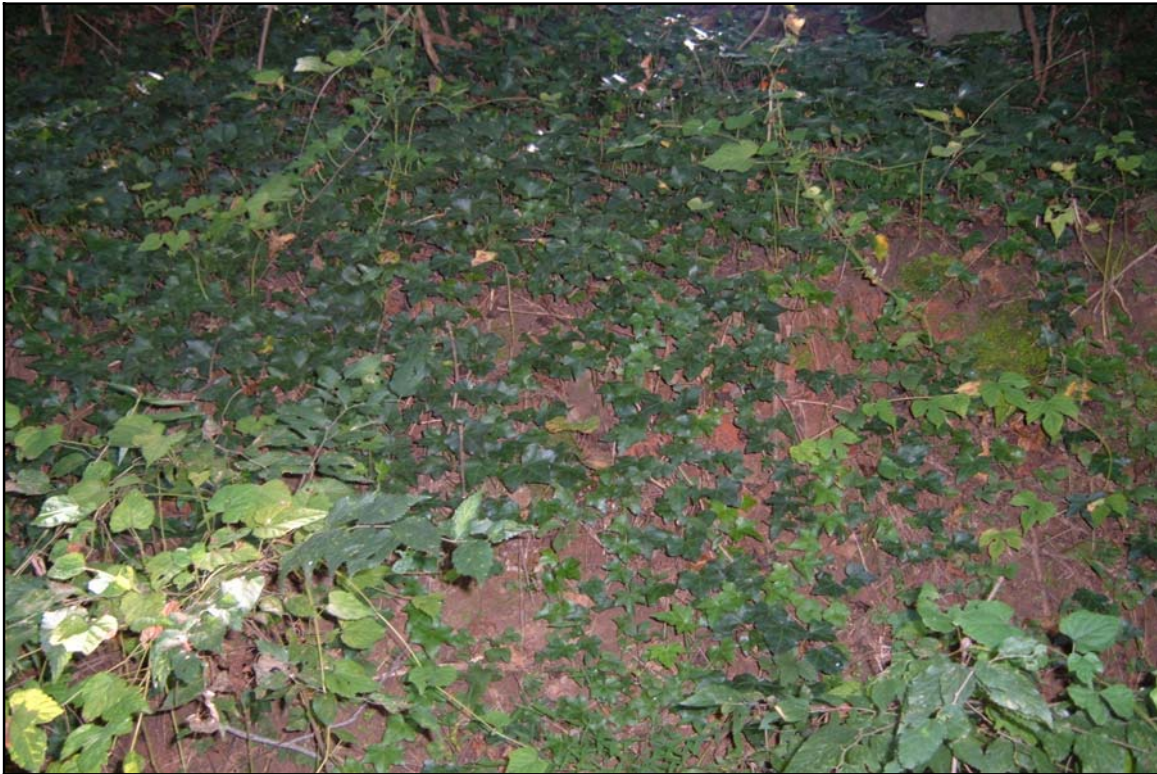
VP5 – English ivy (*Hedera helix*) on stream bank. Photo taken near station 17+00. 10/3/06 - MY 03

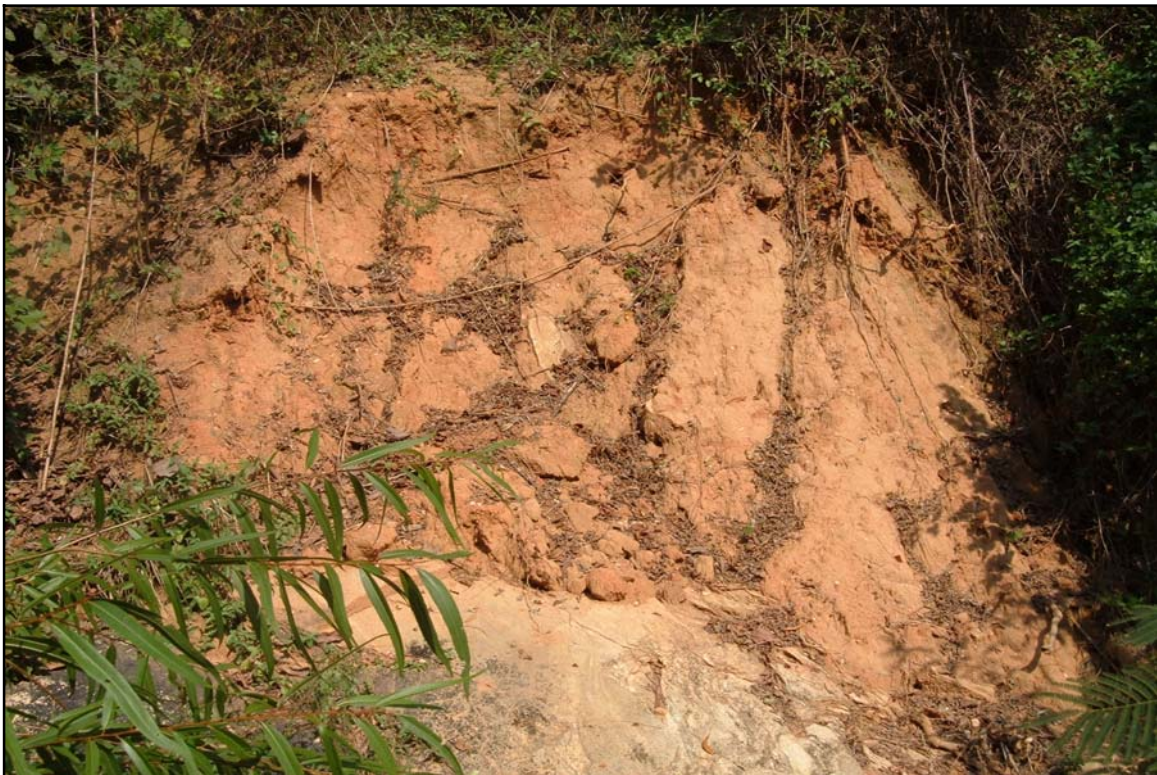
VP6 – Bare bank on streamside, above bedrock. Photo taken near station 26+25. 10/3/06 - MY 03

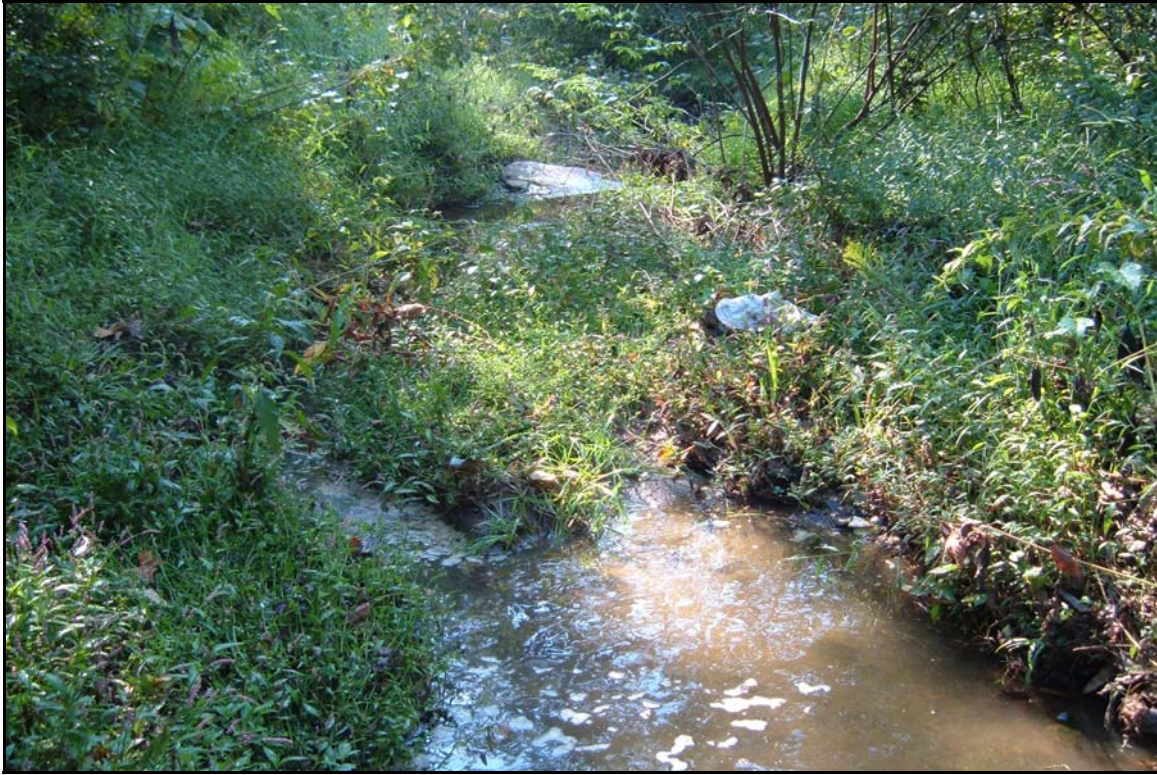
SP1 – Mid-channel bar forming. Photo taken near station 13+30. 10/3/06 - MY 03

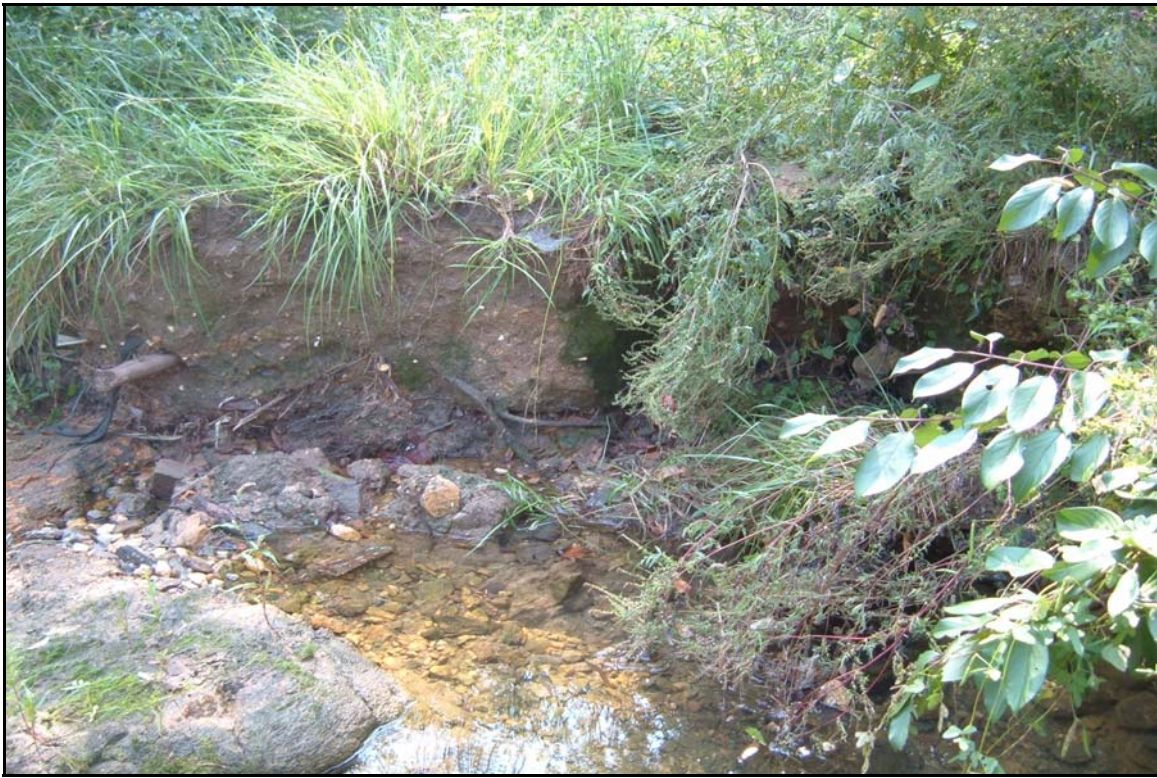
SP2 – Bank erosion/slumping. Photo taken near station 24+50. 10/3/06 - MY 03

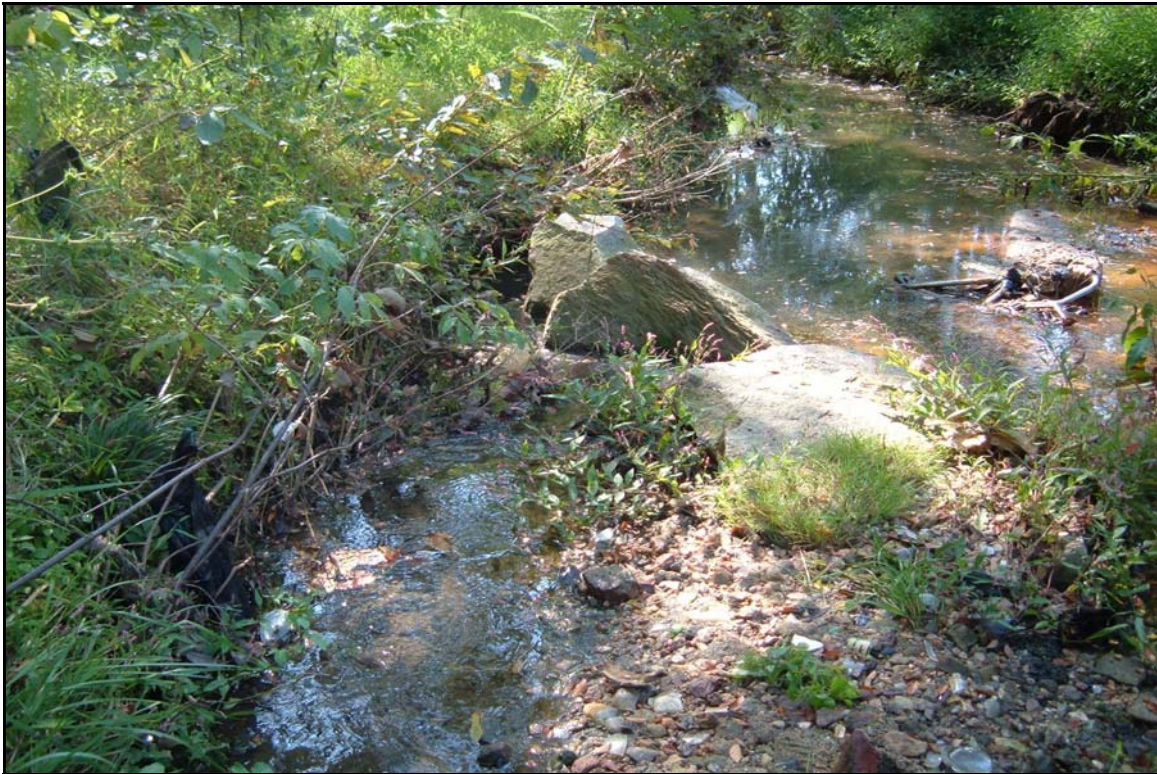
SP3 – Back arm scour on cross vane. Photo taken near station 14+50. 10/3/06 - MY 03

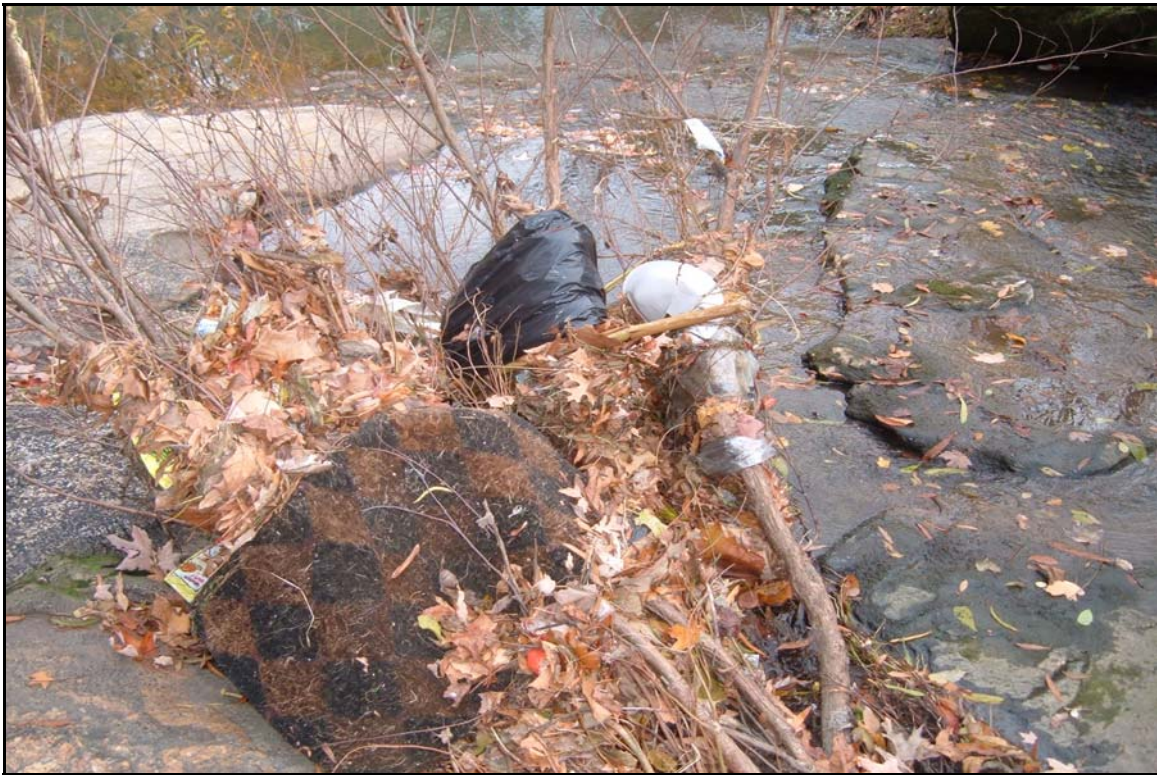
SP4 – Excessive trash. Photo taken near station 25+30. 10/3/06 - MY 03
