**Chavis Park (Garner Branch)
Stream Restoration Monitoring Report
EEP Project # 87
Monitoring Year – 04
2007**

February 2008

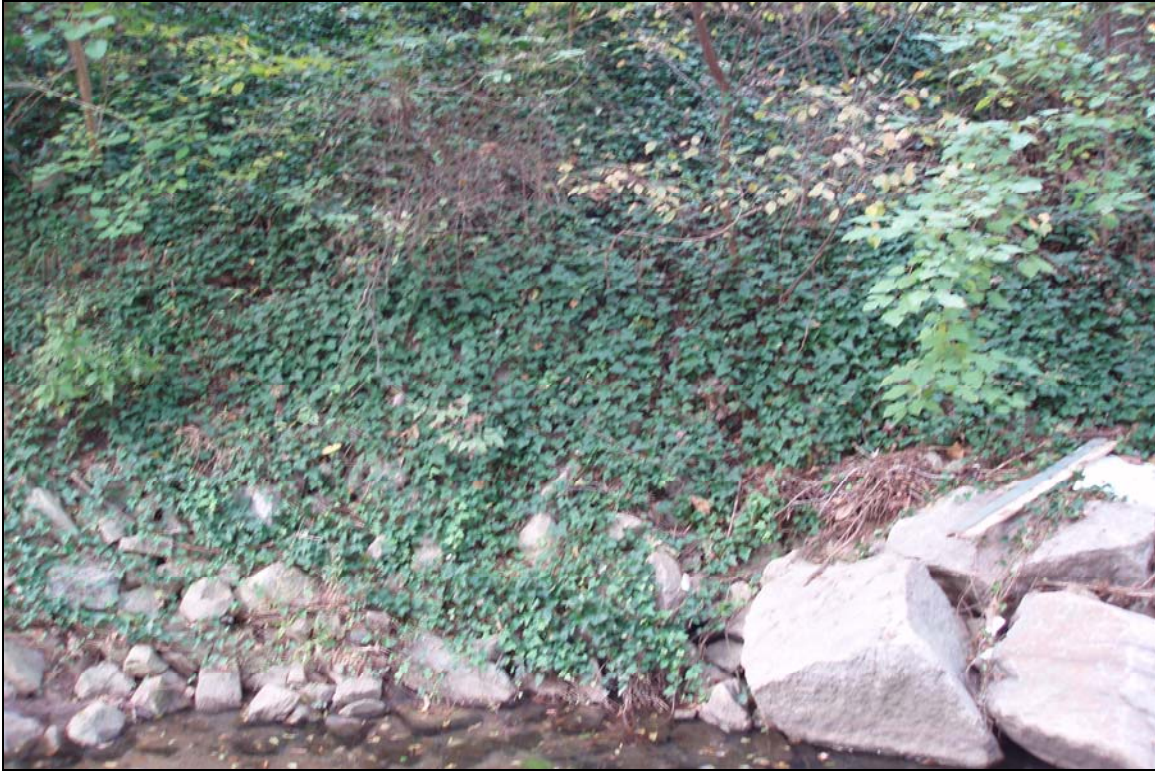
VP1 – English ivy (*Hedera helix*) on stream bank. Photo taken near Station 10+50. 11/12/07 - MY 04

Due to the urban location of Chavis Park there are many sources of invasive species close to the project and complete eradication of these plants is not possible. Controlling the invasive species by spraying and manual removal could help reduce the closest seed sources and decrease competition with the planted native species. The removal of the large white mulberry trees in the easement is recommended.

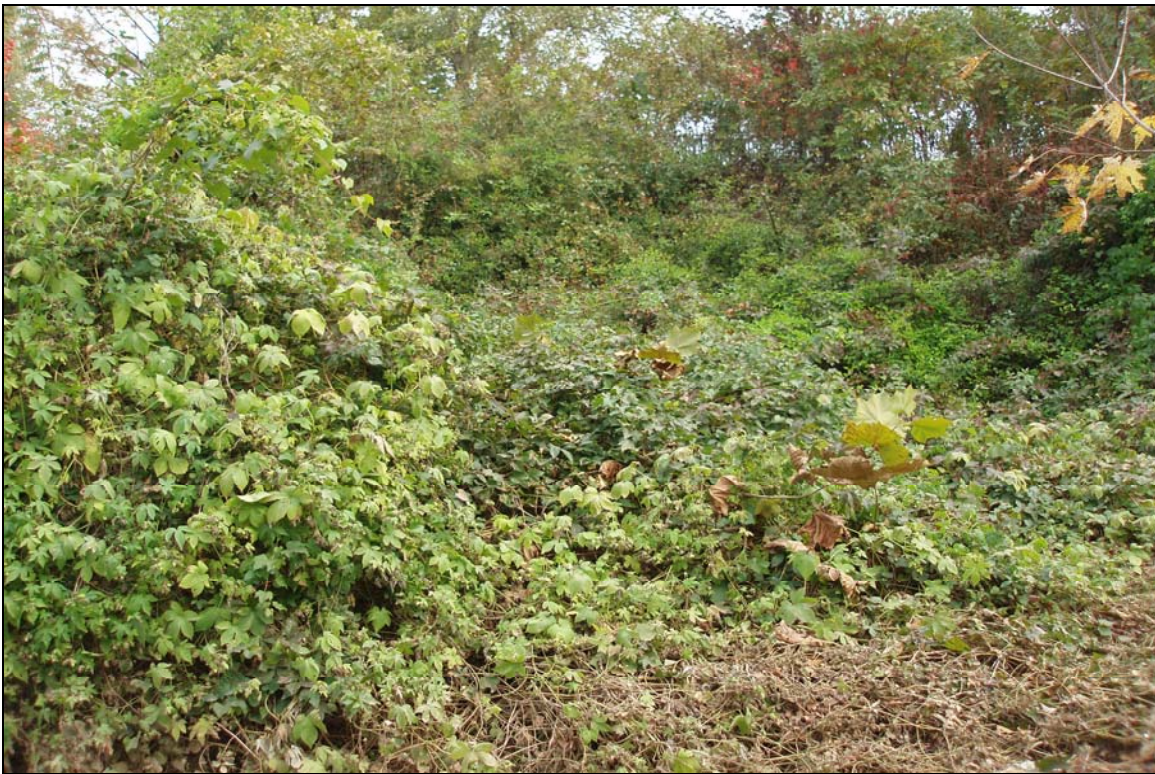
VP2 – Japanese hops (*Humulus japonicus*) on stream bank and terrace. Photo taken near Station 24+50. 11/12/07 - MY 04

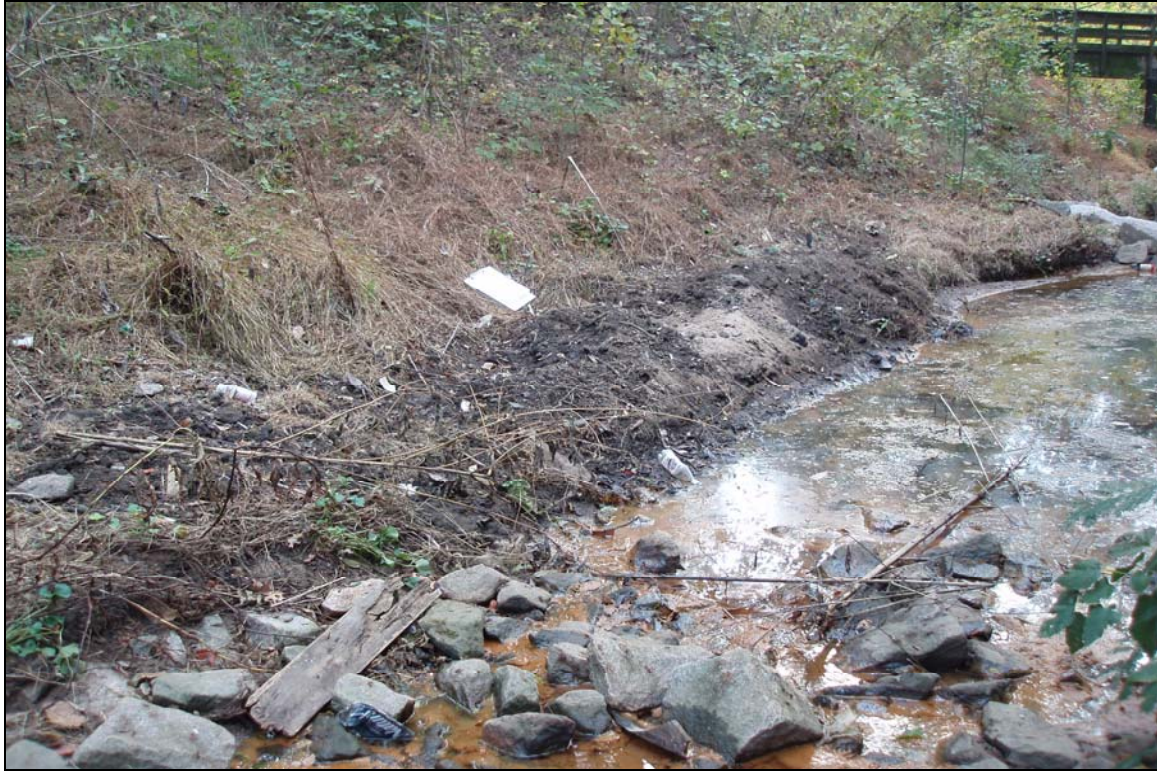
VP3 – Unconsolidated dirt dumped on stream bank. Photo taken near Station 10+50. 11/12/07 - MY 04

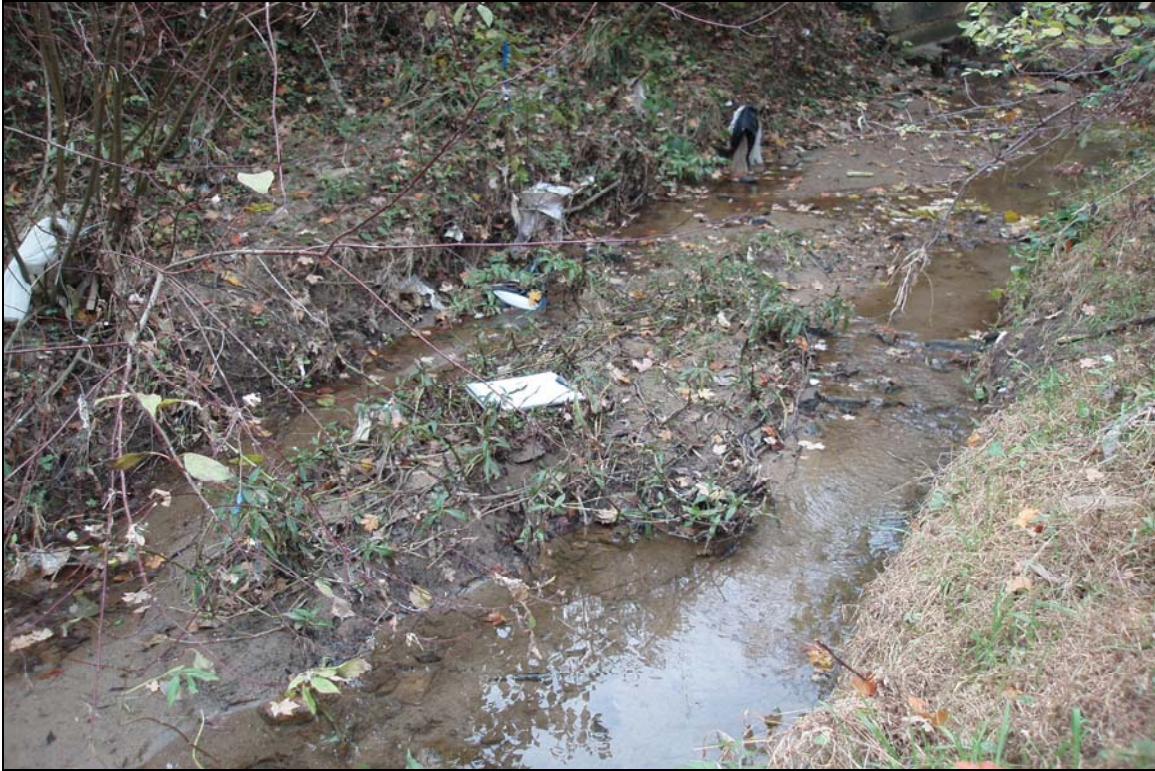
SP1 – Mid-channel bar forming. Photo taken on tributary. 11/12/07 - MY 04

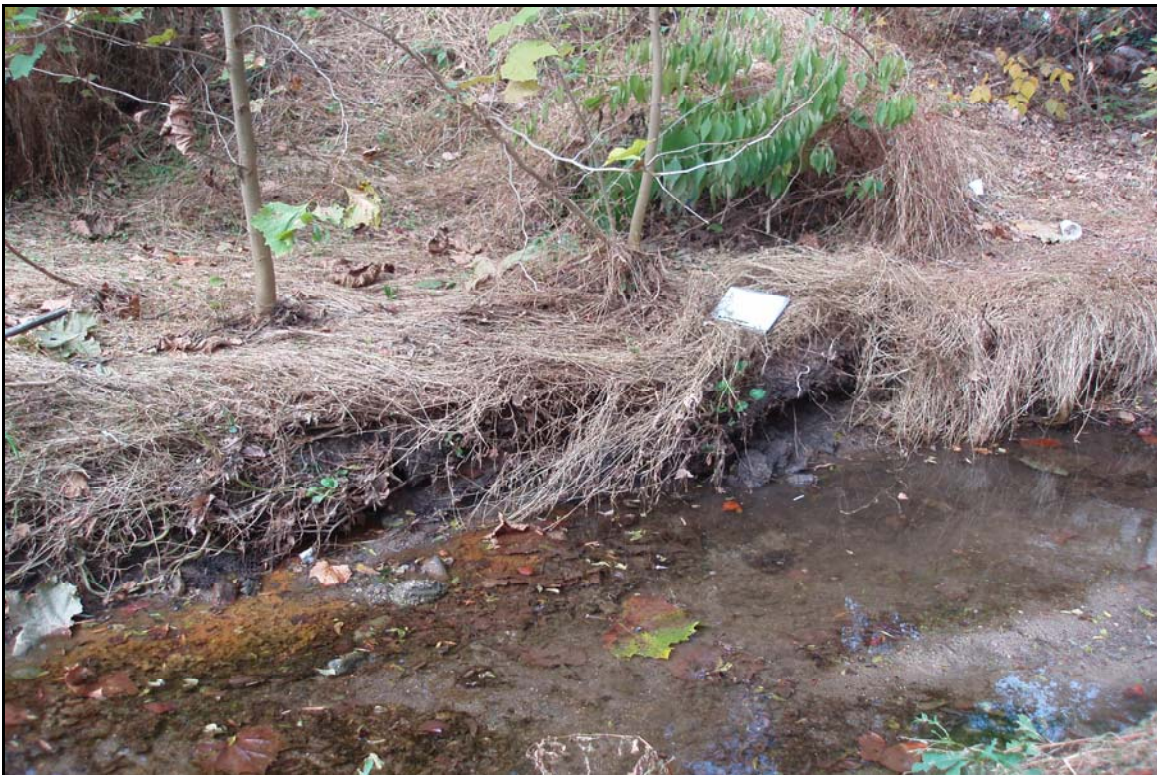
SP2 – Bank erosion/slumping. Photo taken near Station 11+60. 11/12/07 - MY 04

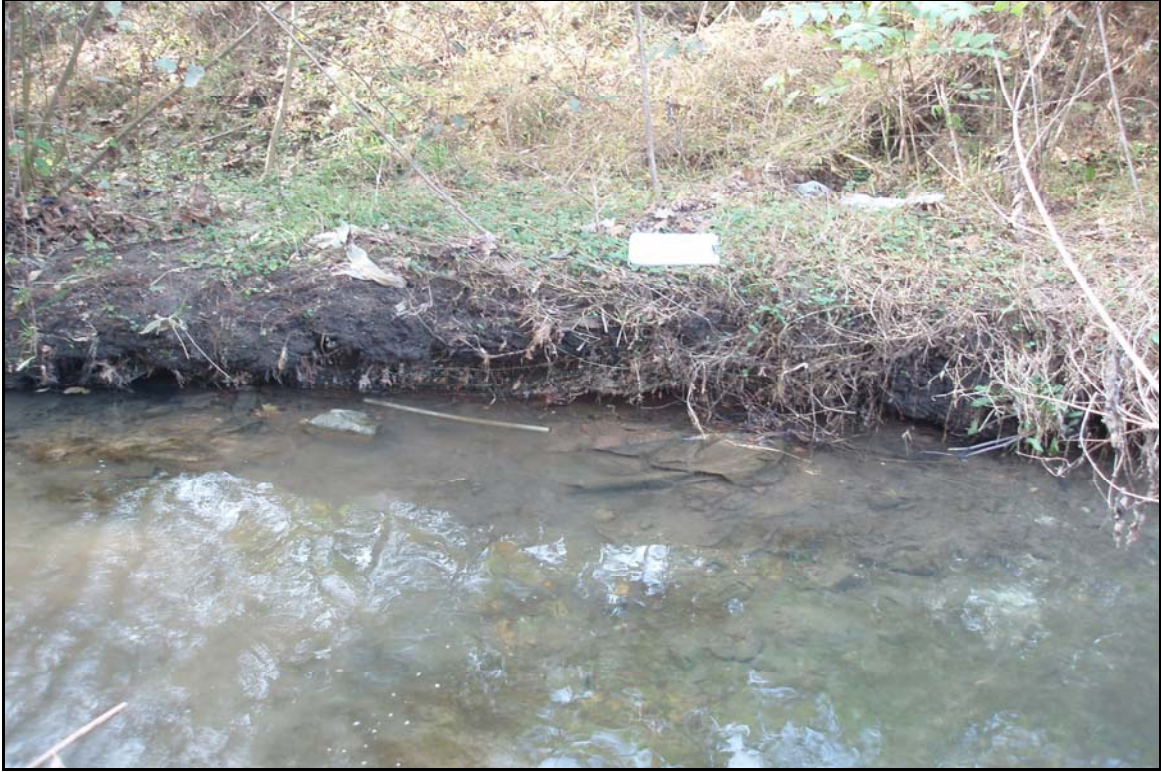
SP3 – Bank erosion/slumping. Photo taken near Station 13+70. 11/12/07 - MY 04

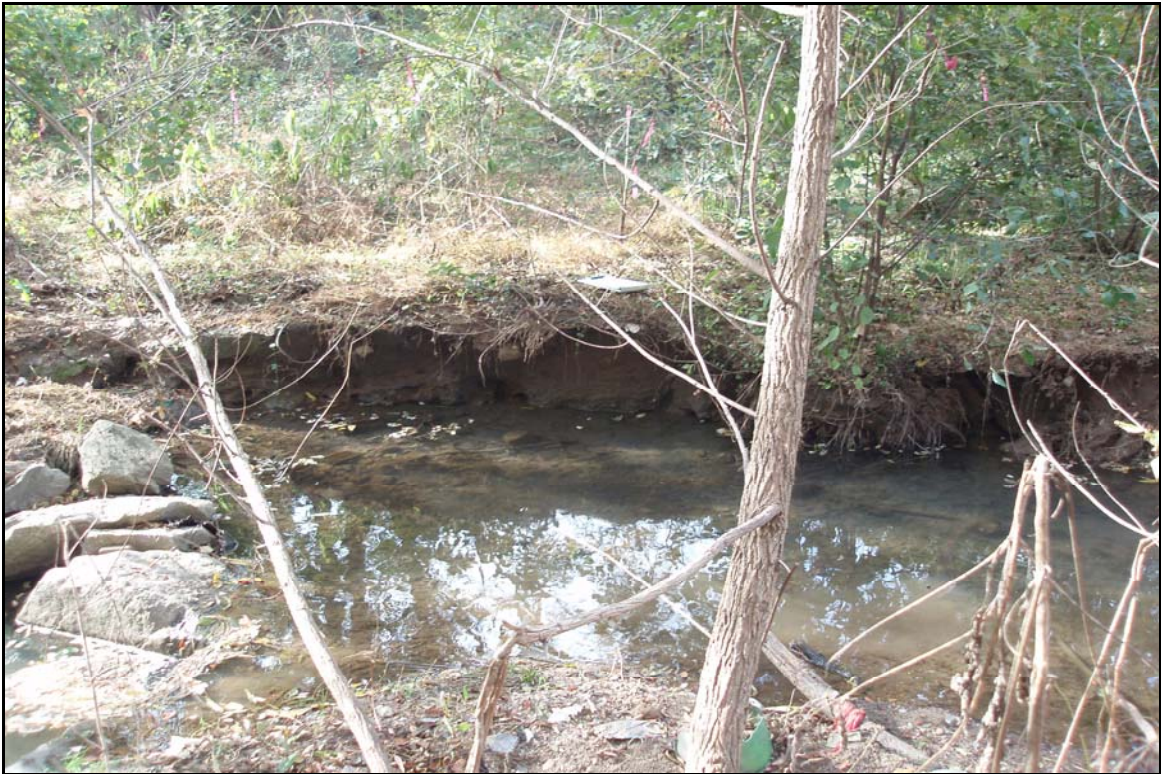
SP4 – Bank erosion/slumping. Photo taken near Station 14+95. 11/12/07 - MY 04

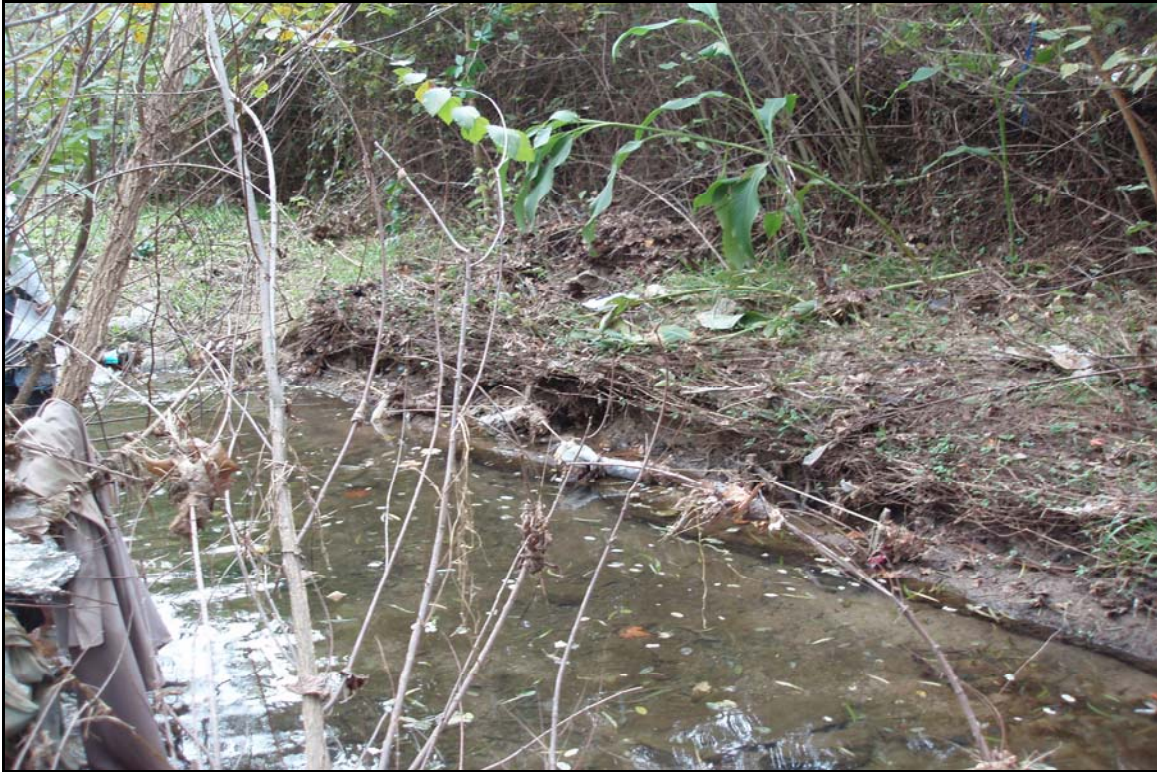
SP5 – Bank erosion/slumping. Photo taken near Station 24+25. 11/12/07 - MY 04

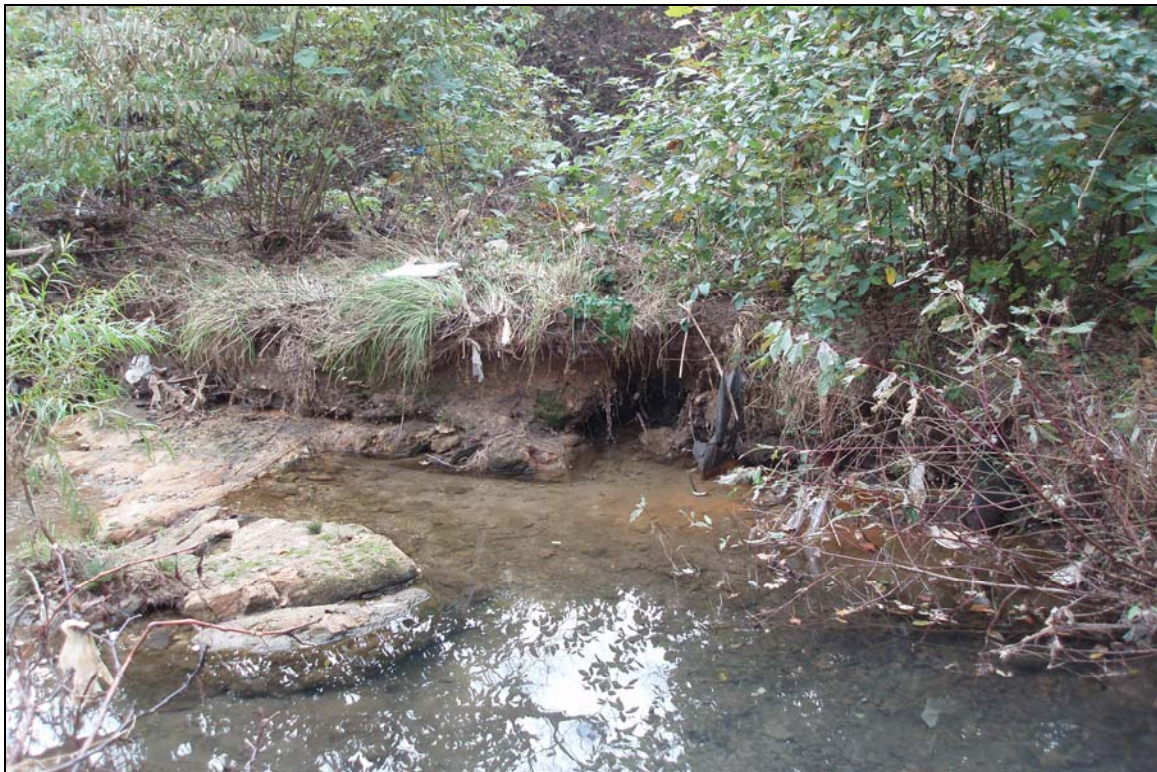
SP6 – Bank erosion/slumping. Photo taken near Station 24+60. 11/12/07 - MY 04

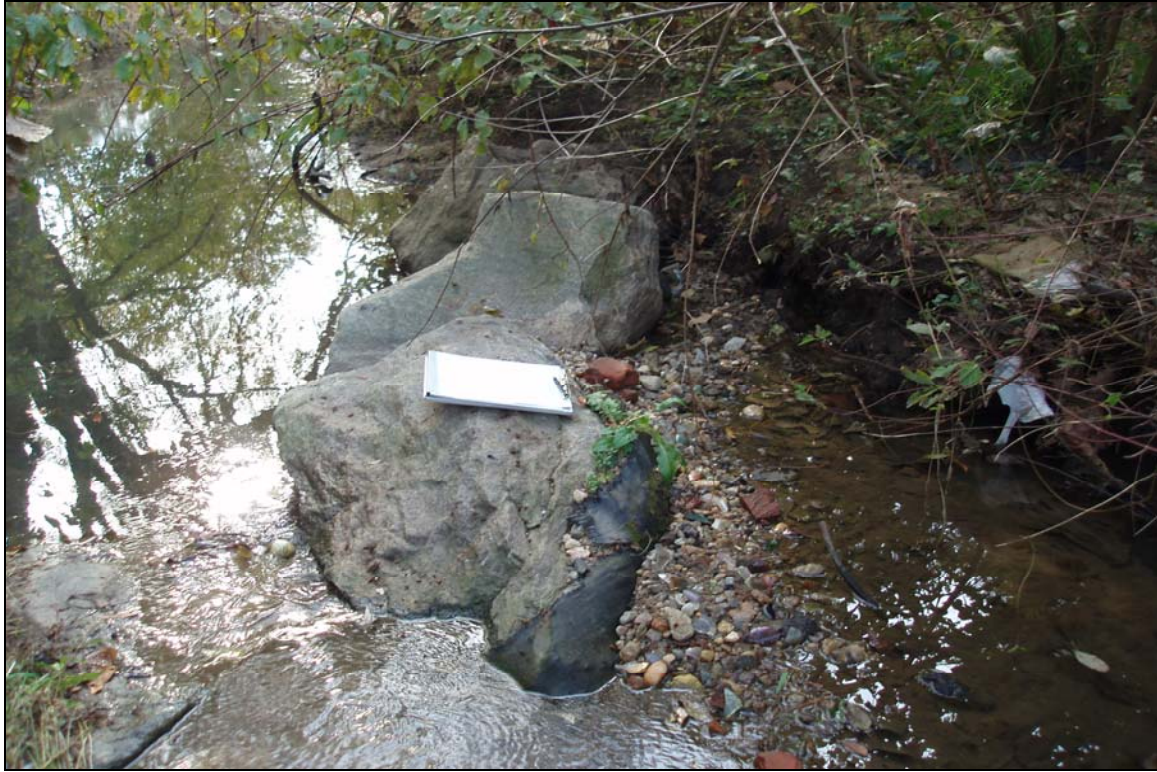
SP7 – Back arm scour on cross vane. Photo taken near Station 14+00. 11/12/07 - MY 04

G. Vanes	1. Free of back or arm scour?	12	19	N/A	63	82%
	2. Height appropriate?	16	19	N/A	84	
	3. Angle and geometry appear appropriate?	18	19	N/A	95	
	4. Free of piping or other structural failures?	16	19	N/A	84
