**Chavis Park (Garner Branch)
Stream Restoration Monitoring Report
EEP Project # 87
Monitoring Year – 05
2008**

March 2009

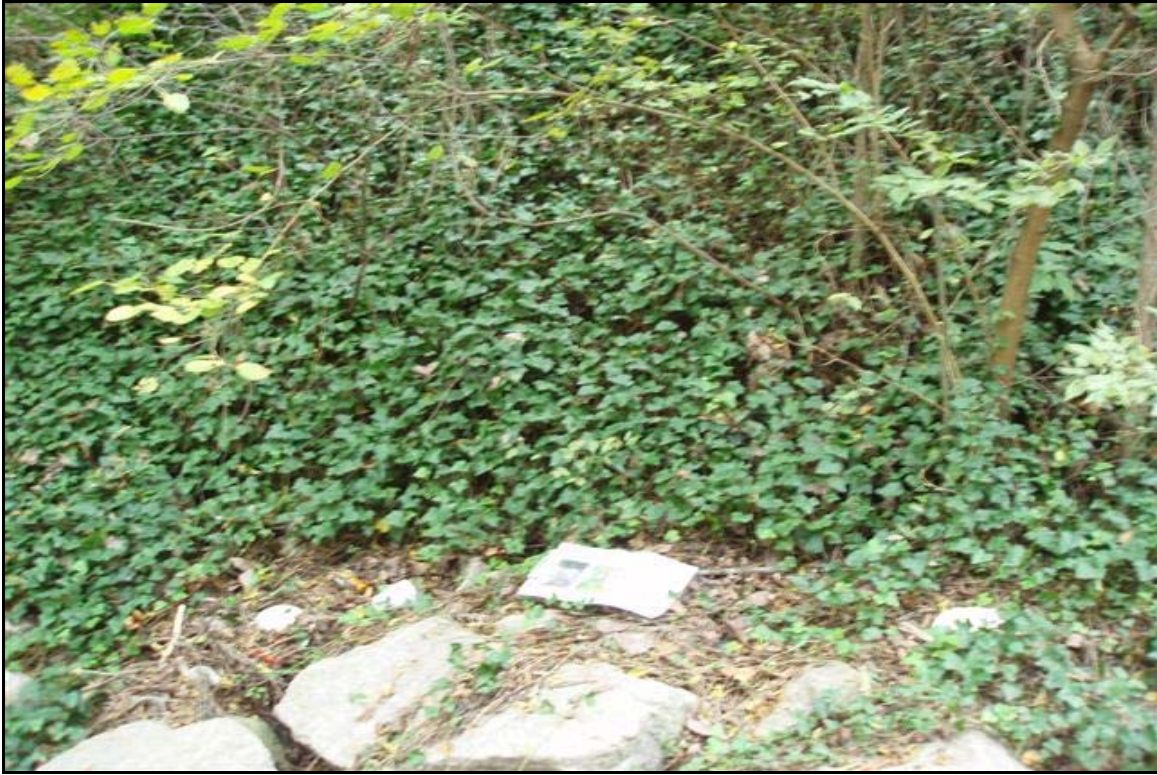
VP1 – English ivy (*Hedera helix*) on stream bank. Photo taken near Station 10+50. 10/27/08 - MY 05

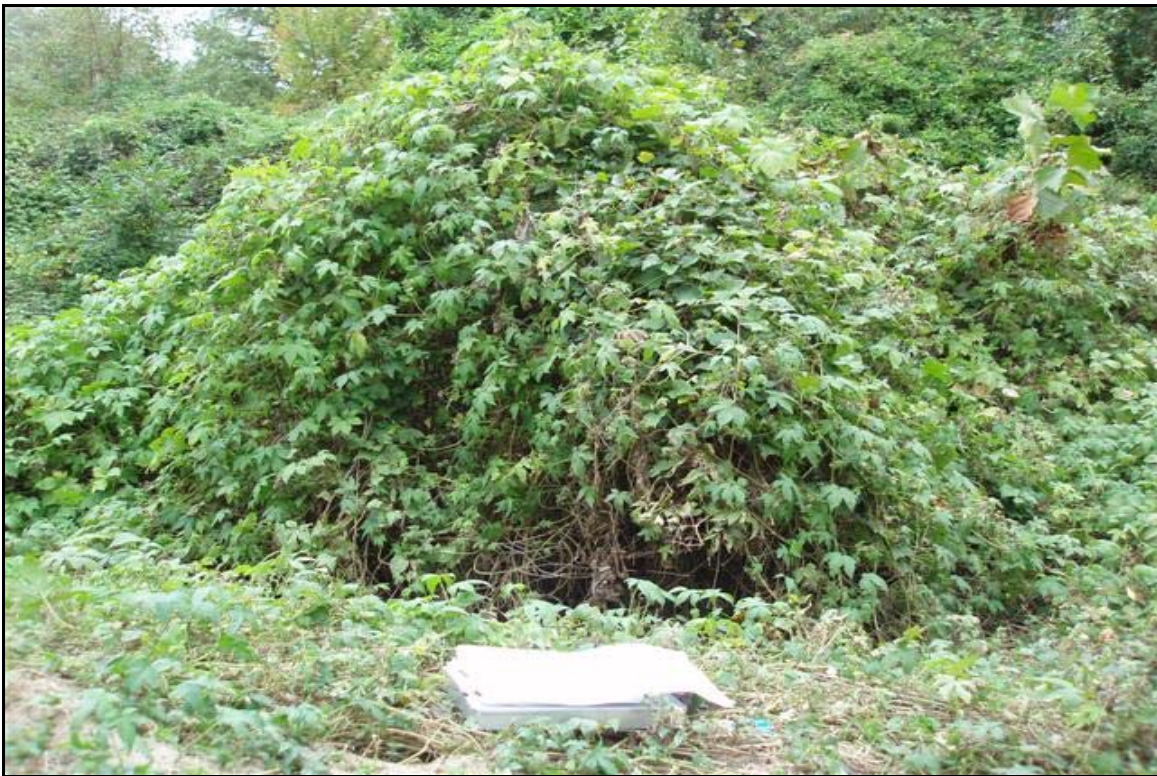
VP2 – Japanese hops (*Humulus japonicus*) on stream bank and terrace. Photo taken near Station 24+50. 10/27/08 - MY 05

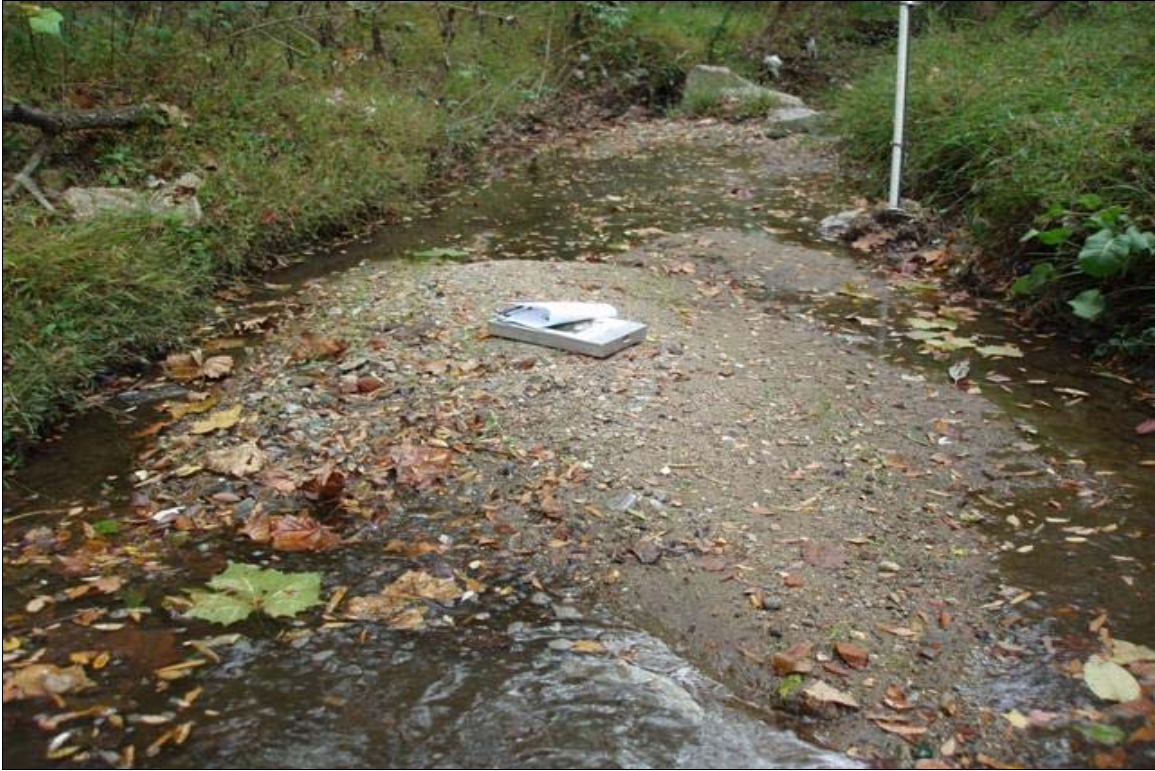
SP1 – Mid-channel bar forming. Photo taken near station 14+30. 10/27/08 - MY 05

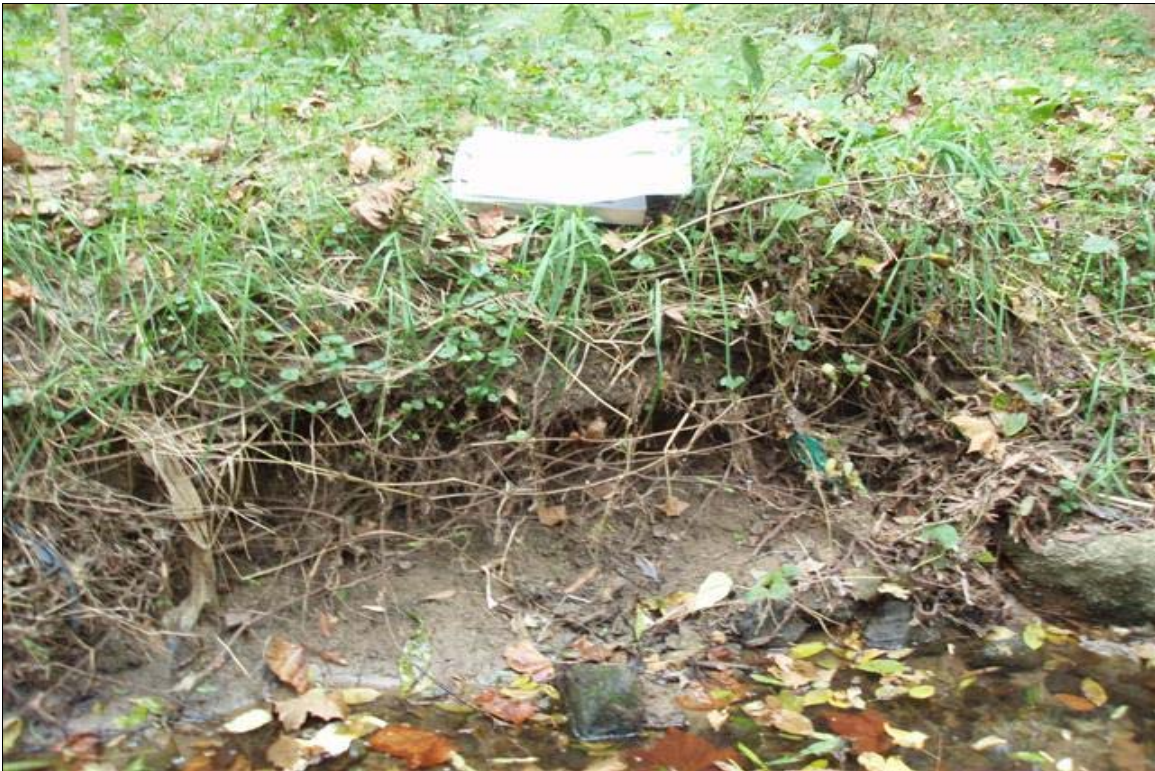
SP2 – Bank erosion/slumping. Photo taken near Station 20+75. 10/27/08 - MY 05

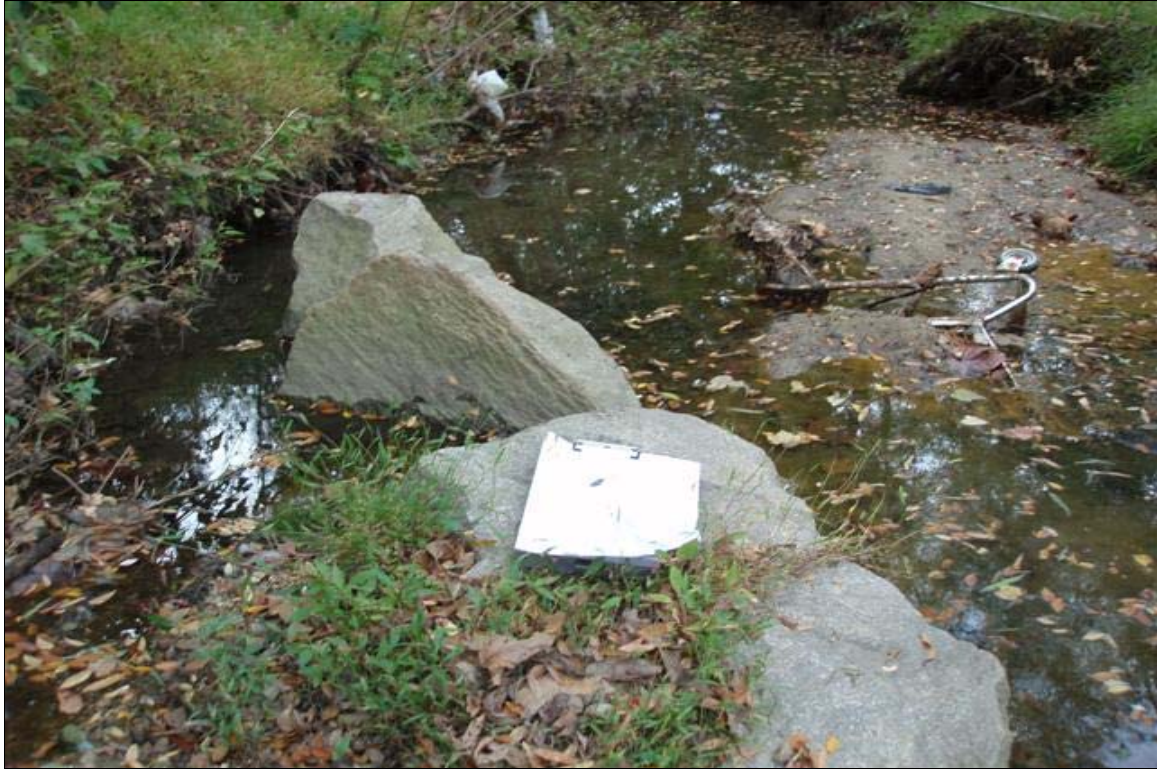
SP3 – Back arm scour, pool aggradation and debris in stream. Photo taken near station 14+75.
10/27/08 - MY 05

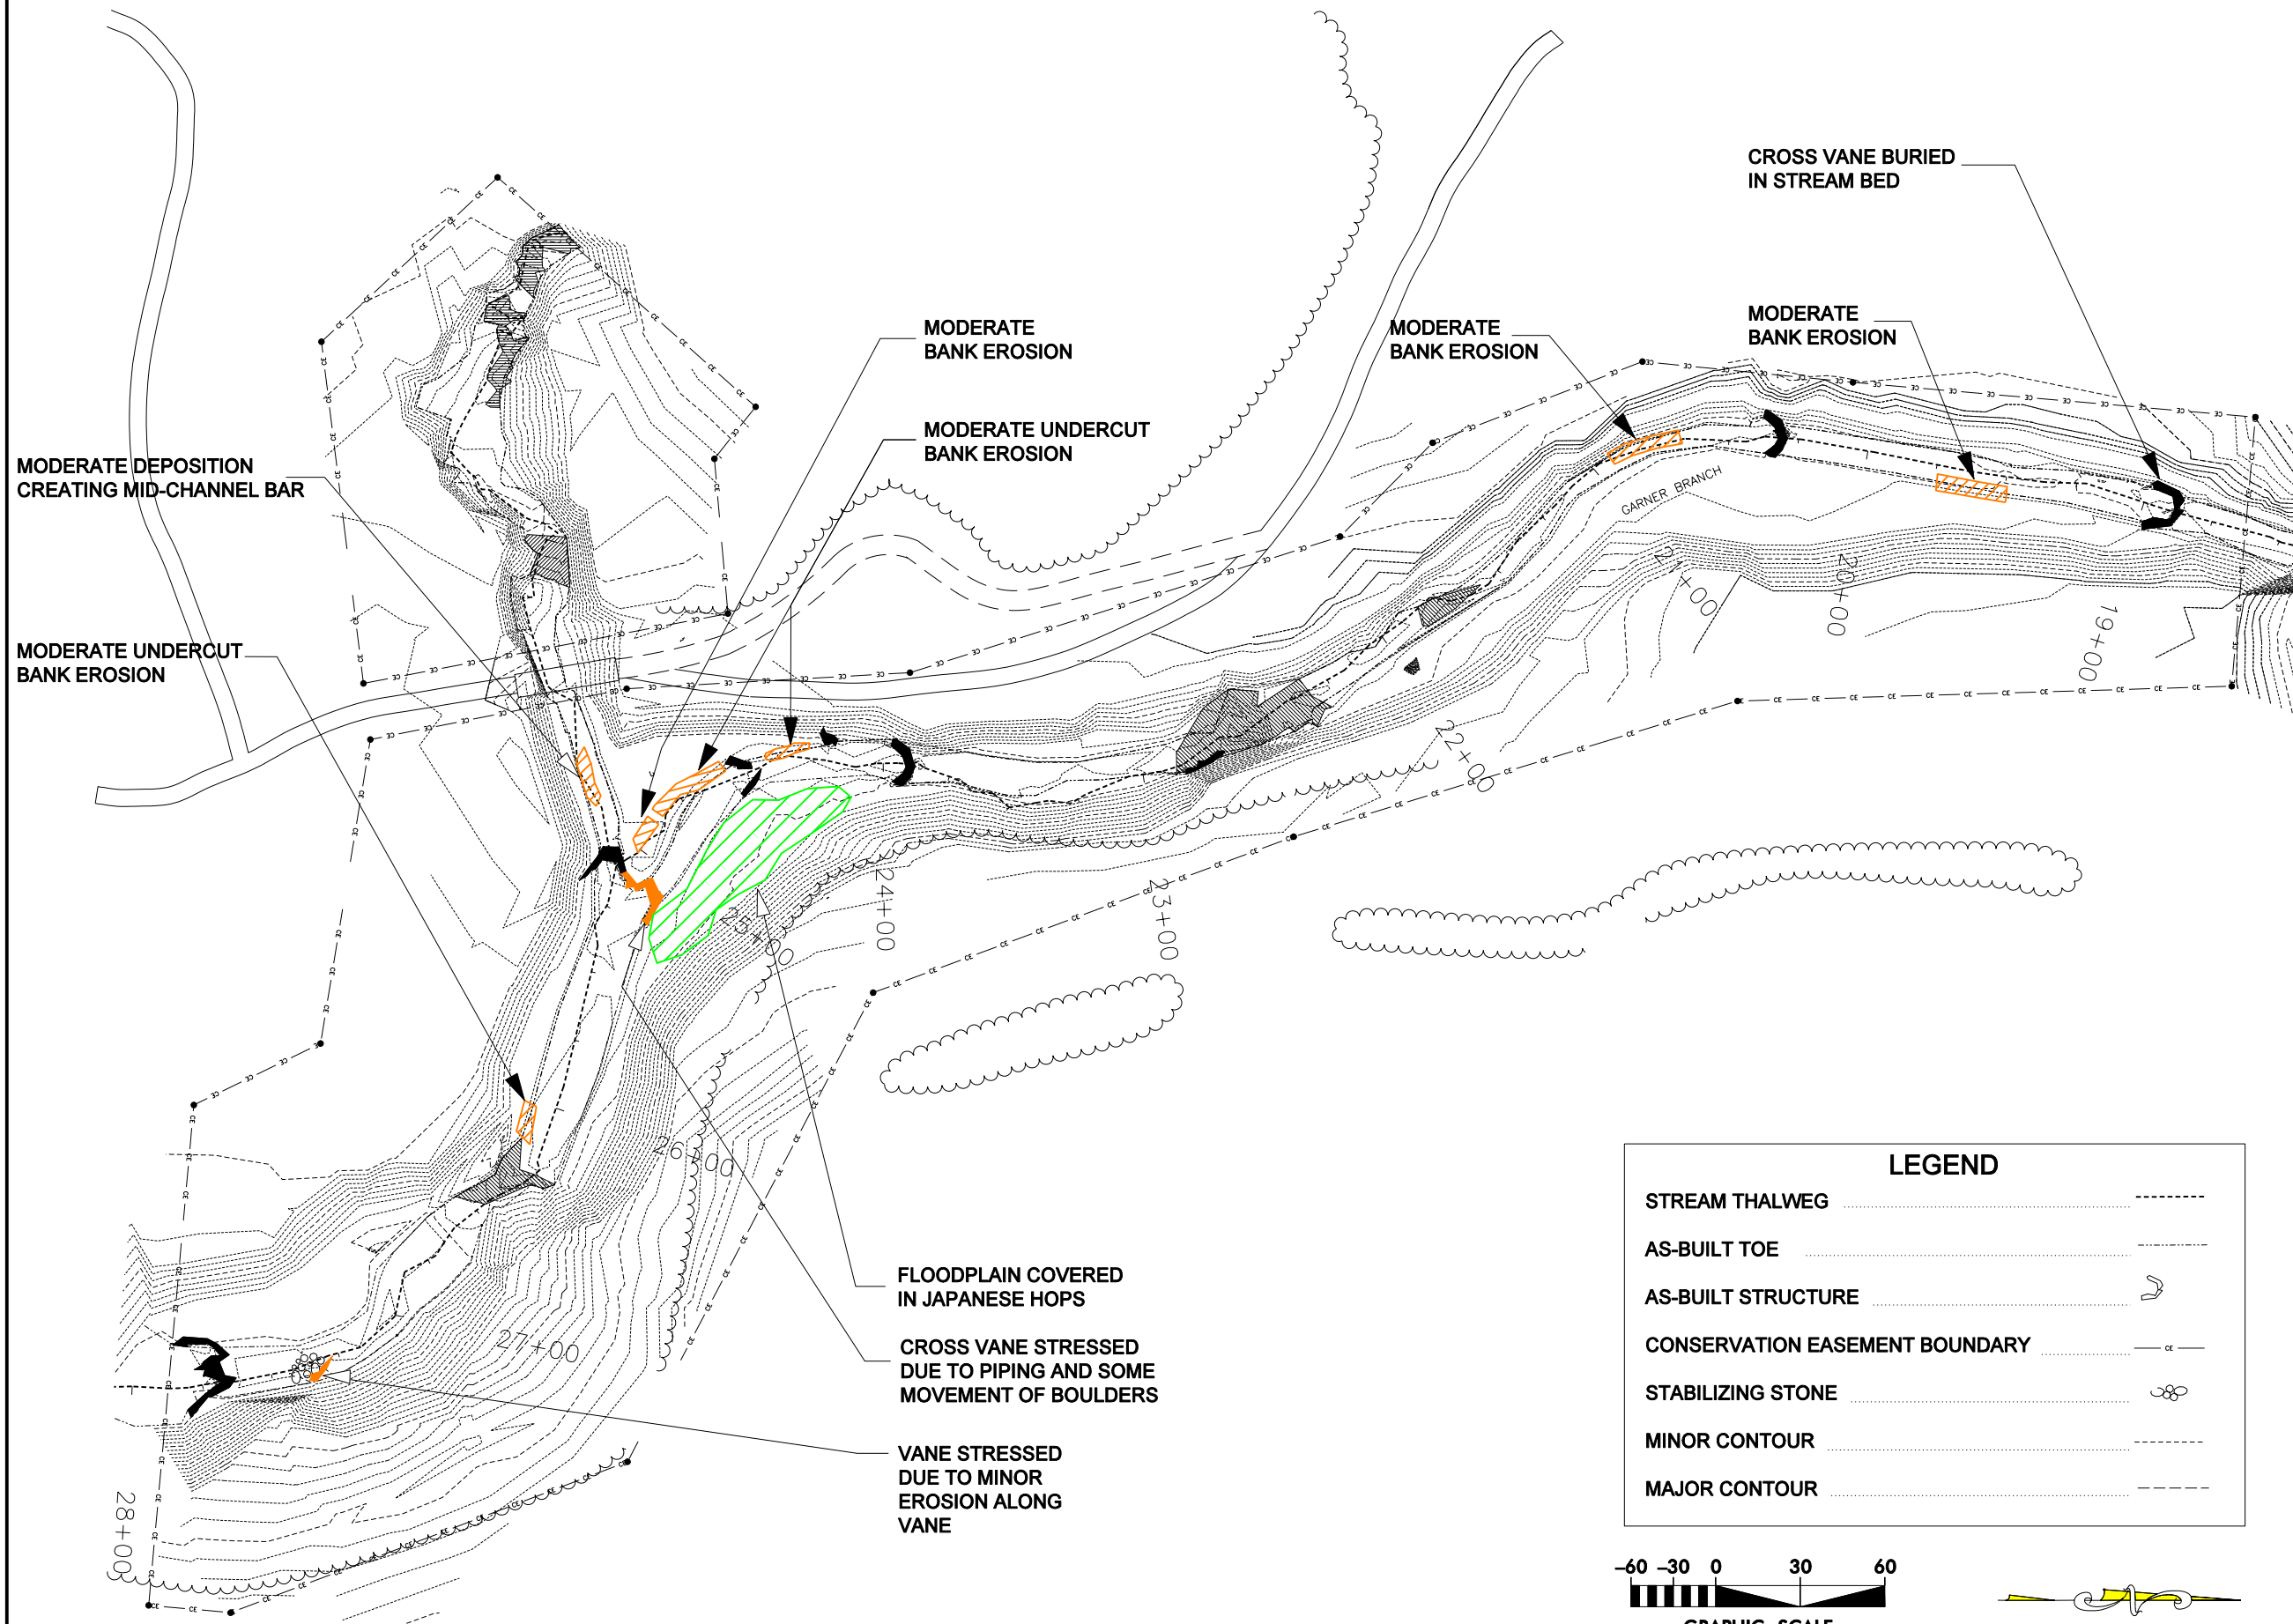
DATE: NOVEMBER 2008
SCALE: SEE SHEET
CURRENT
CONDITIONS
PLAN VIEW
SHEET 2 OF 2

MODERATE DEPOSITION
CREATING MID-CHANNEL BAR

MODERATE UNDERCUT
BANK EROSION
