**City Pond Mitigation Project
Anson County, North Carolina**

Year 4 Monitoring Report

November 2008

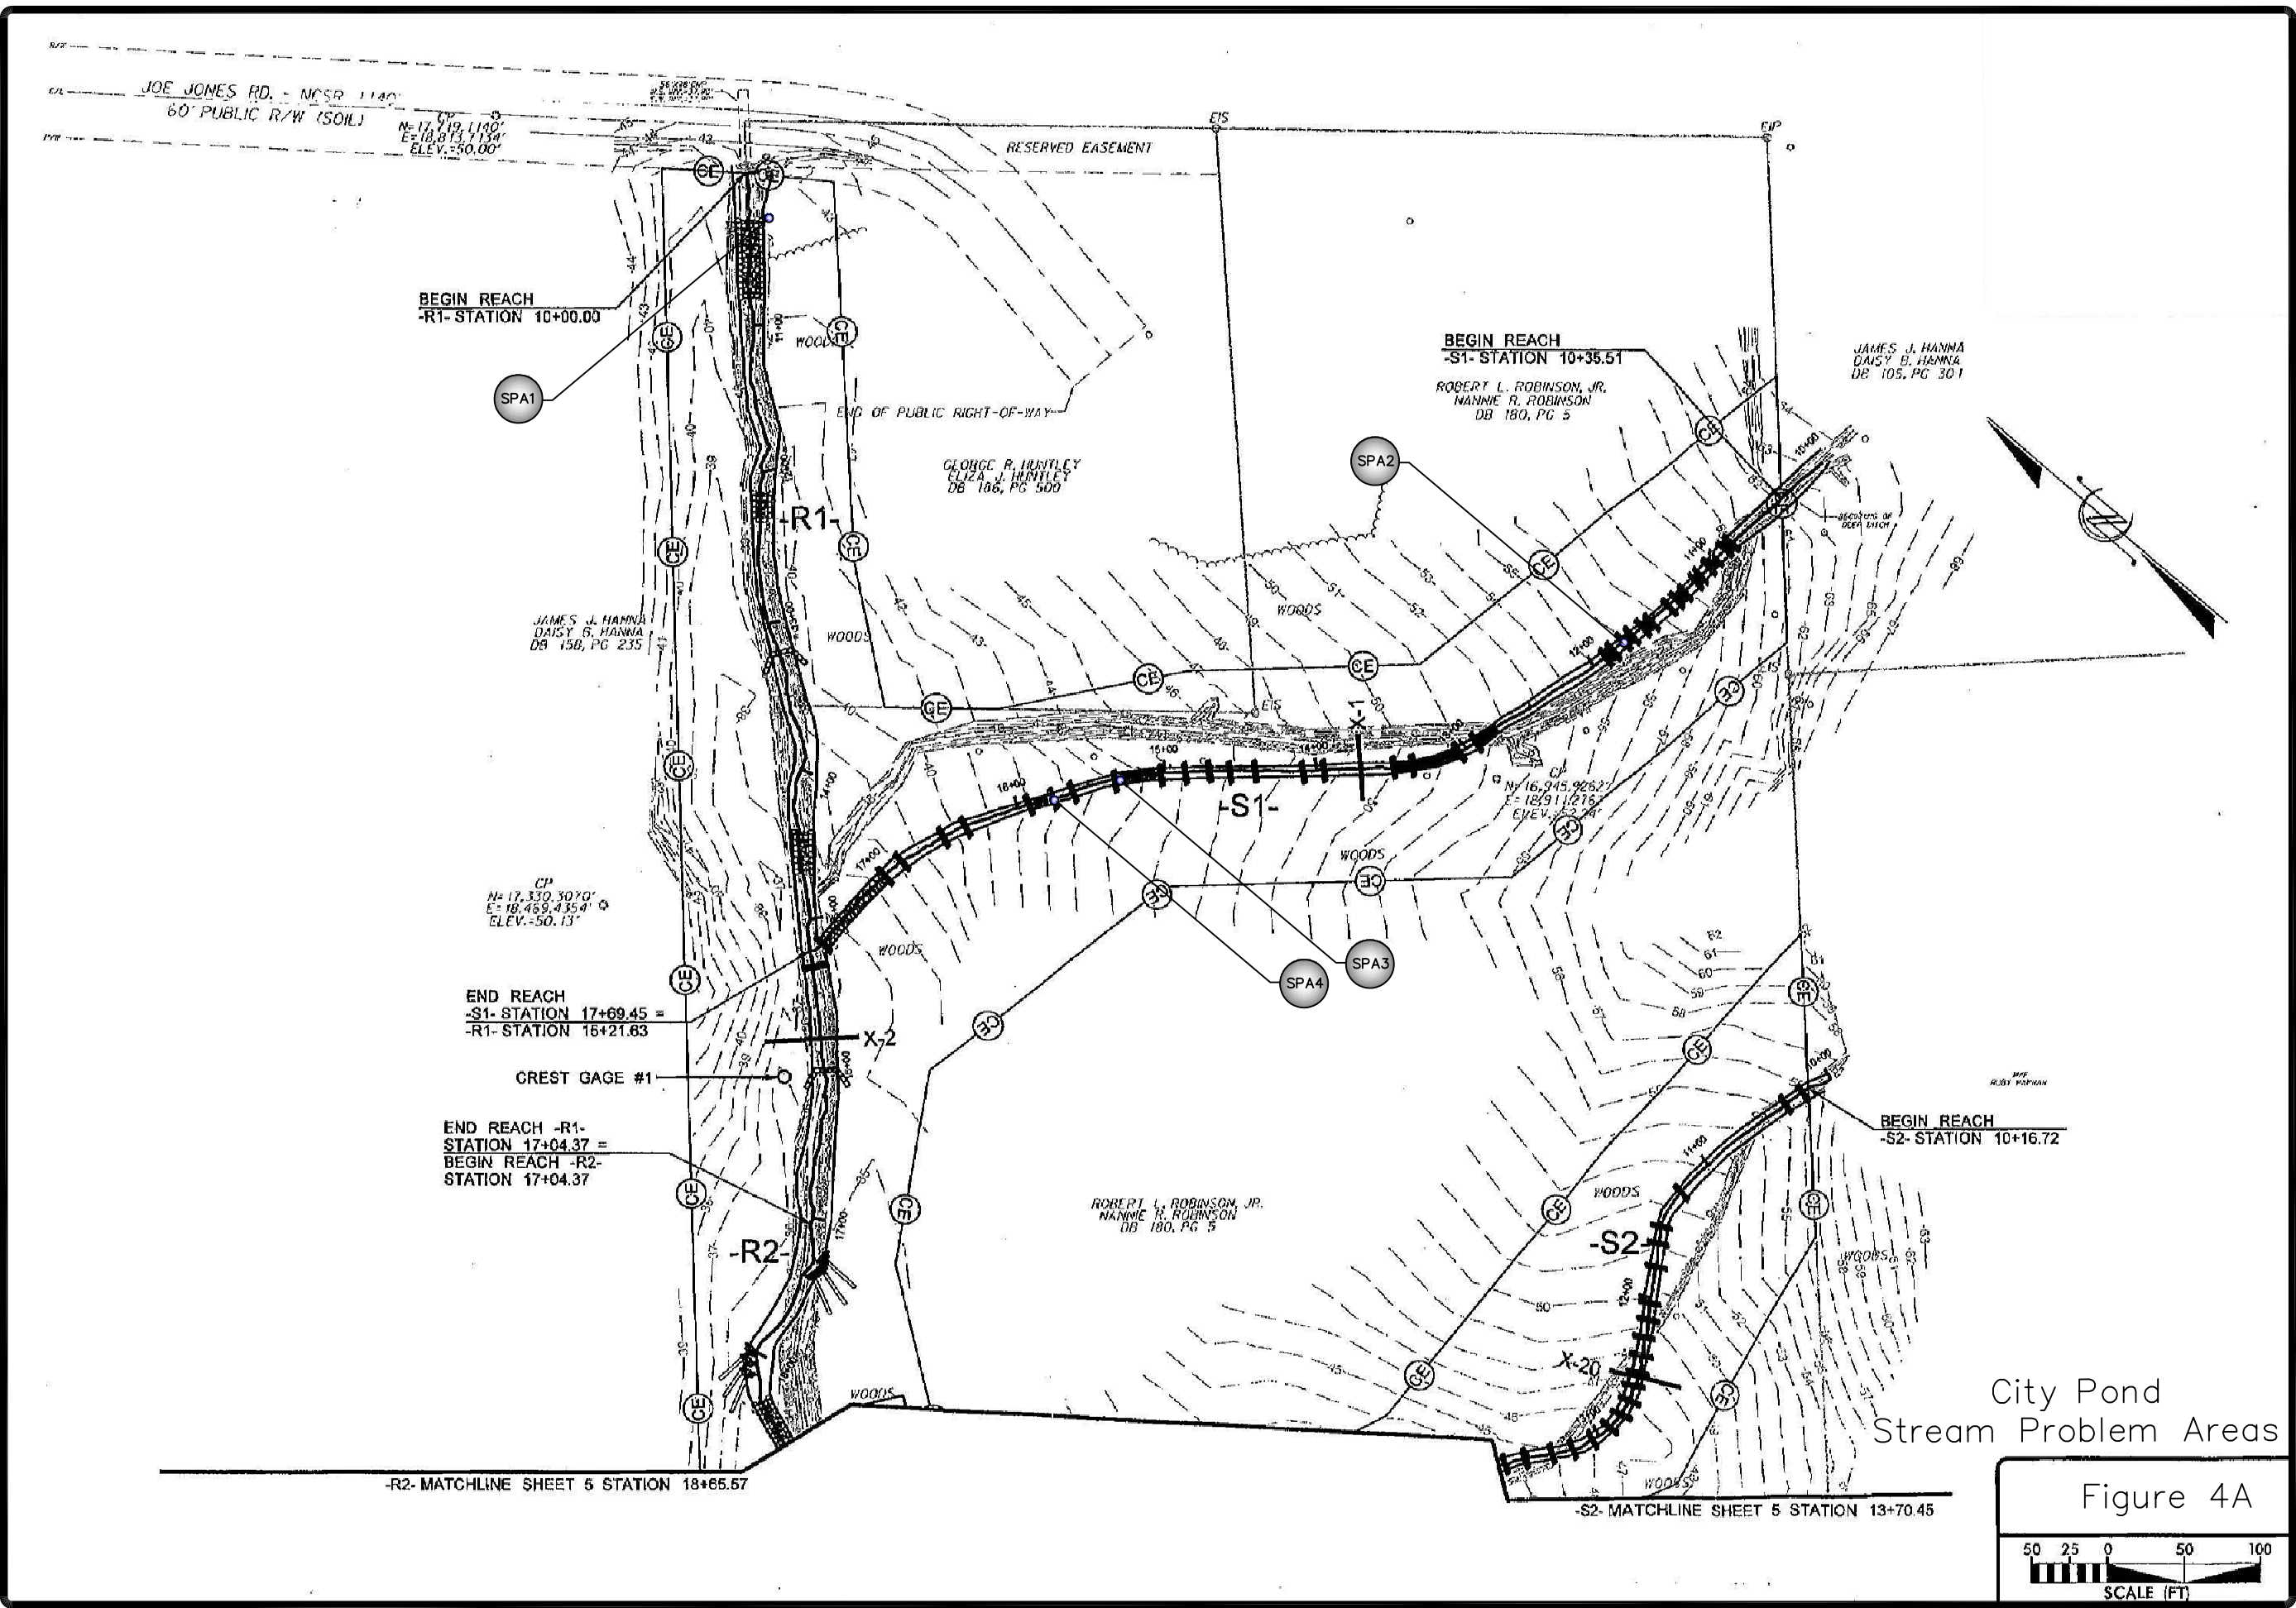
Figure 4A

ID	Station	Feature	Problem	Severity	Recommended Action
SPA1	R1 10+20	Culvert	Left bank erosion at culvert outlet	Moderate	Monitor
SPA2	S1 11+80	Log weir	Erosion US of structure	Minor	Monitor
SPA3	S1 15+30	Log weir	Headcut	Minor	Monitor
SPA4	S1 15+80	Log weir	Erosion, potential problem	Minor	Monitor
SPA5	S5 18+50	Left bank	Erosion behind matting	Minor	None
SPA6	R2 23+90	Left bank	Undercut, approx. 15' long	Moderate	Monitor
SPA7	R2 34+50	Right bank	Erosion behind matting	Minor	None
SPA8	R3 47+80	Left bank	Erosion	Minor	Monitor
SPA9	R3 48+50	Floodplain	Lack of vegetation on right bank	Moderate	None
SPA10	S3 13+20	Left bank	Erosion behind matting	Heavy	Monitor

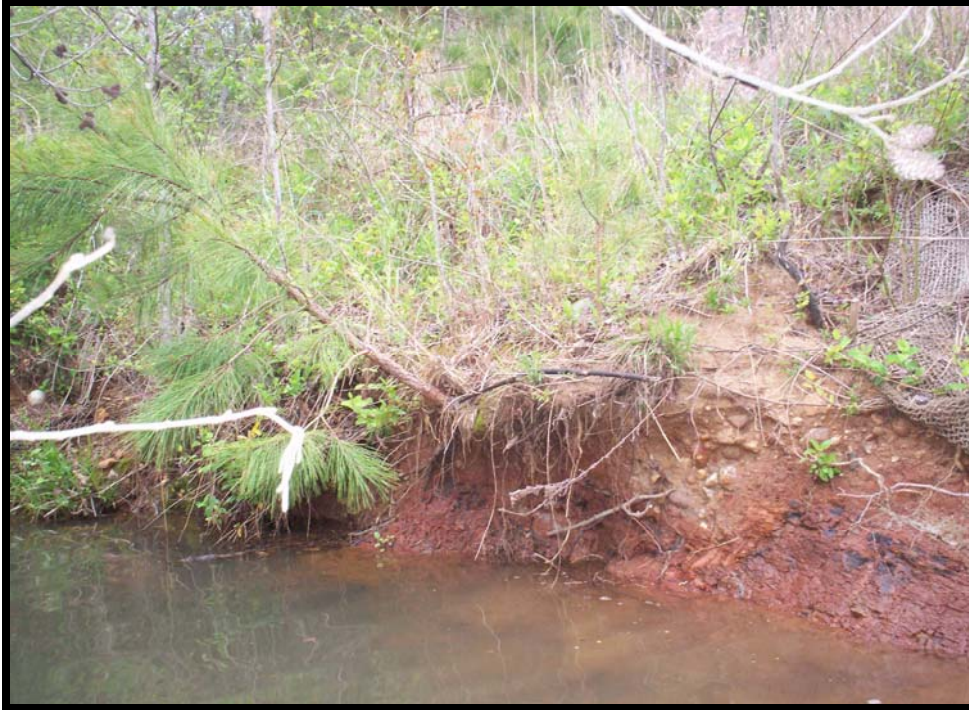
Left bank erosion @ station 10+20 facing downstream (R1)

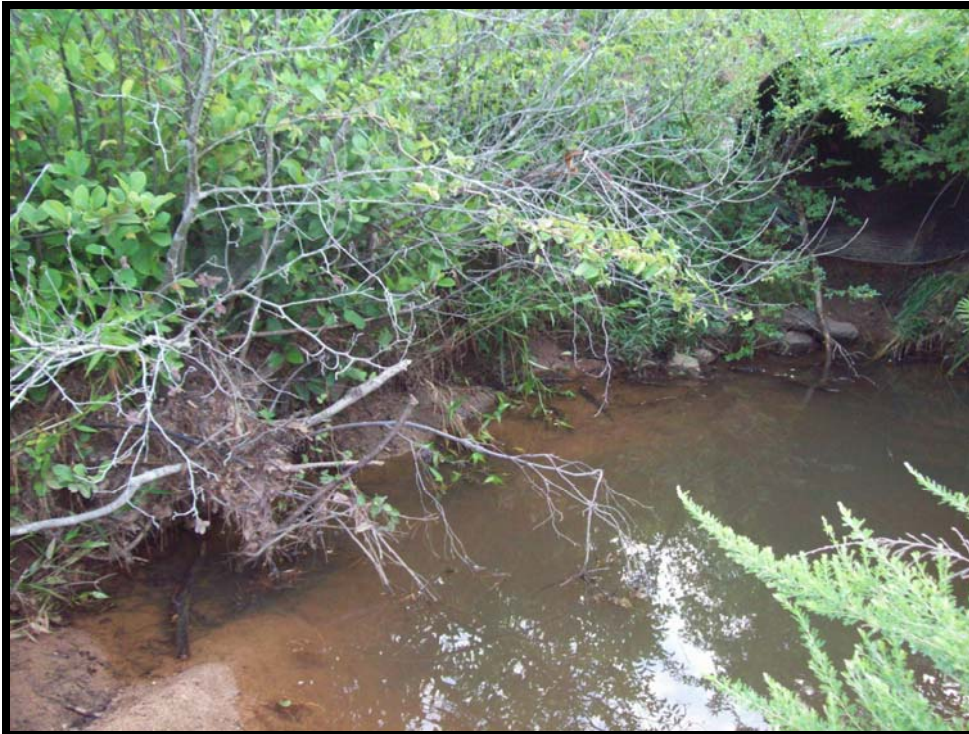
Left bank erosion @ station 10+20 facing upstream (R1)

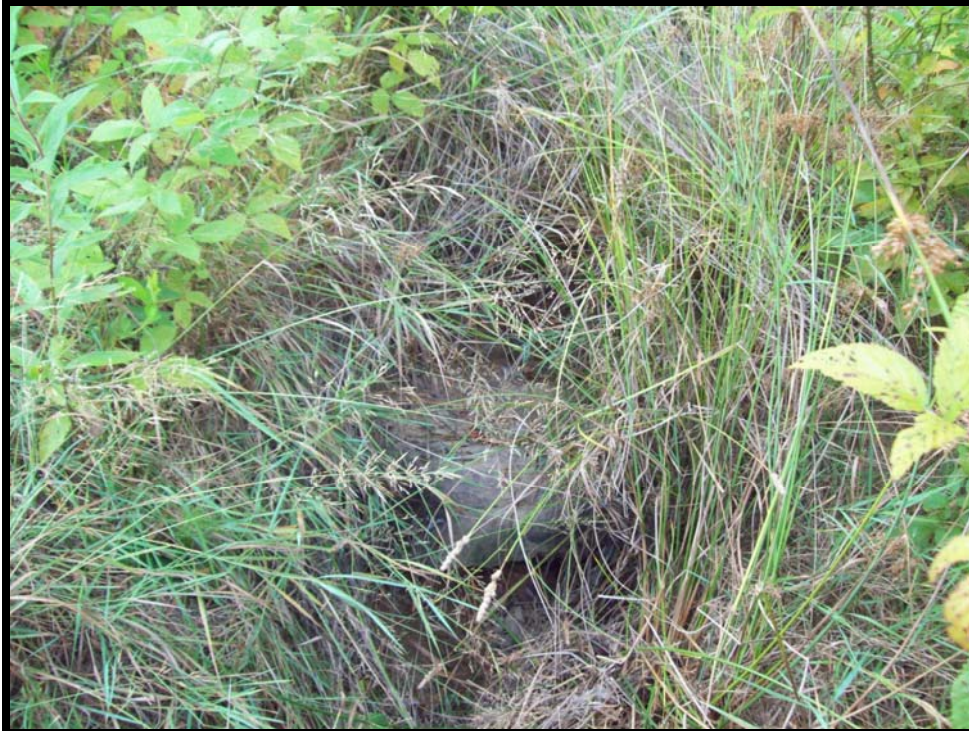
Erosion behind log weir @ station 11+80 facing upstream (S1)

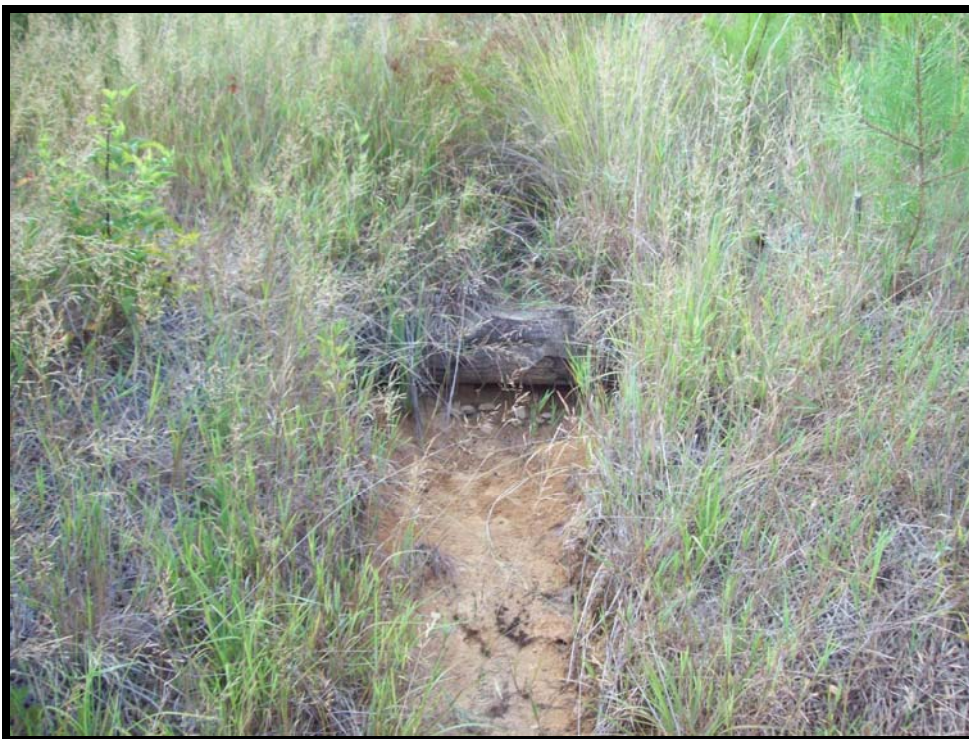
Headcut forming downstream of log weir @ station 15+30 (S1)

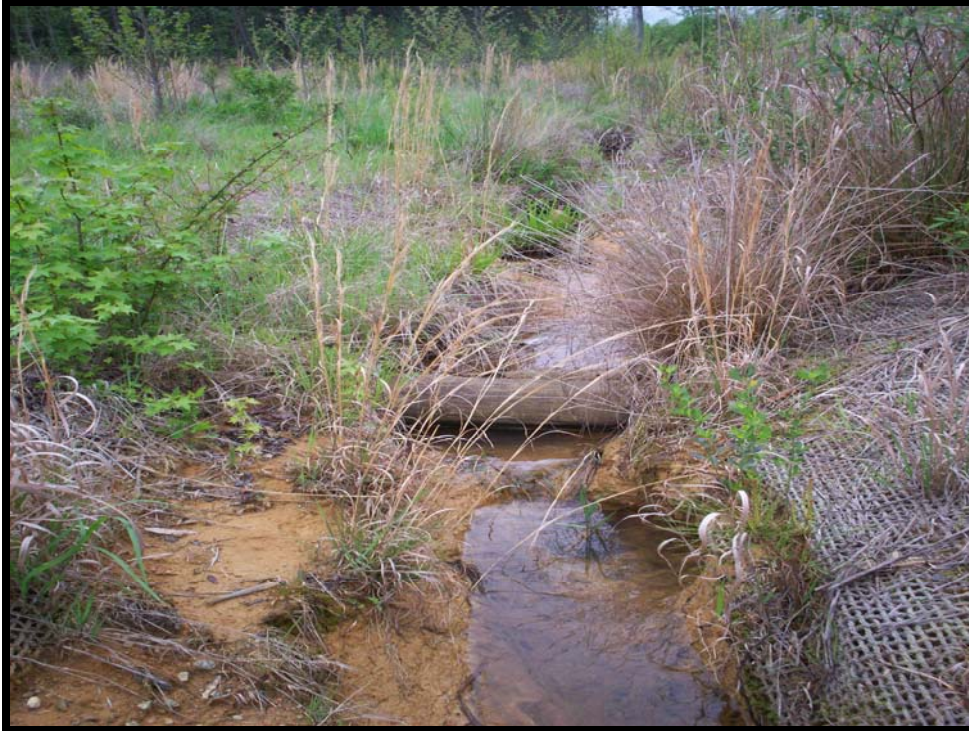
Channel erosion downstream of log weir @ station 15+80 (S1)

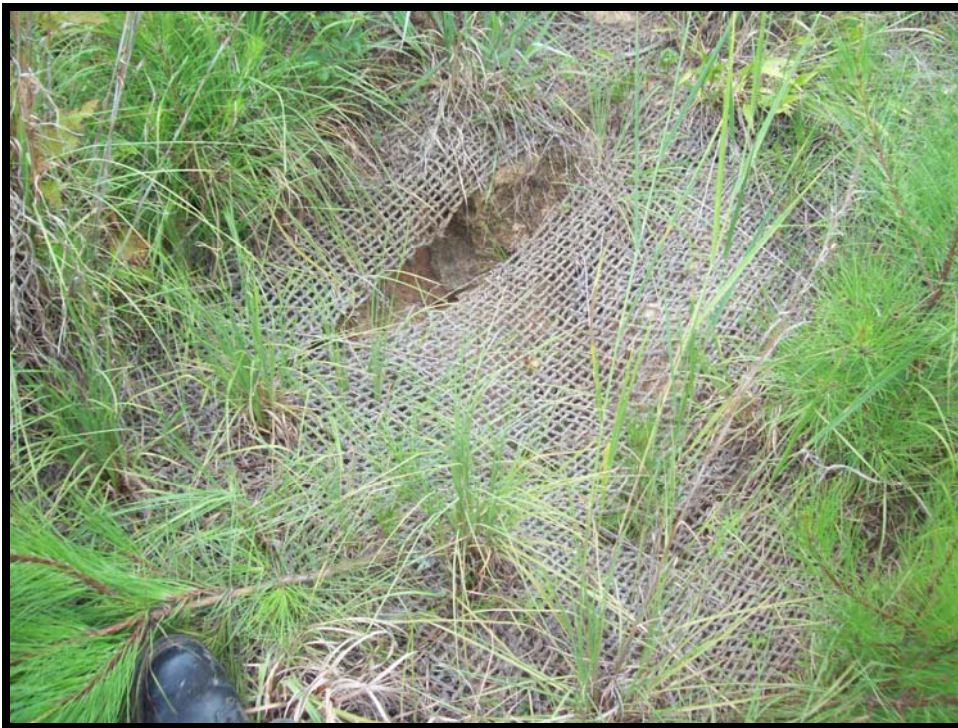
Erosion behind coir matting @ station 18+50 (S5)

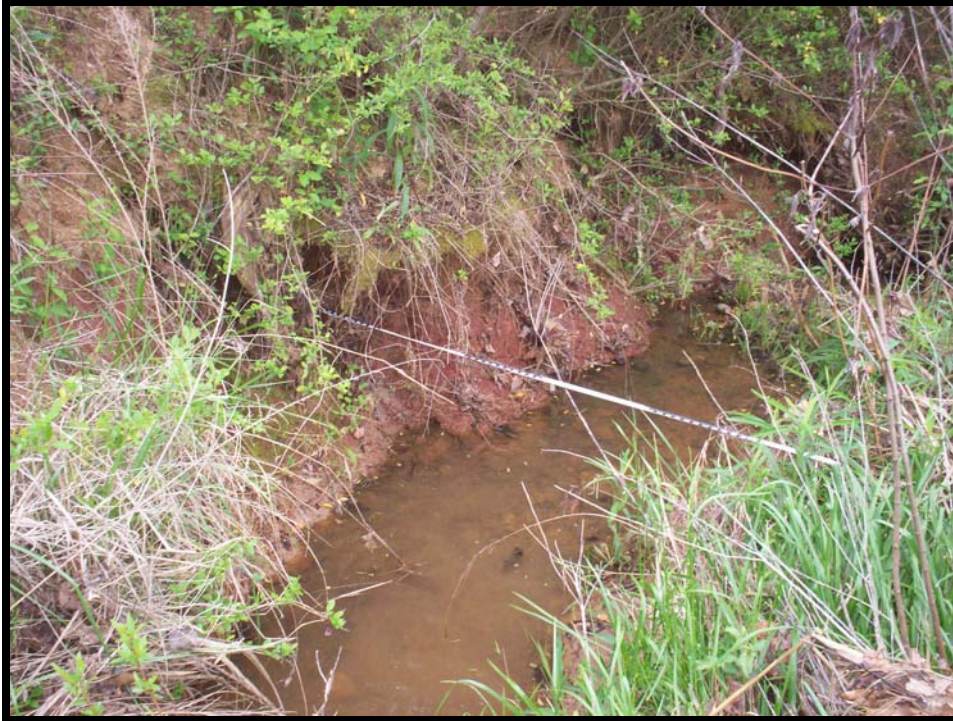
Undercutting along left bank @ station 23+90 (R2)

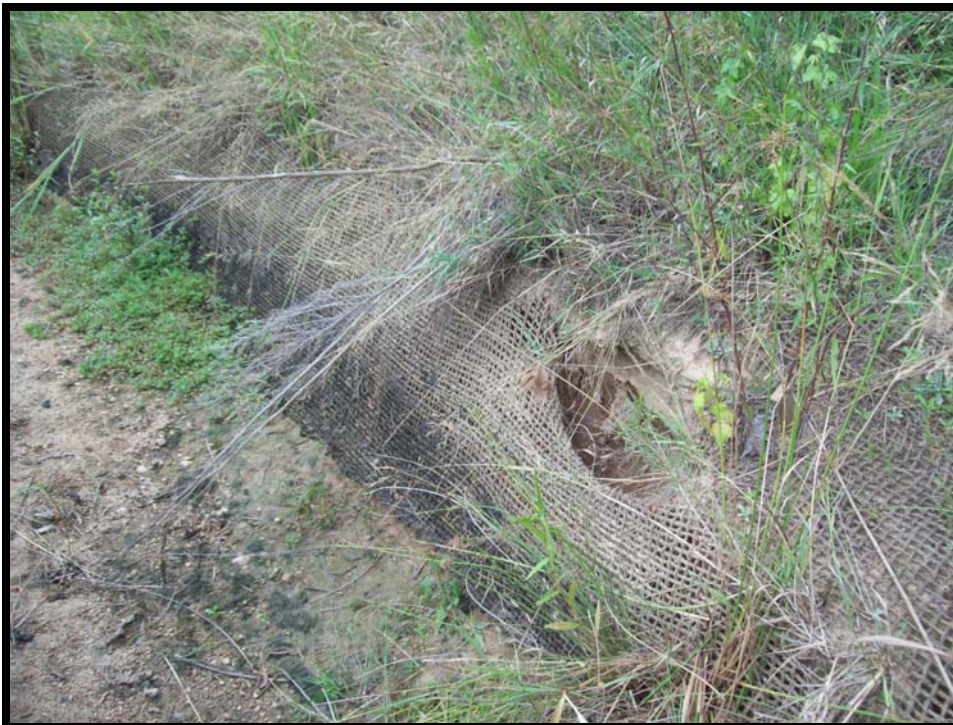
Erosion behind matting along right bank @ station 34+50 (R2)

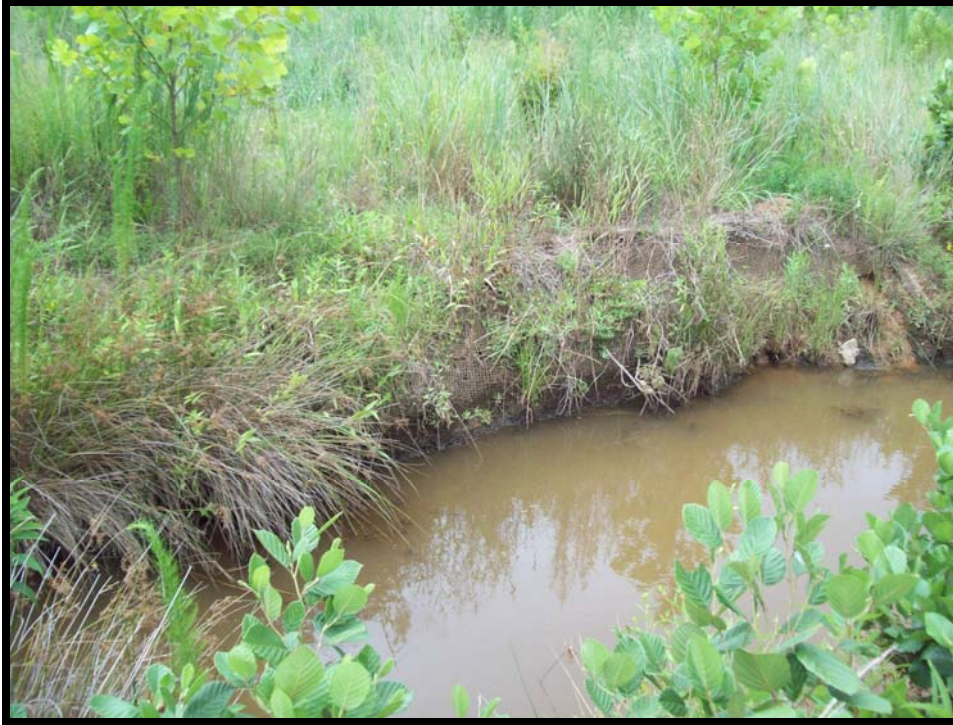
Erosion along left bank @ station 47+80 (R3)

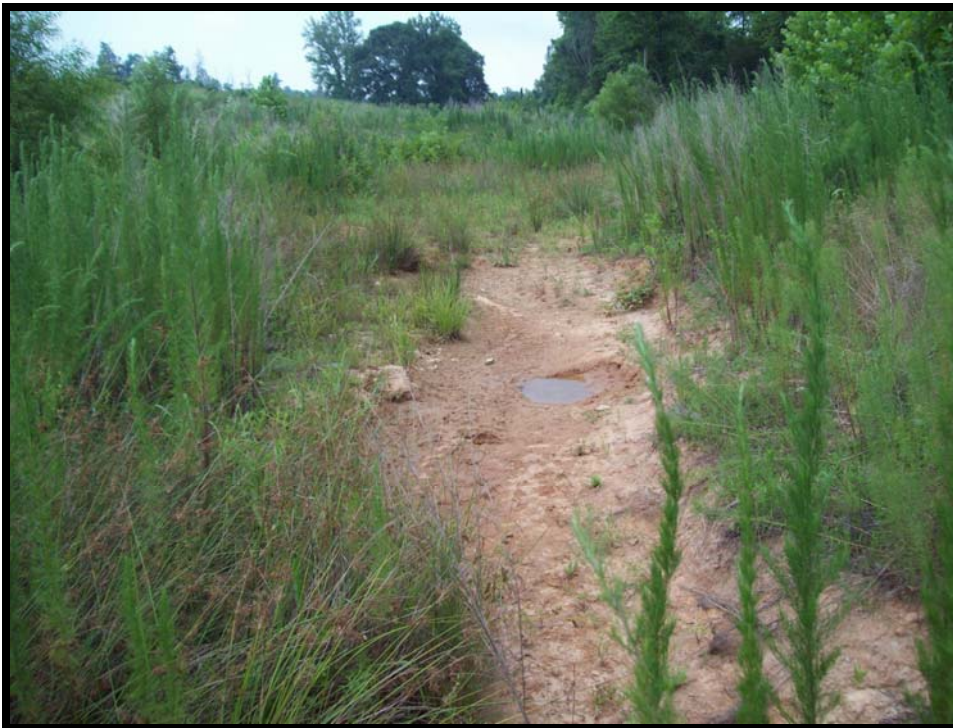
Bare floodplain due to lack of vegetation @ station 48+50 (R3)

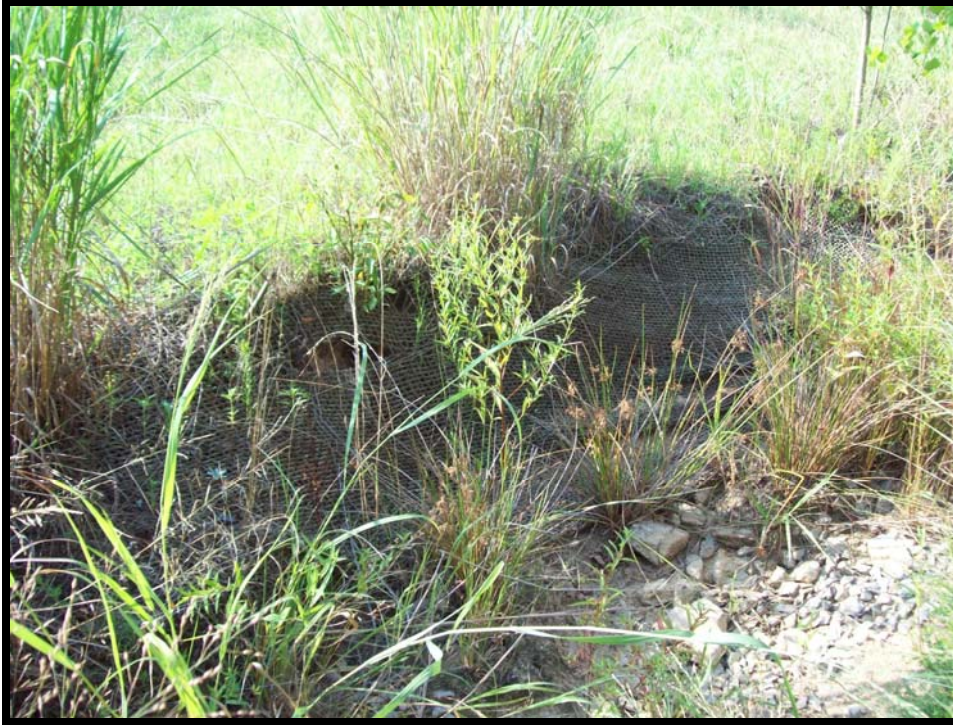
Erosion on left bank @ station 13+20 (S3)
