**City Pond Mitigation Project
Anson County, North Carolina**

Year 5 Monitoring Report

February 2010

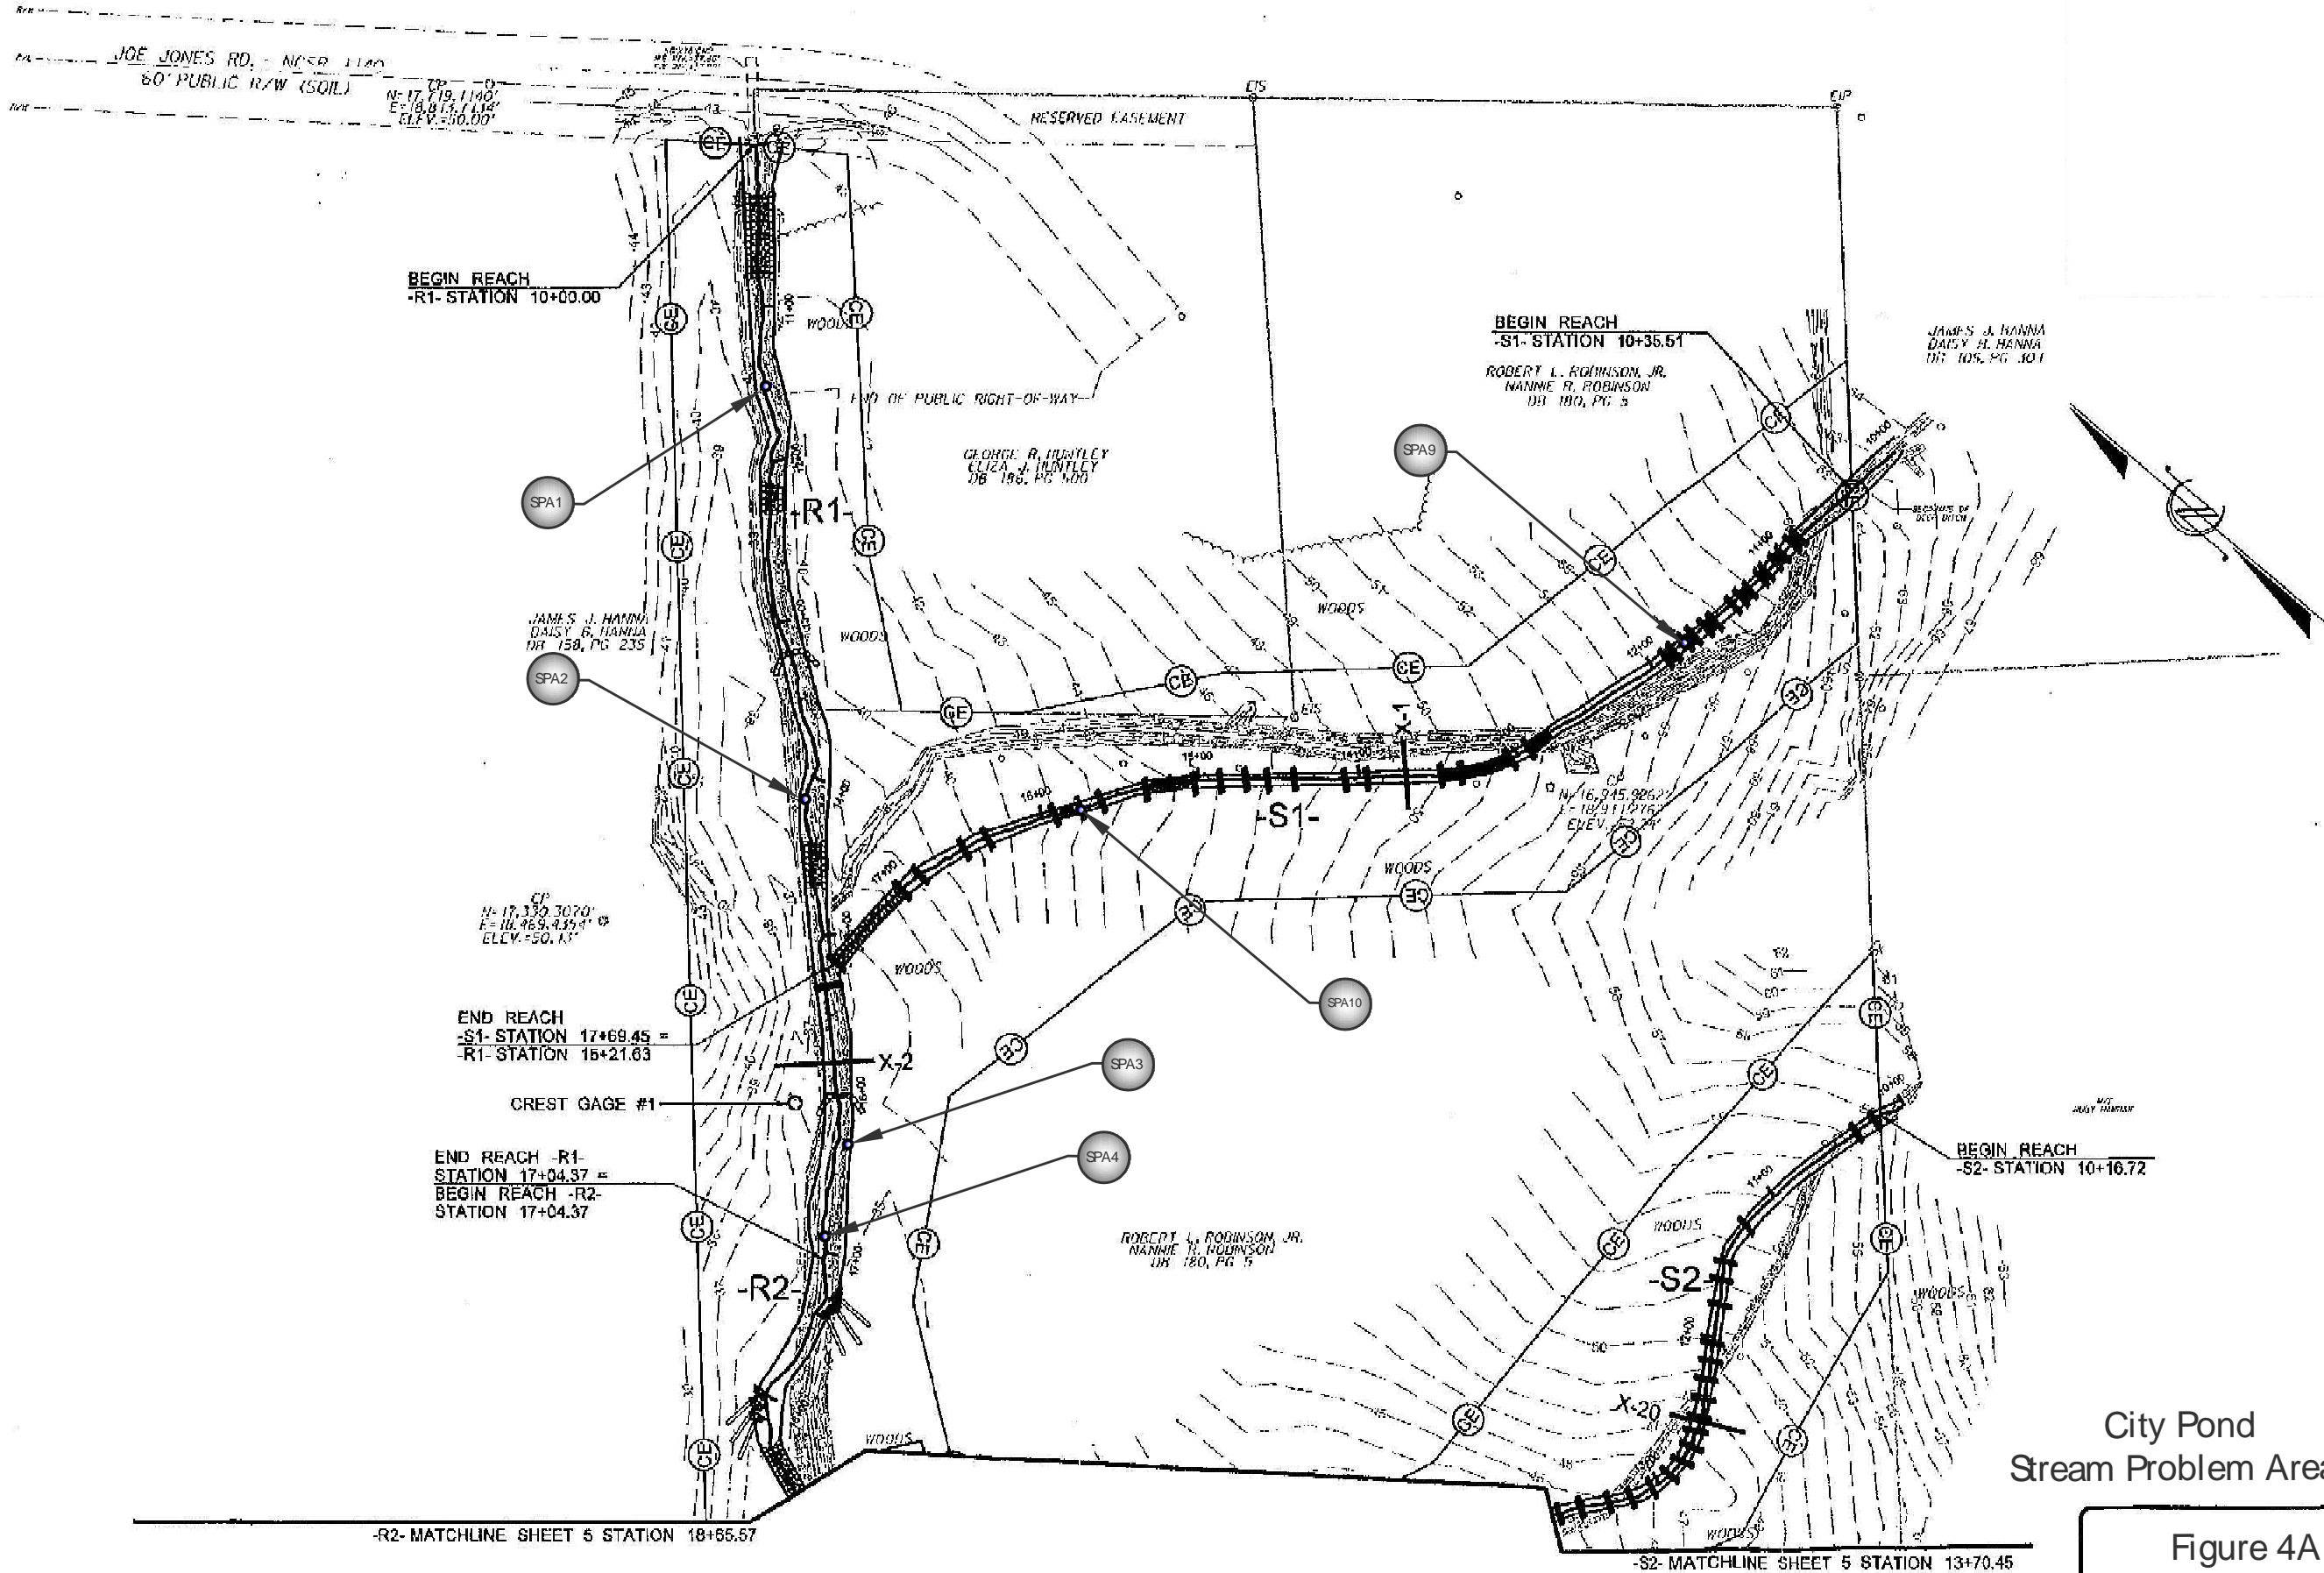
Figure 4A

Table 6 summarizes stream areas requiring observation. **Figures 4a-4e** shows the locations of the stream problem areas observed. All of the problem areas observed are minor and localized. SPA2 and SPA3 are localized and are expected to stabilize and become vegetated. Problem area SPA5, SPA6, and SPA7 are not affecting channel stability and have good vegetative cover on the adjacent banks and floodplain. SPA10 is a small head-cut that is expected to stabilize. Upstream of this are a number of stable grade control structures that will halt progression if necessary. Vegetation along the banks at this area is still filling in and is expected to provide additional stabilization. No remedial actions are necessary.

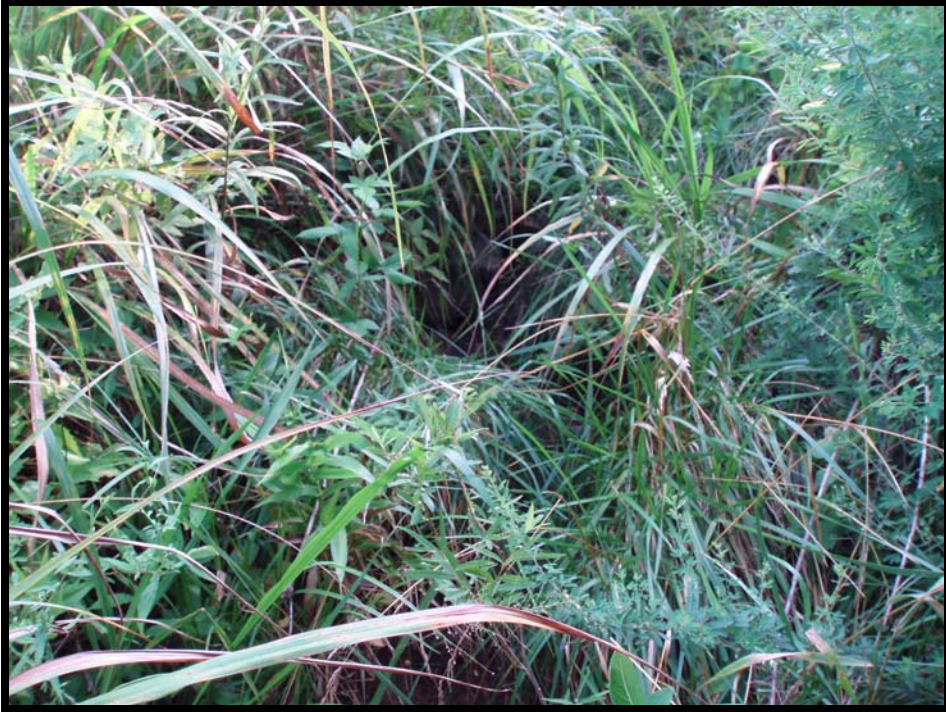
SPA1 - Small head cut in channel @ station 11+50 (R1)

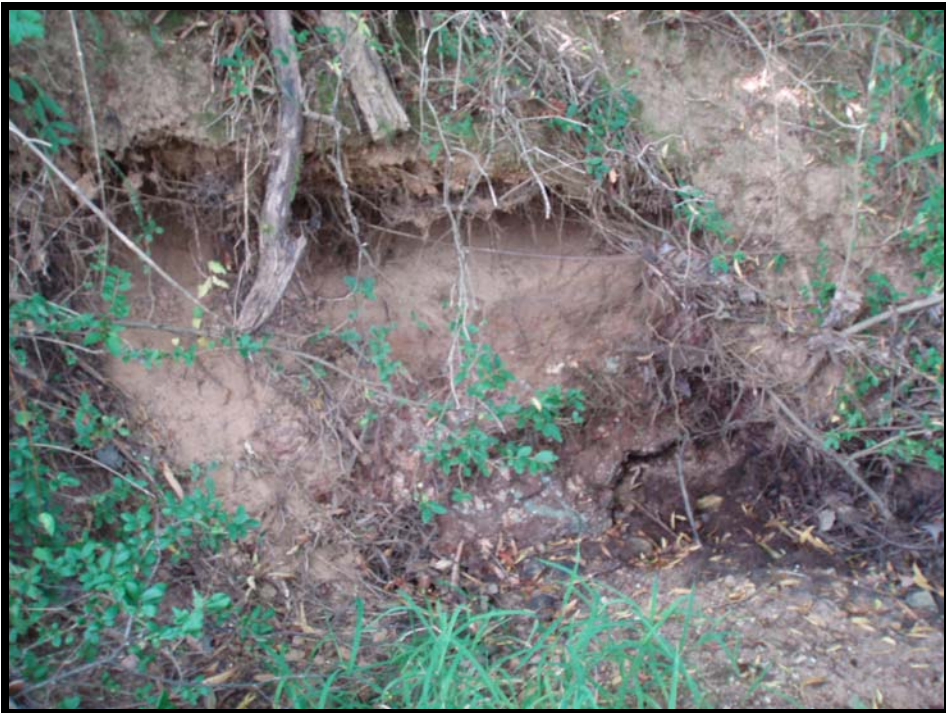
SPA2 - Left bank erosion and lack of vegetation from station 13+80 to 14+10 (R1)

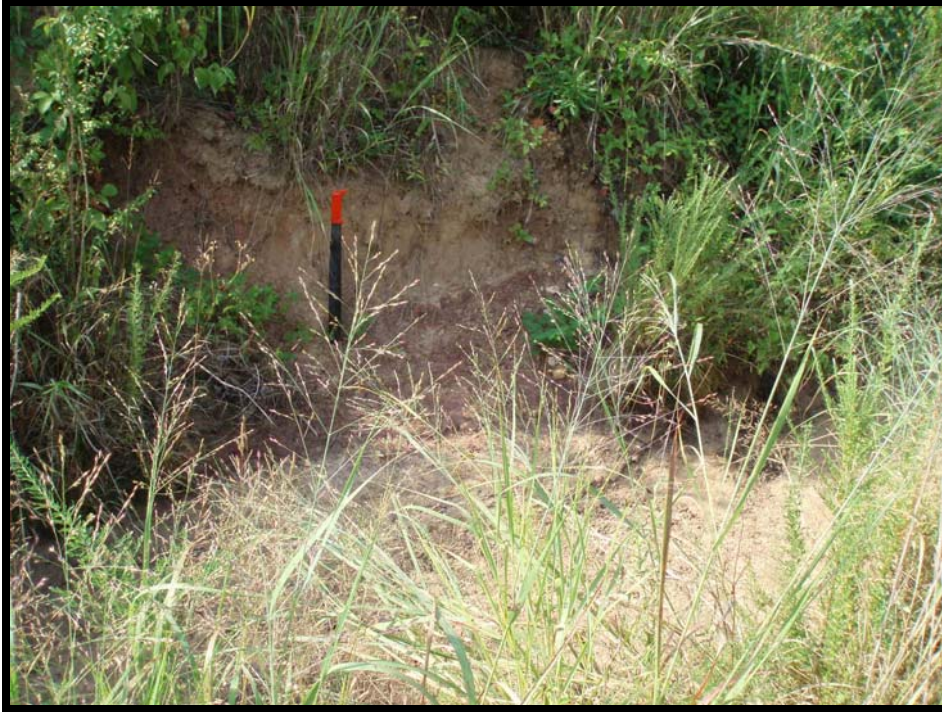
SPA3 - Left bank erosion and loss of vegetation @ station 16+30 (R1)

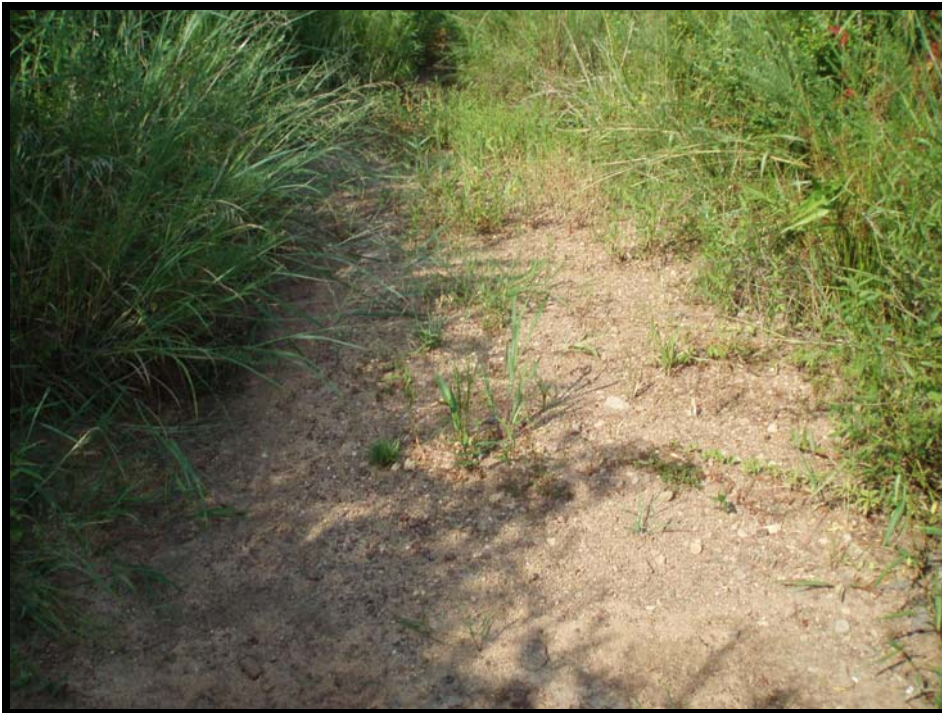
SPA4 - Sand aggradation in channel @ station 16+75 (R1)

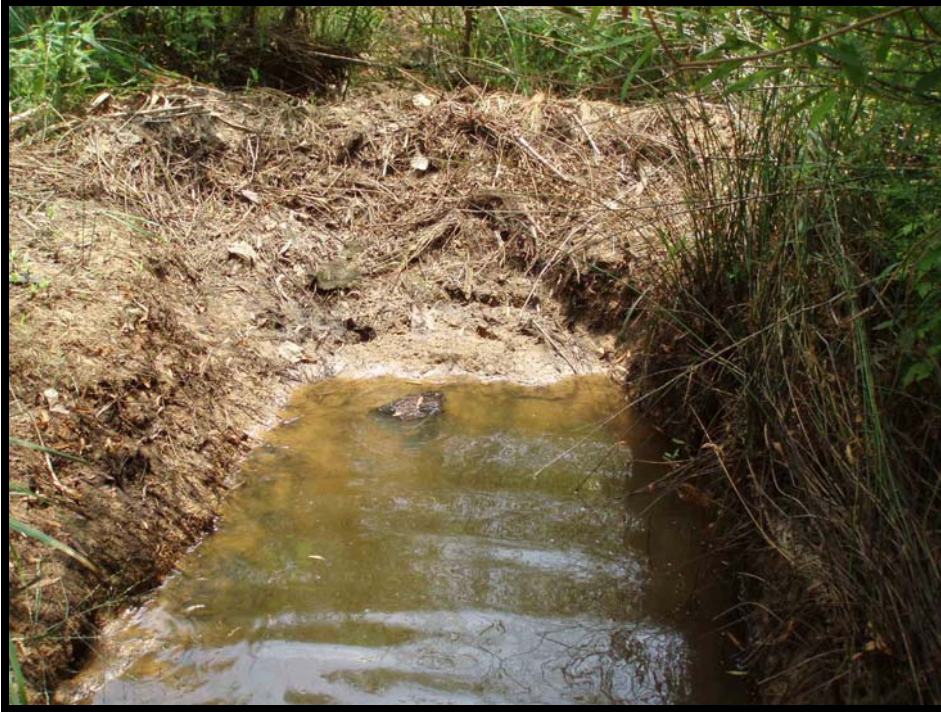
SPA5 - Beaver dam across channel @ station 33+00 (R2)

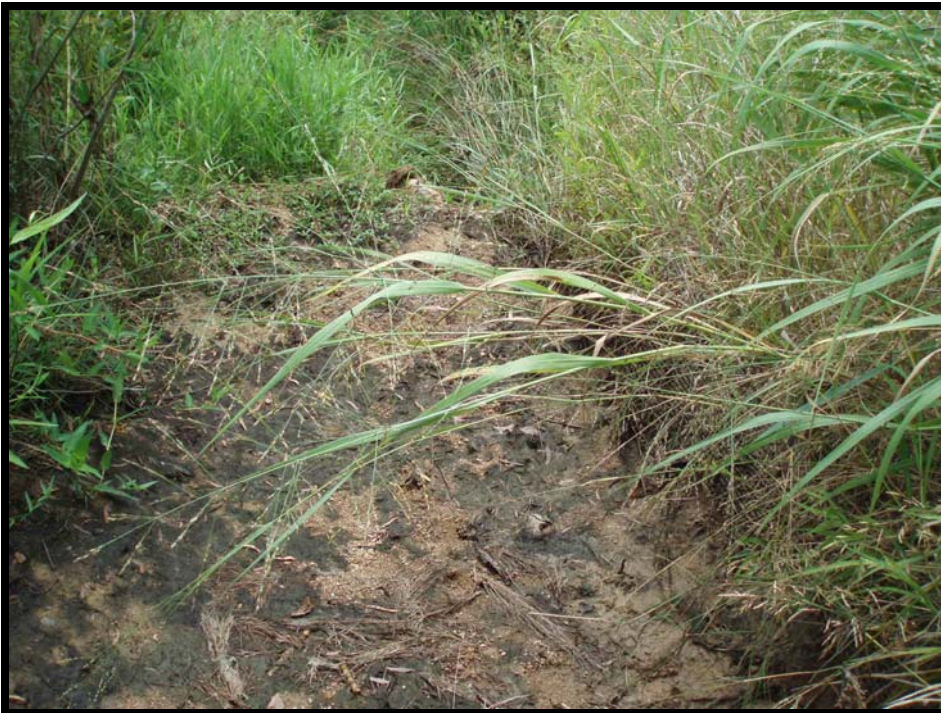
SPA6 - Beaver dam across channel @ station 34+50 (R2)

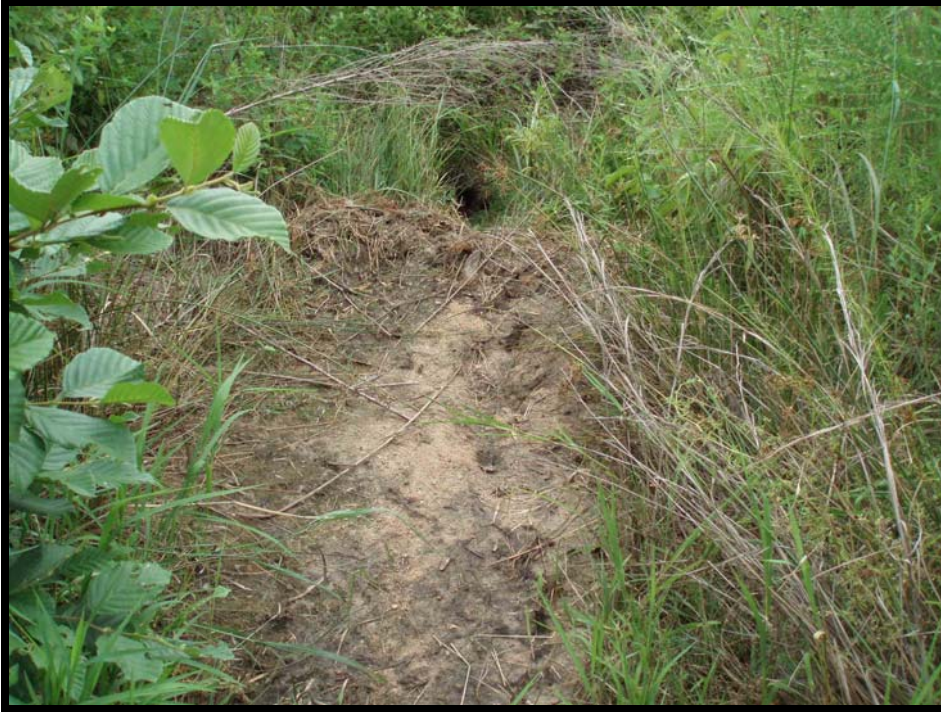
SPA7 - Beaver dam across channel @ station 38+20 (R2)

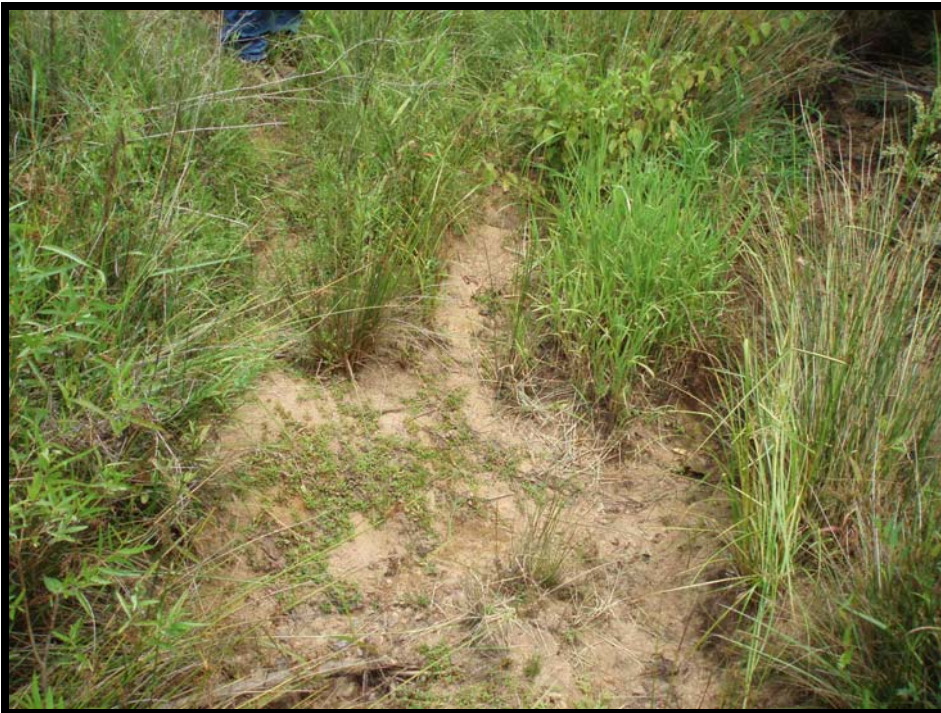
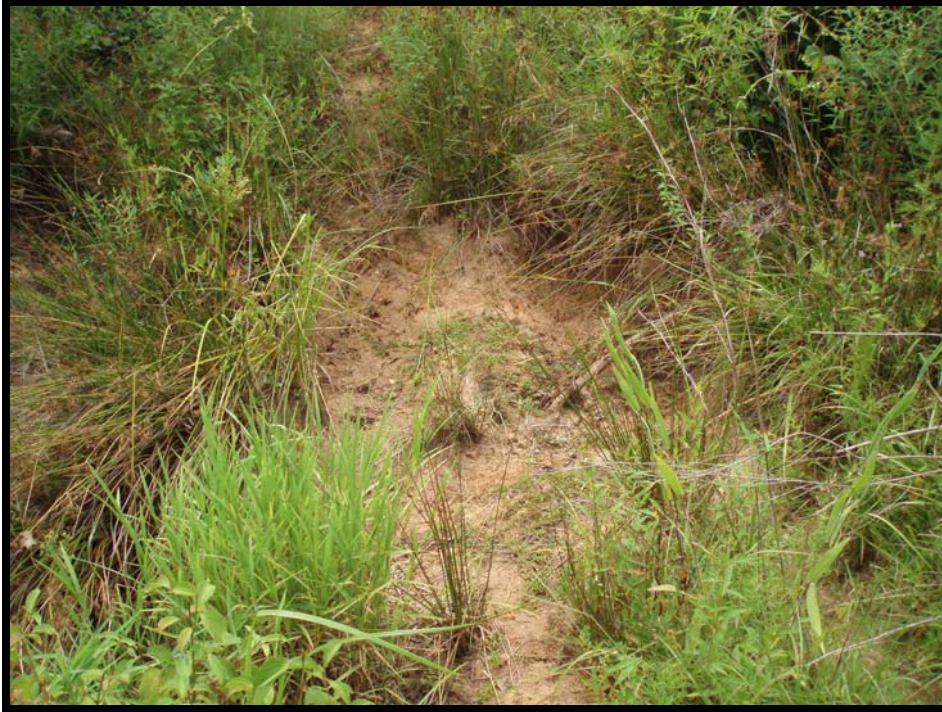
SPA8 - Right bank ATV trail crossing channel @ station 43+15 (R2)

SPA8 - Left bank ATV trail crossing channel @ station 43+15 (R2)

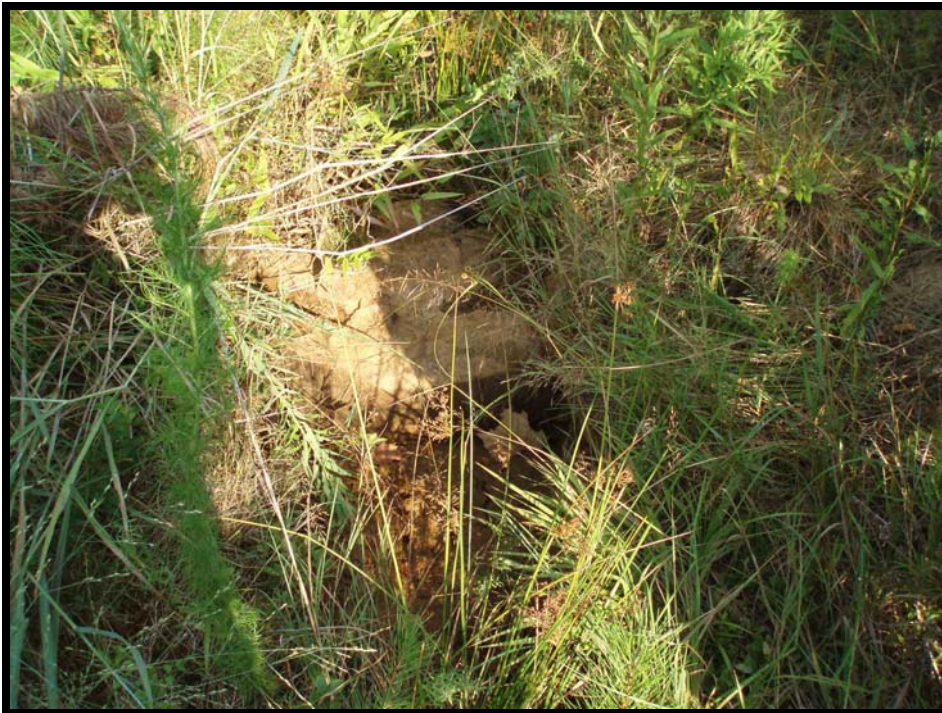
SPA9 - Erosion behind log weir structure @ station 12+00 (S1)

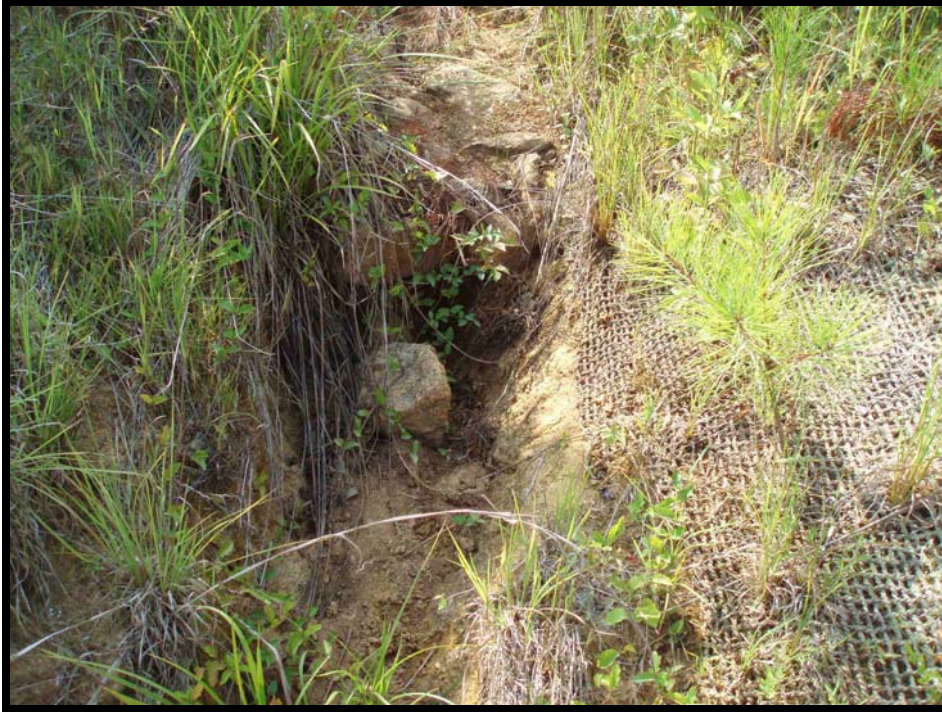
SPA10 - Erosion behind rock vane structure @ station 15+85 (S1)
