# ANNUAL MONITORING REPORT FOR 2006 CLAYHILL FARMS

**CLAYHILL FARMS MITIGATION SITE**  
**JONES COUNTY, NORTH CAROLINA**  
**TIP No. R-2105 WM**  
**(EEP Project Number .00018)**  
2006 Annual Monitoring Report (Year 1 of 5)

April 2007

Prepared by:  
Axiom Environmental, Inc.  
2126 Rowland Pond Drive  
Willow Spring, North Carolina 27592

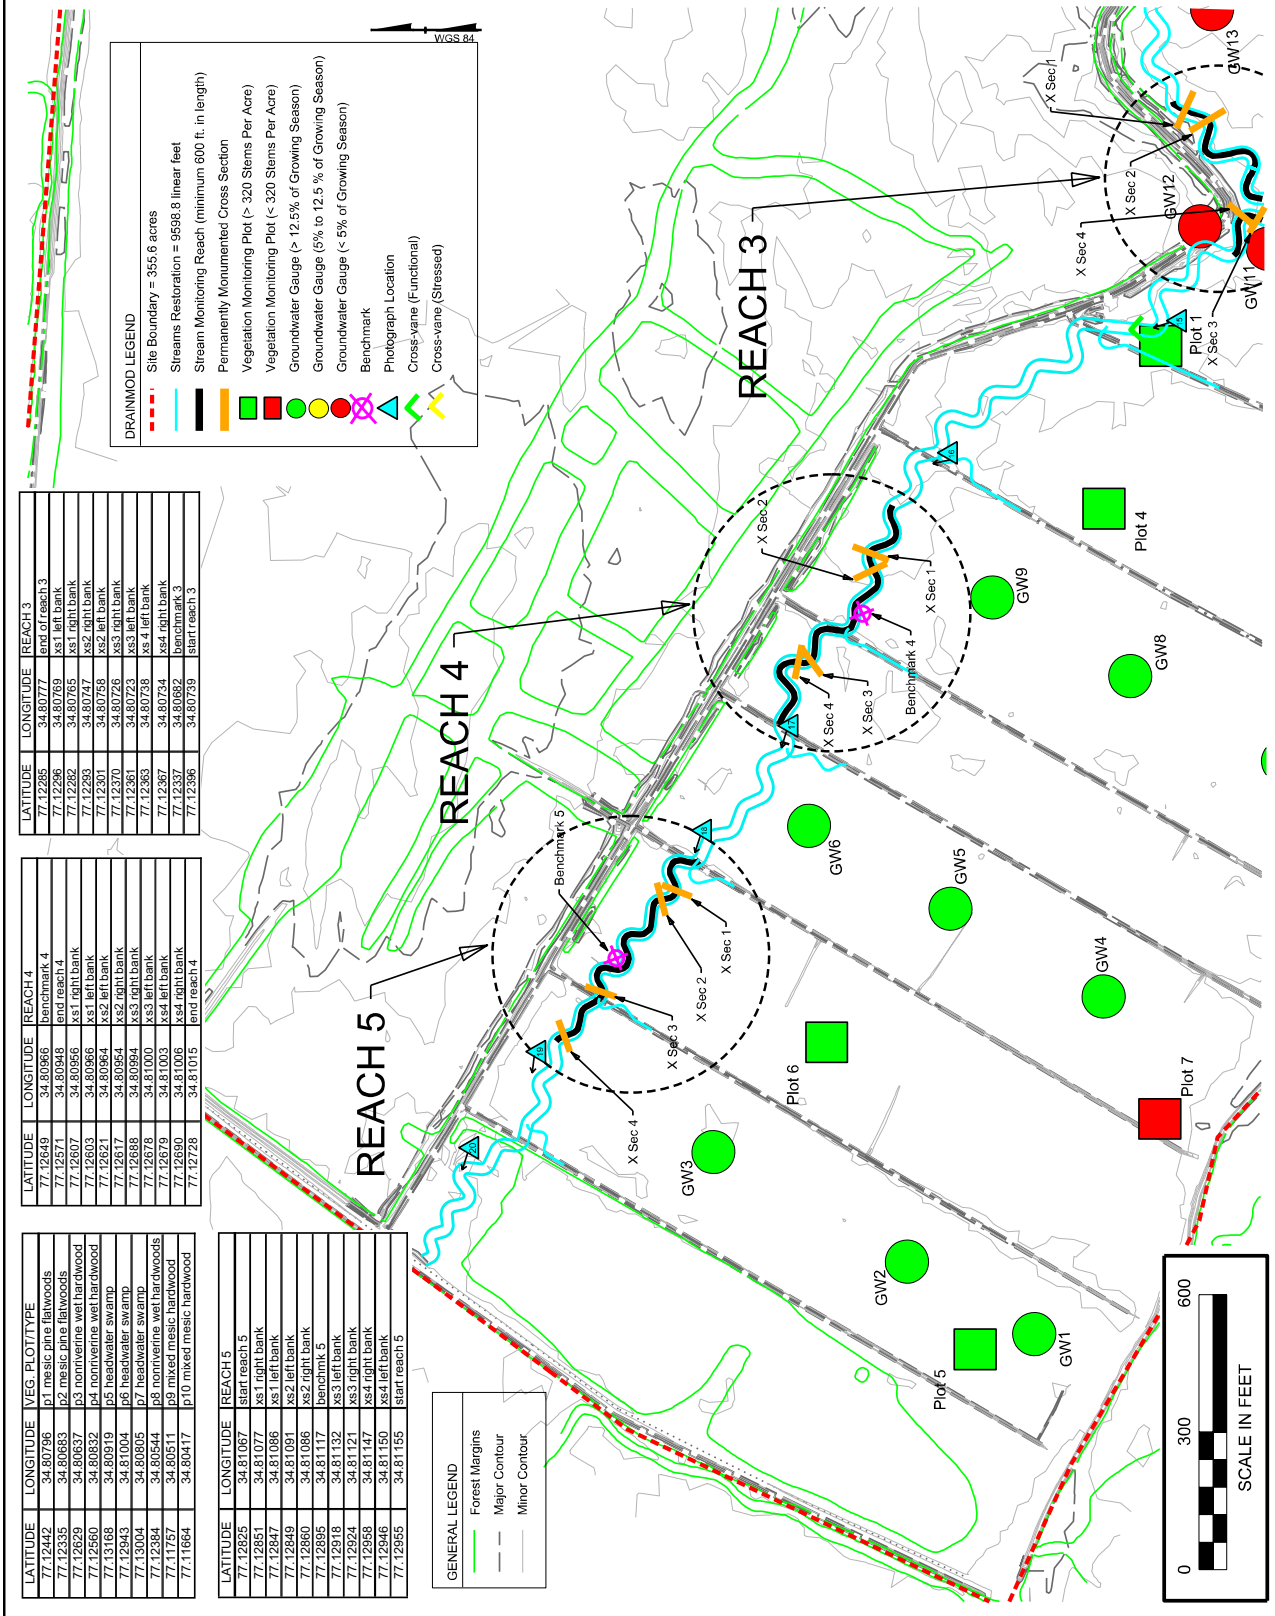
**2B**

The vegetation problem area within the Site is depicted on Figure 2B. A large area of poor planted stem survival was observed adjacent to the restored stream (near Reach 1) during year 1 (2006) monitoring. Poor survival may have resulted from soil infertility or drought.

Stream problem areas within the Site are depicted on Figures 2A through 2B. Two problem areas were noted for the year 1 (2006) monitoring. Both problem areas are stressed cross-vanes with failing right bank arms resulting from a lack of footers; photographs of each are included in Appendix C. Additional inspections and monitoring of bed and banks up and downstream of compromised structures is recommended prior to initiation of proactive maintenance measures.

Stream problem areas within the Site included two stressed cross-vanes with failing right bank arms resulting from a lack of footers. Additional inspections and monitoring of bed and banks up and downstream of compromised structures is recommended prior to initiation of proactive maintenance measures.

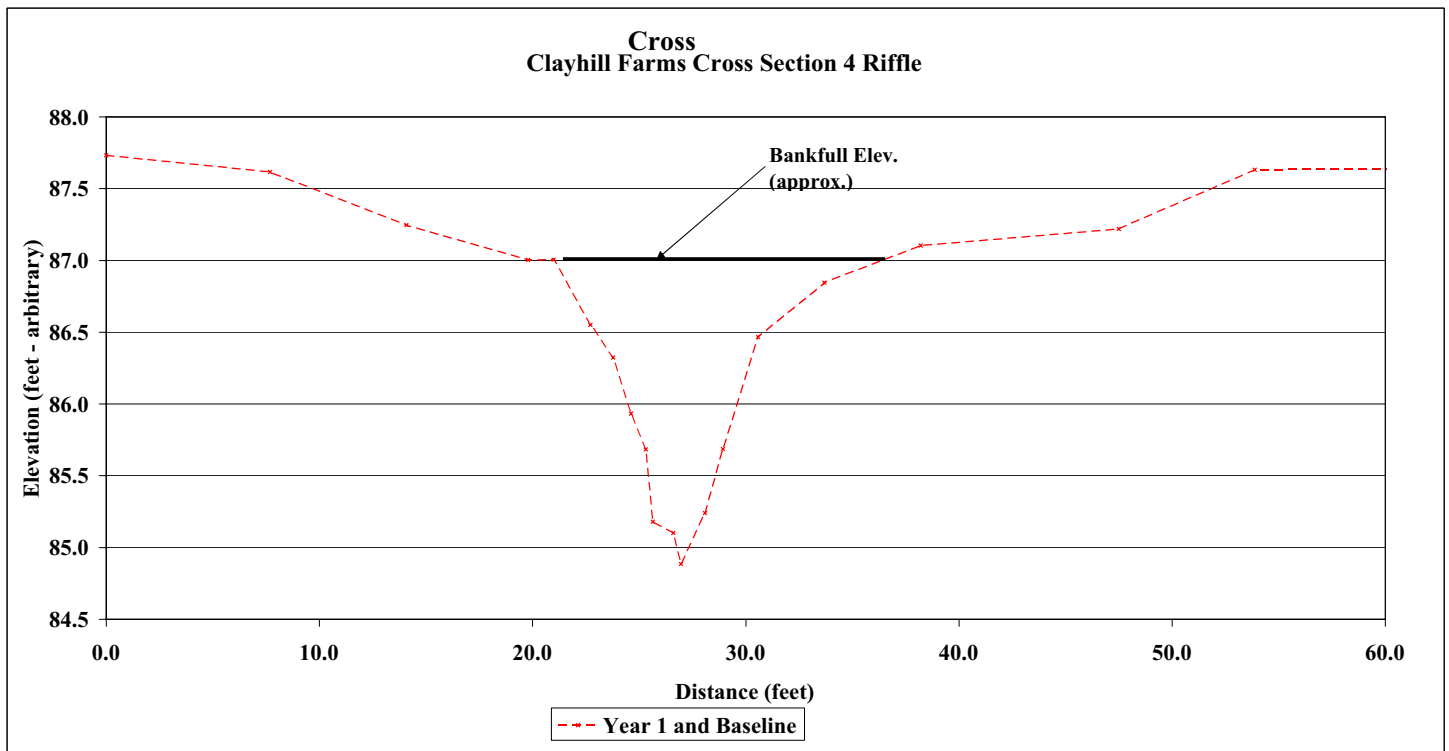
Photo of Reach 1 Cross-Section 4 - Looking Upstream

2006	2007	2008	2009	2010
Area	11.9				
Width	15.4				
Mean Depth	0.8				
Max Depth	2.1				
W/D	20.0

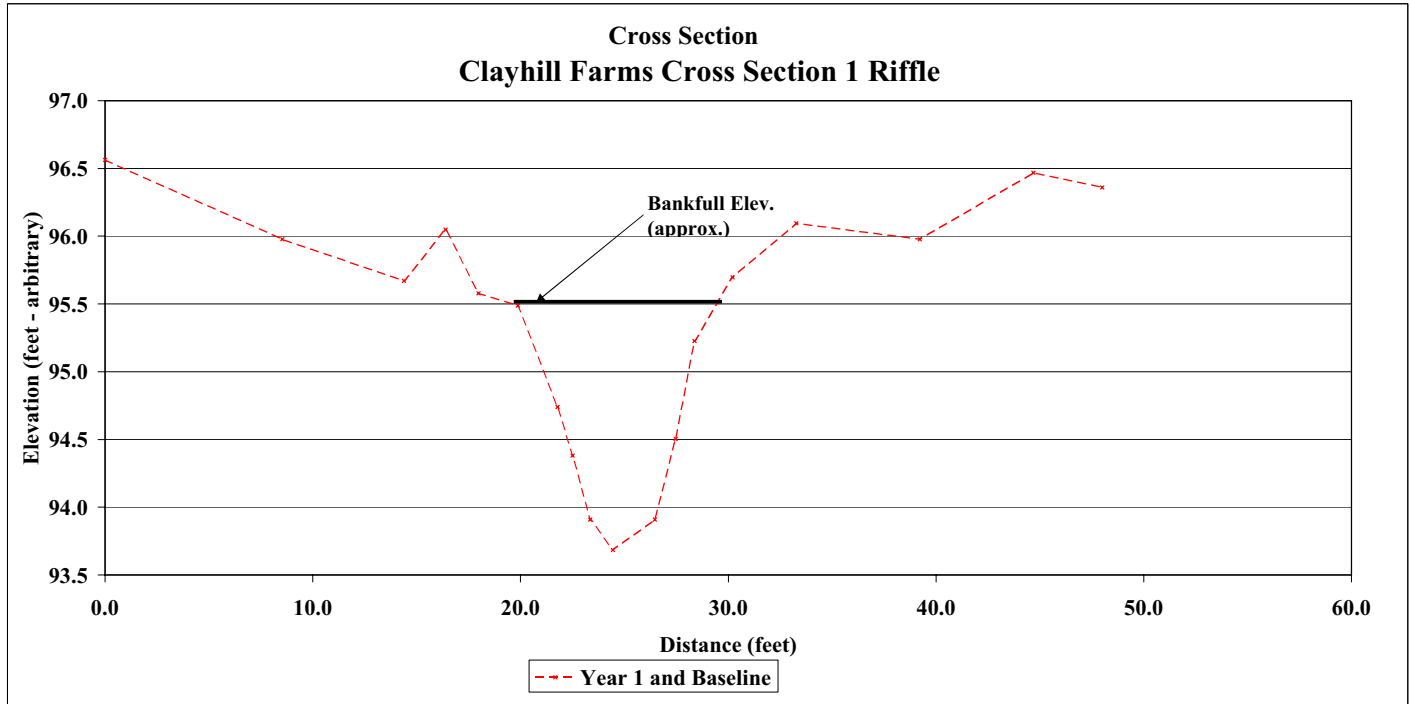
Photo of Reach 2 Cross-Section 1 - Looking Upstream

2006	2007	2008	2009	2010
Area	10.0				
Width	10.1				
Mean Depth	1.0				
Max Depth	1.8				
W/D	10.2

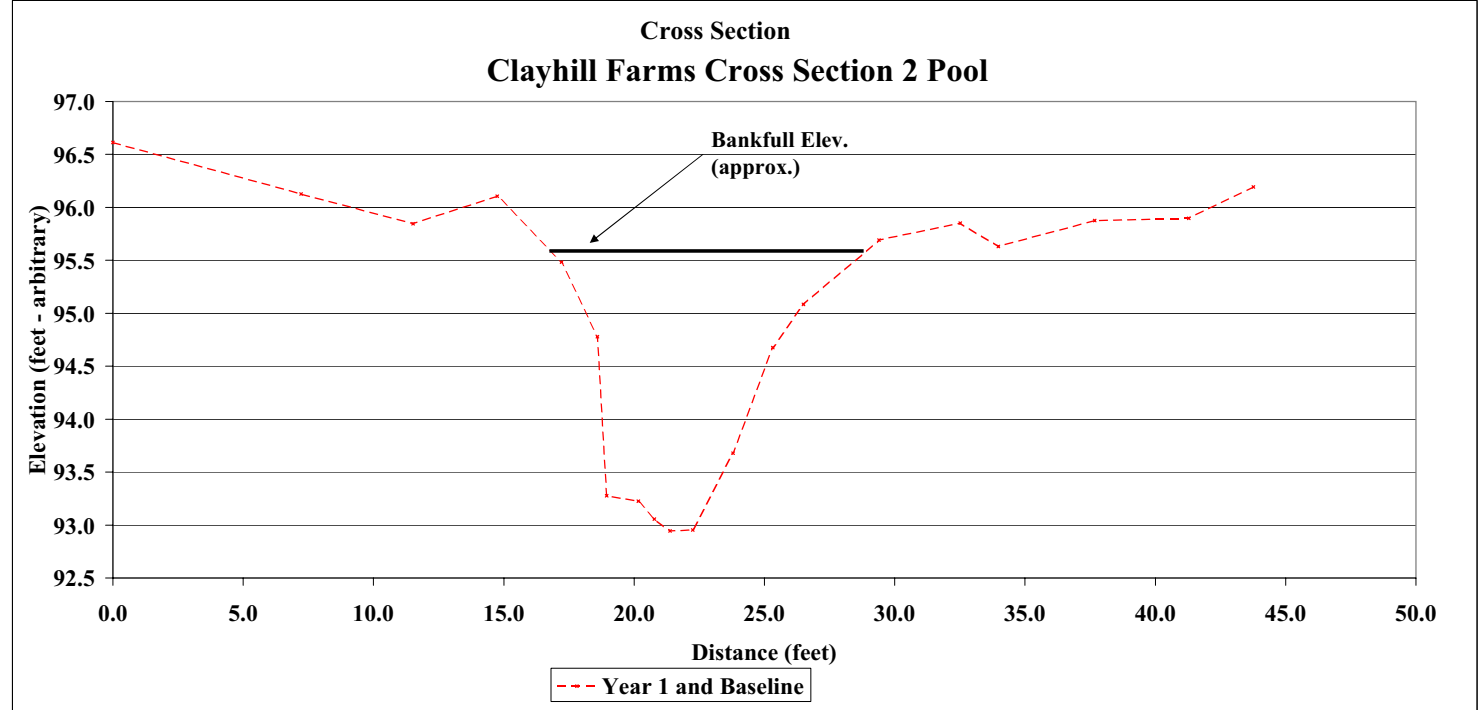
**Photo of Reach 2 Cross-Section 2 - Looking Upstream**

2006	2007	2008	2009	2010
<b>Area</b>	18.1				
<b>Width</b>	13.5				
<b>Mean Depth</b>	1.3				
<b>Max Depth</b>	2.8				
<b>W/D</b>	NA

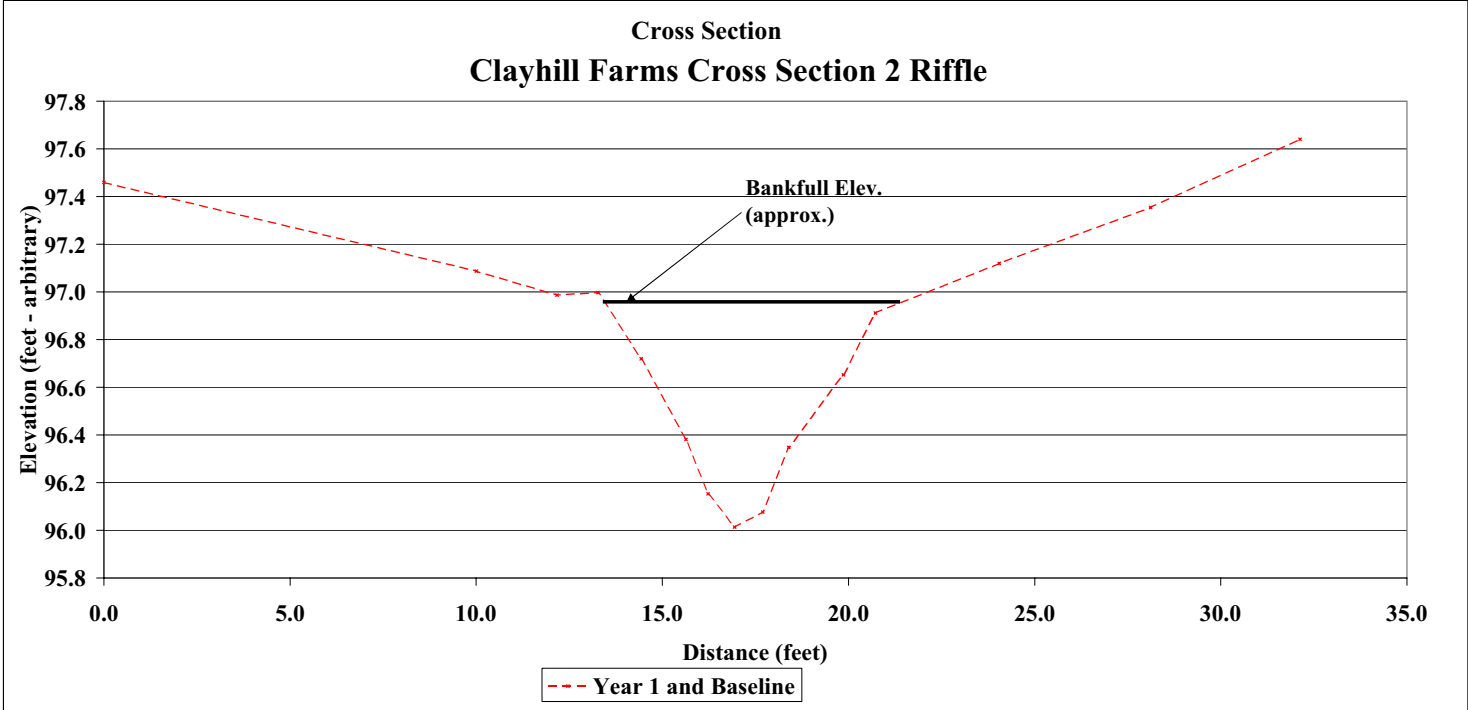
Photo of Reach 4 Cross-Section 2 - Looking Upstream

2006	2007	2008	2009	2010
Area	3.4				
Width	7.4				
Mean Depth	0.5				
Max Depth	0.9				
W/D	15.7
