**CLAYHILL FARMS MITIGATION SITE
JONES COUNTY, NORTH CAROLINA
TIP No. R-2105 WM
(EEP Project Number .00018)
2007 Annual Monitoring Report (Year 2 of 5)**

February 2008

Prepared by:
Axiom Environmental, Inc.
2126 Rowland Pond Drive
Willow Spring, North Carolina 27592

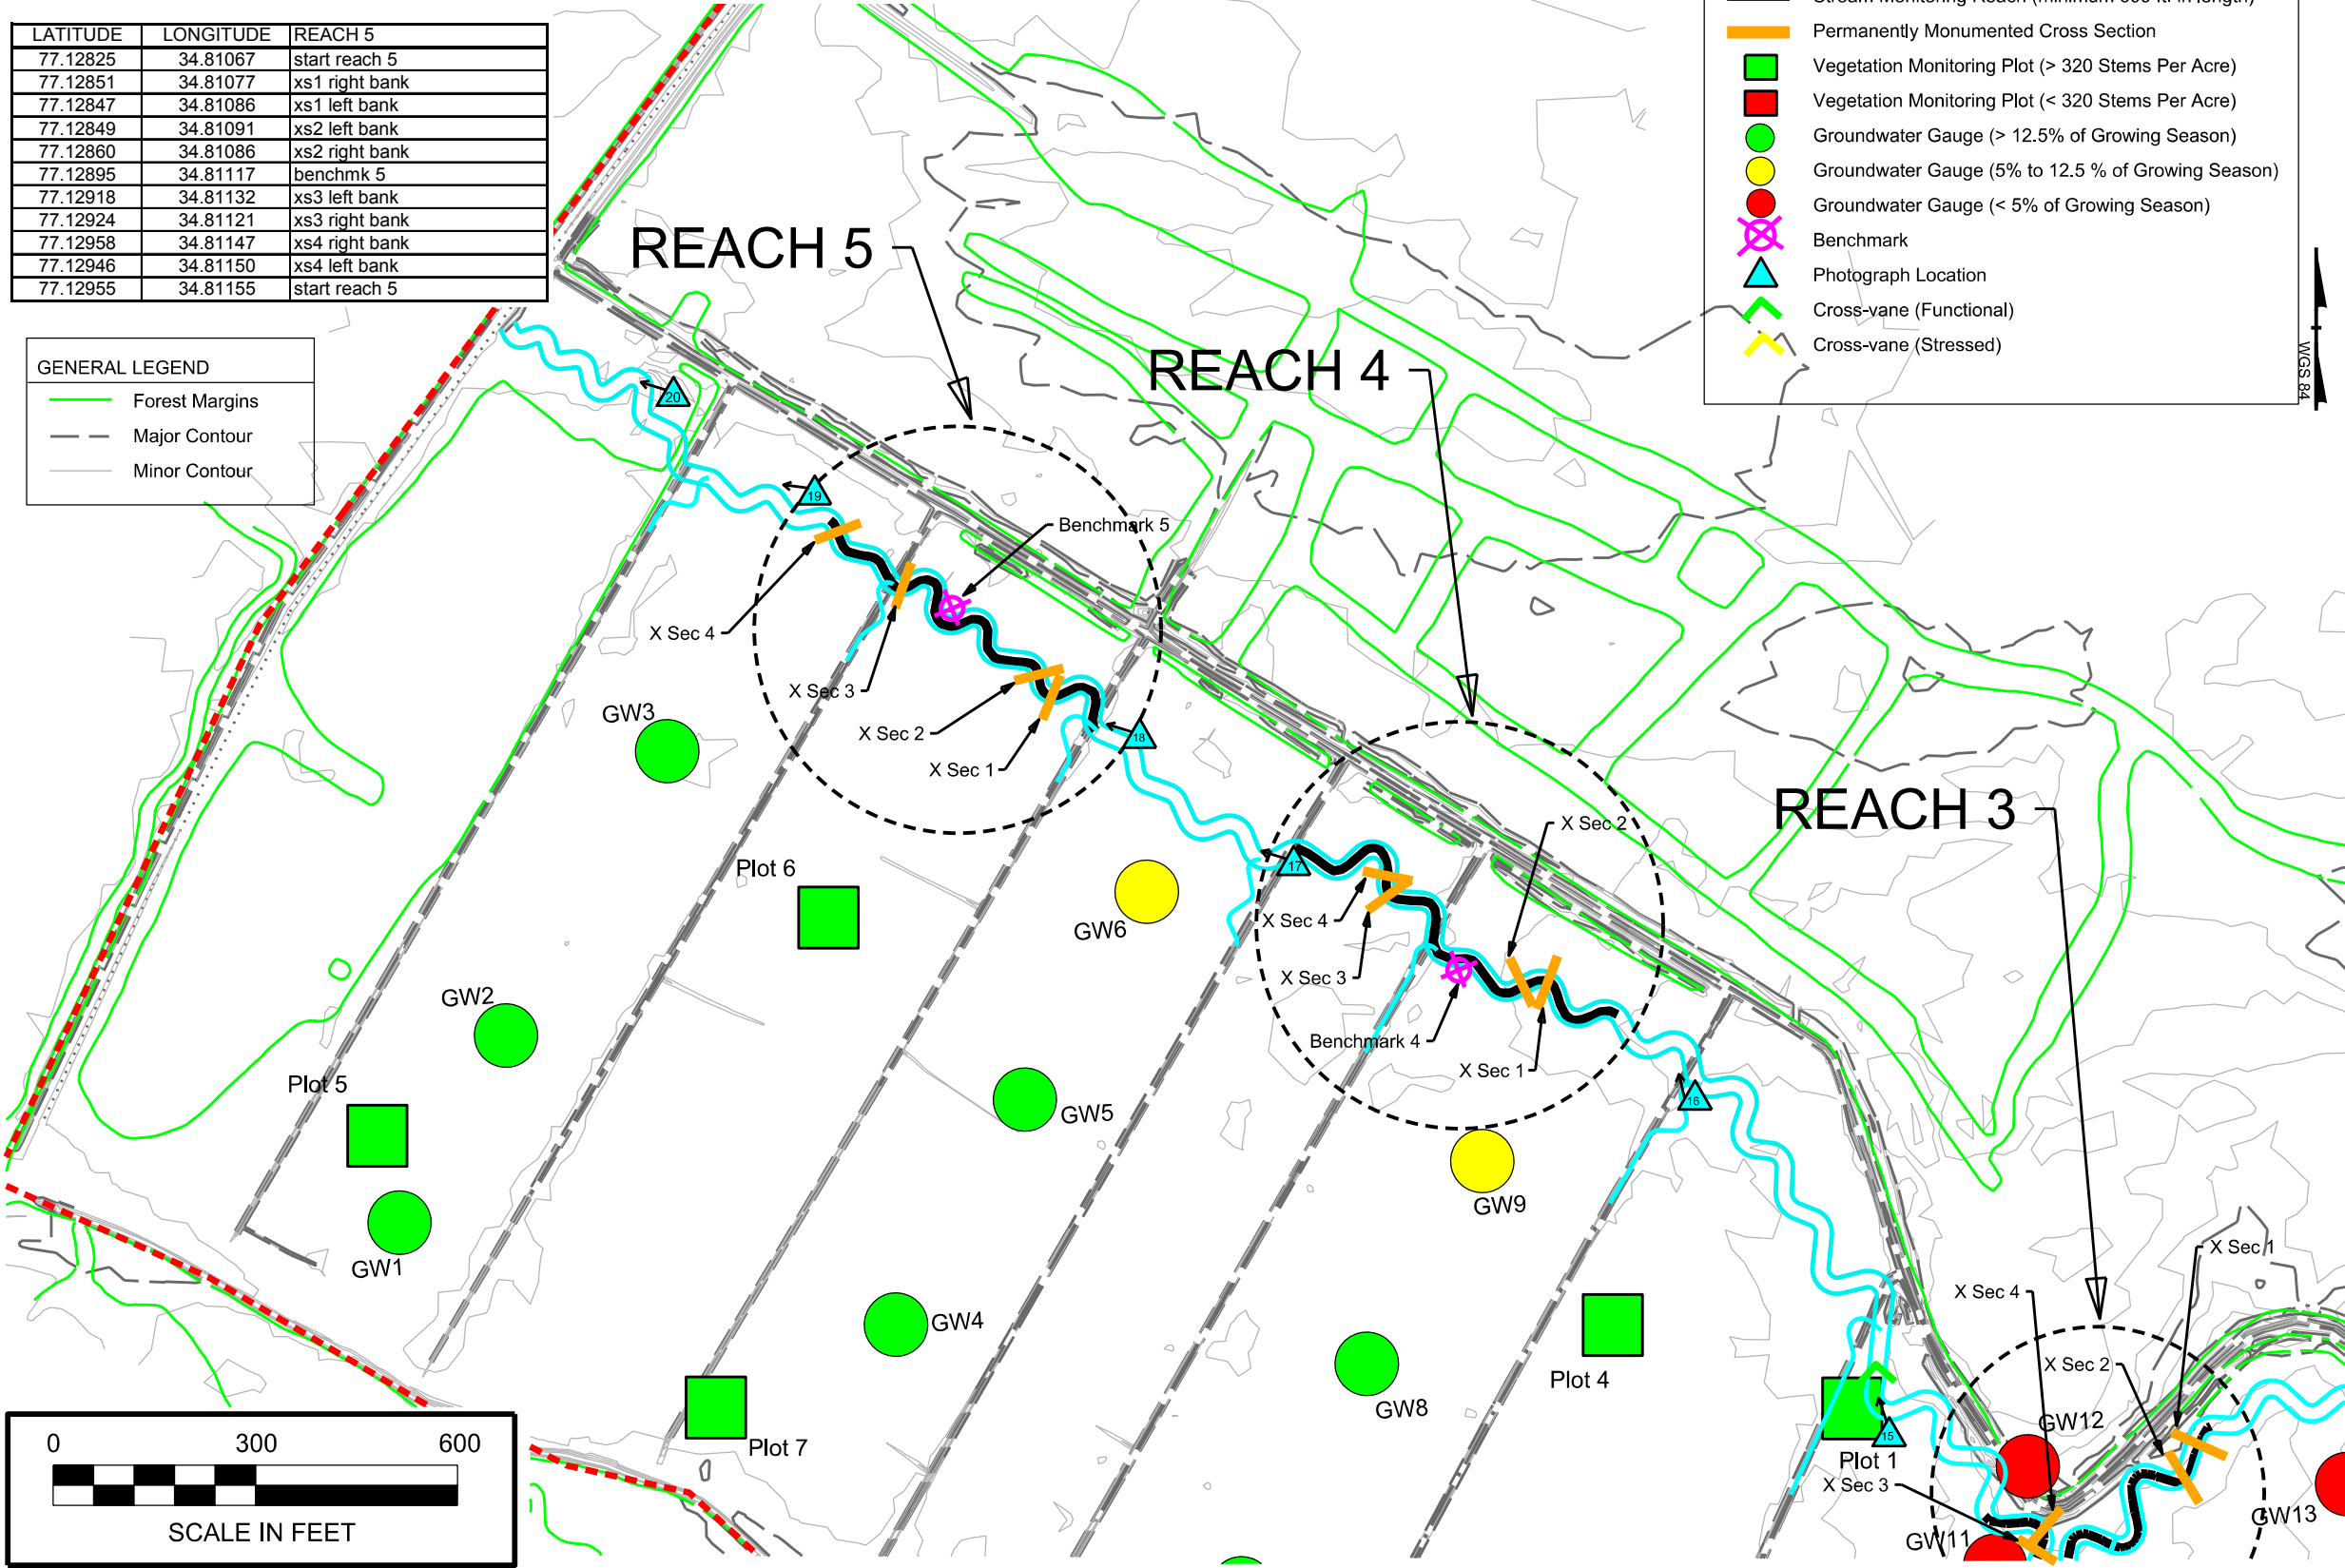
Stream problem areas within the Site are depicted on Figures 3A through 3B. Two problem areas were noted for the year 2 (2007) monitoring. Both problem areas are stressed cross-vanes with failing right bank arms resulting from a lack of footers; photographs of each are included in Appendix D. Additional inspections and monitoring of bed and banks up and downstream of compromised structures is recommended prior to initiation of proactive maintenance measures.

Stream problem areas within the Site included two stressed cross-vanes with failing right bank arms resulting from a lack of footers. Additional inspections and monitoring of bed and banks up and downstream of compromised structures is recommended prior to initiation of proactive maintenance measures.

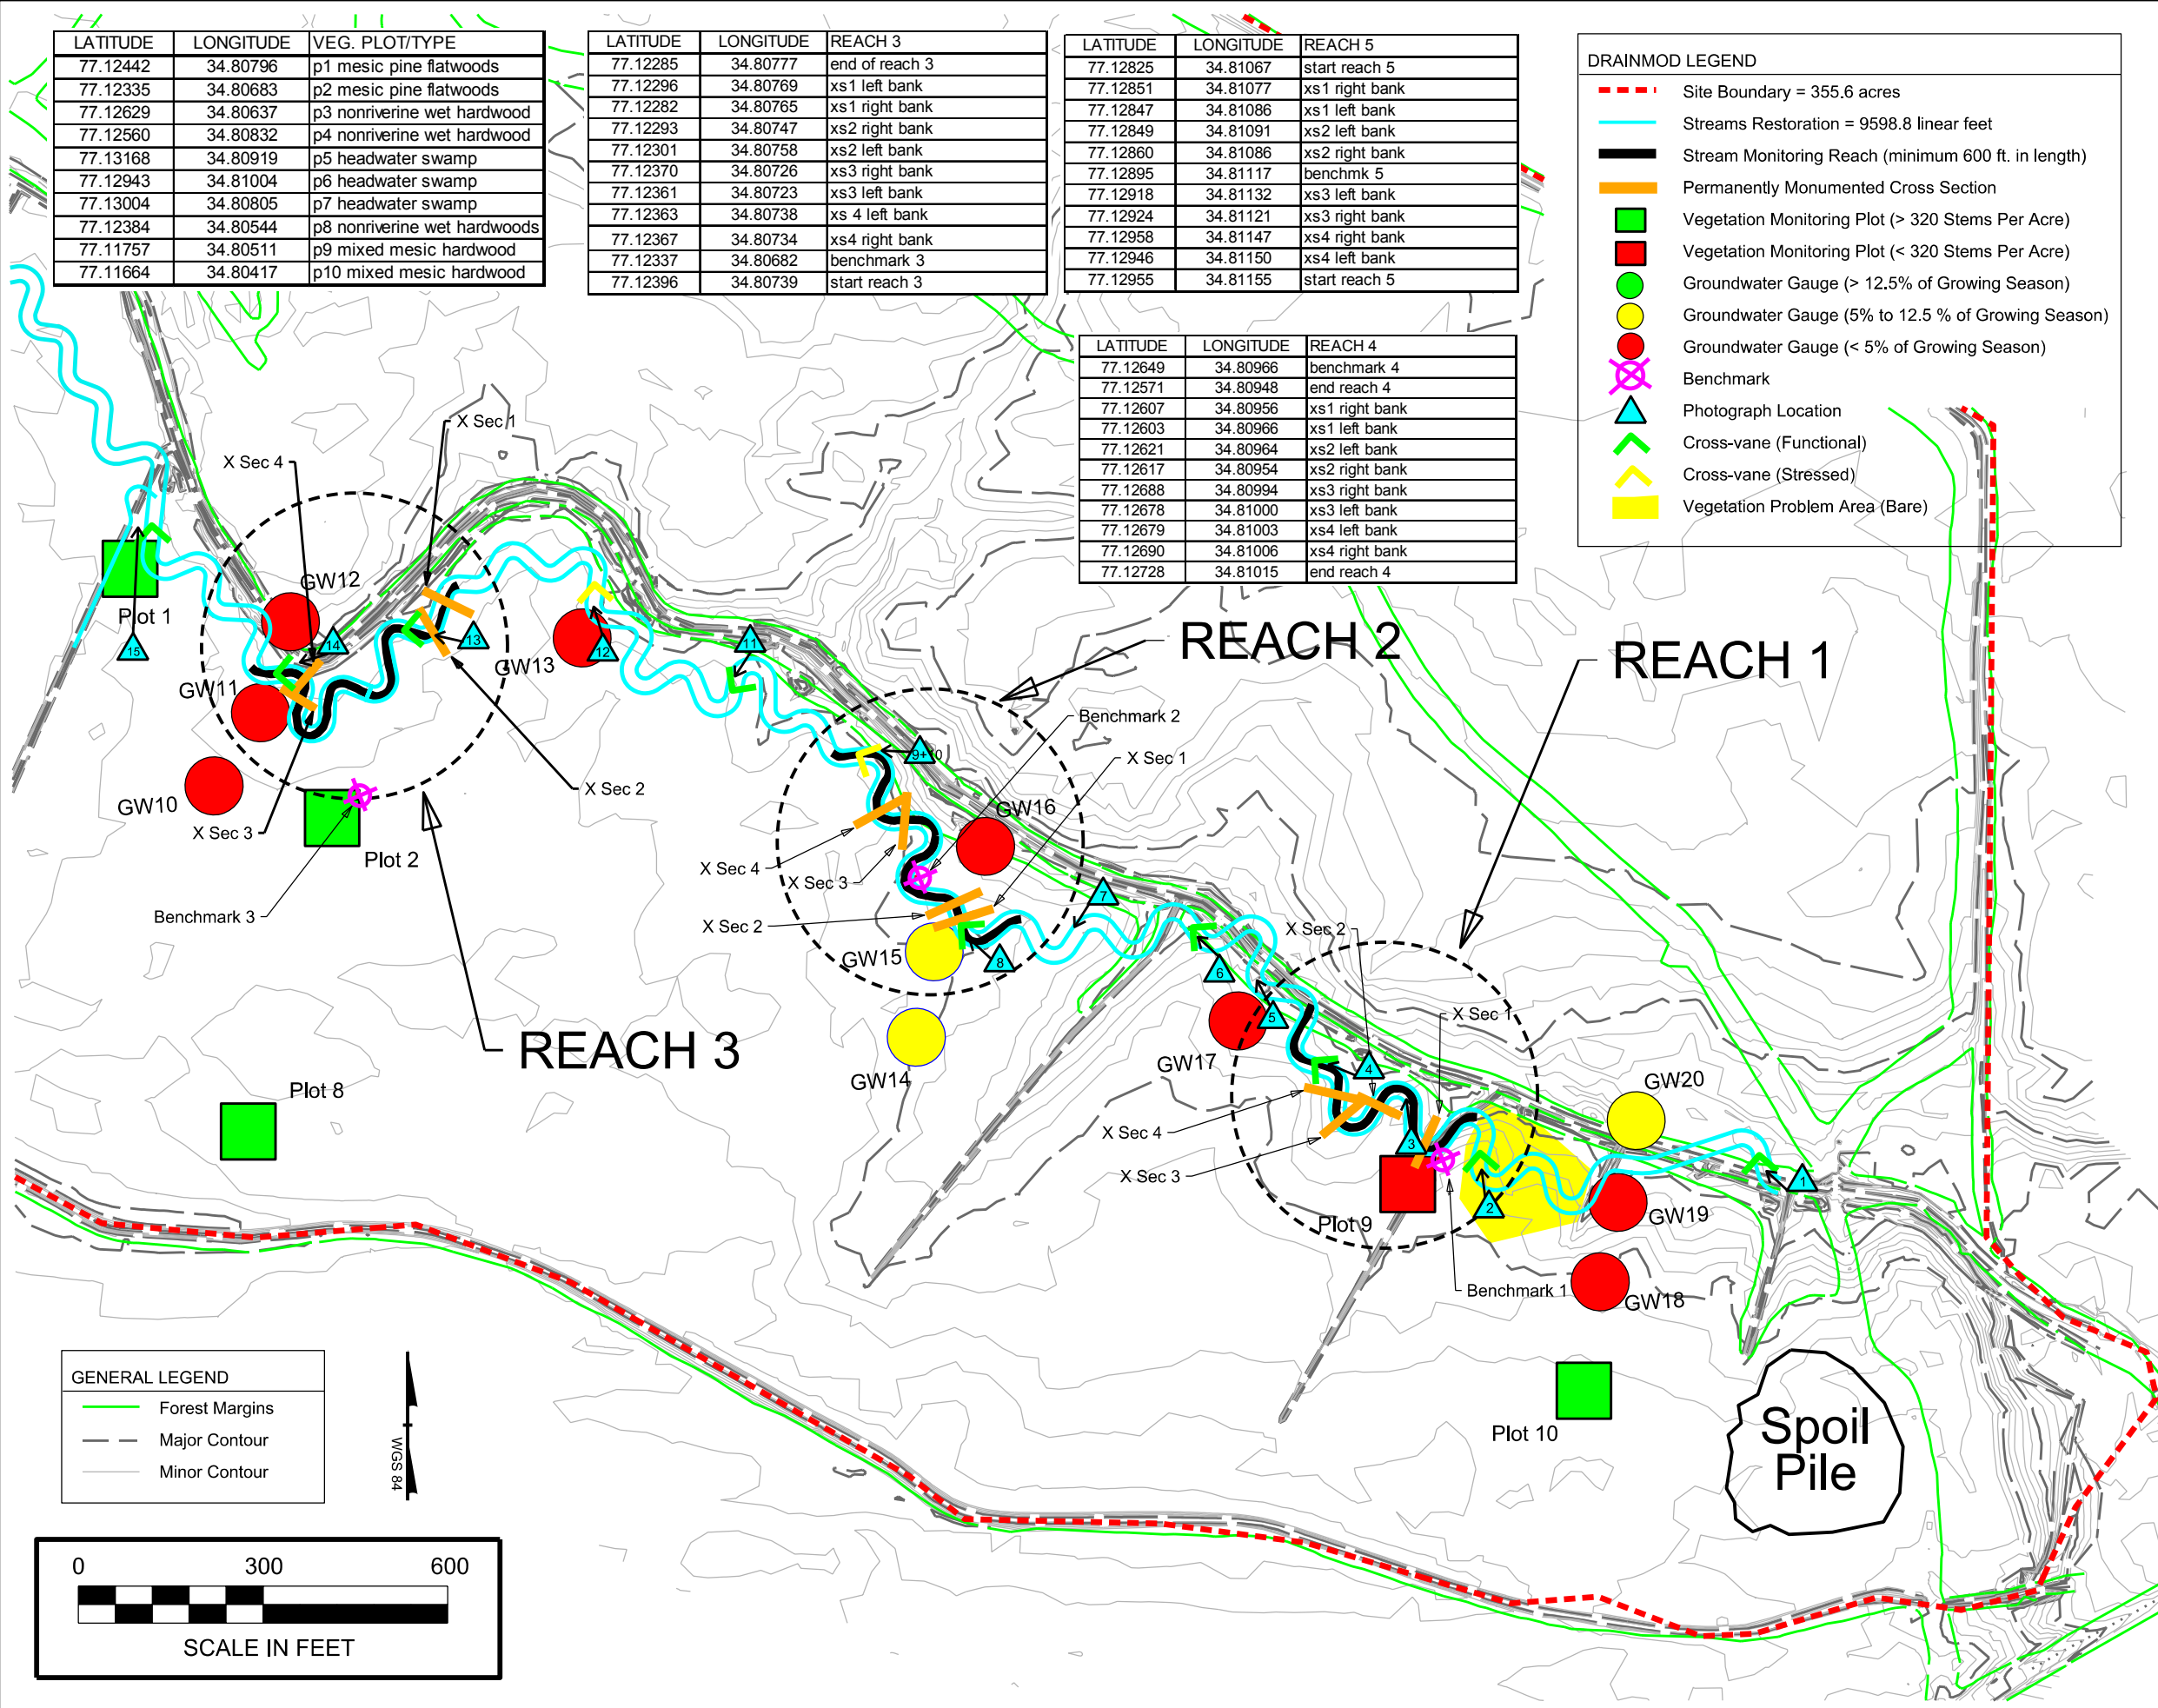
Scale: 1 in. = 270 ft.	FIGURE NO. 3B
Date: July 2007	
Project No.: 07-002

The vegetation problem area within the Site is depicted on Figure 3B. A large area of dead stems was observed adjacent to the restored stream (near Reach 1) during year 2 (2007) monitoring. Poor survival may have resulted from soil infertility and/or drought.
