**CLAYHILL FARMS MITIGATION SITE
JONES COUNTY, NORTH CAROLINA
TIP No. R-2105 WM
(EEP Project Number .00018)
2008 Annual Monitoring Report (Year 3 of 5)**

CLAYHILL FARMS MITIGATION SITE
JONES COUNTY, NORTH CAROLINA
TIP No. R-2105 WM
(EEP Project Number .00018)
2008 Annual Monitoring Report (Year 3 of 5)

Prepared by:
Axiom Environmental, Inc.
2126 Rowland Pond Drive
Willow Spring, North Carolina 27592

December 2008

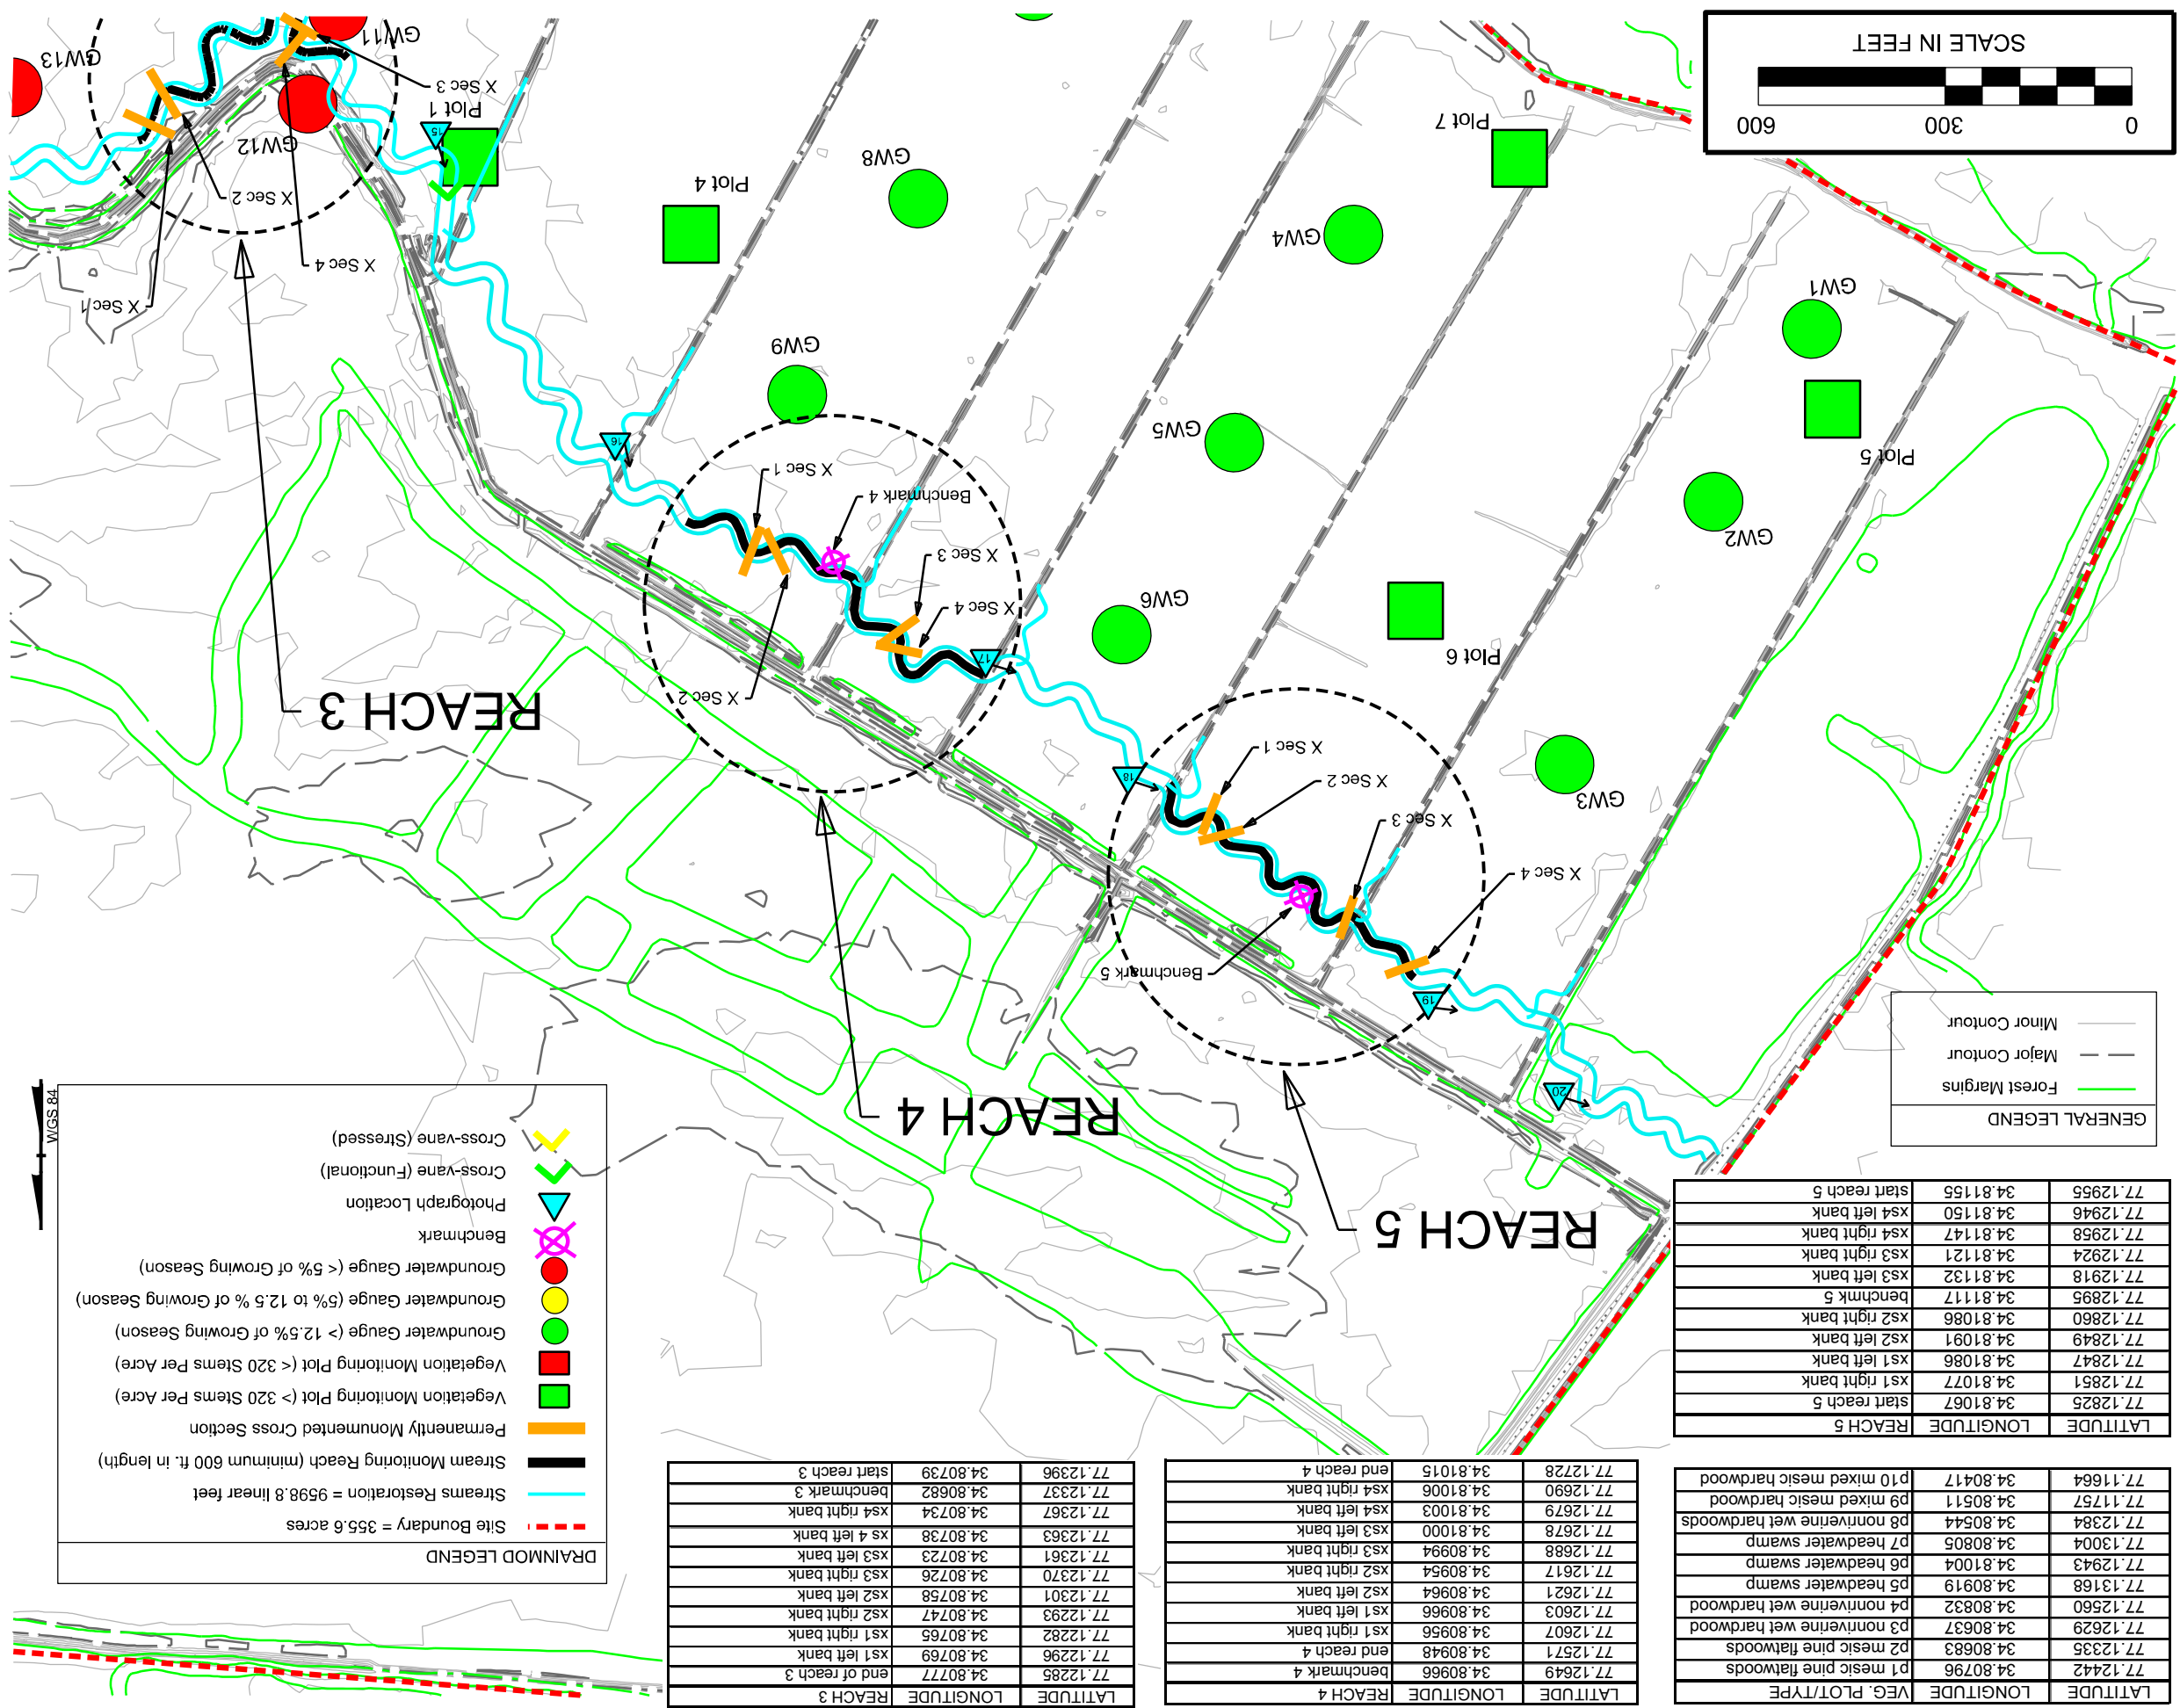
Stream problem areas within the Site are depicted on Figures 3A through 3B. Two problem areas were noted for the year 3 (2008) monitoring period. Both problem areas are stressed cross-vanes with failing right bank arms resulting from a lack of footers; photographs of each are included in Appendix E. Additional inspections and monitoring of bed and banks up and downstream of compromised structures is recommended prior to initiation of proactive maintenance measures.

Stream problem areas within the Site included two stressed cross-vanes with failing right bank arms resulting from a lack of footers. Additional inspections and monitoring of bed and banks up and downstream of compromised structures is recommended prior to initiation of proactive maintenance measures.

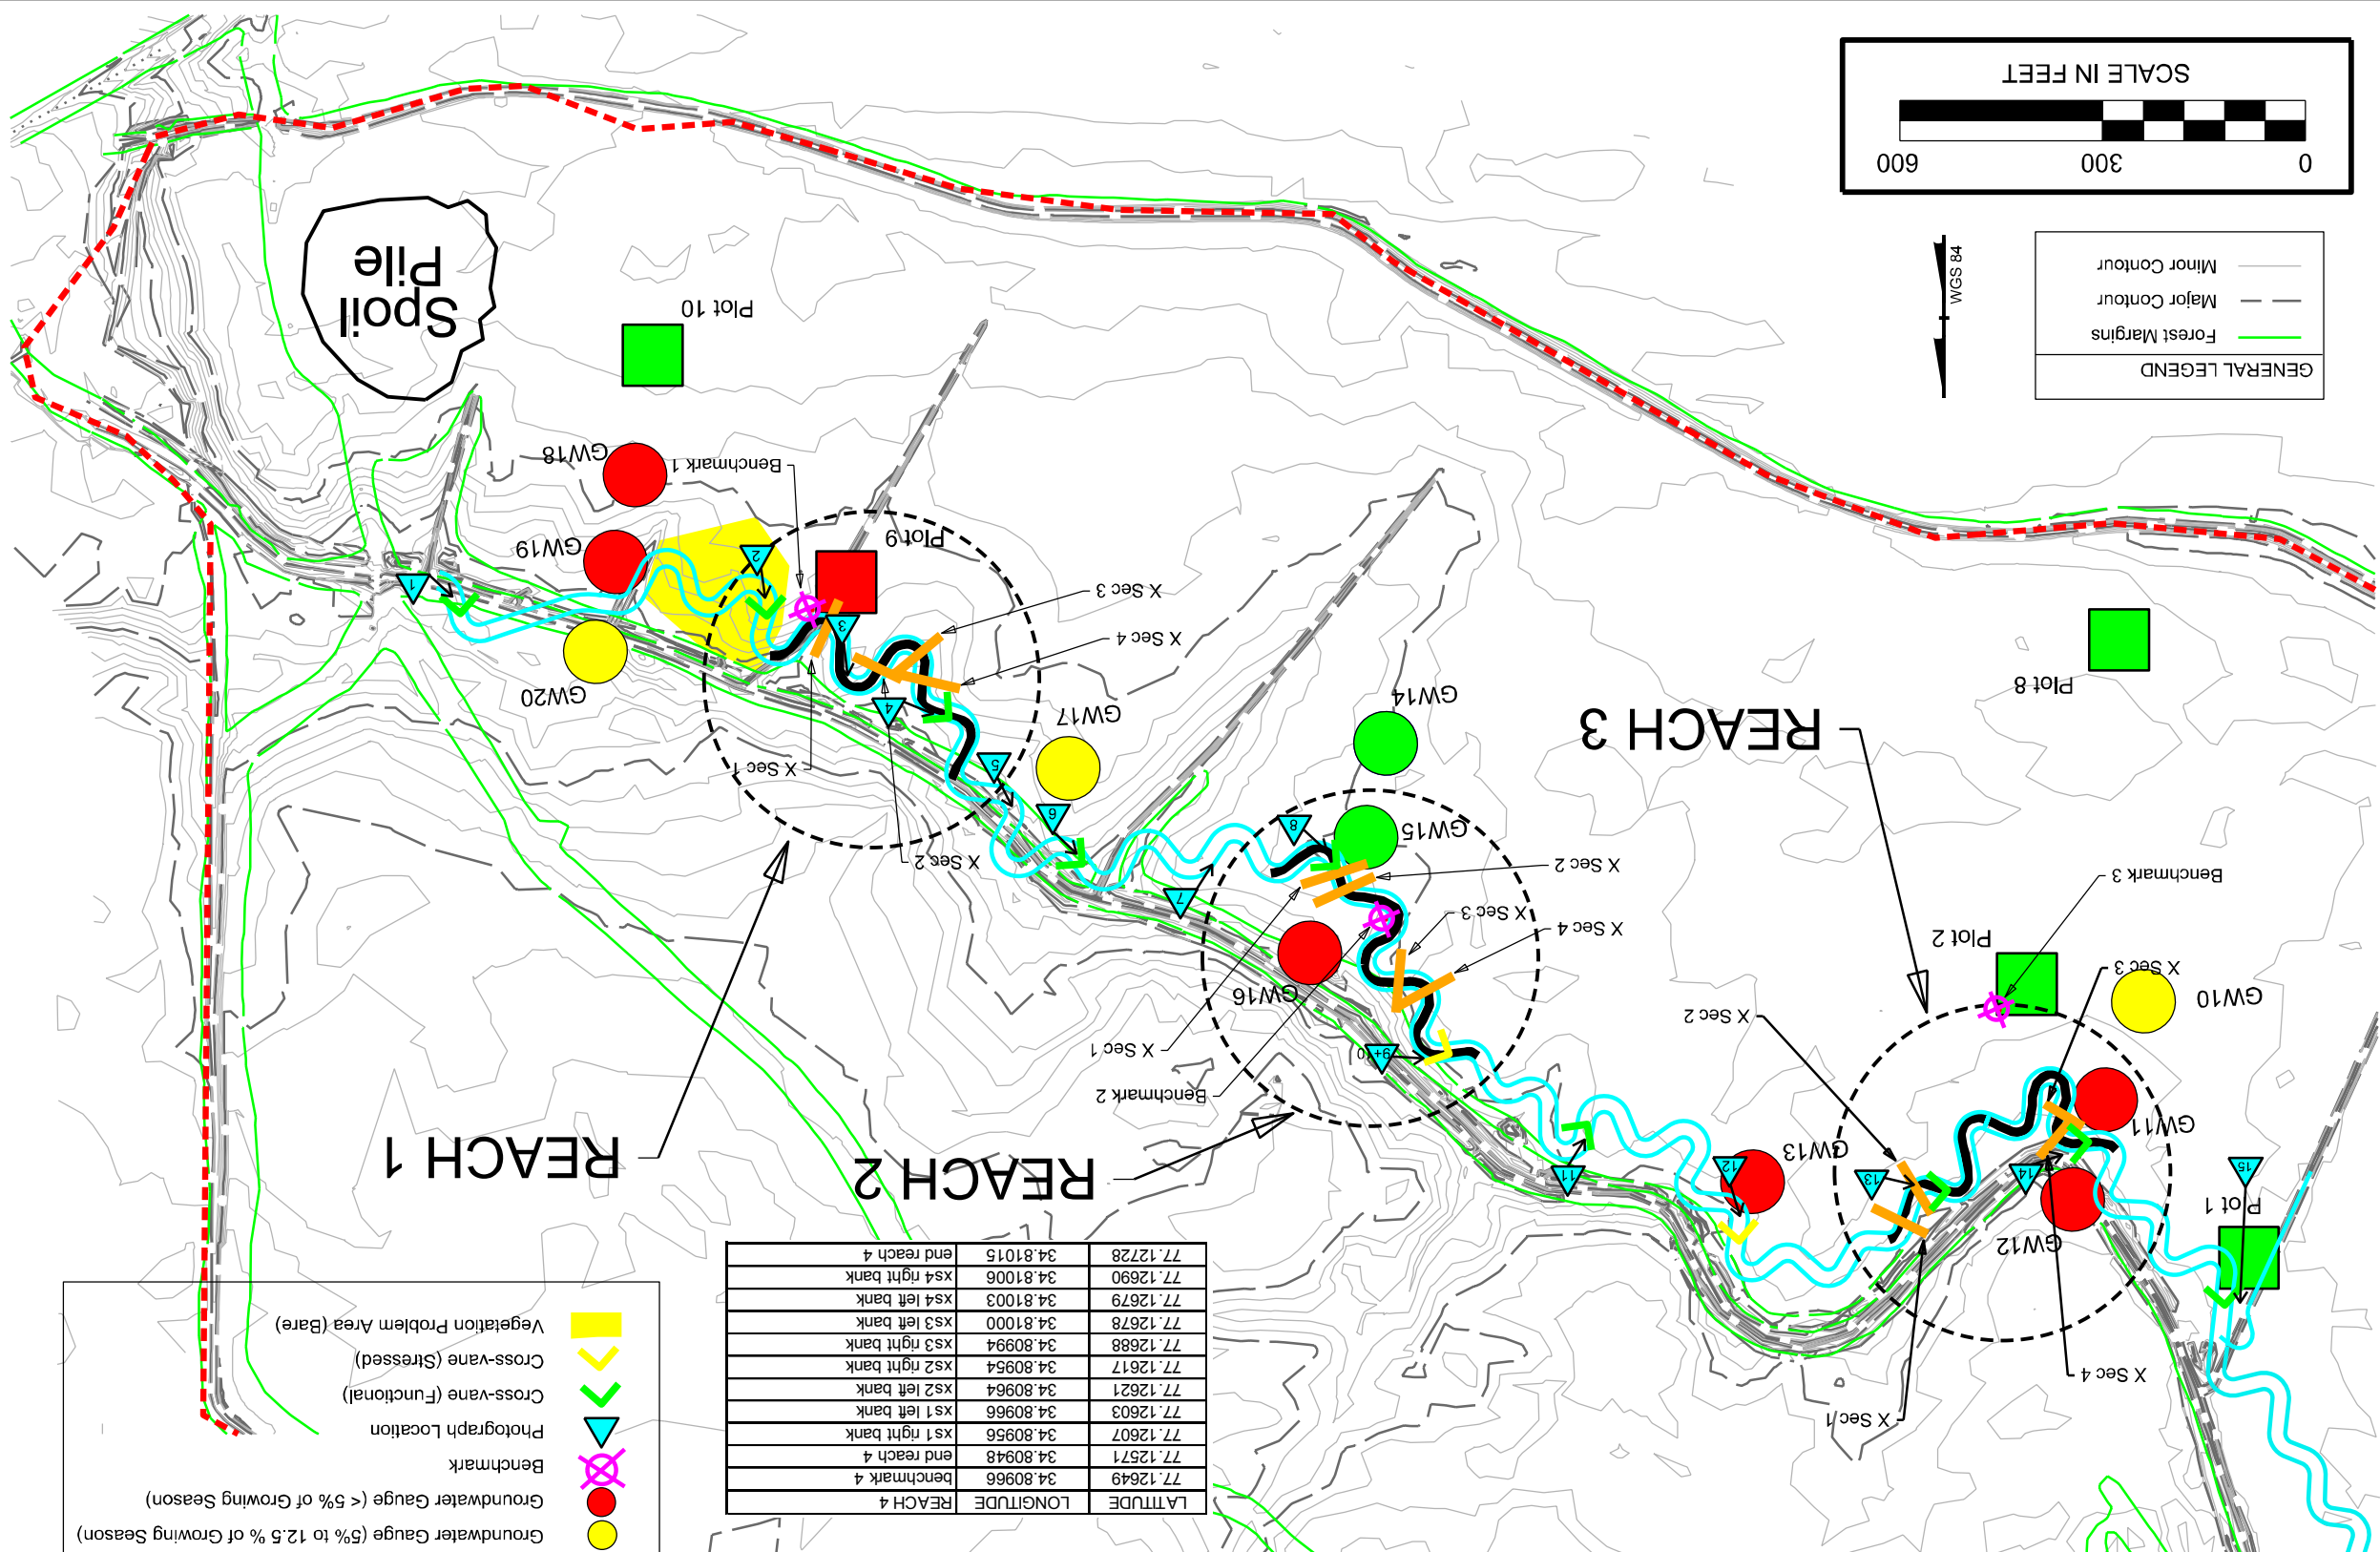
3B

The vegetation problem area within the Site is depicted on Figure 3B. Vegetation problem areas noted during year 3 (2008) monitoring consisted of a large area of poor planted stem survival adjacent to the restored stream (near Reach 1); photographs of this area are included in Appendix D. Poor survival may have resulted from soil infertility and/or drought. Planted seedlings exhibited various degrees of vigor at the Site. Overall, vigor was noted as good. Herbaceous vegetation on the lower half of the Site adjacent to the restored stream is not establishing well most likely due to soil infertility.

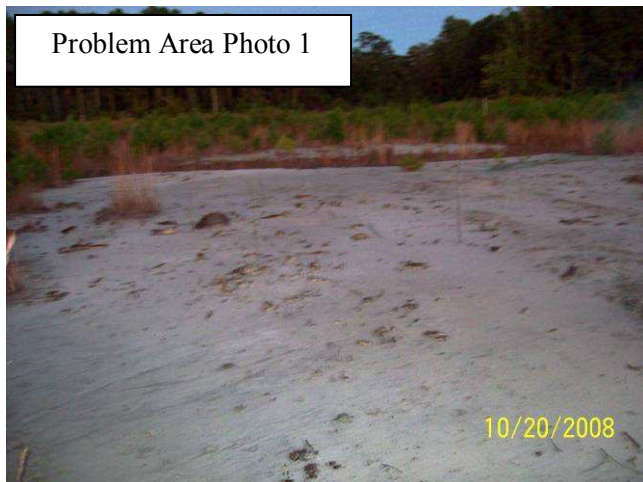
Problem Area Photo 1

The vegetation problem area within the Site is a large area of dead stems observed adjacent to the restored stream (near Reach 1). Poor survival may have resulted from soil infertility or drought. Herbaceous vegetation on the lower half of the Site adjacent to the restored stream is not establishing well most likely due to soil infertility.
