**CLAYHILL FARMS MITIGATION SITE
JONES COUNTY, NORTH CAROLINA
TIP No. R-2105 WM
(EEP Project Number .00018)
2009 Annual Monitoring Report (Year 4 of 5)**

November 2009

Prepared by:
Axiom Environmental, Inc.
20 Enterprise Street, Suite 7
Raleigh, North Carolina 27607

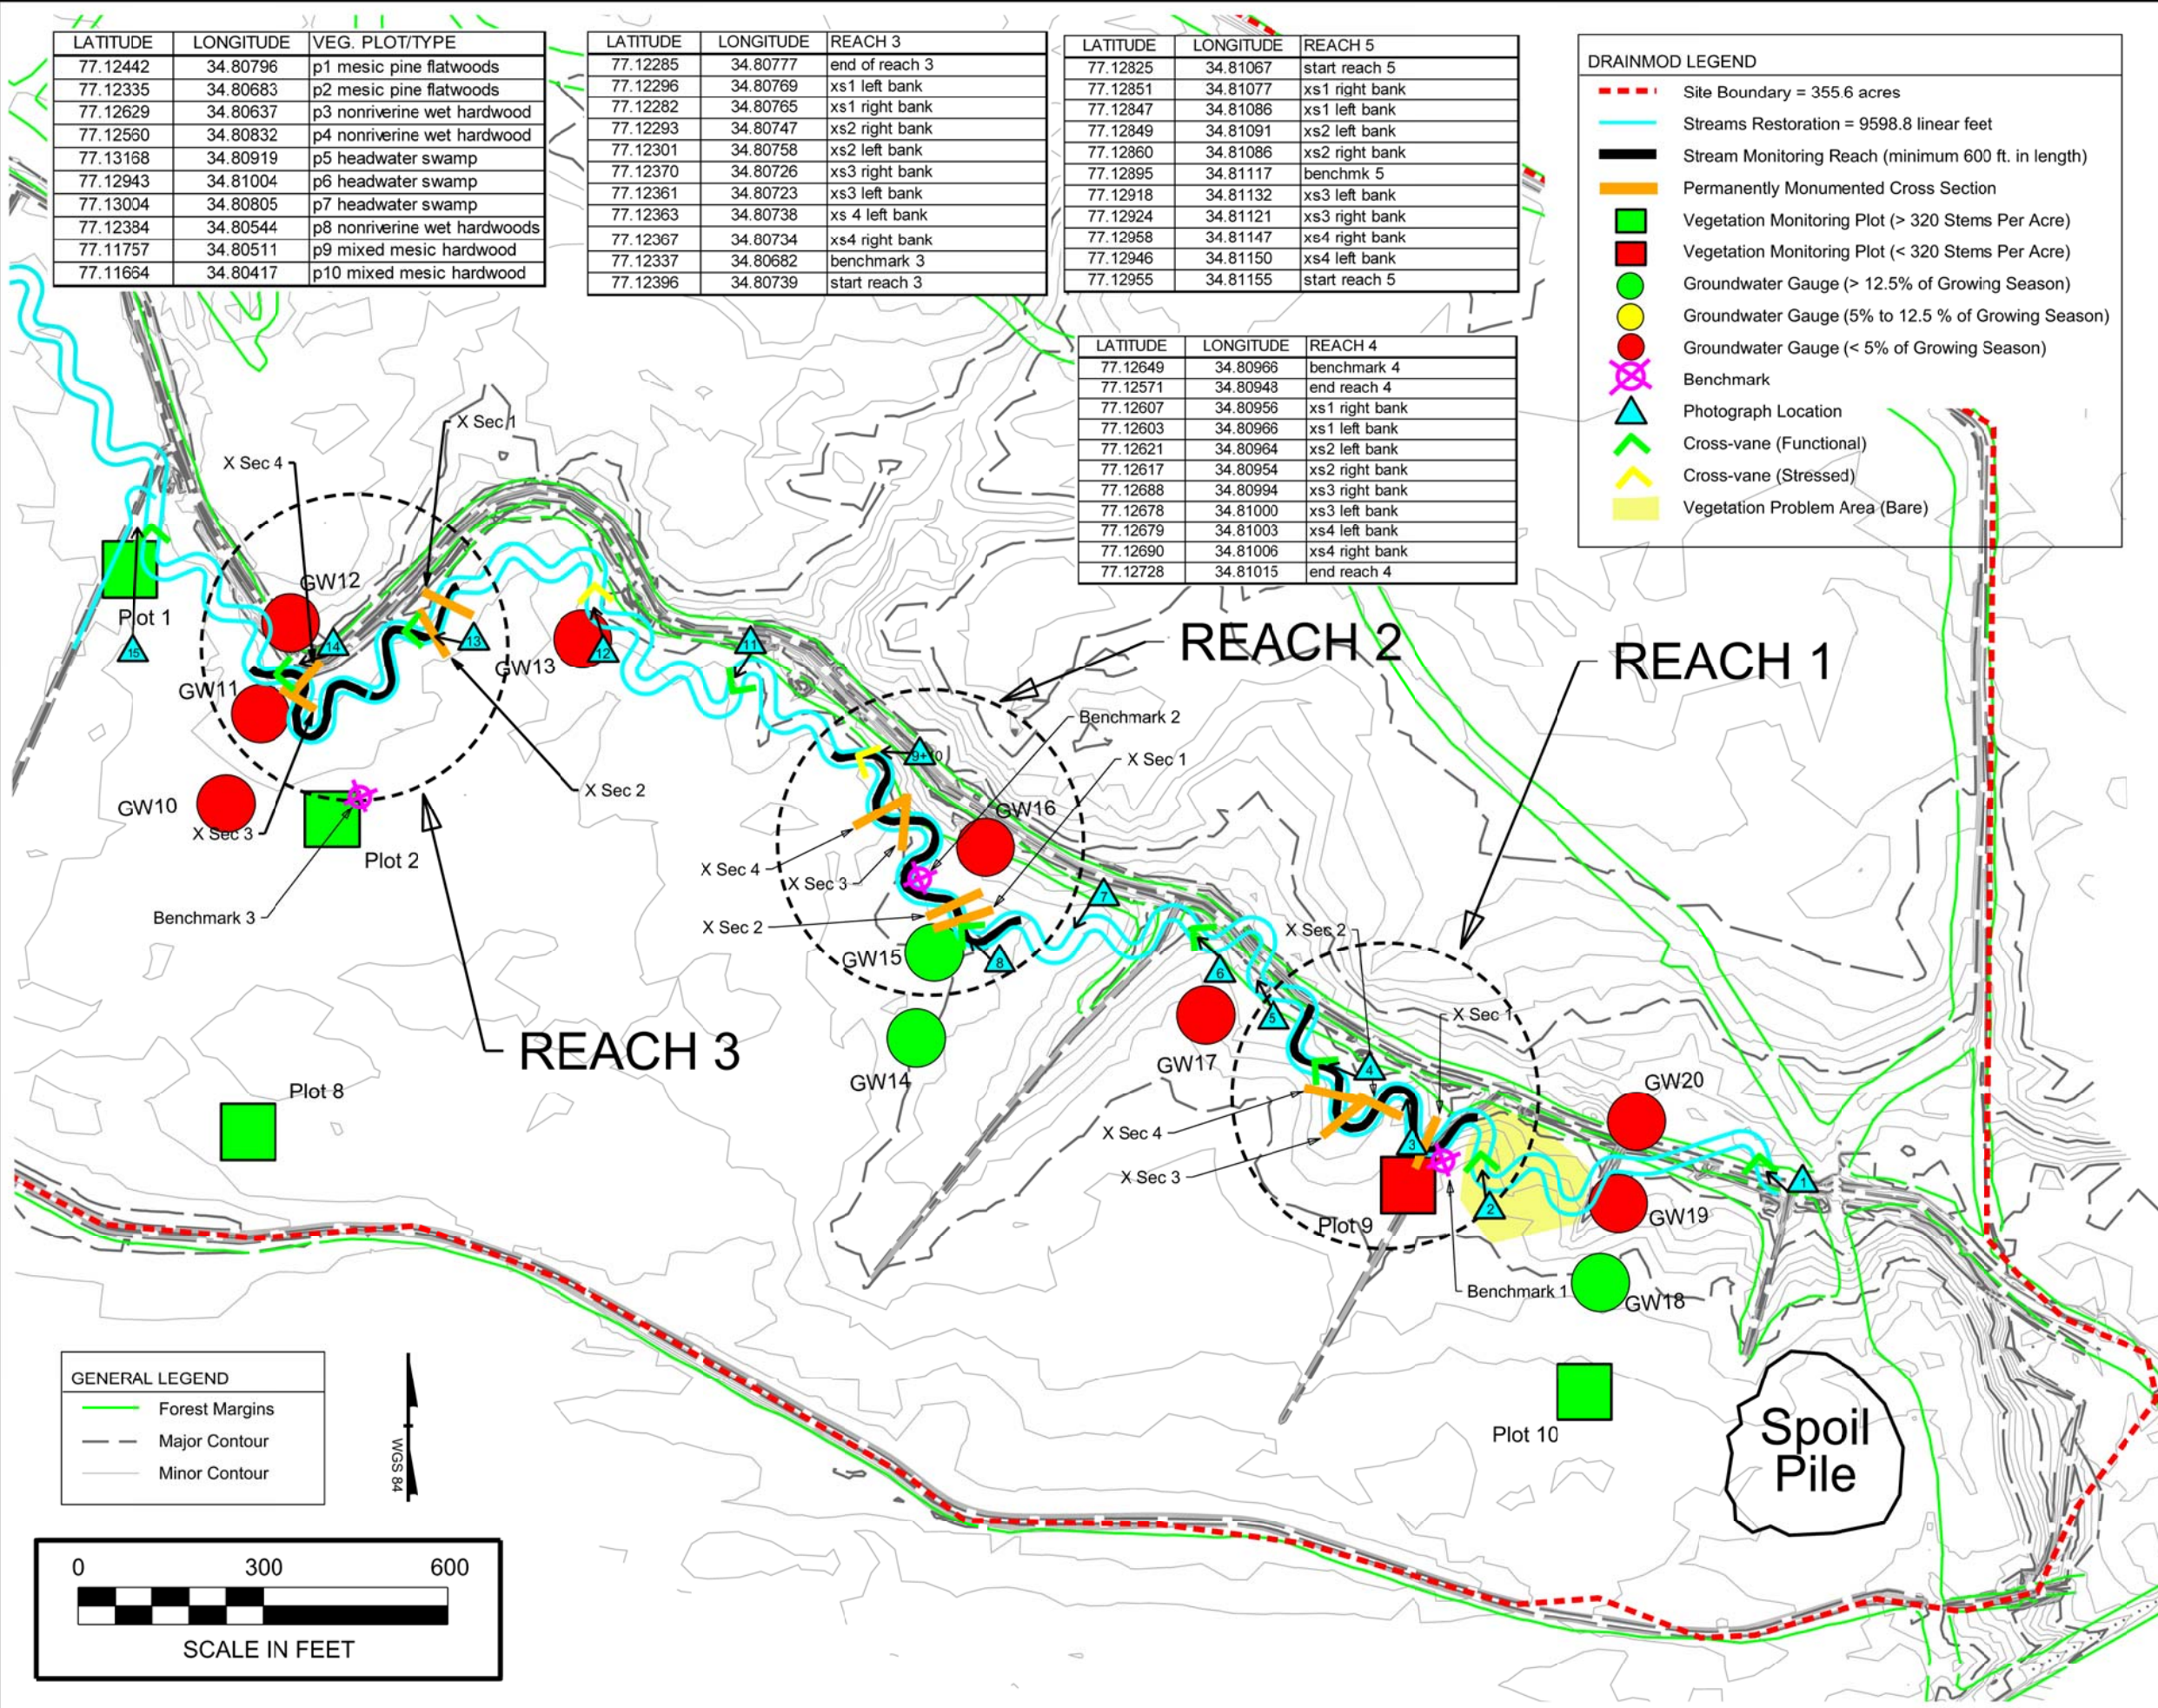
Title:
Monitoring Plan

One vegetation problem area was documented within the Site and is depicted on Figure 3B. The area consists of poor planted stem survival adjacent to the restored stream (near Reach 1); photographs of this area are included in Appendix B. Poor survival most likely has resulted from soil infertility. In addition, herbaceous vegetation on the lower half of the Site adjacent to the restored stream is not establishing well.

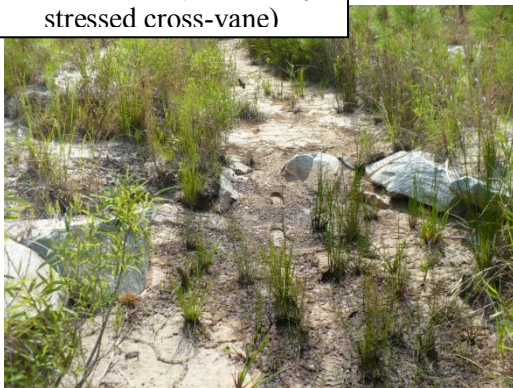
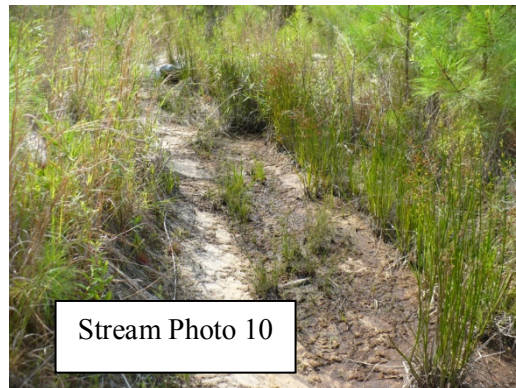
Stream problem areas within the Site are depicted on Figures 3A through 3B. Two problem areas were noted for the year 4 (2009) monitoring period. Both problem areas are stressed cross-vanes with failing right bank arms resulting from a lack of footers; photographs of each are included in Appendix C. Additional inspections and monitoring of bed and banks up and downstream of compromised structures is recommended prior to initiation of proactive maintenance measures.

Stream Photo 9 and Stream Problem Area (moderately stressed cross-vane)

Stream problem areas within the Site included two stressed cross-vanes with failing right bank arms resulting from a lack of footers. Additional inspections and monitoring of bed and banks up and downstream of compromised structures is recommended prior to initiation of proactive maintenance measures.
