**CLAYHILL FARMS MITIGATION SITE
JONES COUNTY, NORTH CAROLINA
TIP No. R-2105 WM
(EEP Project Number .00018)
2010 Annual Monitoring Report (Year 5 of 5)**

Submitted to:
North Carolina Department of Environment and Natural Resources
Ecosystem Enhancement Program
Raleigh, North Carolina

Prepared by:
Axiom Environmental, Inc.
20 Enterprise Street, Suite 7
Raleigh, North Carolina 27607

November 2010

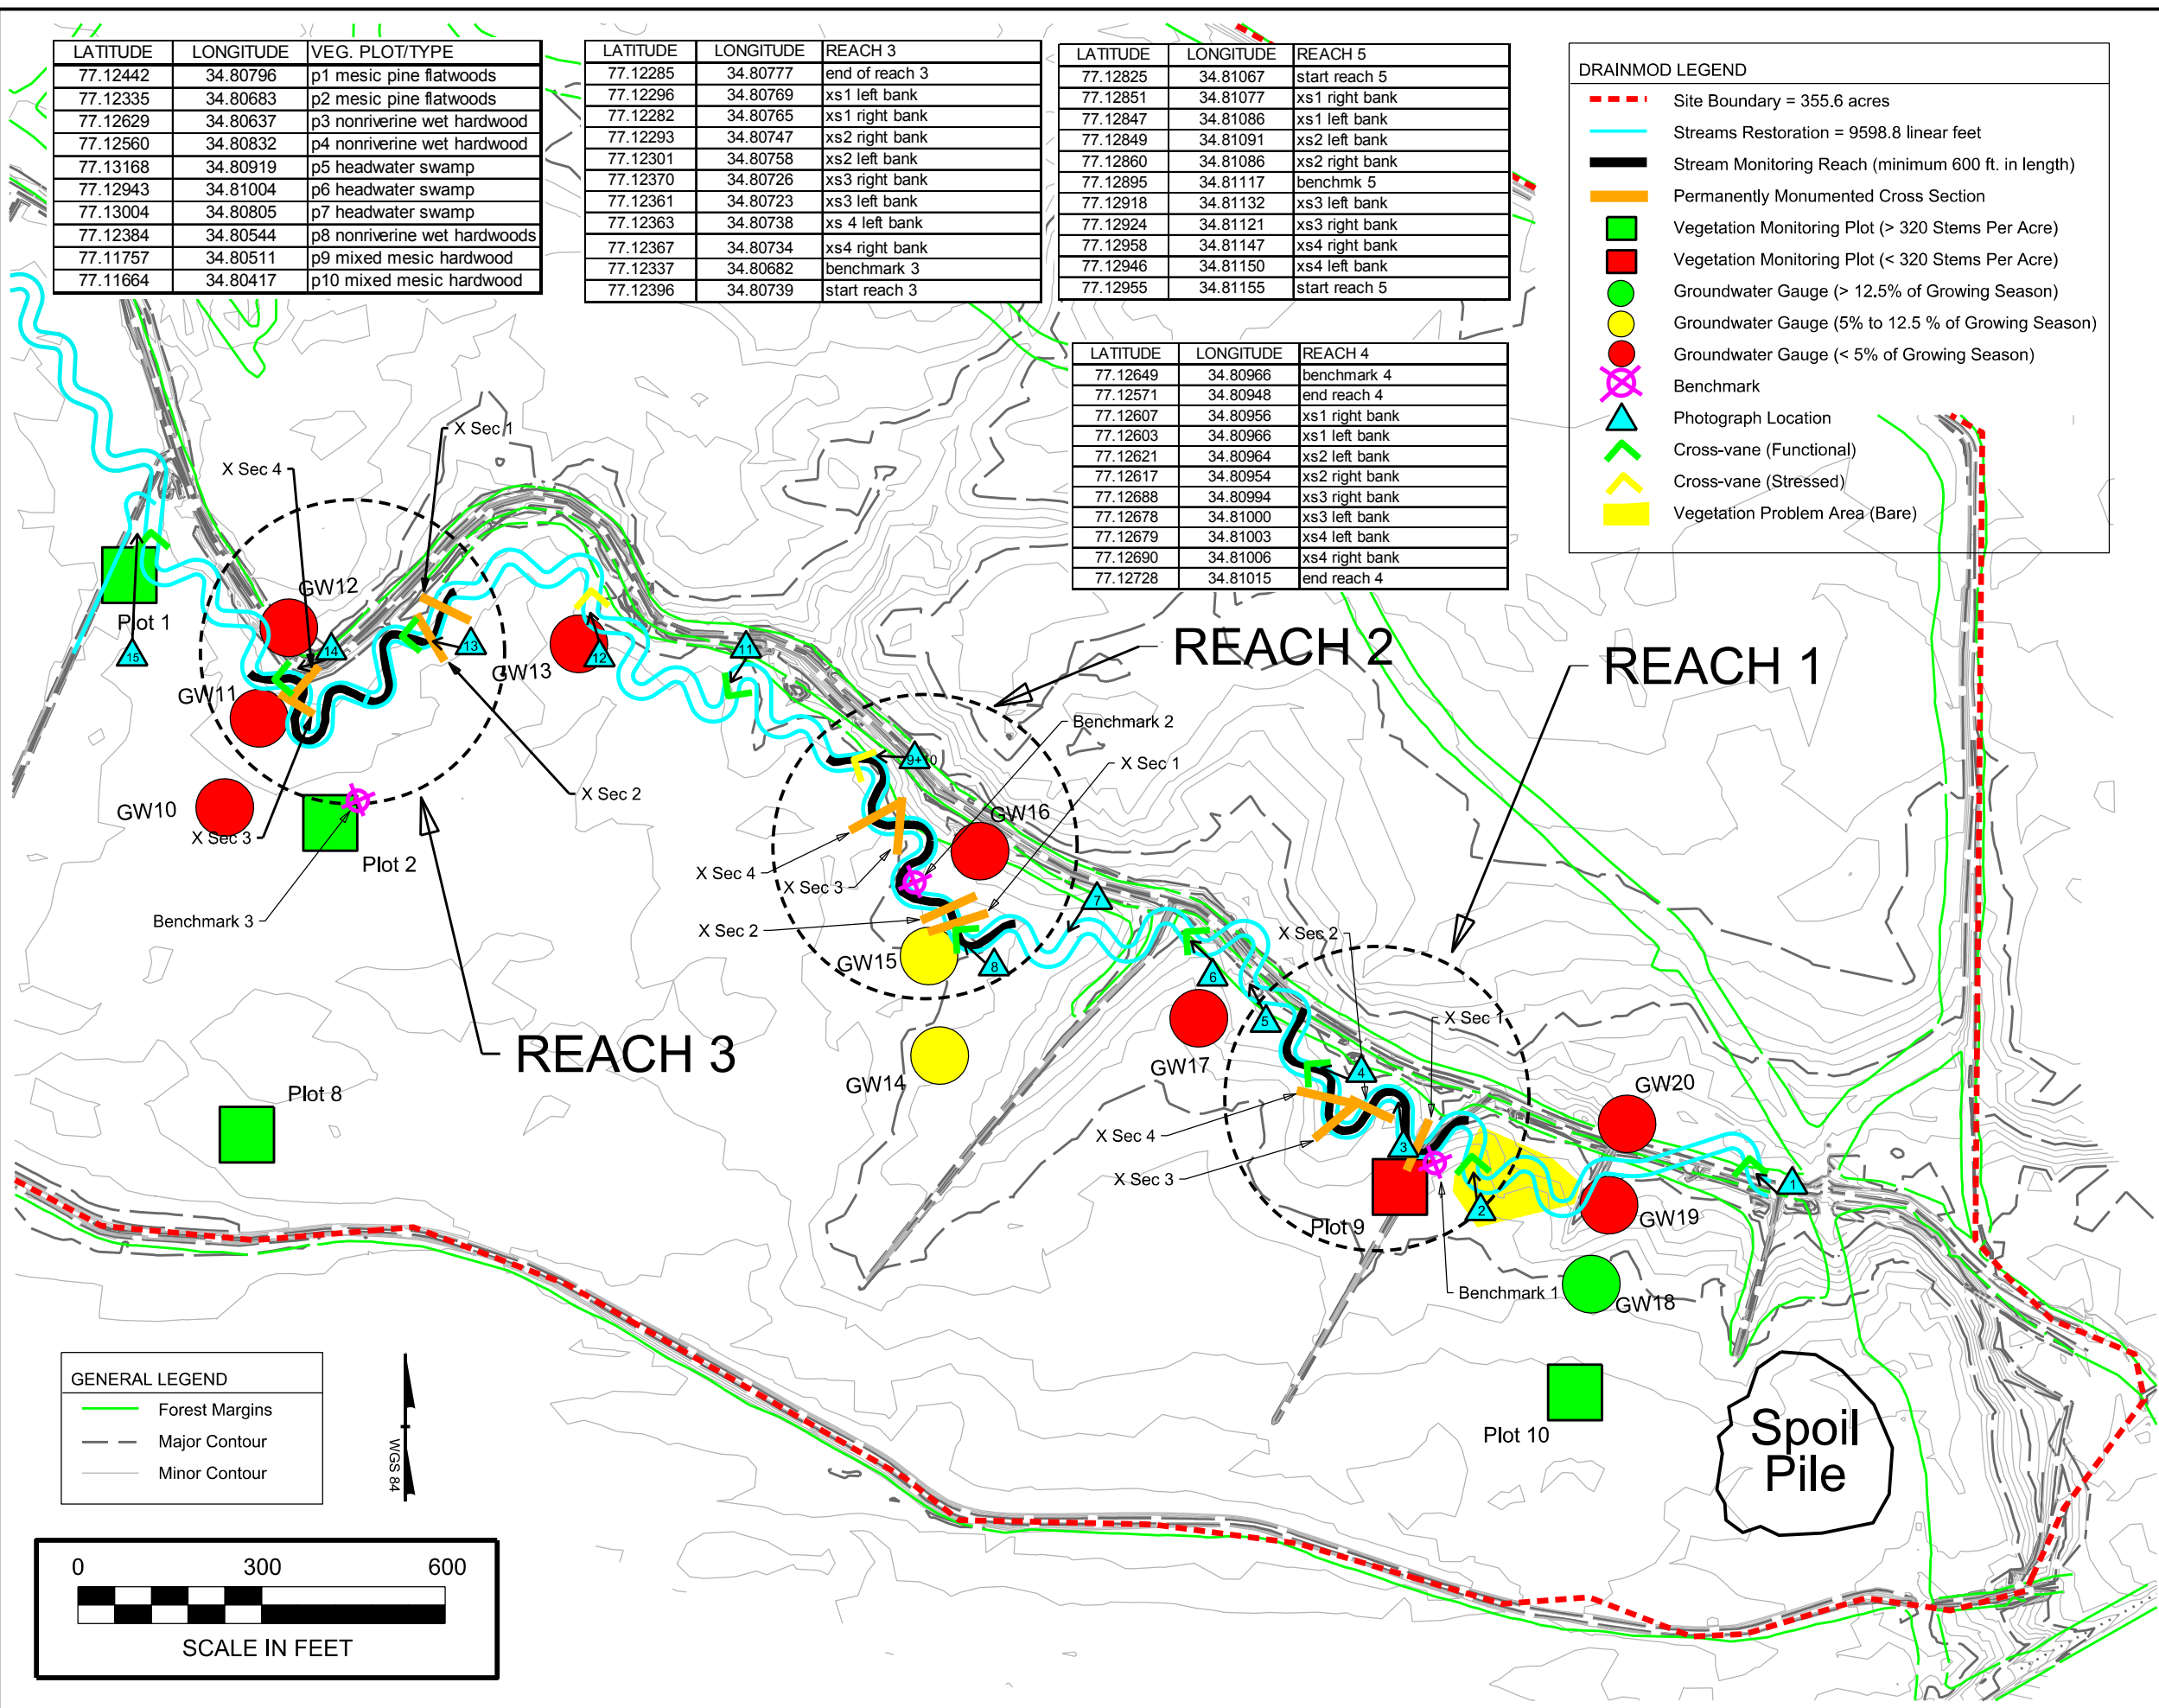
Title:
Monitoring Plan

Stream problem areas within the Site are depicted on Figures 3A through 3B. Two problem areas were noted. The first is related to a bare area noted previously in the vegetation section (Section 3.4 Vegetation Conclusions). The second is a stressed cross-vane resulting from a lack of footers was noted; however, the bed and banks up and downstream of the structure are stable and this is not anticipated to cause any problems. Photographs of each are included in Appendix B and Appendix C, respectively.

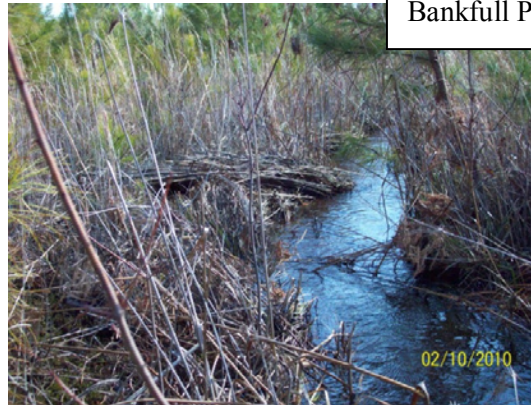
Bankfull Photo 4

Table 4. Verification of Bankfull Events			
Clayhill Farms (EEP Project Number .00018)			
Date of Data Collection	Date of Occurrence	Method	Photo (if available)
September 1, 2006	September 1, 2006	Total of 4.74 inches of rain documented by the onsite rain gauge over a two-day period from August 31 (4.06 inches) to September 1, 2006 (0.68 inches).	--
August 13, 2008	August 13, 2008	Total of 4.0 inches of rain documented by the onsite rain gauge over a seven-day period from August 7-13, 2008.	--
August 14, 2009	August 14, 2009	Total of 6.6 inches of rain documented at a nearby rain station* over a four-day period from August 11-14, 2009.	--
November 12, 2009	November 12, 2009	Visual observations of bankfull as the result of Tropical Storm Ida	1-3
February 10, 2010	February 5, 2010	Visual observations of overbank event including wrack lines and sediment deposition resulting from a 1.9 inch* rainfall event on February 5, 2010 that occurred after numerous rainfall events, within the 3 weeks prior, that totaled 5.26 inches.	4

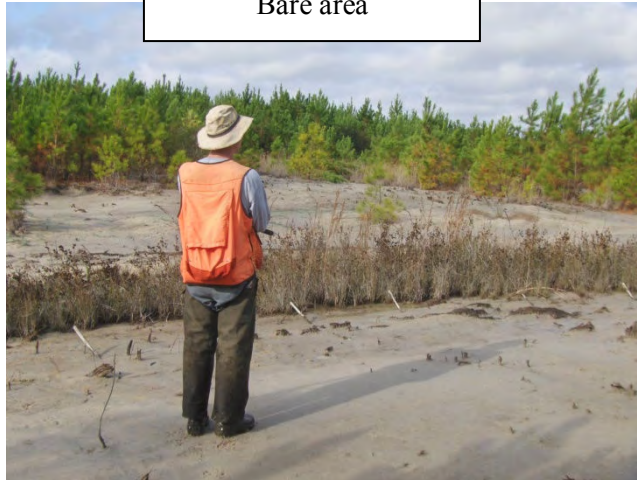
One vegetation problem area was documented within the Site and is depicted on Figure 3B. The area consists of poor planted stem survival/bare area adjacent to the restored stream; photographs of this area are included in Appendix B. Poor survival most likely has resulted from soil infertility. A lack of vegetation has resulted in aggradation of the stream channel in the vicinity of the bare area with ponding within the channel immediately upstream.

Problem Area Photo 1:
Bare area

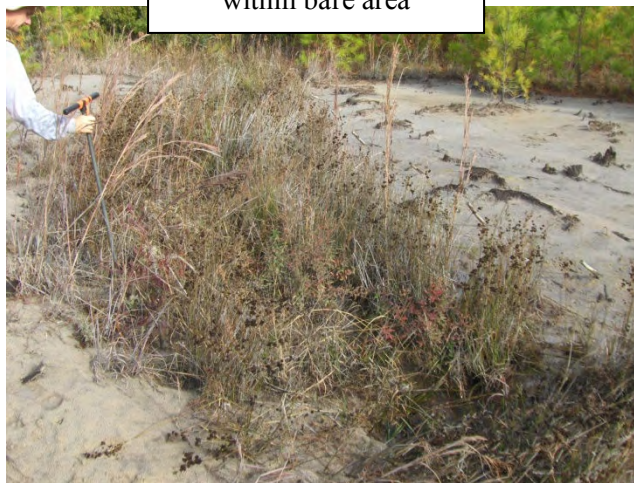
Problem Area Photo 2:
Aggradation of stream
within bare area

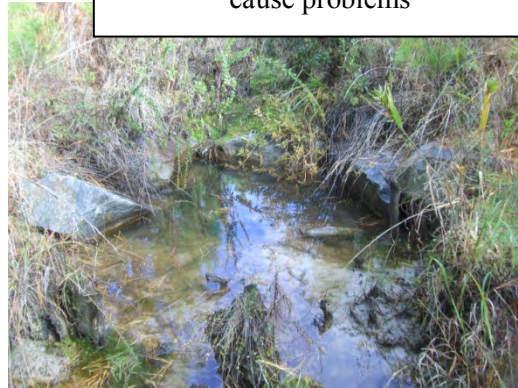
One vegetation problem area noted throughout the monitoring period consists of a large area of poor planted stem survival/bare area adjacent to the restored stream. Poor survival most likely has resulted from soil infertility. A lack of vegetation has resulted in aggradation of the stream channel in the vicinity of the bare area with ponding within the channel immediately upstream (Figure 3B, Appendix A). One additional stressed cross-vane resulting from a lack of footers was noted; however, the bed and banks up and downstream of the structure are stable and this is not anticipated to cause any problems.

Stream Photo 12: stressed cross-vane that is not anticipated to cause problems
