Clear Creek  
Stream Restoration  
2004-2005 Monitoring Reports  
October 2005

# 2004/2005 Clear Creek Monitoring Report

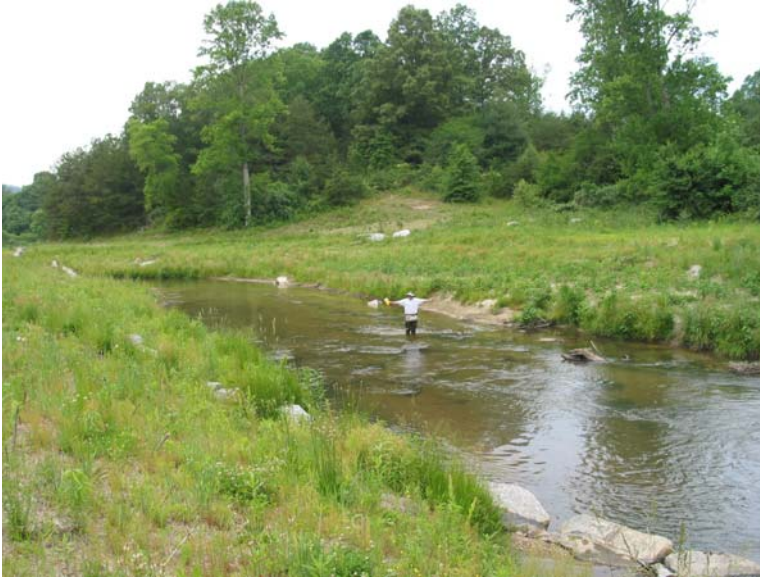
**Photo 1** Reference riffle cross-section at Station 2+25. The low flow channel is of uniform depth and width throughout the reach with only a few small patches of gravel. The bed morphology is dominated by a heavy load of large woody debris and sand.

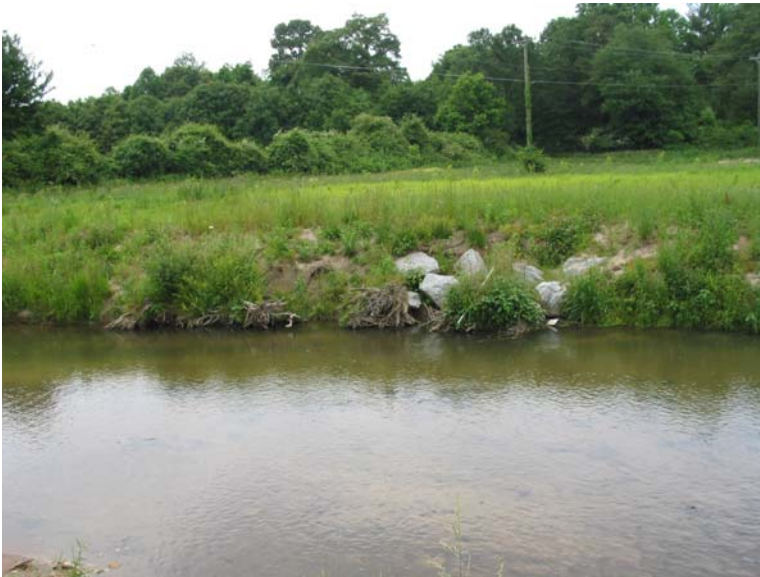
**Photo 2** Pool cross-section at Station 10+50. The outside of this bend is where the most stable pool occurs other than the plunge pools below each cross vane. The low flow depth is over 5 feet just off the root wads in the bank.

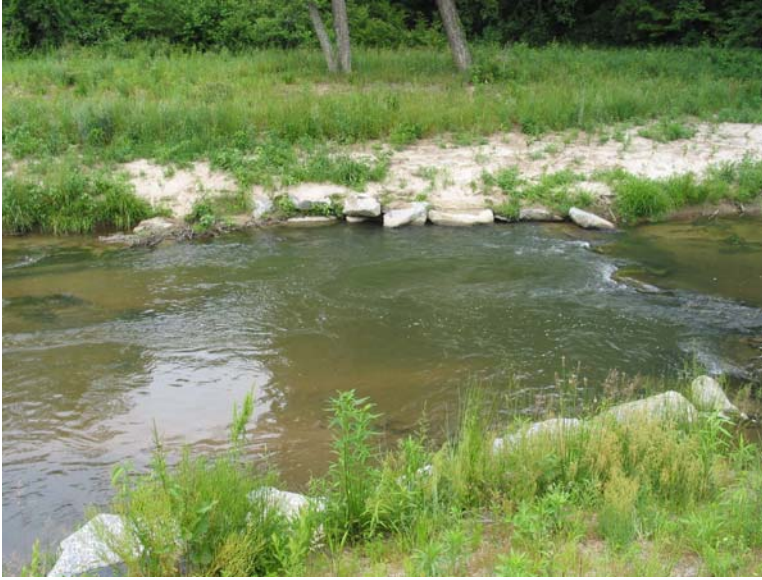
**Photo 3** Cross vane at Station 1+90. Note center section shifted and piping at several locations. At high flows, the arms of the cross vane accumulate sediment and protect the banks.

One problem with the restoration is the cross vanes and j-hooks do not appear to be controlling the thalweg at low to medium flows. The result is that the base flow channel is wide with the thalweg very close to the bank in several locations. The central portions of cross vanes 3 and 4 appear to have shifted and may be sinking into the sandy substrate. In at least one case, a large sunken log appears to have rammed a cross vane rock off its footers. Cross vanes 1 and 2 are performing adequately but should be monitored closely. The rocks at the end of most of the j-hooks have likewise sunken into the bed or have become buried by the high bedload of sand in this low slope, alluvial channel.

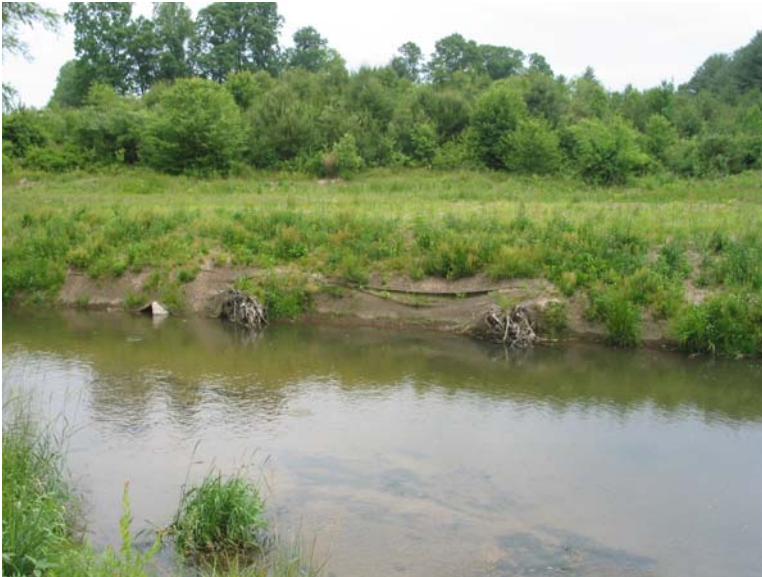
**Photo 4** Bank instability at Station 1+00. Insufficient toe protection and too few root wads allowed steepening of the bank at this point.

The banks are currently stable and well vegetated throughout most of the reach. Several sections of bank have receded (steepened) from the as-built geometry, but appear to have stabilized at the steeper angle.

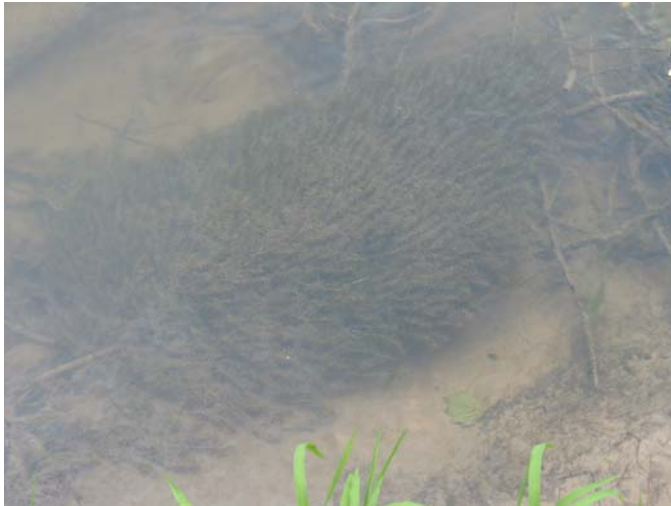
There is also a significant amount of woody debris in the bottom of the channel. The largest of these create significant scour holes and in many cases have become colonized by several species of aquatic plants.

**Figure 1 Aquatic plants growing on submerged wood**

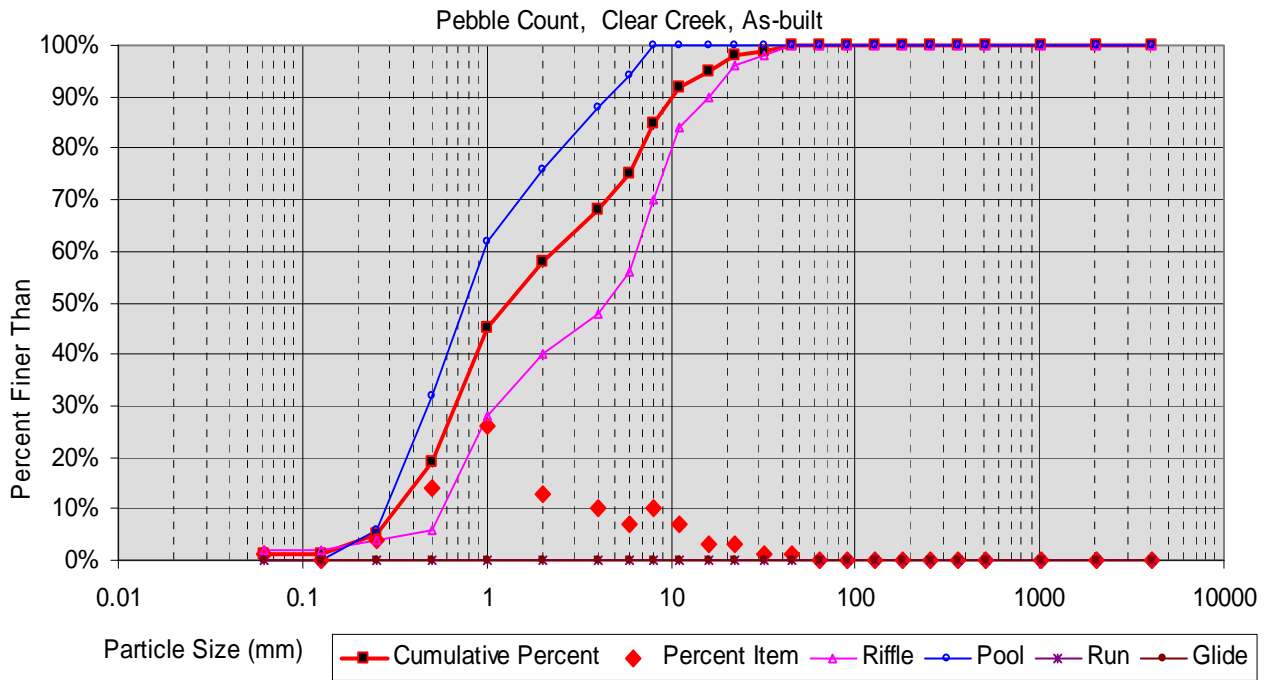
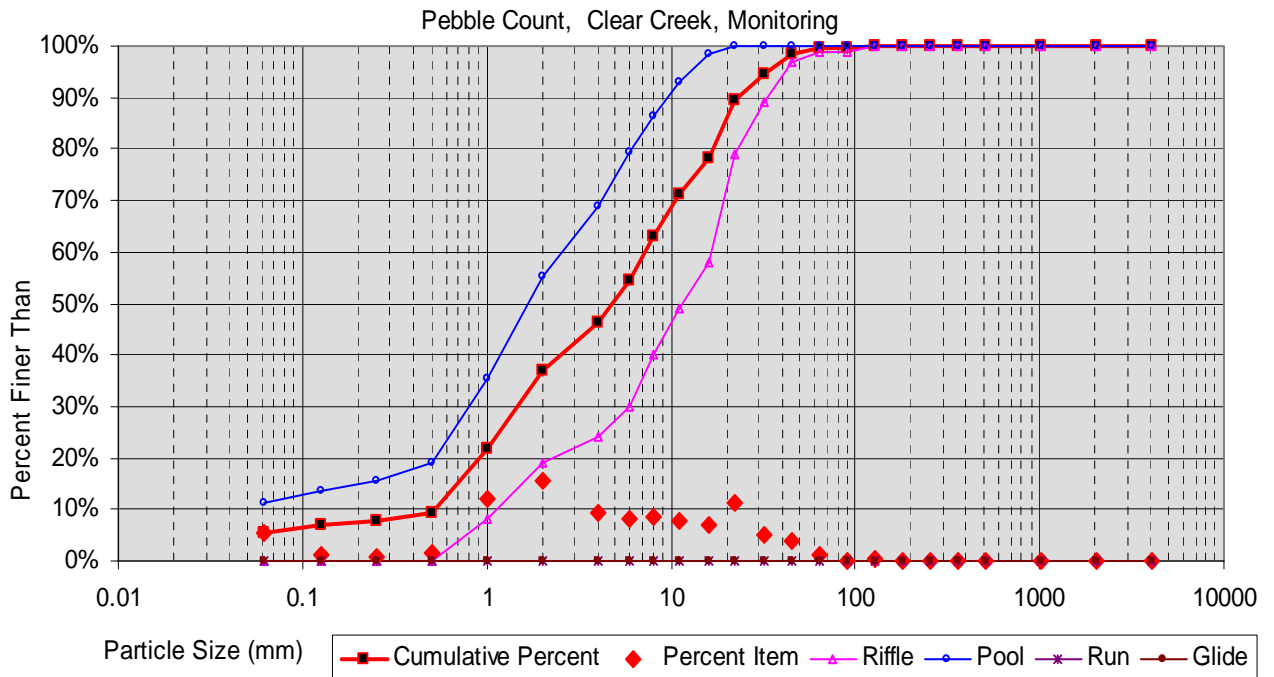
**Figure 5 Clear Creek Particle Analysis**

The pebble counts of the restoration reach show the overall coarsening of the sediments with the reach d50 going from 1.4 to 4.8mm. The reach d84 went from 8 to 19mm.

As-Built d50= 1.3mm d84=8mm

MY1 d50=4.8mm d84=19mm

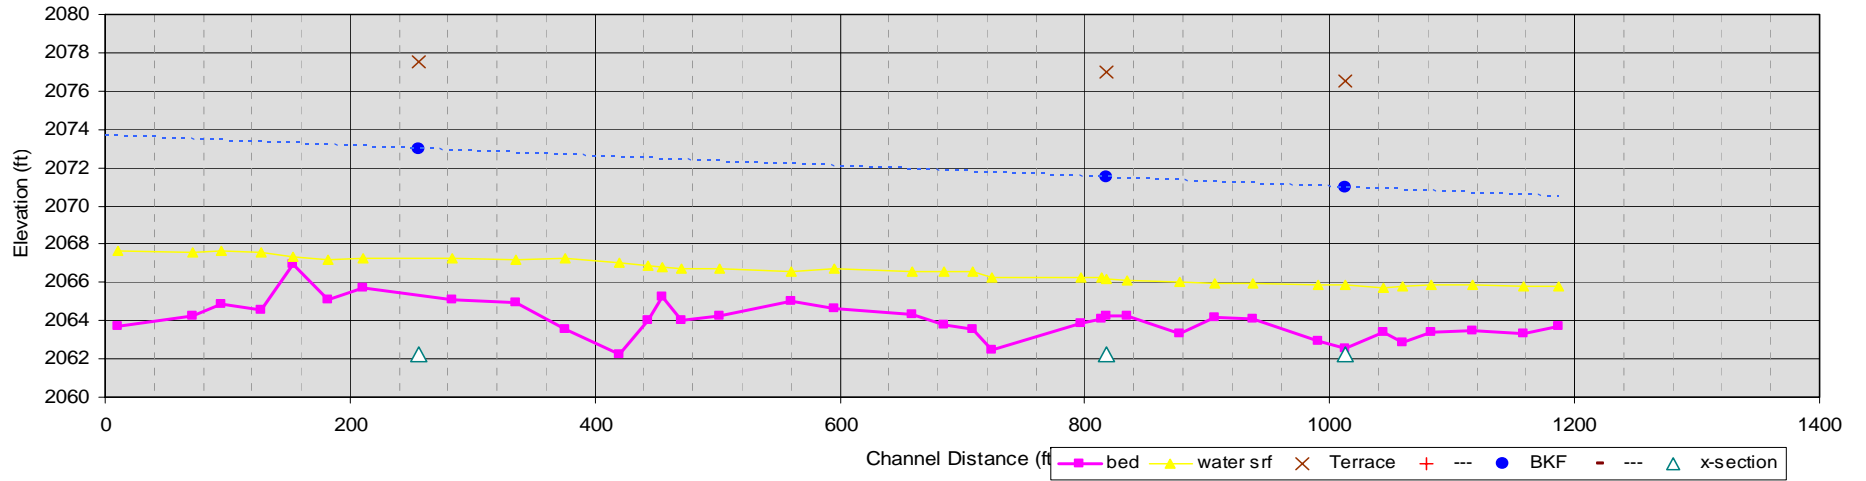
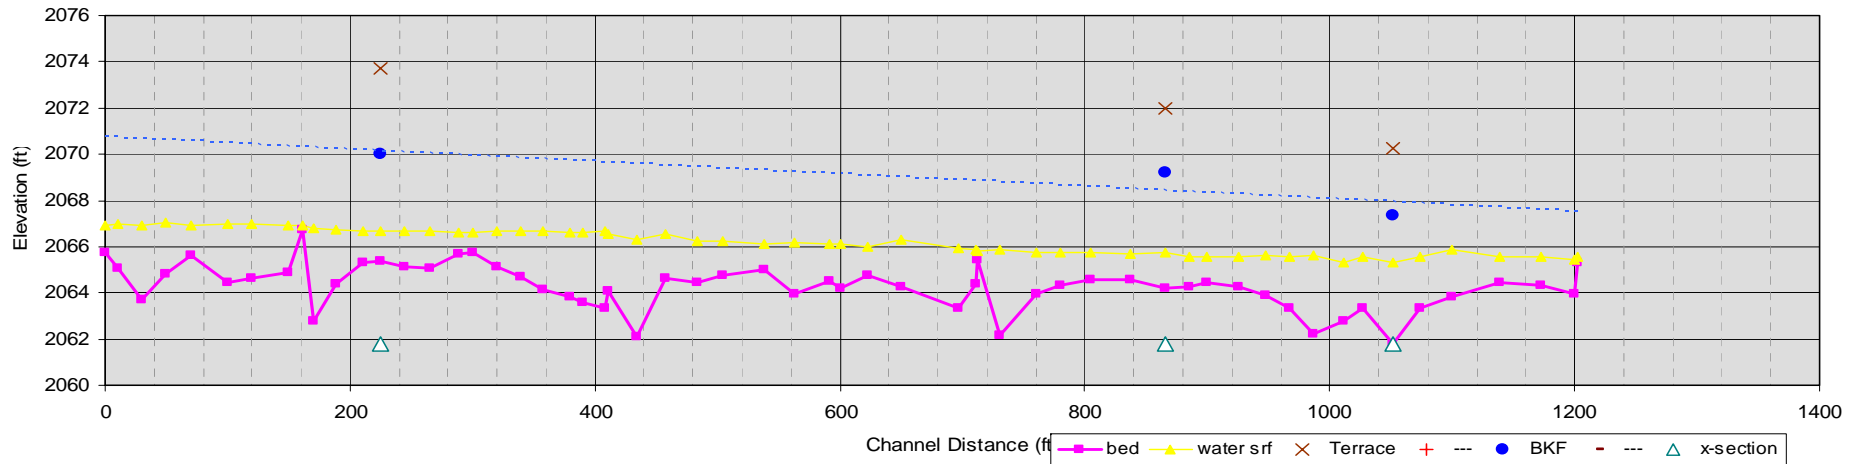
**Figure 8 Clear Creek Longitudinal Profiles**

The profile of the channel is very flat with very few well-defined riffles and pools. The majority of the reach appears to be morphologically a run. As a result, the morphological features that can be identified as riffles are short and have not accumulated enough coarse sediments to be stable at this point. These riffles are also relatively flat. Over the course of the monitoring period (1 year), the riffles seem to have lengthened and flattened. The substrate has also coarsened slightly. When walking down the channel, one can feel a thin pavement collapsing underfoot. Under the pavement is a deep layer of very soft sand and silty deposits.
