Year 3 Monitoring Report

Clear Creek Stream Restoration

February 2006
S&EC Project No. 9446.D1
EEP Project No. 00019

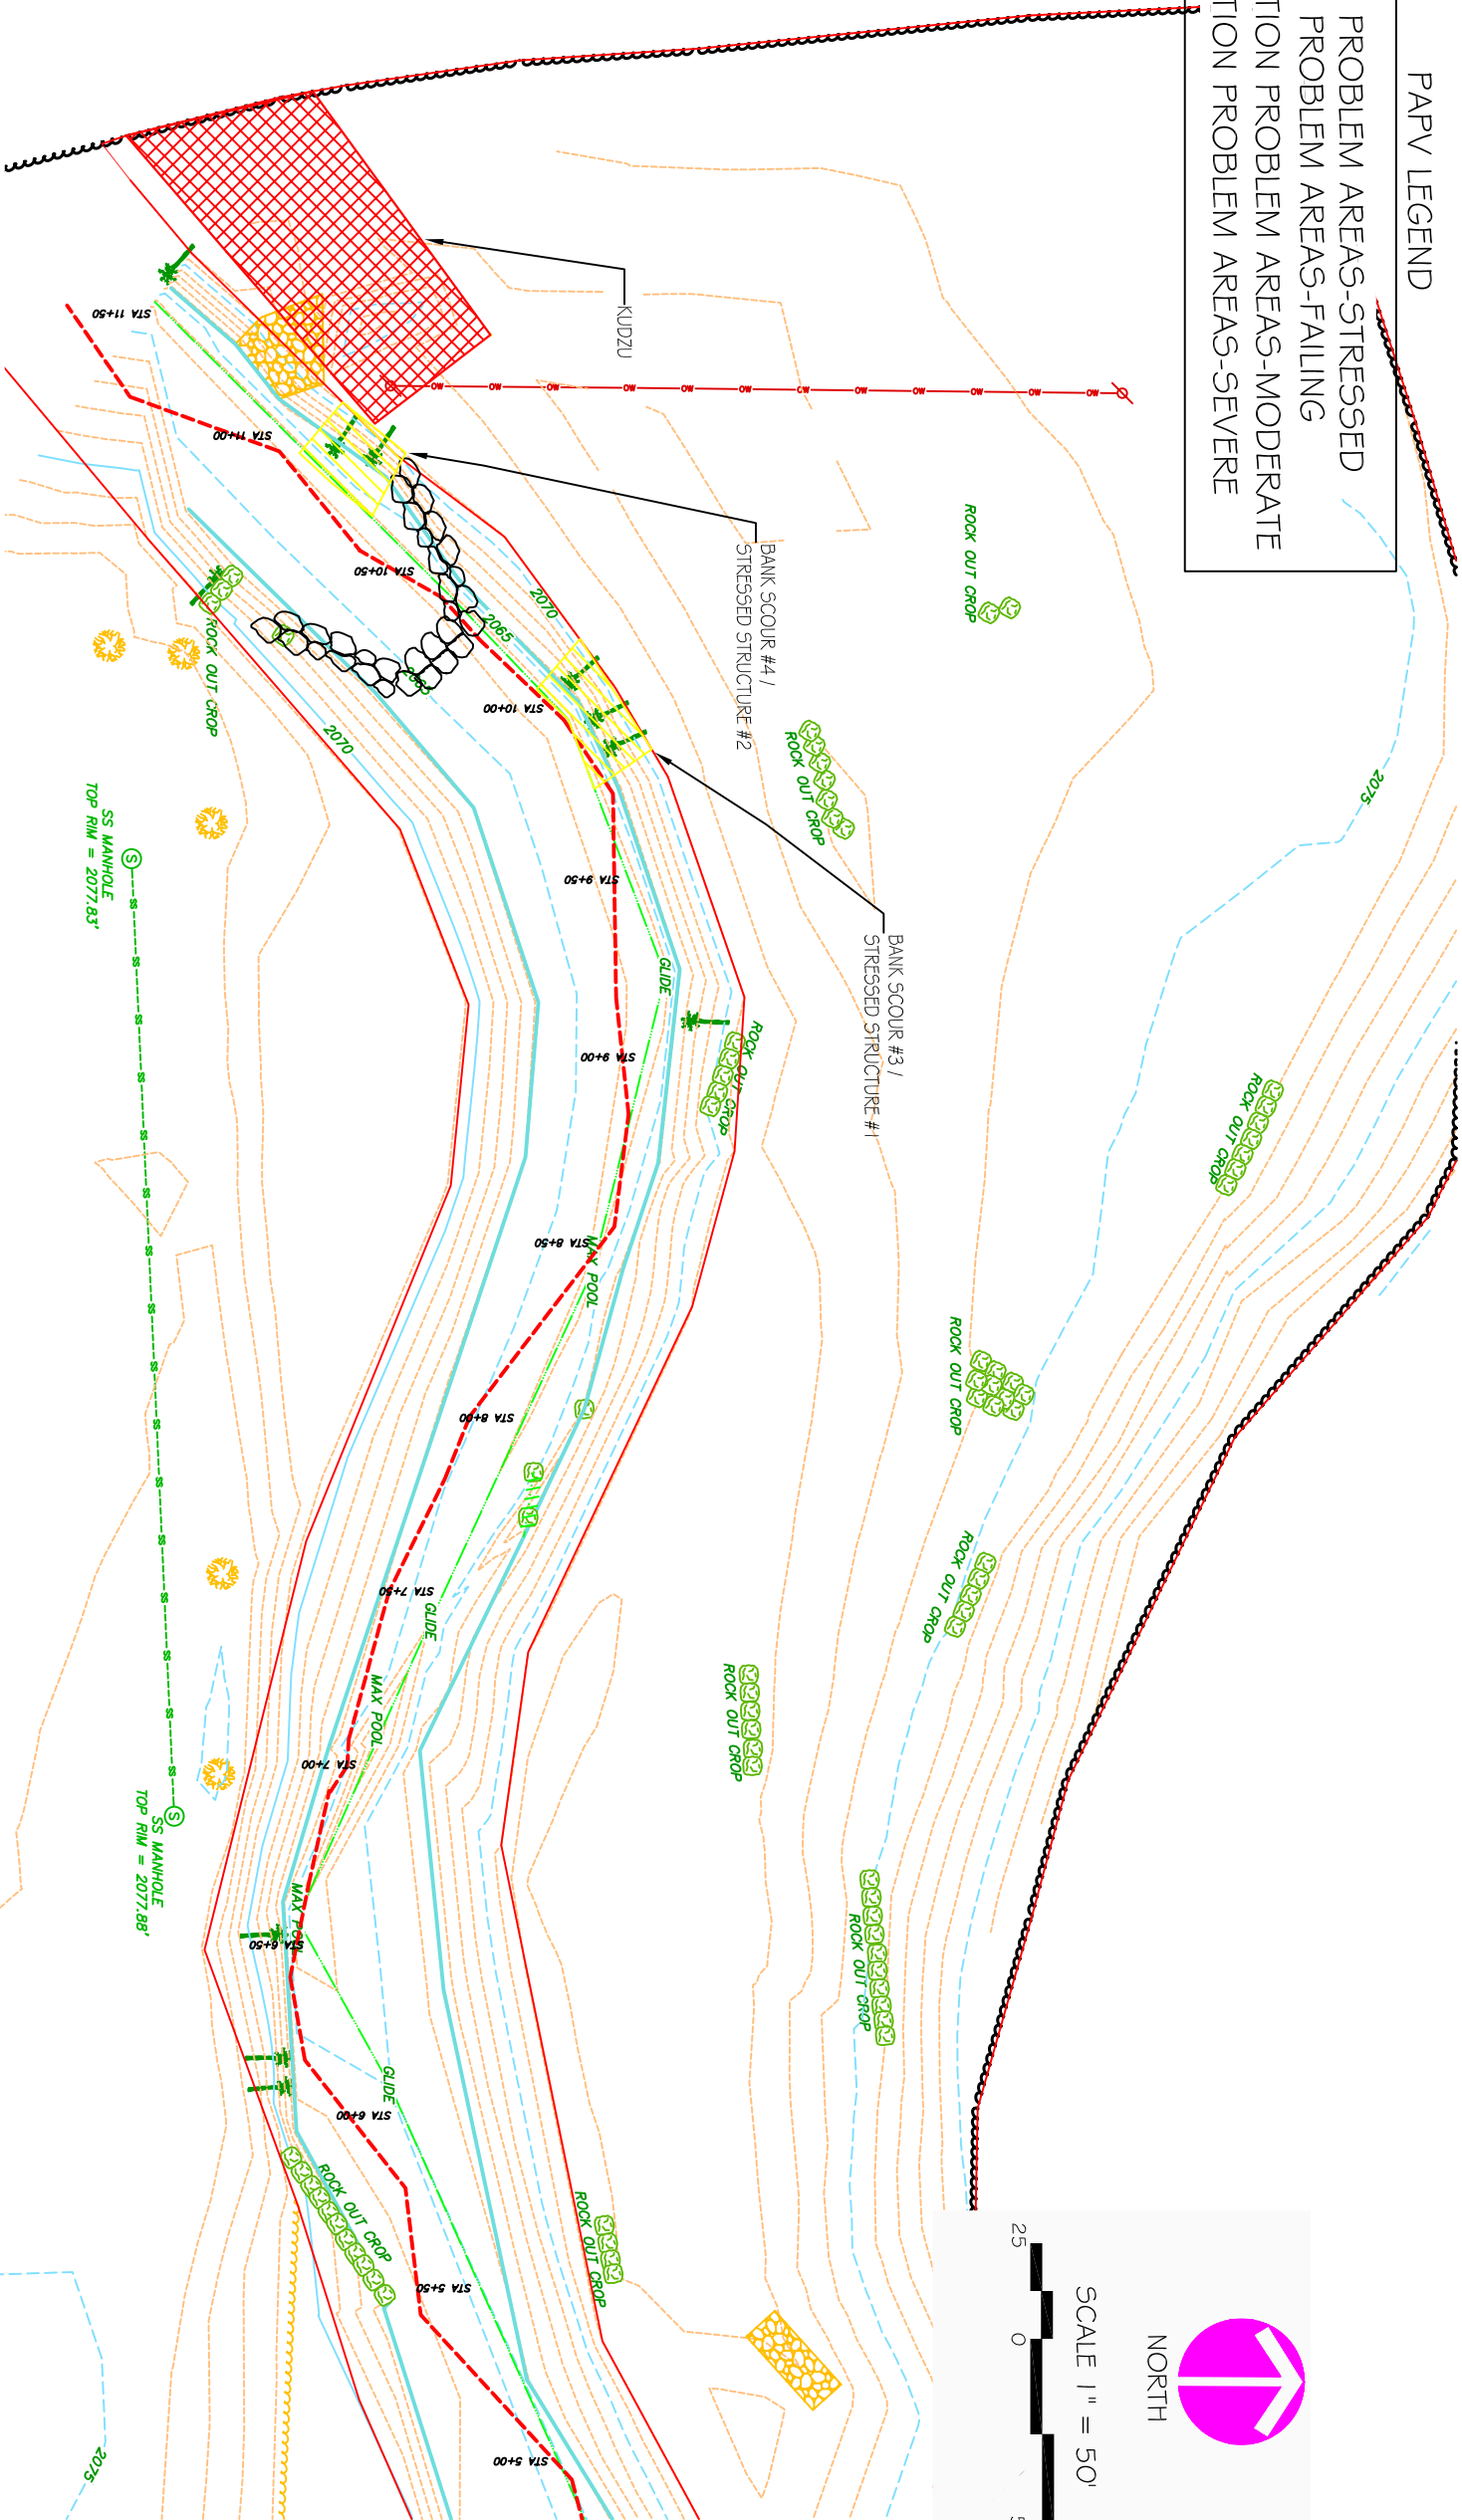
Project: CLEAR CREEK STREAM RESTORATION		Project No.: 9446.D1	
Location: HENDERSON CO., NC	Client: NCEEP	Proj. Mgr.: FKS	Drawn: JER
Sheet Title: PAPV - SEGMENT 1		Scale: 1" = 50'	Sheet No.: 3 OF 4

The vegetative problem area is shown on Sheets 3 and 4 (Problem Area Plan View). A representative photo is included in Appendix A.

An assessment of channel stability was performed on August 10, 2005, by S&EC. Areas of concern that were observed and documented included localized bank scour, and stressed or failing structures. These problem areas are shown on Sheets 3 through 4 – Problem Area Plan View.

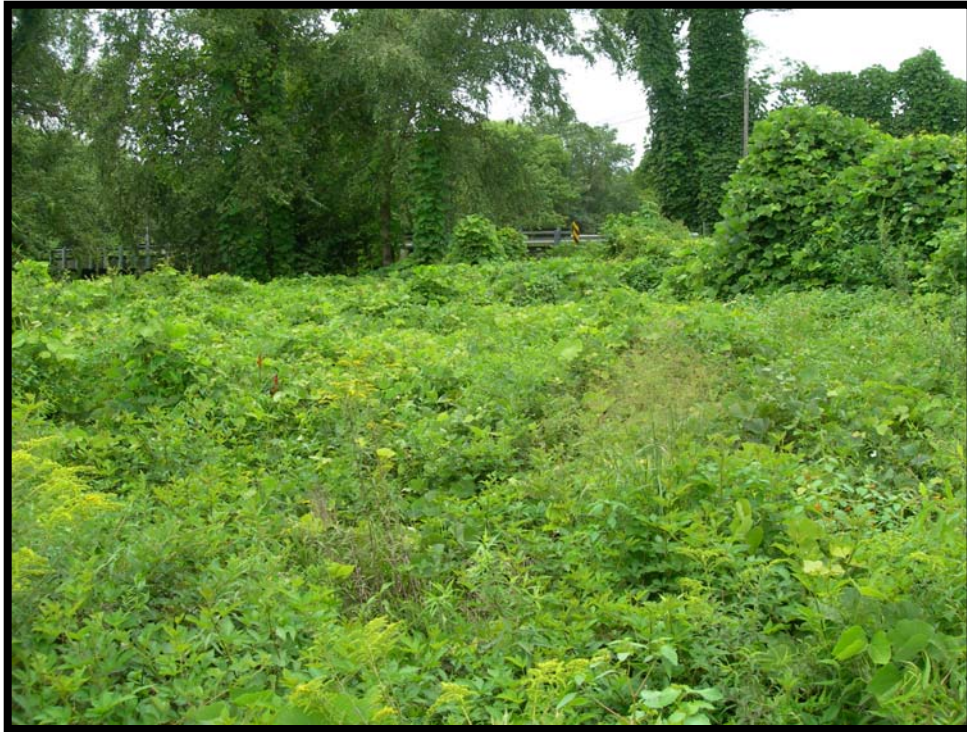
Upon inspection on August 10, 2005, it was noted that a large population of *Kudzu* has infested the upstream end of the restoration reach.

Photo 1—*Kudzu* population

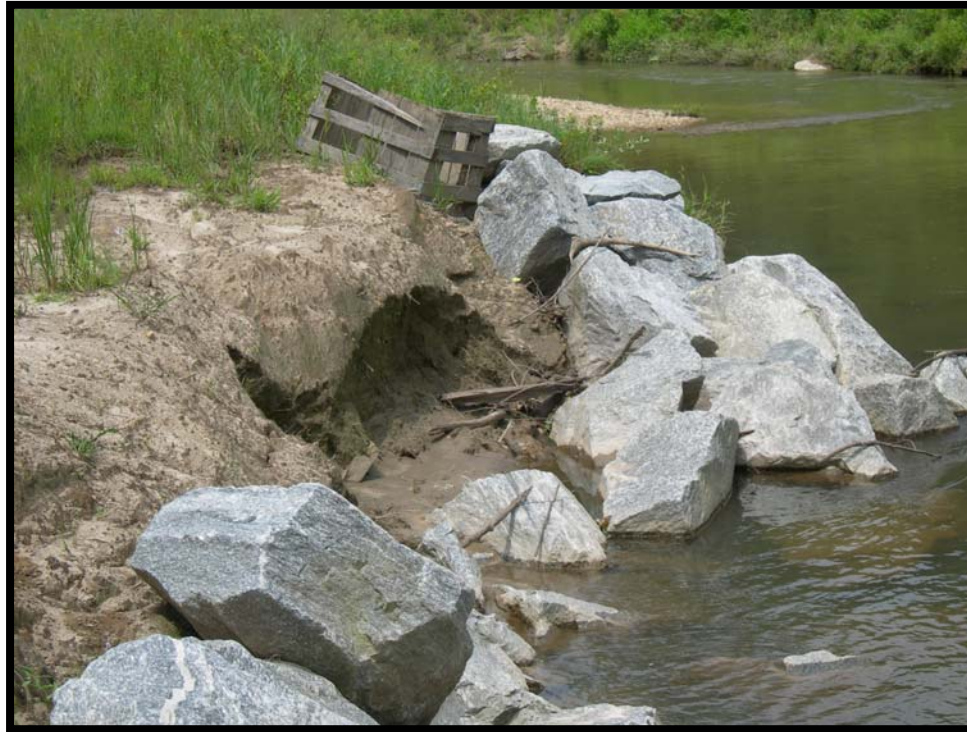
Feature Issues	Station numbers	Suspected Cause	Photo number
Bank Scour	1+21 to 1+66	Scour at arm of crossvane	Stream Problem Area Photos 1-2
	2+12 to 2+29	Scour at arm of crossvane	
	9+75 to 10+07	Root wads on outside bend, excessive scour	
	10+68 to 10+92	Root wads on outside bend (near crossvane), excessive scour	
Stressed or Failing Structures	9+75 to 10+07	Root wads on outside bend, excessive scour	Stream Problem Area Photo 2
	10+68 to 10+92	Root wads on outside bend (near crossvane), excessive scour

Photo 1—Representative Bank Scour

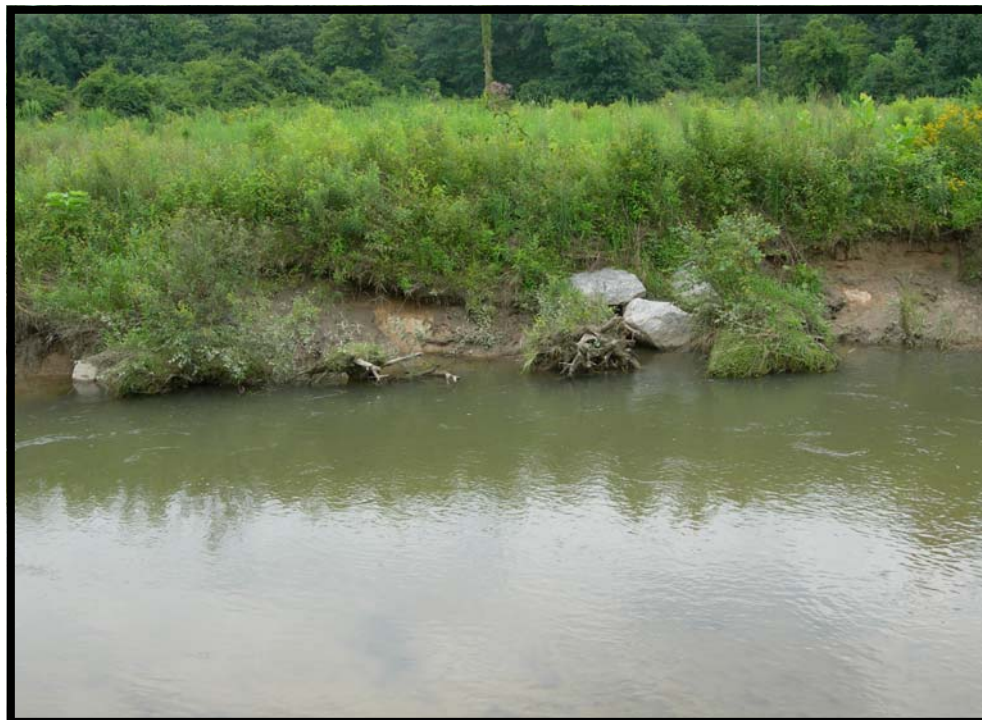
Photo 2—Representative Bank Scour/Stressed or Failing Structure
