Clear Creek Final Monitoring Report Year 3 of 5 (2006)

Henderson County, North Carolina

Project ID No. 92

January 2007

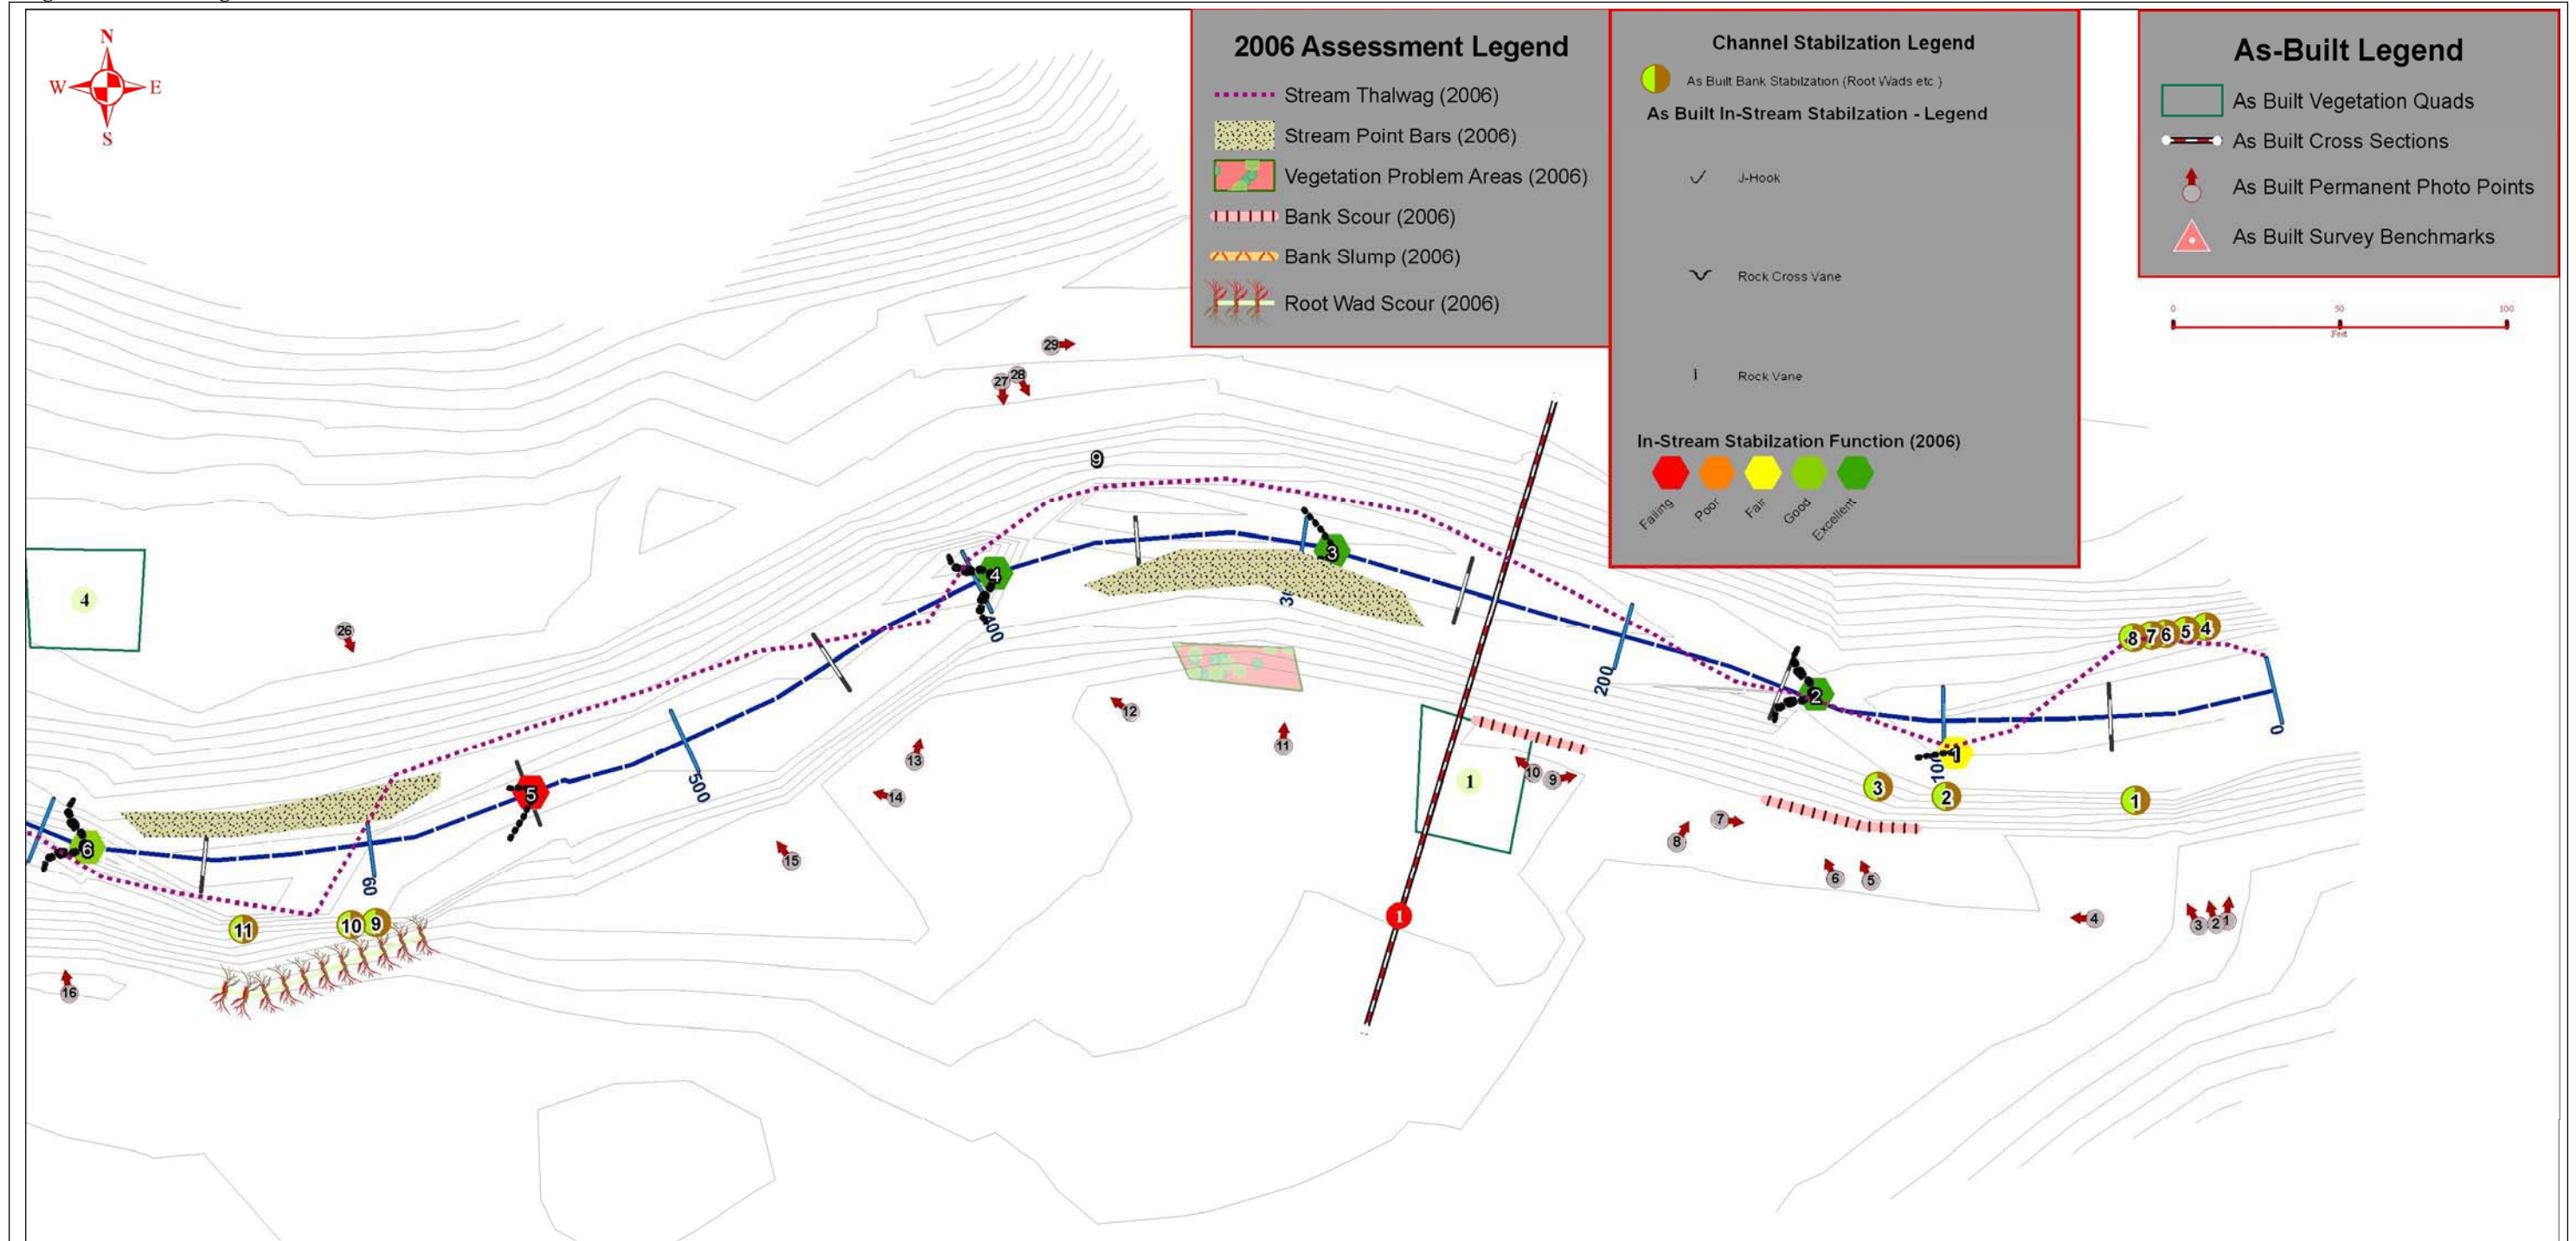
Figure 2: Monitoring Plan View Sheet 1

The Kudzu population reported during the MY2 2005 monitoring report remains on site. The population falls within an isolated area near Clear Creek Road and does not appear to be spreading. A small riparian area upstream of the Kudzu population along the right bank does not appear to be thriving. Vegetation growth in this area is more scattered and less vigorous than the rest of the site.

KHA assessed the stream channel during the spring and fall of 2006. Several isolated sections exhibited bank scour. Excessive shear stresses and possibly historic flood flows may have a role in the scour. Back eddy currents immediately below a structure may be causing bank slumping along a section of the left bank. Some structures seemed to exhibit signs of stress including partial to complete structure collapse; excessive arm scour; and missing header rock. Several root wads along the middle and lower section of the reach have experienced scour behind the root balls and may be unstable. The bottommost structure was mapped as a cross vane in the MY2 2005 monitoring report, but appeared as a rock vane running up the right bank during the 2006 field visits. Figures 1 and 2 show the location of the stream problem areas and table B1 in appendix B summarizes the stream problem areas.
