Clear Creek Monitoring Report Year 5 of 5 (2008)

Henderson County, North Carolina

Project ID No. 92

May 2009

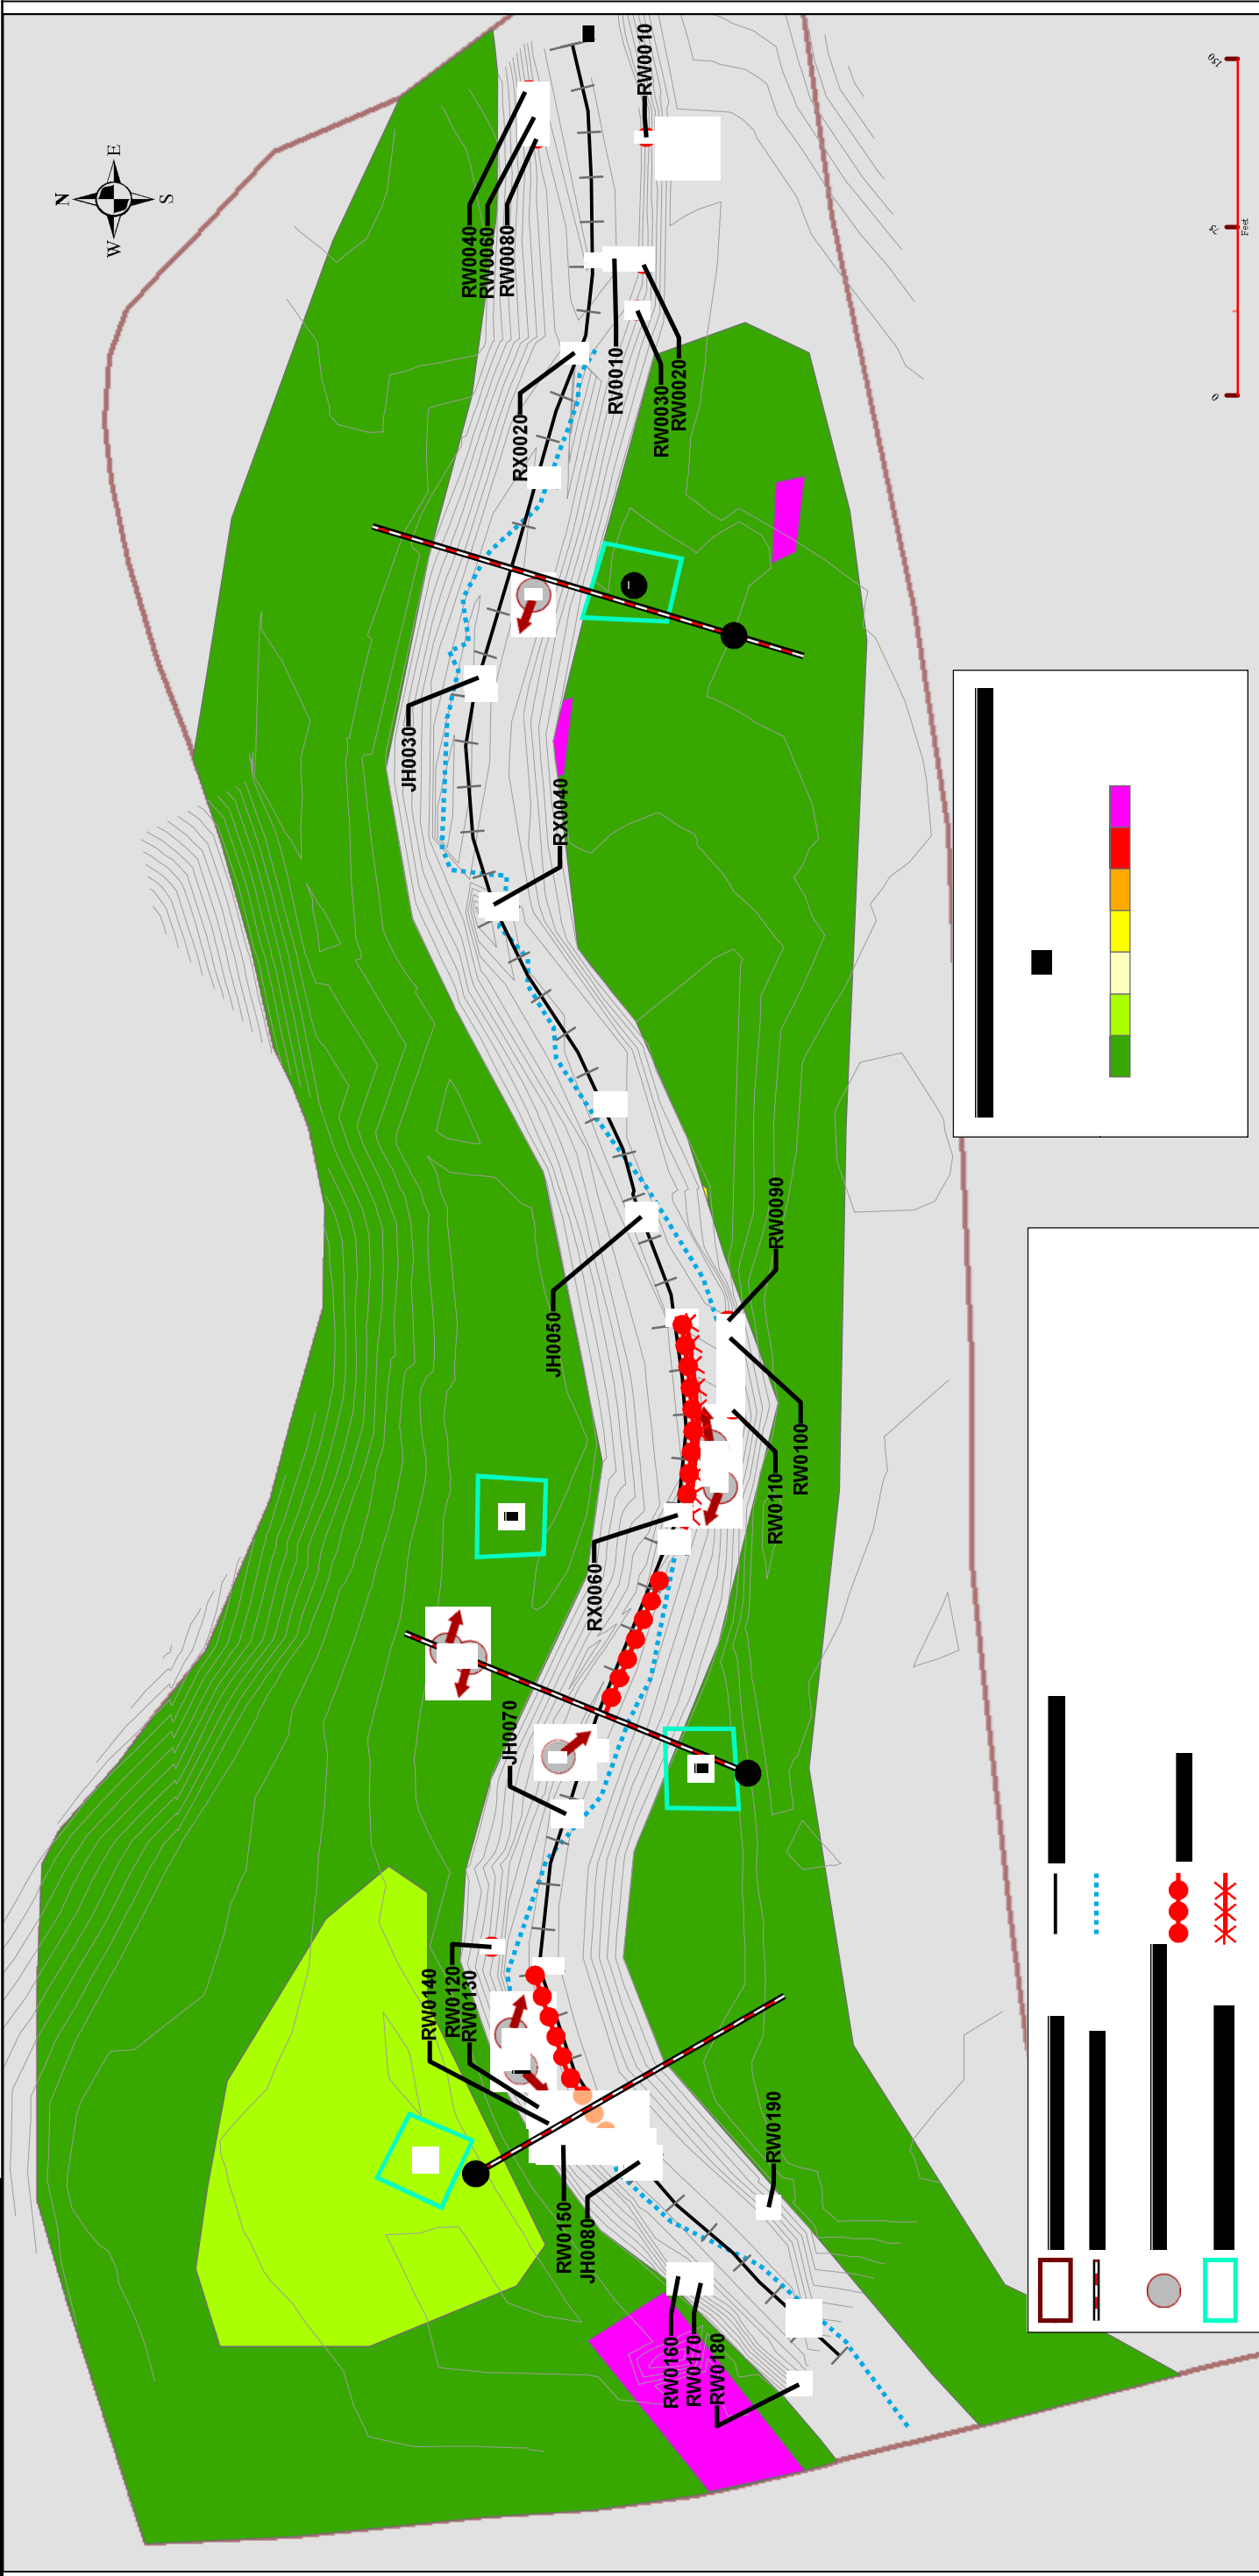
The kudzu (*Pueraria montana*) population reported during the MY2 2005 monitoring report remains on site. The population falls within an isolated area near Clear Creek Road and does not appear to be spreading. A small riparian area upstream of the kudzu population along the right bank does not appear to be thriving. Vegetation growth in this area is more scattered and less vigorous than the rest of the site. Russian olive (*Elaeagnus pungens*) grows in isolated populations (3-4 specimens) throughout the site. The larger populations are shown on Figure 2.

Appendix A provides representative photos of problem areas and sampling areas. Figure 2 shows the problem areas.

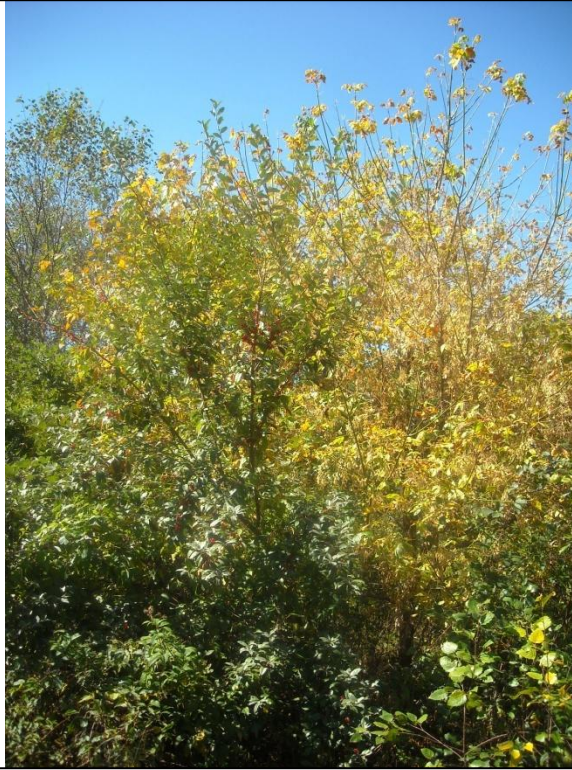
VP1: Stand of Russian Olive. Typical of stands scattered through site.

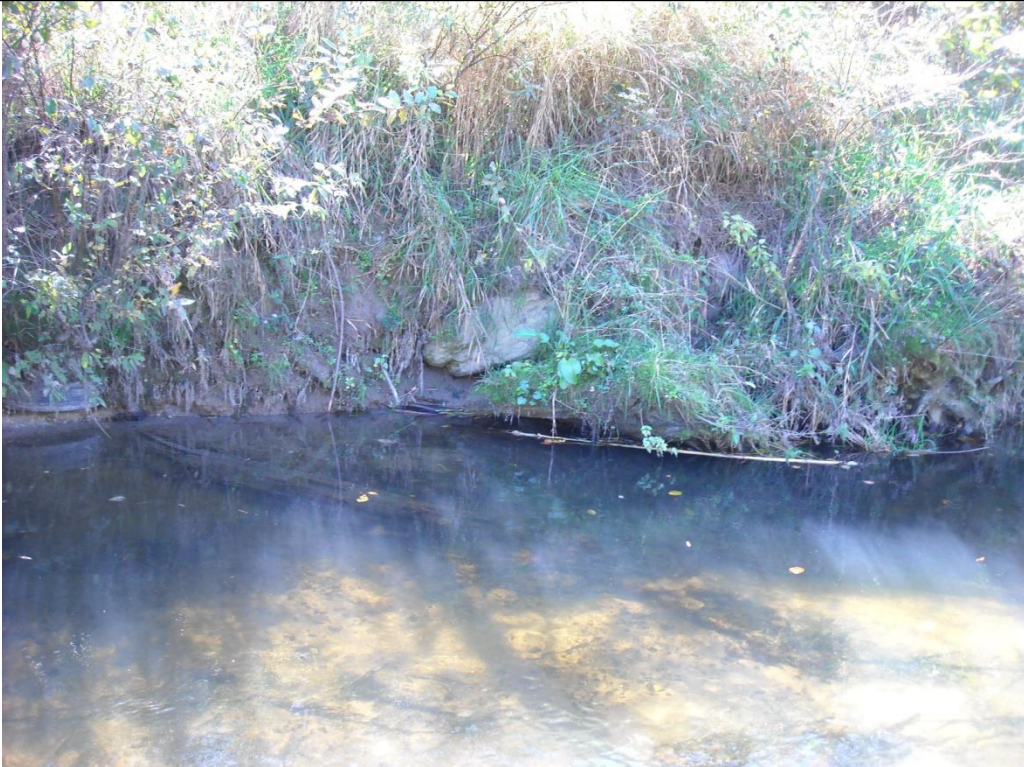
Table I. Stream Problem Areas Clear Creek Stream Restoration Site (EEP Project #92)					
Feature Issue	Reach	Station numbers	Description	Suspected Cause	Photo number
2008					
Aggradation/Bar Formation					
Bank scour		600 - 690	Bank Slump/ Bank Scour	Excessive shear stress	SP1
		715 - 780	Bank Scour	Back eddy from upstream in-stream stabilization	SP2
		900 - 1,000	Bank Scour	Excessive shear stress	SP3
Engineered structures – back or arm scour Etc.		545	Structure Collapse	Excessive shear stress	
		690	Excessive Arm Scour	Back eddy due to improper geomerty	
		990	Structure Collapse	Excessive shear stress	
		600 - 650	Rootwad Scour	Excessive shear stress	
		940 - 980	Rootwad Scour	Excessive shear stress	
2007					
Aggradation/Bar Formation					
Bank scour		100 - 150	Bank Scour	Excessive shear stress	
		200 - 240	Bank Scour	Excessive shear stress	
		410 - 430	Bank Scour	Excessive shear stress	
		710 - 750	Bank Slump/ Bank Scour	Back eddy from upstream in-stream stabilization

SP1: Eroding bank
Taken 10/13/2008

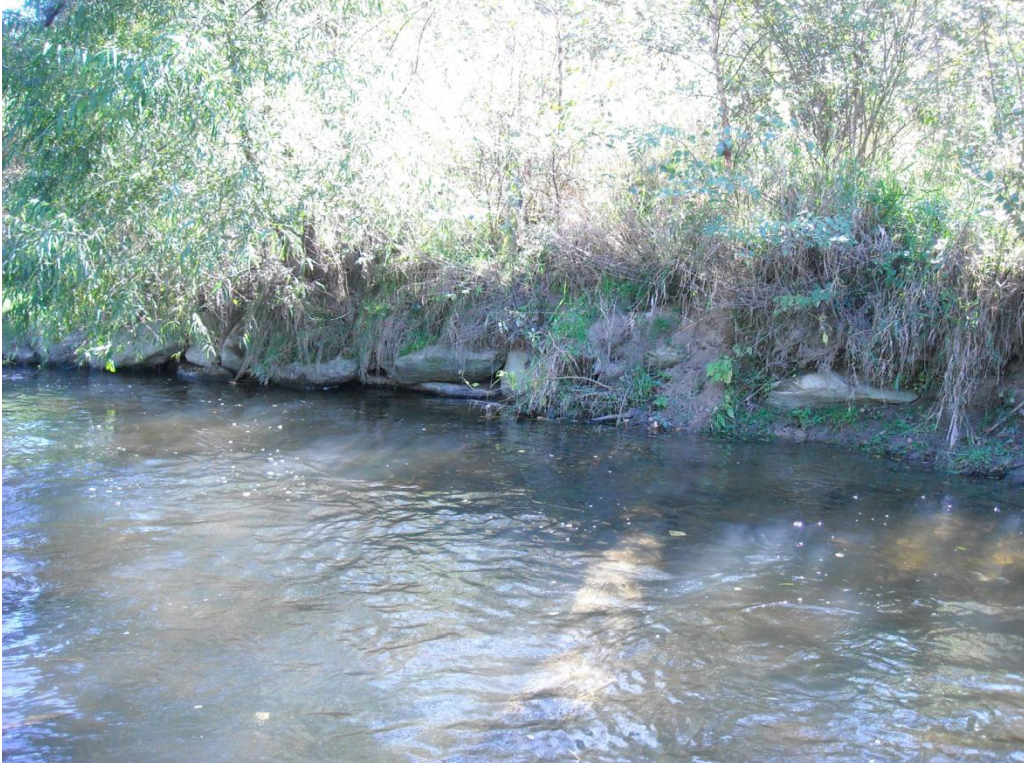
SP2: Eroding bank with undercut rootwads
Taken 10/13/2008

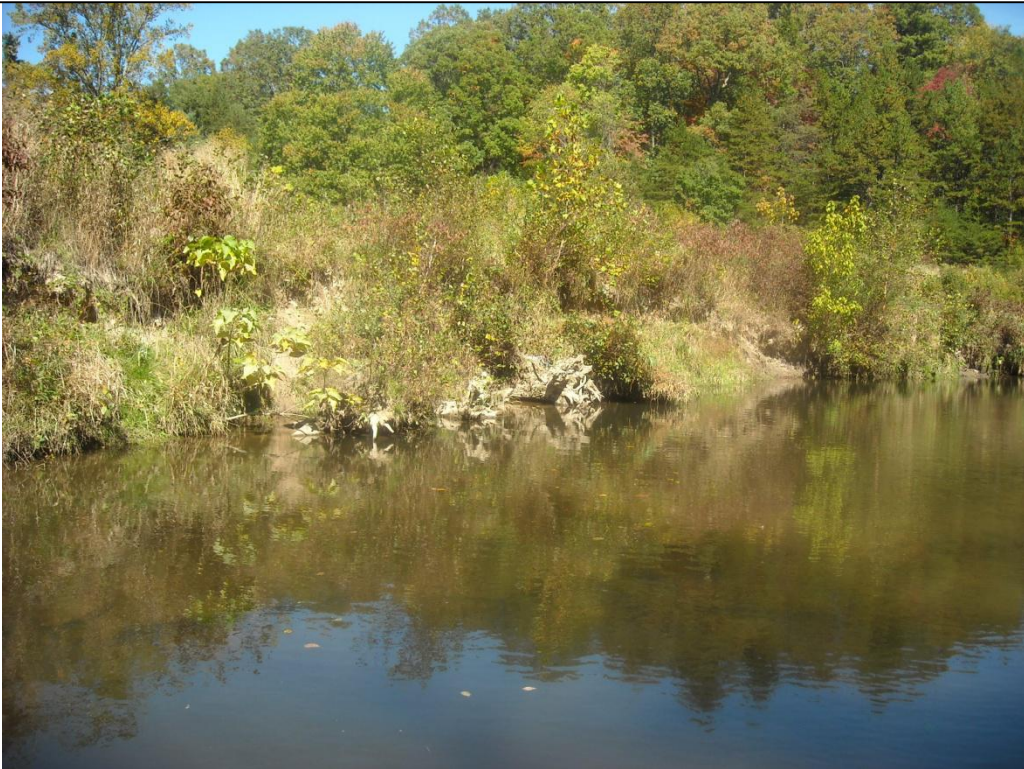
SP3: Scour behind rootwads
Taken 10/13/2008
