Annual Monitoring Report

Monitoring Year 1 of 7

Cochran Stream and Wetland Restoration Site

NCDMS Project No.: 95720

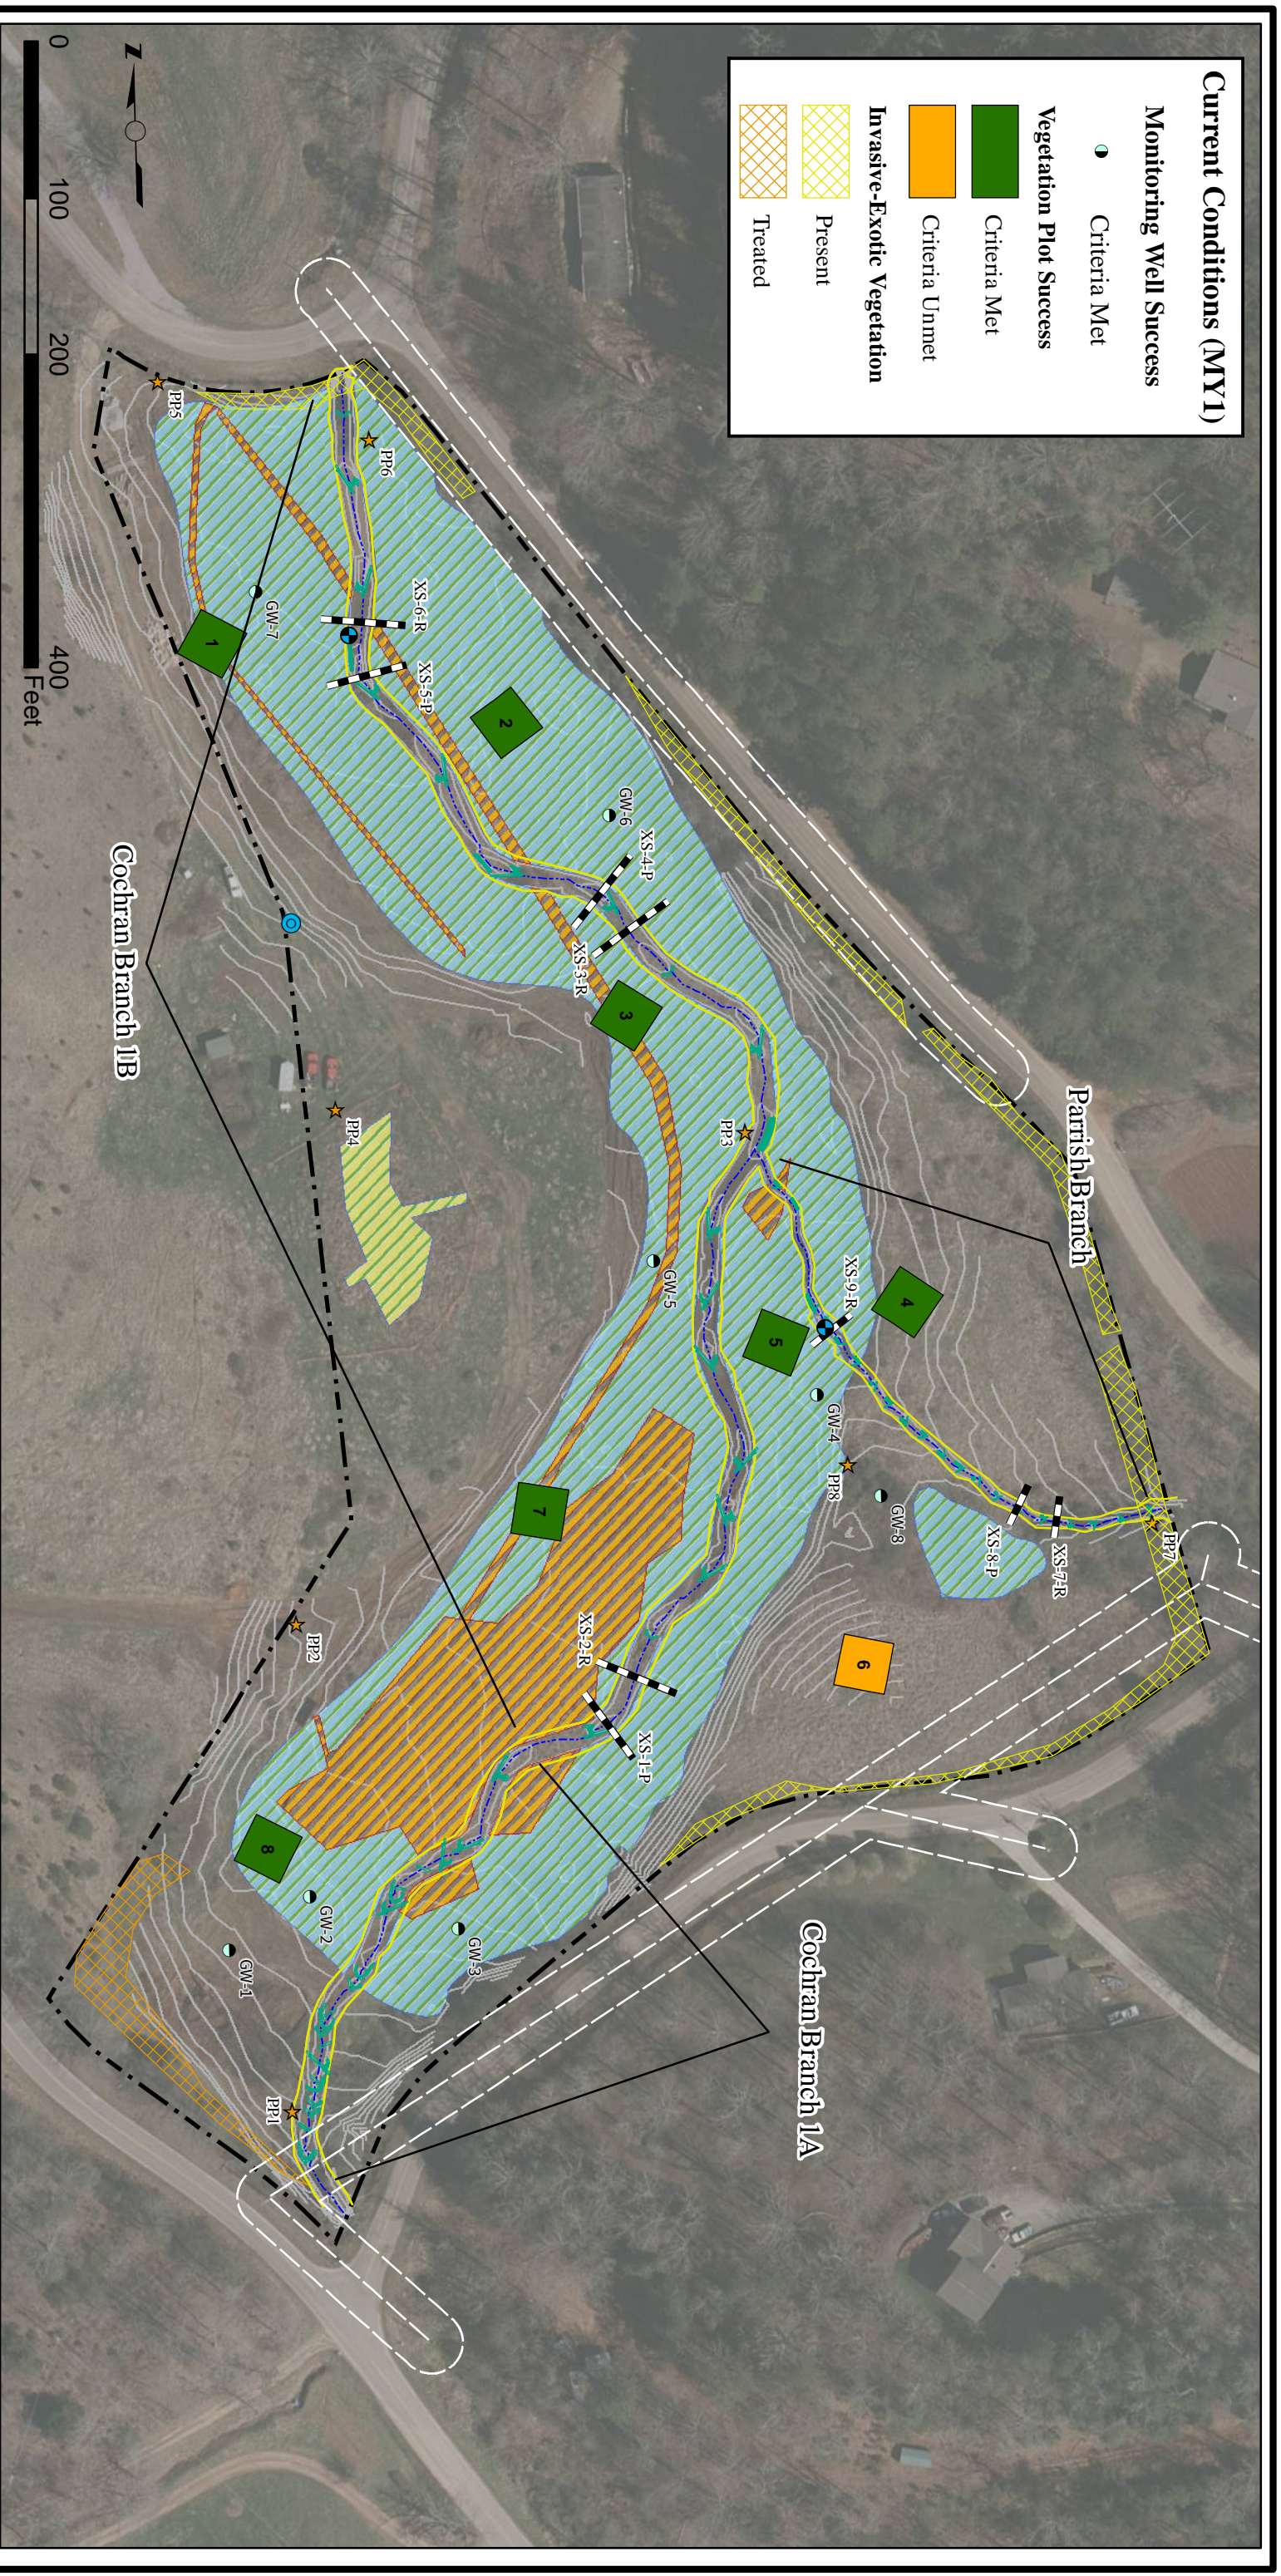
Figure 2. Cochran Branch Stream and Wetland Restoration Project - Monitoring Year 1

Visual assessment of the stream channel was performed to document signs of instability, such as eroding banks, structural instability, or excessive sedimentation. No indication of instability was observed during visual assessment and all structures are functioning as designed (Table 5 and Figure 2).

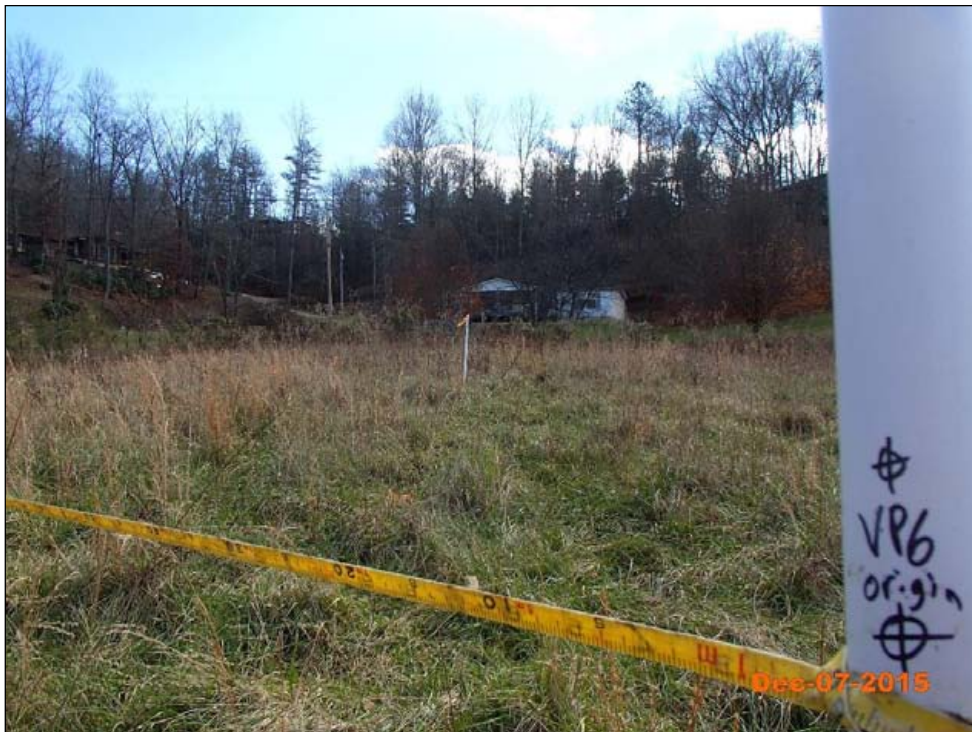
Cochran - Vegetation Monitoring Plot 6
December 7, 2015

planted stems per acre. Vegetation Plot 6 had a density of 121 planted stems per acre, well below the Year 5 and Year 3 target densities of 260 and 320 planted stems per acre, respectively. Planted stem densities among plots ranged from 121 to 769 planted stems per acre with an annual mean of 582 planted stems per acre across all plots. A total of 10 species were documented within the plots. When volunteer stems are included, the mean annual total stems per acre rose to 597 and ranged between 121 and 769 stems per acre. The lack of success in VP-6 can likely be attributed to the location of this plot on top of a small knoll, where it is generally dryer, followed by a dry summer. Additionally, vegetation within, and surrounding, the plot is dominated by fescue. This area will be replanted during spring 2016.

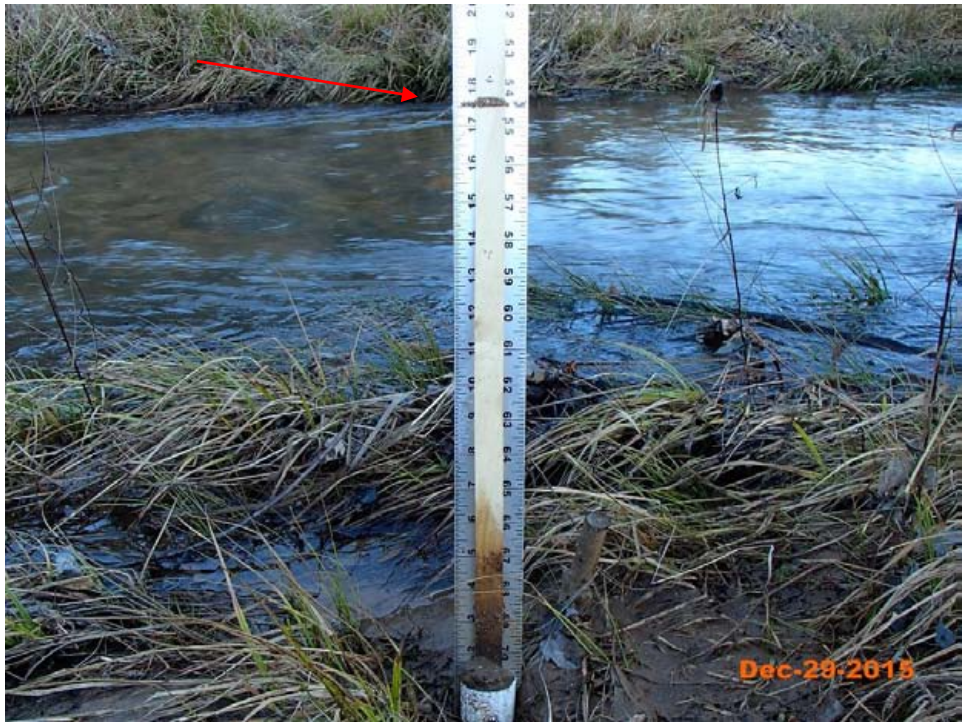
Photo #1- Cochran Branch Crest Gauge

During a December 2015 site visit, one bankfull event was recorded on Cochran Branch (mainstem), at 0.86 feet above bankfull (Table 12). This is the first bankfull event since project completion.
