Annual Monitoring Report

Monitoring Year 2 of 7

Cochran Stream and Wetland Restoration Site

NCDMS Project No.: 95720

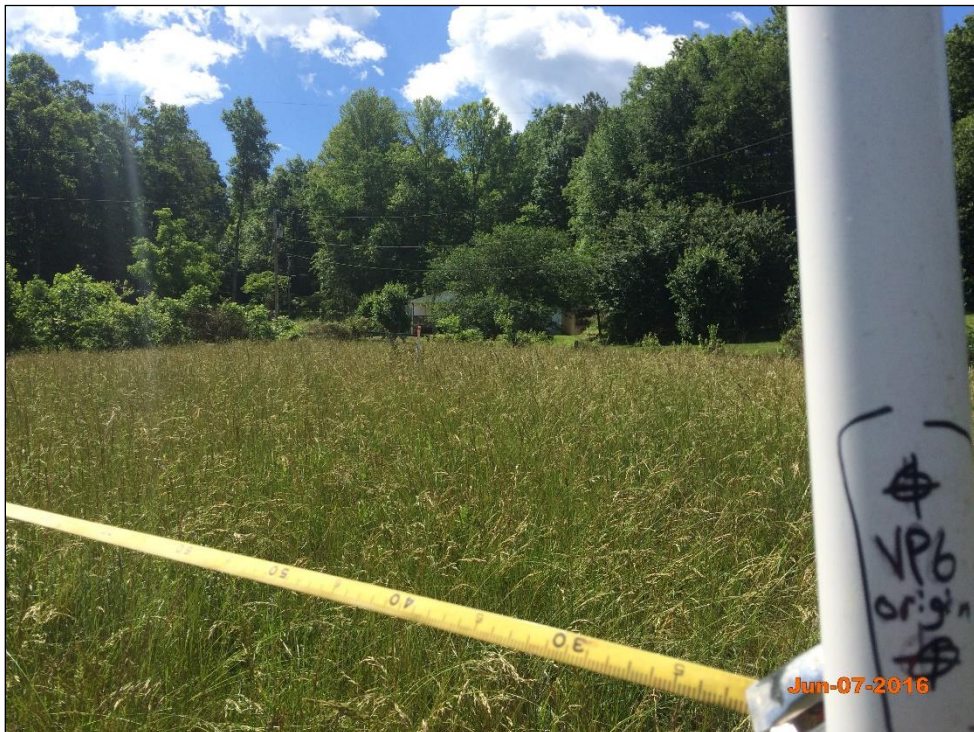
Cochran - Vegetation Monitoring Plot 6
June 7th, 2016

Monitoring of the permanent vegetation plots (n = 8; VP) was completed during Junes 2016. Summary tables and photographs associated with MY2 monitoring are located in Appendix C. MY2 monitoring data indicates that all but VP-6 are on track to meet the MY3 interim success criteria of 320 planted stems per acre. Planted stem densities among plots ranged from 121 to 688 planted stems per acre with an annual mean of 541 planted stems per acre across all plots. A total of 12 species were documented within the plots. When volunteer stems are included, the mean annual total stems per acre rose to 607 and ranged between 243 and 728 stems per acre. The lack of success in VP-6 can likely be attributed to the

location of this plot on top of a small knoll, where it is generally dryer, followed by a dry summer. Additionally, vegetation within and surrounding the plot is dominated by fescue (*Festuca* spp.). This area will be replanted during the early part of 2017.

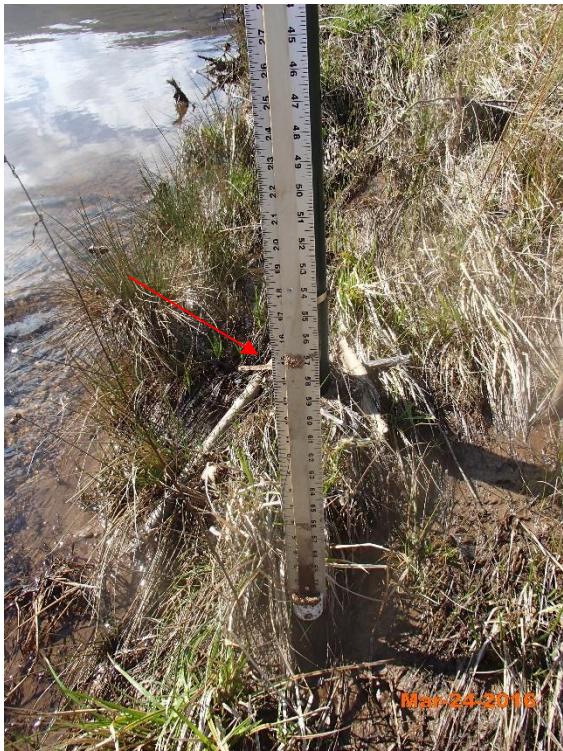
Photo #1 - Cochran Branch Crest Gauge

Two bankfull events occurred on Cochran Branch (mainstem) during 2016, one each during March and August. These events measured 0.68 and 0.58 feet above bankfull (Appendix E Table 12). These are the second and third bankfull events recorded on Cochran Branch since project completion.
