Annual Monitoring Report

Monitoring Year 3 of 7

Cochran Stream and Wetland Restoration Site

NCDMS Project No.: 95720

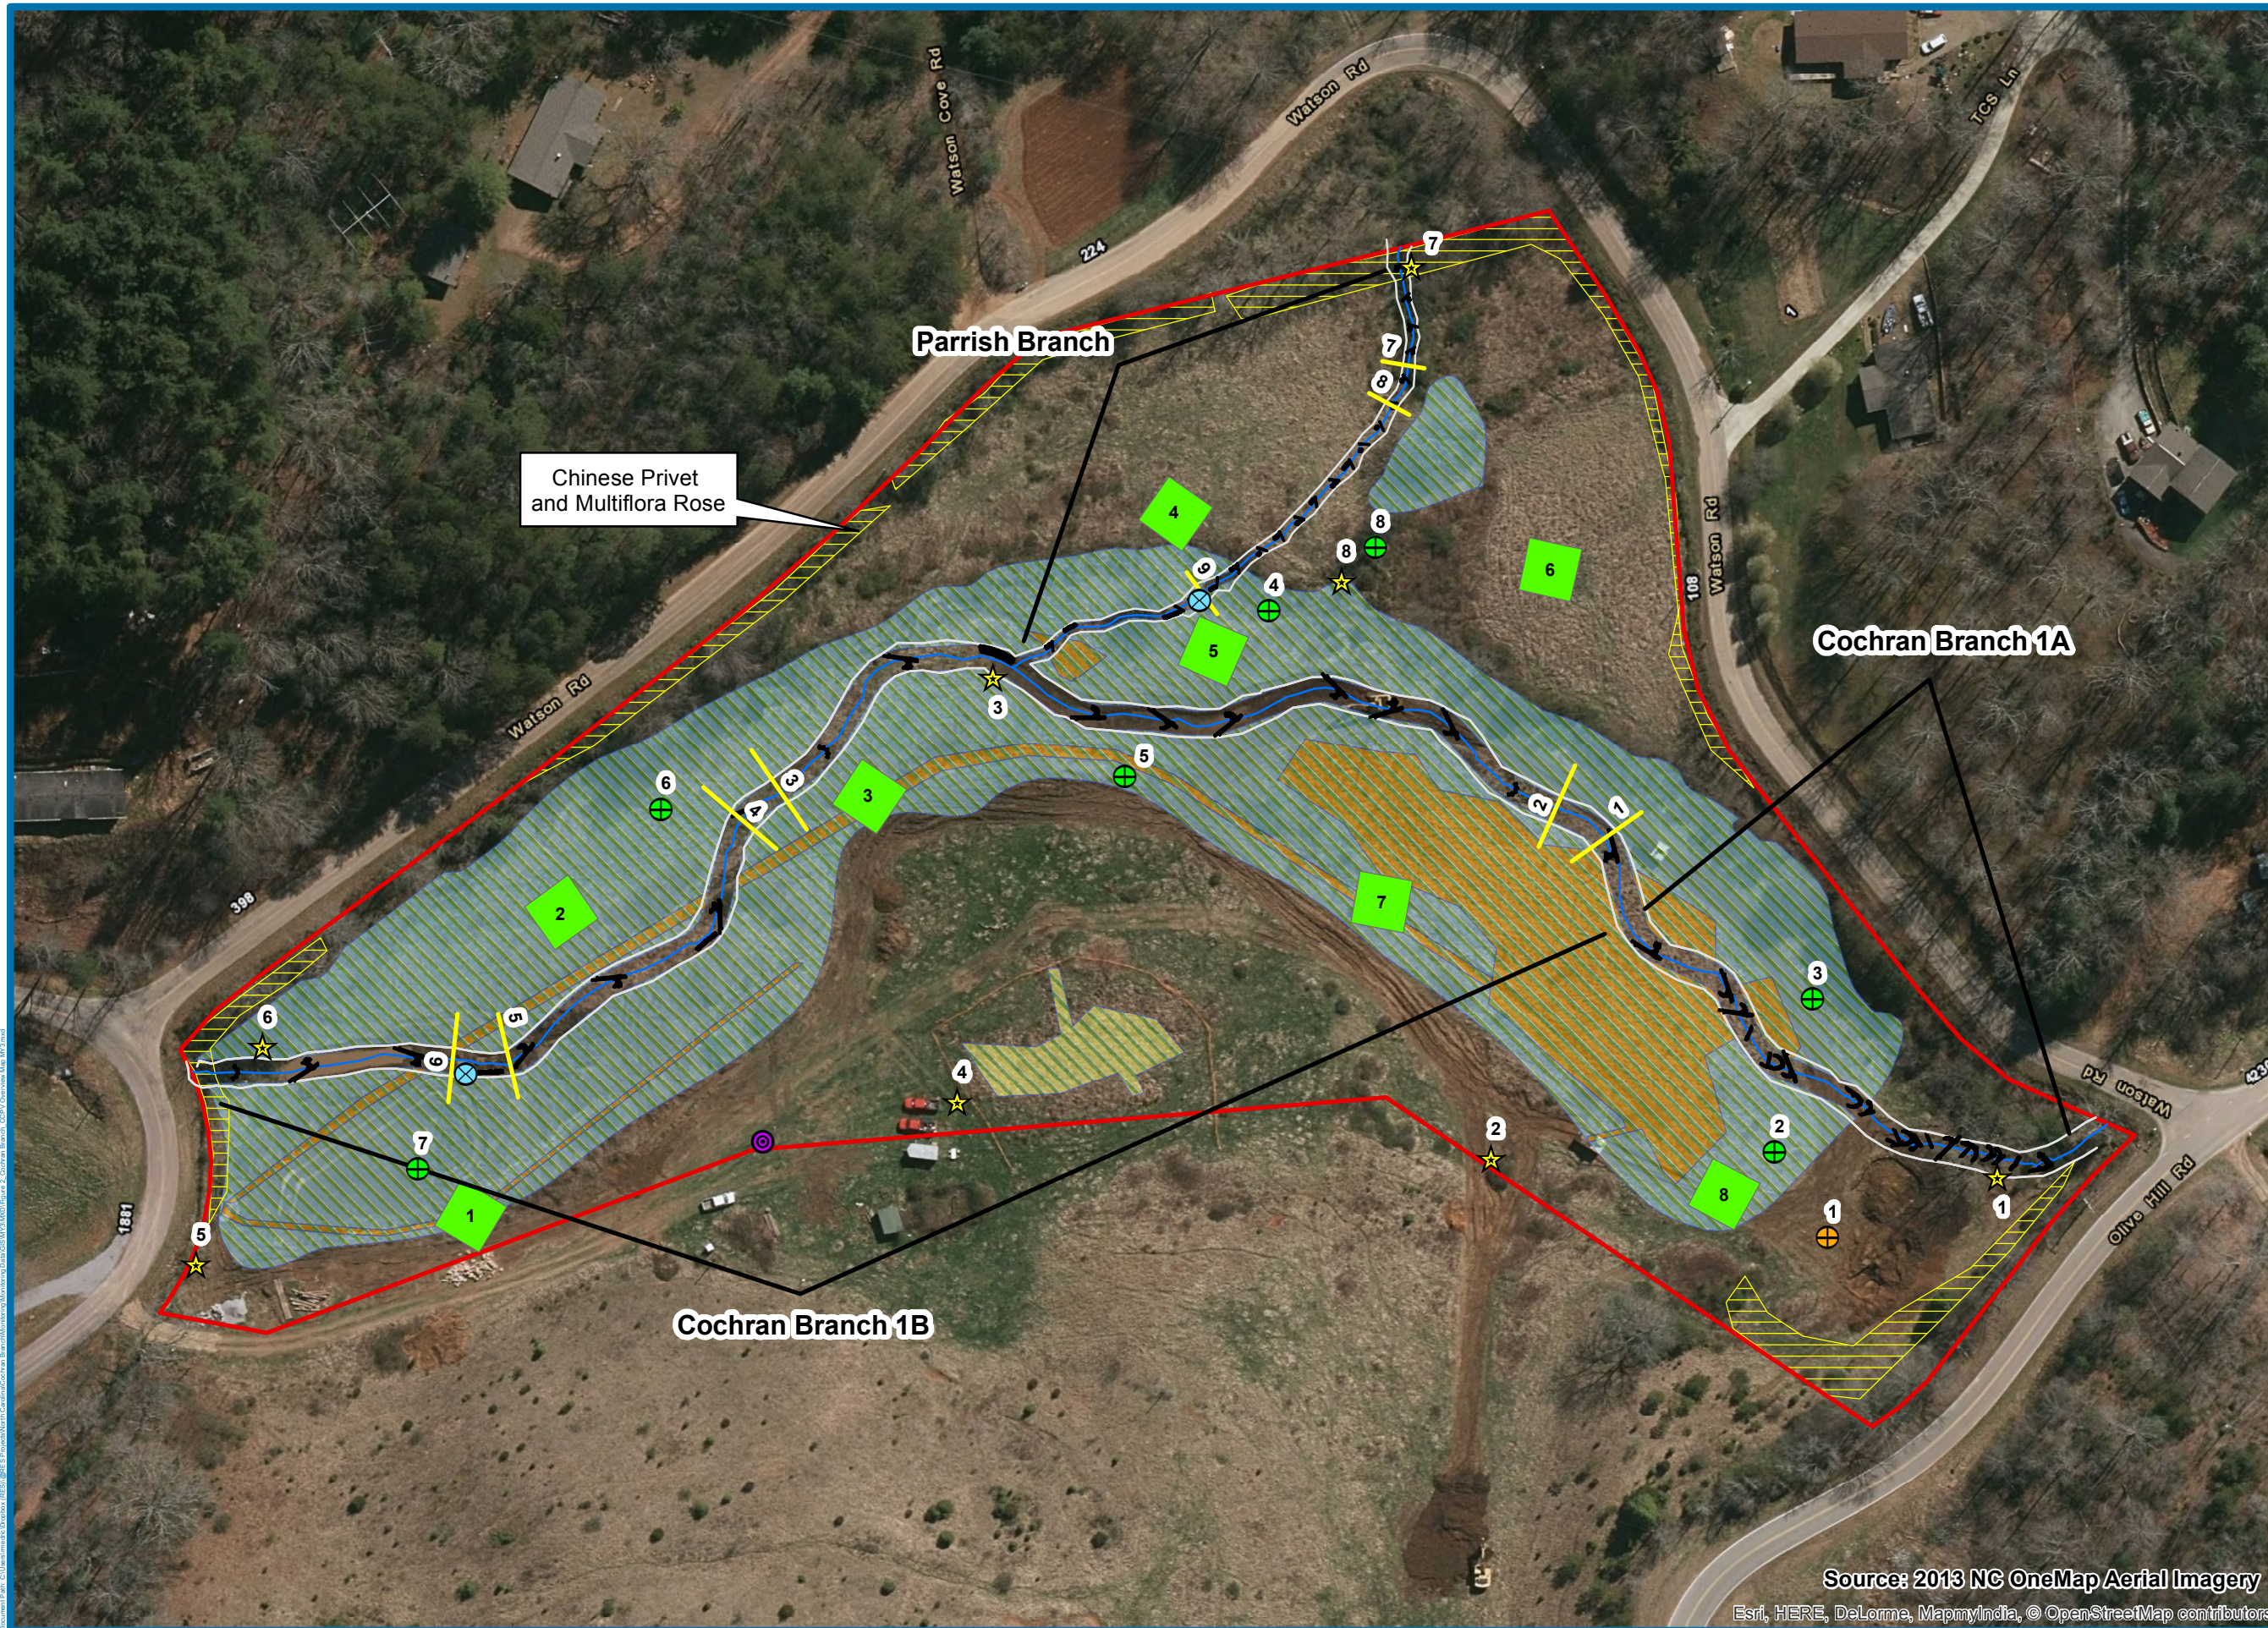
Chinese Privet
and Multiflora Rose

No invasive treatment was conducted in MY3. The invasives are limited to the edge of the easement boundary and will be treated in MY4. This has been added to the report.

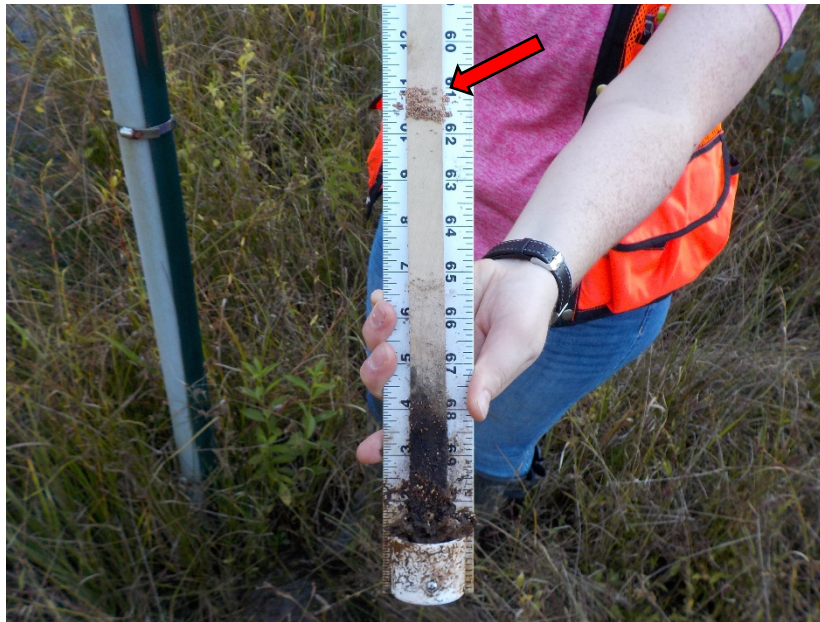
Crest Gauge @ Cochran Branch – 0.92 ft.

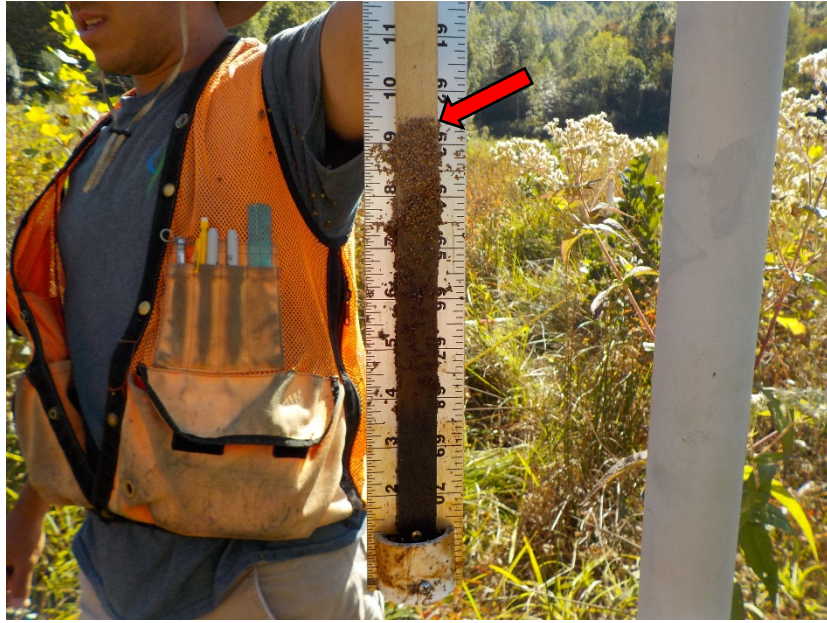
Crest Gauge @ Parrish Branch – 0.79 ft.

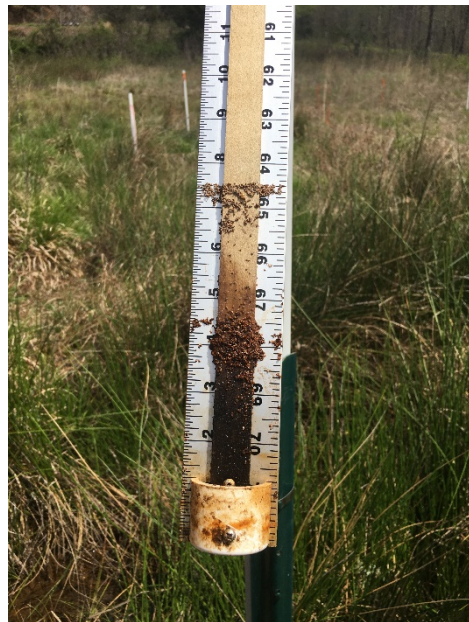
Crest Gauge @ Parrish Branch – 0.38 and 0.60 ft.
