Annual Monitoring Report

Monitoring Year 4 of 7

Cochran Branch Stream and Wetland Restoration Site

NCDMS Project No.: 95720

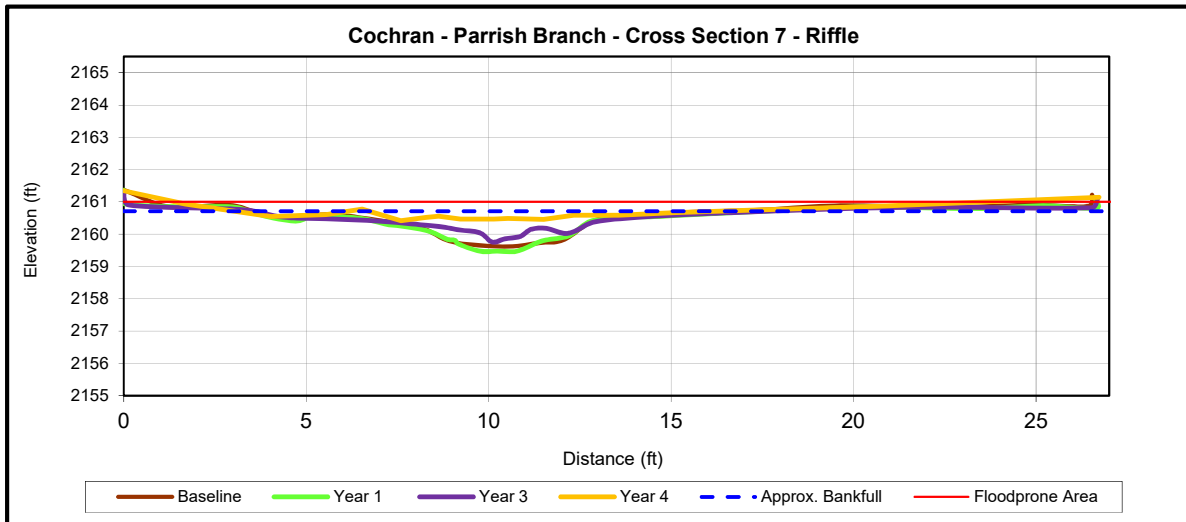
General: The Parrish Branch cross sections (#7, #8, and #9) show notable aggradation. DMS also conducted a site visit on 11/13/18. Based on a review of the data and a site visit, DMS believes that the 396 SMUs associated with Parrish Branch are potentially "at risk" and may not receive full mitigation credit at project closeout. DMS is recommending that the IRT visit the Cochran Branch site as part of the DMS credit release site visits in 2019. RES should not invoice for MY4 (2018) until the IRT provides input during the 2019 credit release meeting and/ or site visit.

Visual assessment of the stream channel was performed to document signs of instability, such as eroding banks, structural instability, or excessive sedimentation. Parrish Branch shows signs of aggradation in segments along the reach, likely due to dense herbaceous growth, specifically *Juncus* spp., in and around the channel that is attenuating water flow through the channel. RES plans to heavily livestock the banks of Parrish Branch as well apply herbicide to the vegetation in the channel. With the exception of Parrish Branch, no indication of instability was observed during visual assessment and all structures are functioning as designed (**Appendix A Figure 2 and Appendix B Table 5**).

[Noted. RES plans on re-livestaking the banks of Parrish Branch to help shade out the vegetation that is trapping the sediment in the channel.](#)

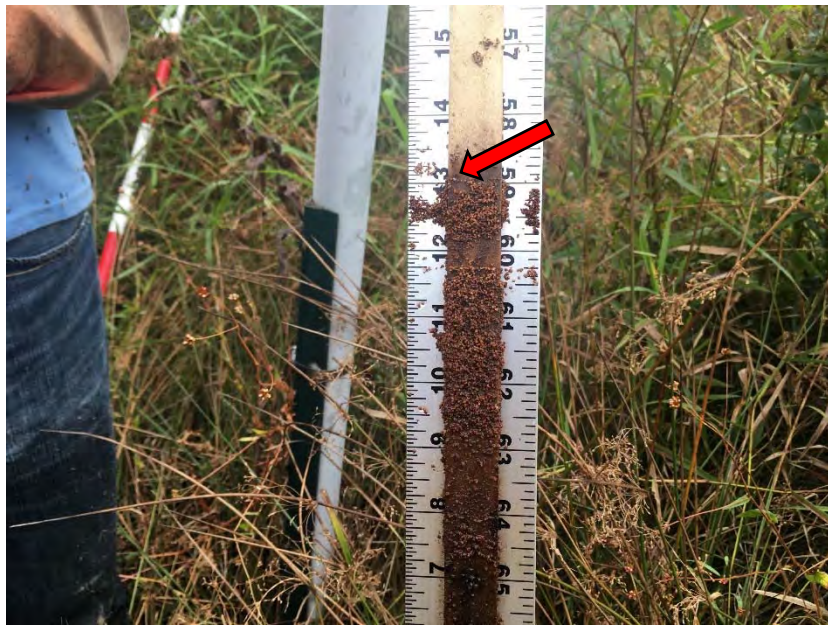
Multiple bankfull events occurred on Parrish Branch during MY4 with the highest event measured as 1.08 feet (**Appendix E; Table 14**). As for Cochran Branch (mainstem), the crest gauge was damaged due to an ant infestation and will be replaced this winter. Parrish Branch has had at least four bankfull events (at least one in MY4 and three in MY3) while Cochran Branch has had four bankfull events prior to MY4.

Crest Gauge @ Cochran Branch – 1.08 ft.
