Annual Monitoring Report

Monitoring Year 6 of 7

Cochran Branch Stream and Wetland Restoration Site

NCDMS Project No.: 95720

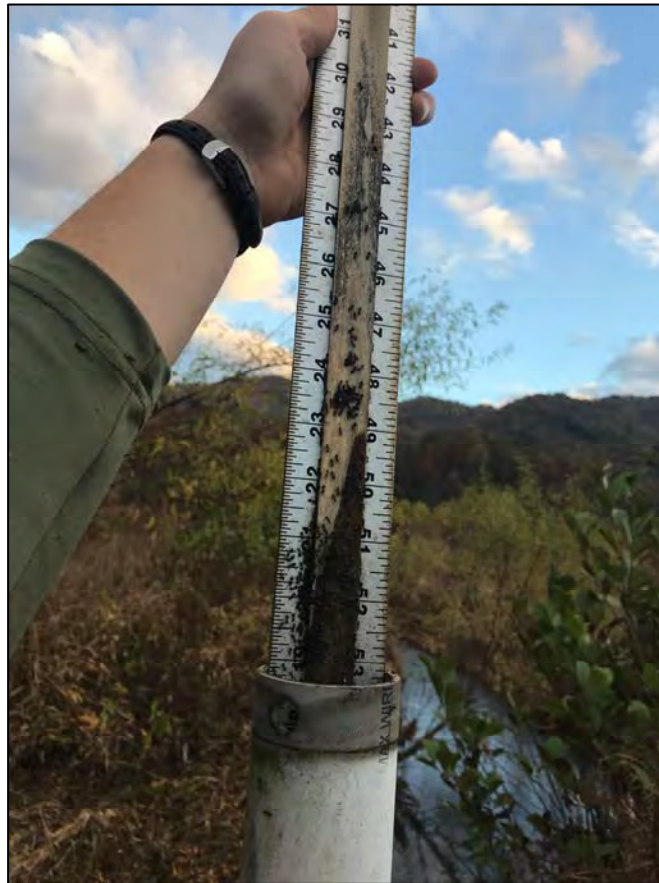
At least two bankfull events were observed in MY6. The crest gauge on Cochran Branch had a water mark that was 1.92 feet high and Parrish Branch had a water mark that was 1.33 feet high. Photos of the crest gauges are in Appendix E.

Photo 1 – Cochran Branch – 1.92 ft

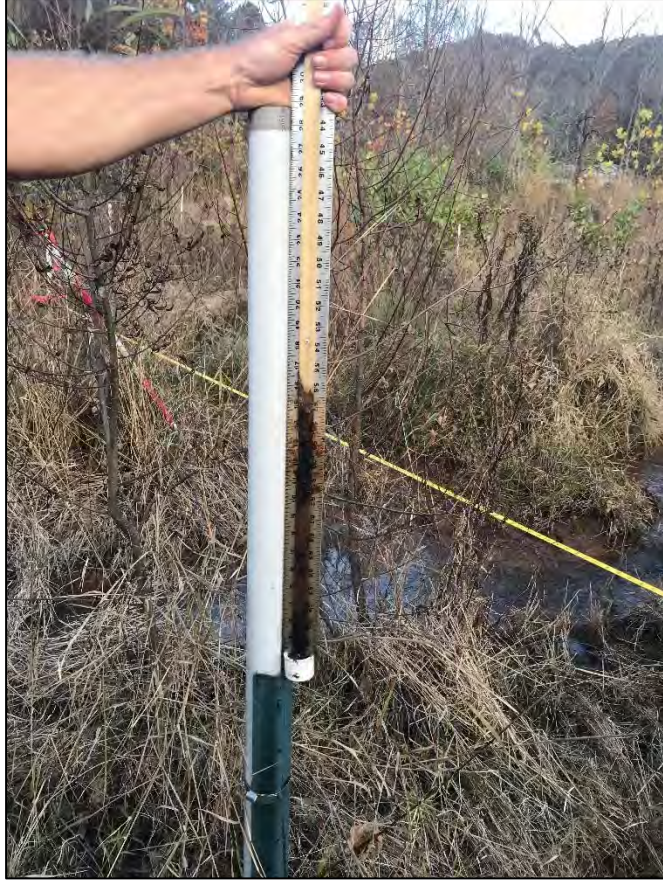
Photo 2 – Parrish Branch – 1.33 ft
