**Coddle Creek Tributary
(Indian Run) Stream Restoration
Project # 94**

Baseline Monitoring Document and As Built Baseline Report

Cabarrus County, North Carolina

Report Submission: September 2011

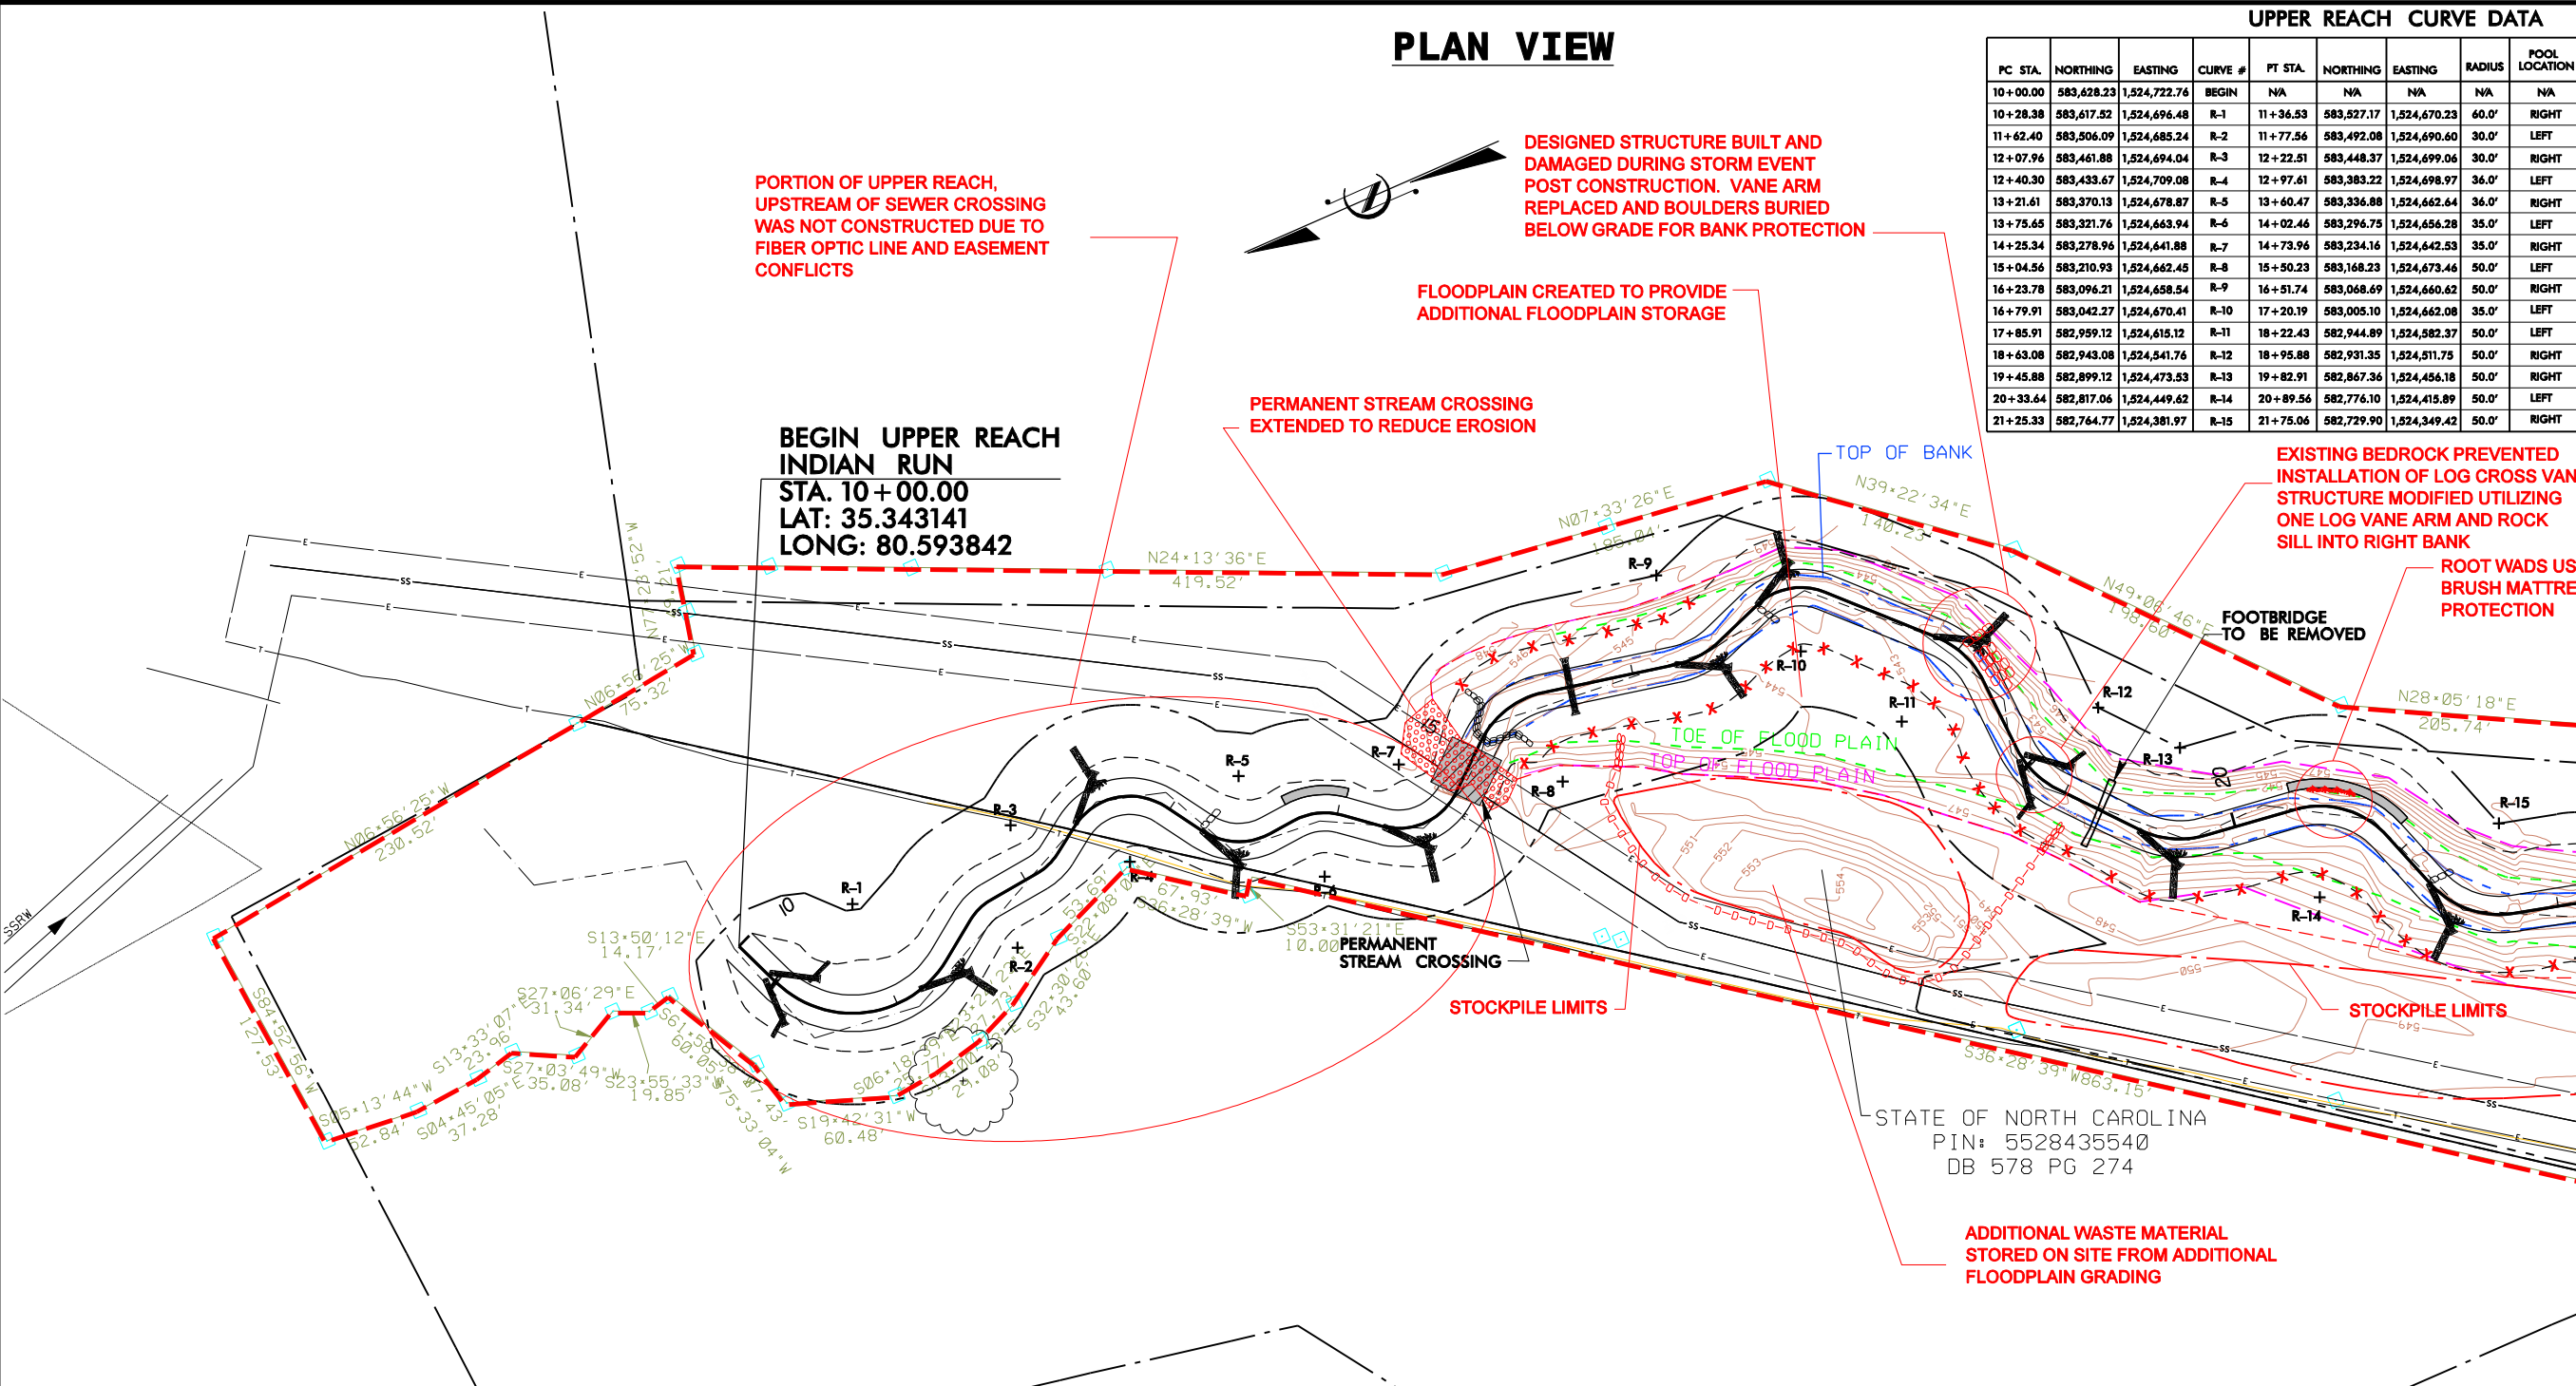
DESIGNED STRUCTURE BUILT AND DAMAGED DURING STORM EVENT POST CONSTRUCTION. VANE ARM REPLACED AND BOULDERS BURIED BELOW GRADE FOR BANK PROTECTION

ADDITIONAL WASTE MATERIAL STORED ON SITE FROM ADDITIONAL FLOODPLAIN GRADING
